U.S. 95 Long Bridge: Phase 1 Construction Repair

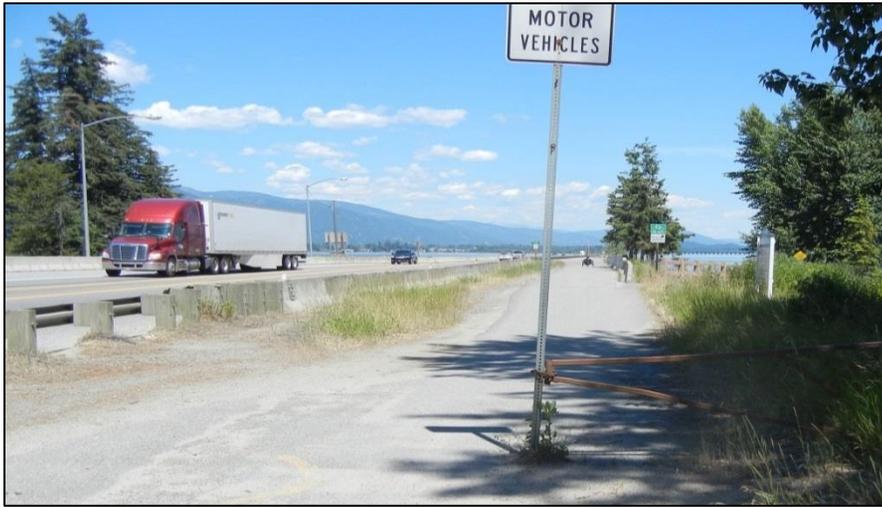
The work consisted of applying epoxy overlay to the deck of the Long Bridge (left).

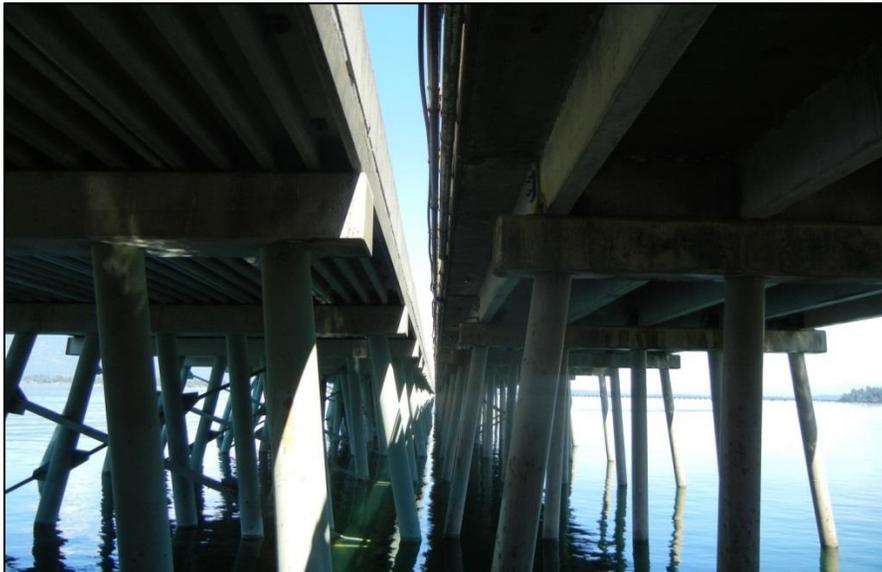
Work under the bridges consisted of applying fiber reinforced polymer wraps on some of the submerged piers and painting above the waterline level under the U.S. 95 Long Bridge. On the Pedestrian Bridge, expansion joints were repaired, saddles installed and support beams underslung at selected locations.

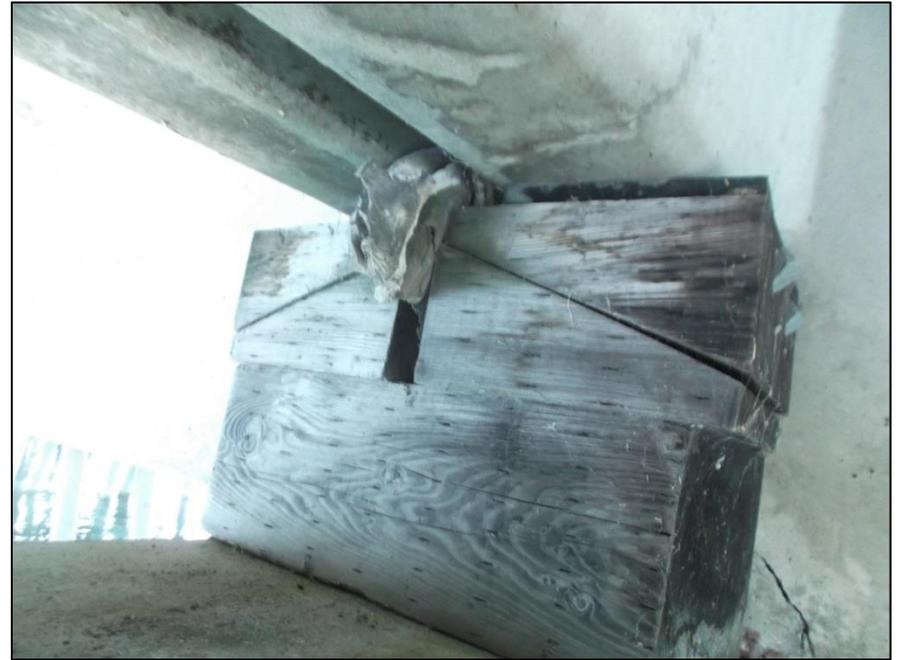
Large timbers were installed on the Pedestrian Bridge to reinforce bridge girders during construction.

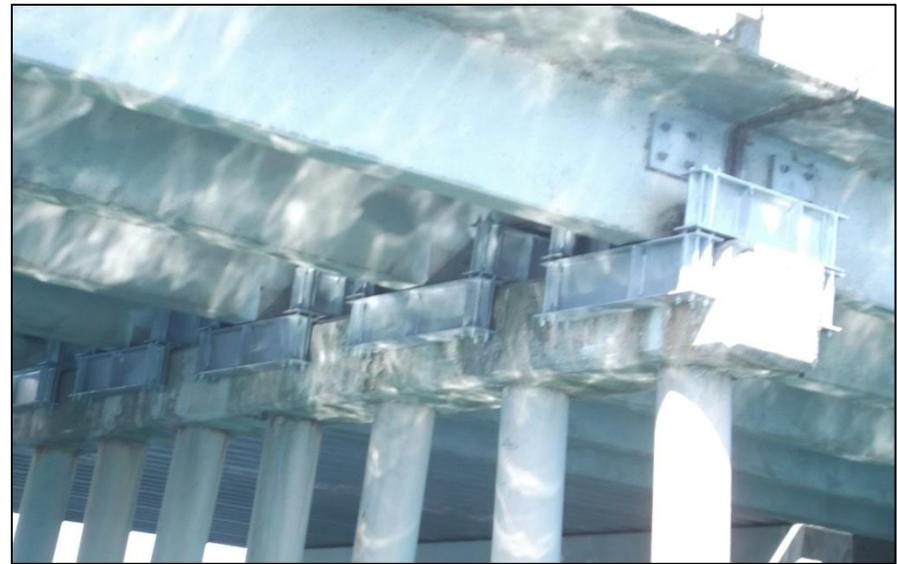
The large wood timbers were removed, girder-saddle assemblies were installed at girder locations at selected bents, and saddle jacks were adjusted to level expansion joints on the deck surface above.

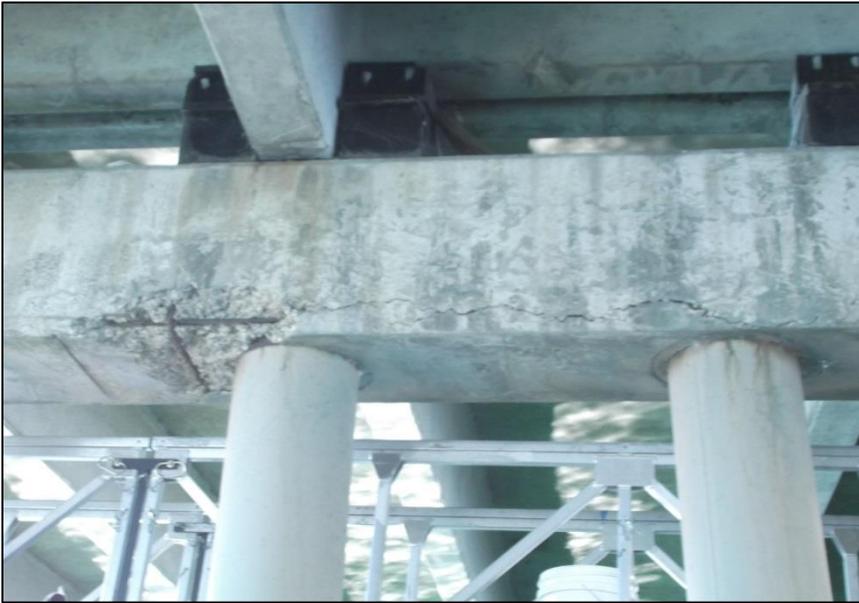
The contractor repaired and patched spalls on the Pedestrian Bridge; fixed scaling, delaminating, and honeycombing; and repaired deteriorated concrete on selected bent caps.

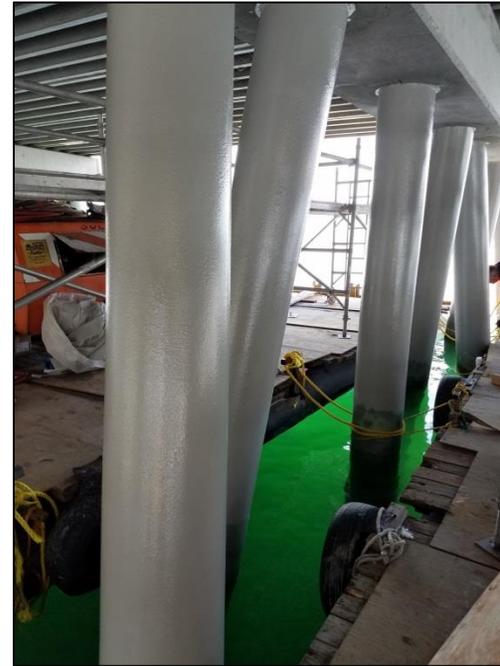
The surface was prepared by blasting and hand or power tooling. The contractor fully contained the operation, tested and disposed of surface preparation debris, furnished and applied paint, shielded adjacent areas from unwanted paint, and cleaned up after painting was completed.

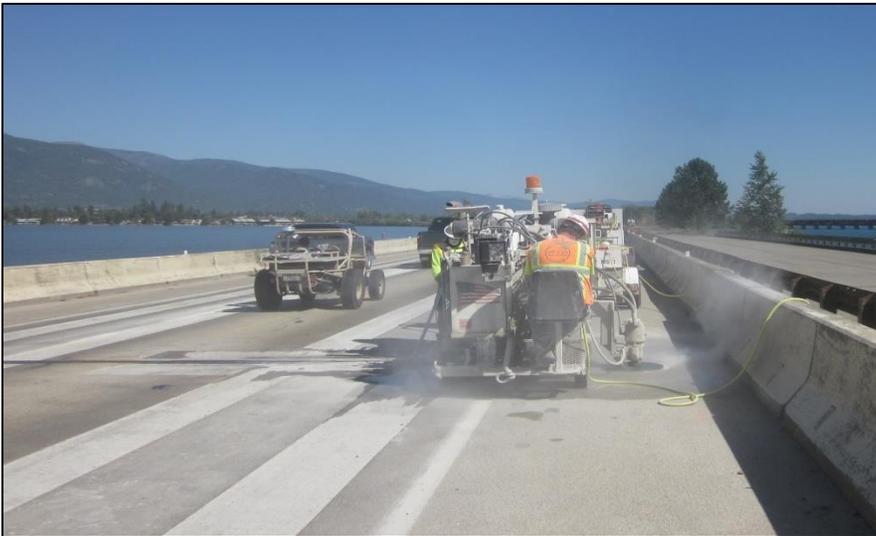
The contractor removed existing epoxy from the wheel paths on the bridge. After removal, the surface was prepared for application of an epoxy and aggregate overlay on the concrete bridge deck surface areas between the curb faces and from the beginning of the bridge to the end.

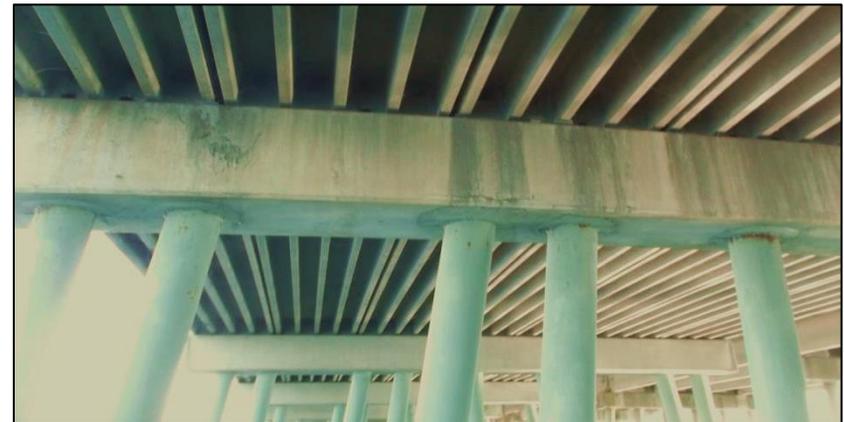
Crews inspected the bearing pads in selected locations. The superstructure was jacked up for the repositioning of misaligned bearings in those locations.
