**Your Safety • Your Mobility
Your Economic Opportunity**

Fatigue Crack Detection Using Unmanned Aerial Systems in Under-Bridge Inspection

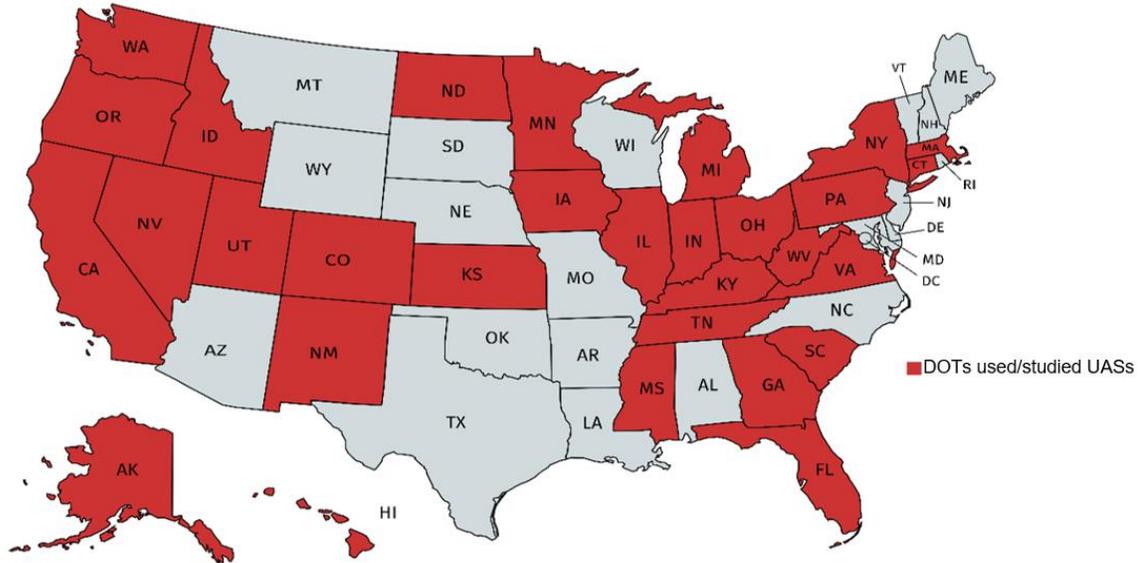
Figure 1. Map of State DOTs that Have Documented Past or Current Study of UASs

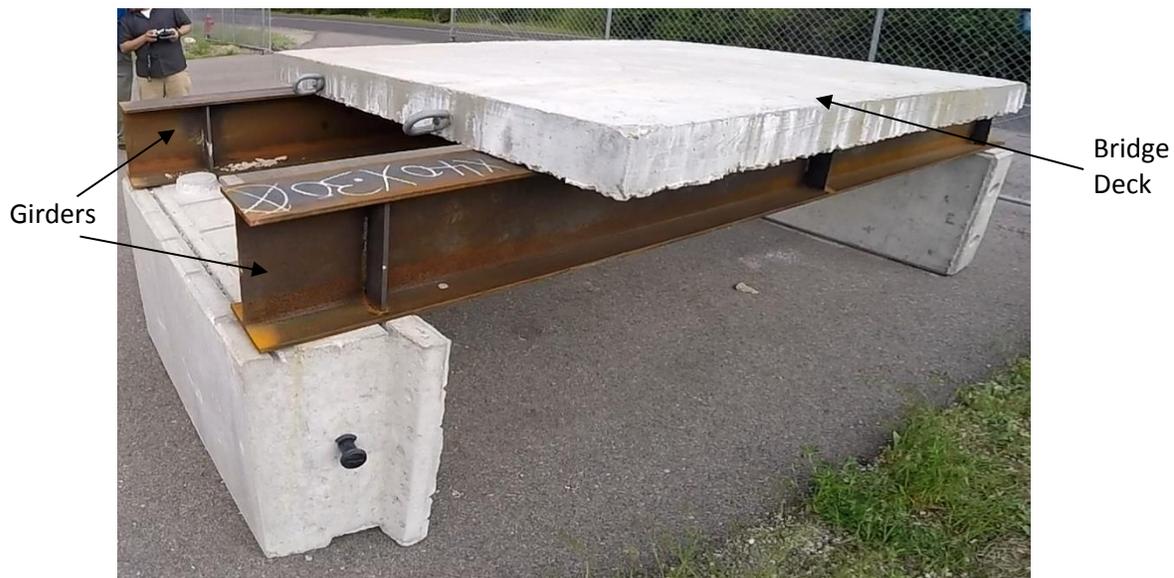
Figure 2. Small Bridge at the SMASH Lab

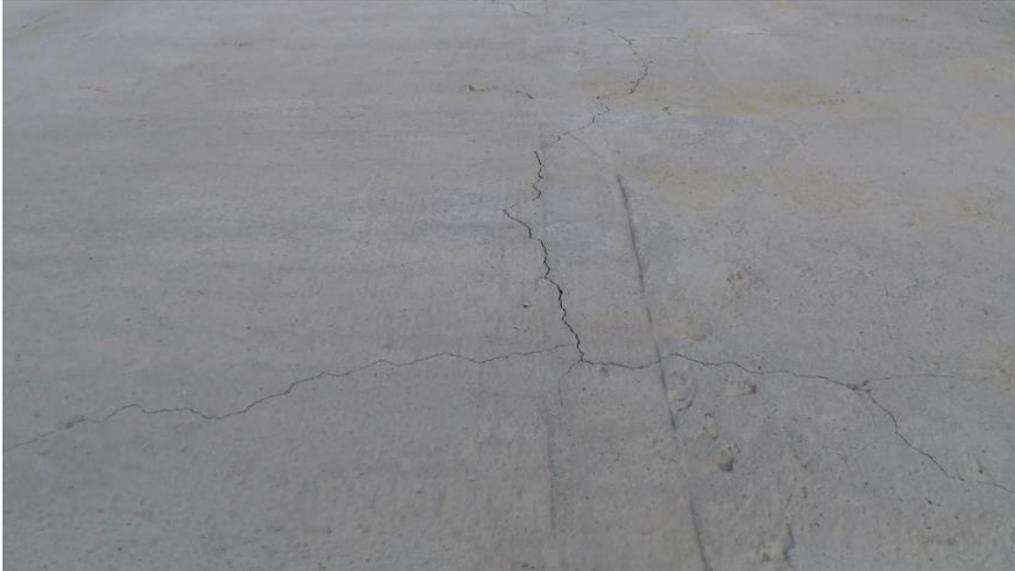
Figure 3. Example of Top Cracks in the Color Image Acquired by the UAS, E001

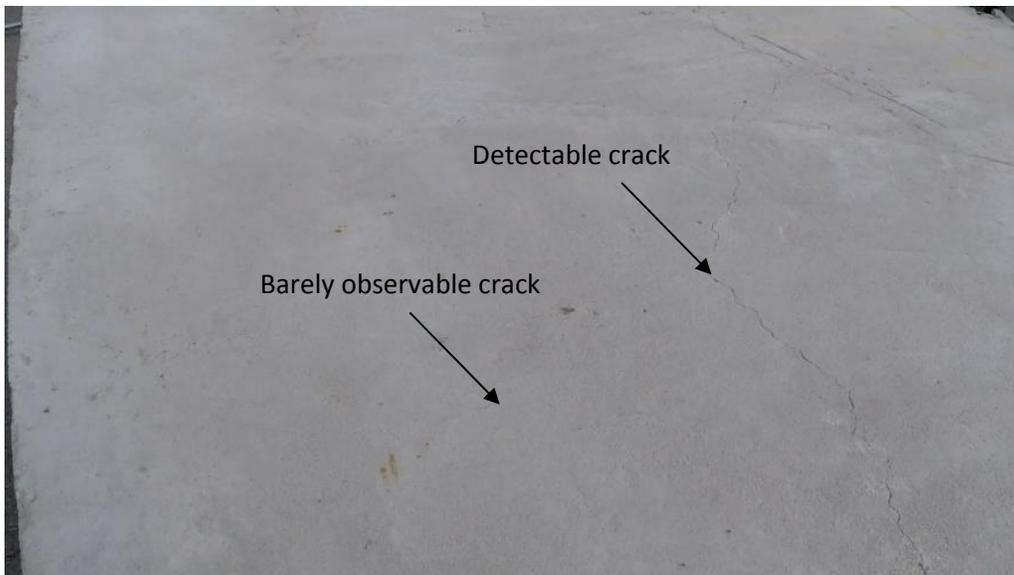
Figure 4. Variety of cracks' Dimensions on the Bridge Deck, E001

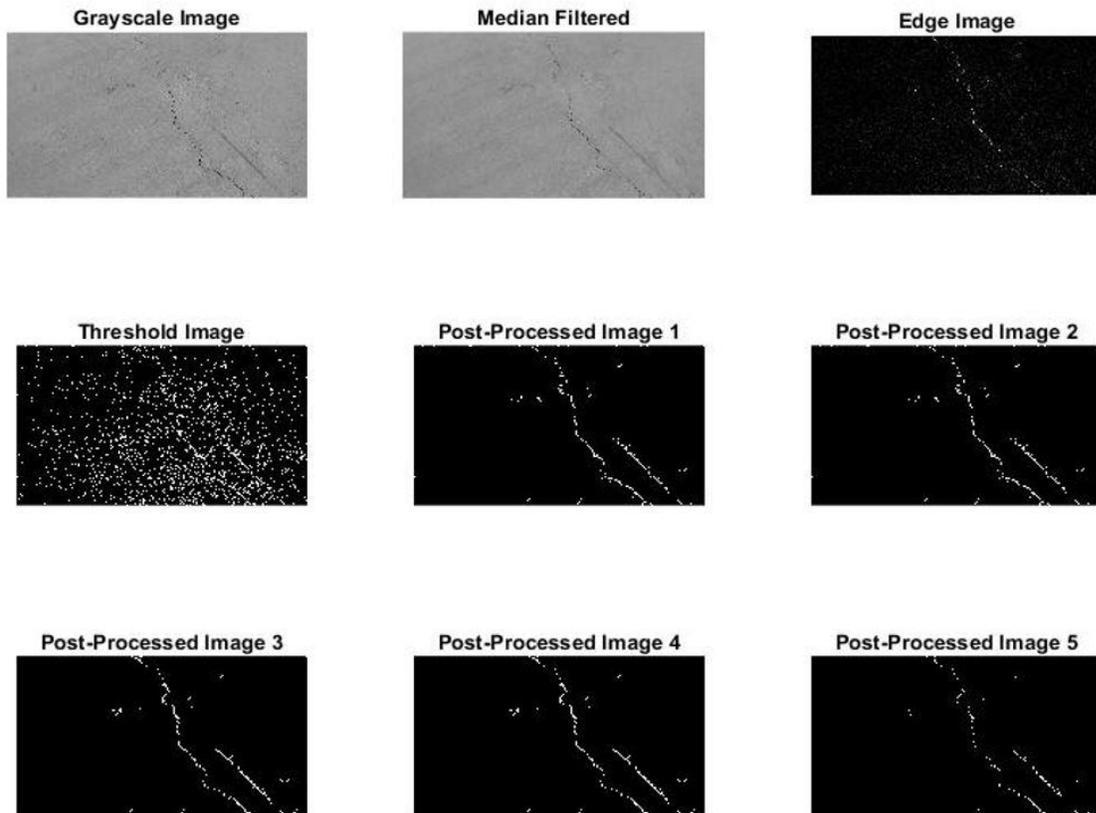
Figure 5. Automatic Crack Detection Based on UAS Images, E002

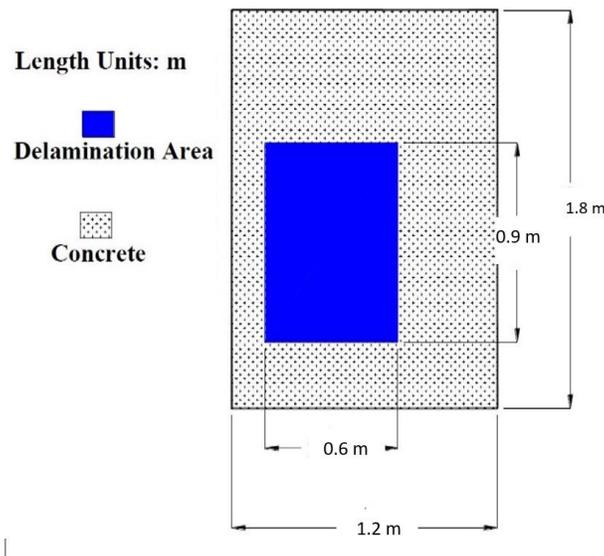
Figure 6. The Plan and Elevation View of the Deck and its Delamination, (E003)

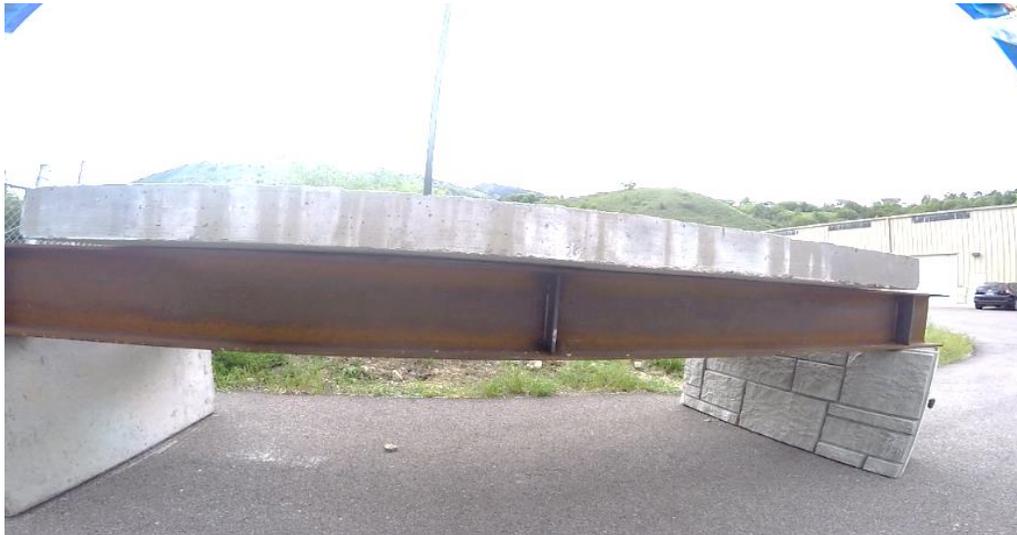
Figure 8. Steel Girder Surface Corrosion and Rust in the Image Acquired by UAS, E004

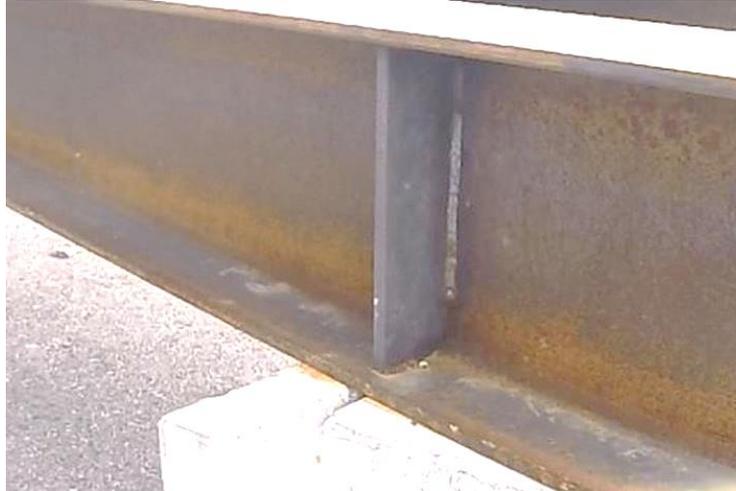
Figure 9. Visual Weld Inspection on the Small Bridge, E004

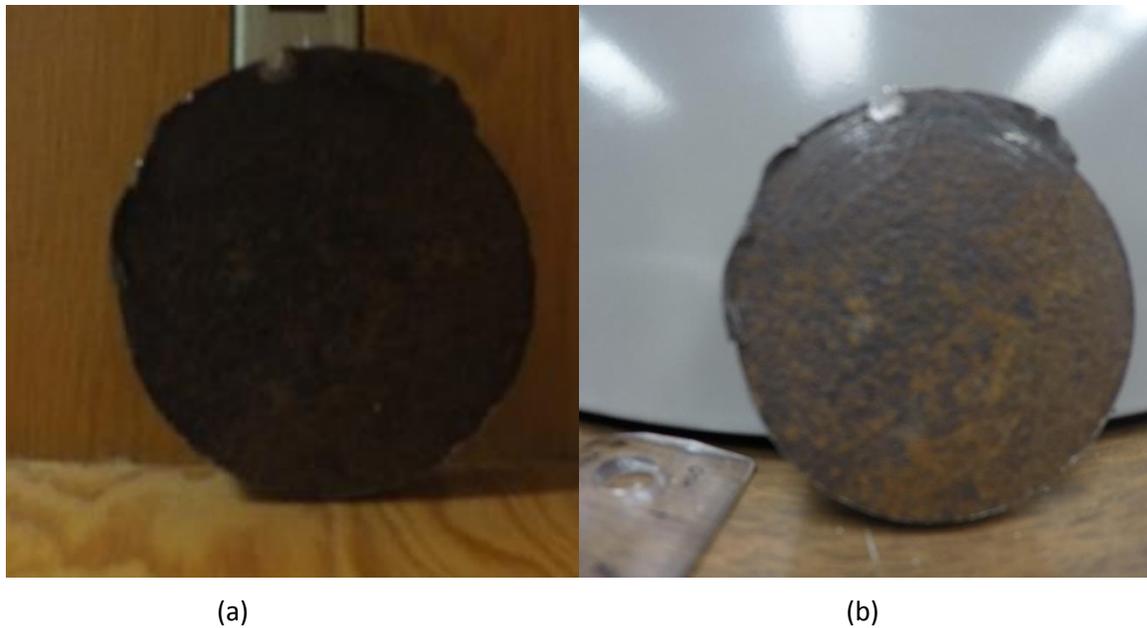
Figure 11. (a) Dark Condition, 10 cm (4 inches), GoPro (b) Normal Condition, 5 cm (2 inches), GoPro, E006

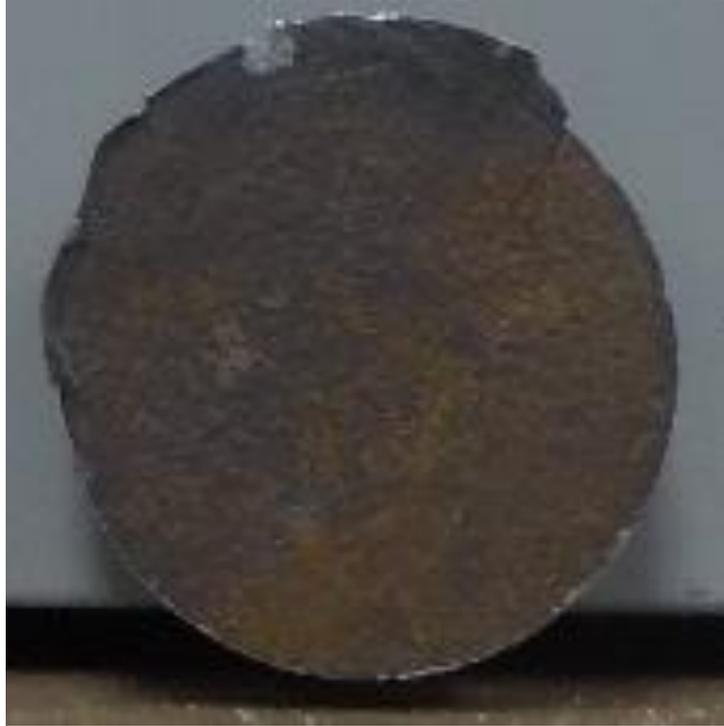
Figure 12. Normal Condition, 20 cm (8 inches), GoPro, Fatigue Crack Visible

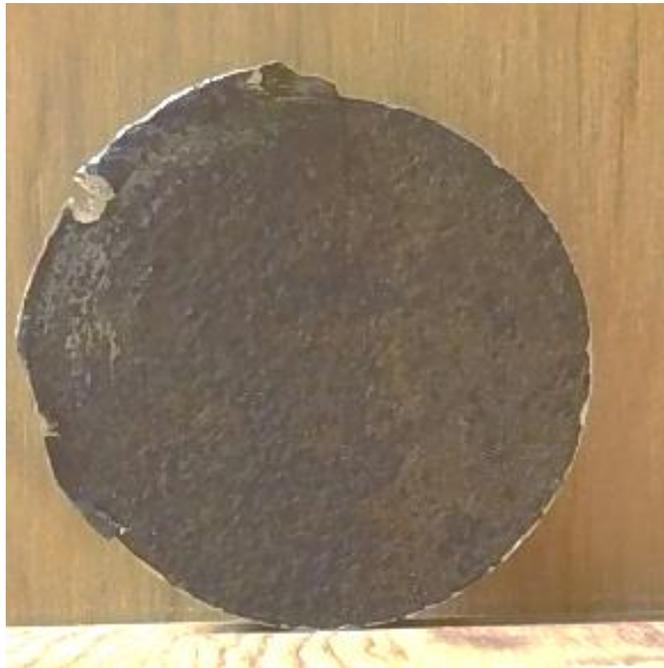
Figure 13. Dark Condition, 15 cm (6 inches), DJI Mavic, E007

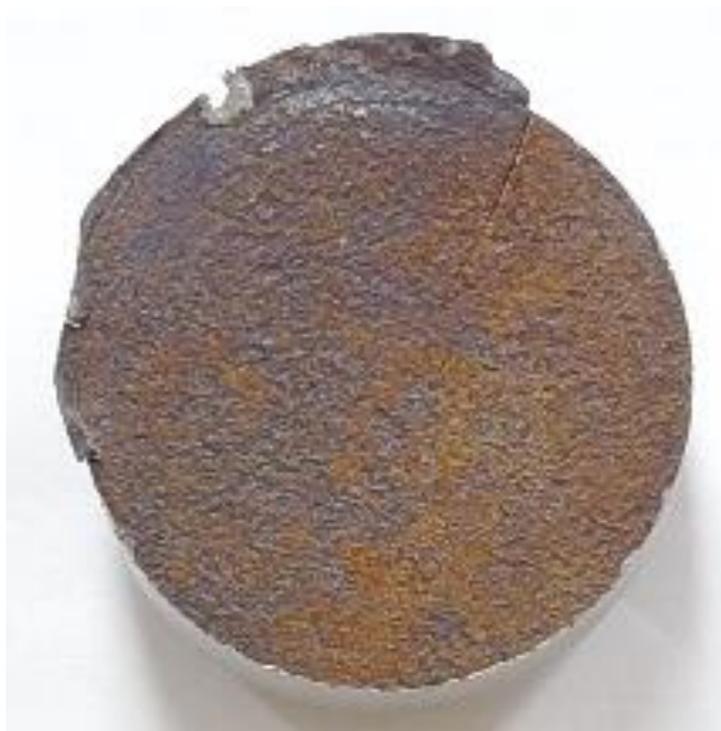
Figure 14. Bright Condition, 25 cm (10 inches), DJI Mavic, E007

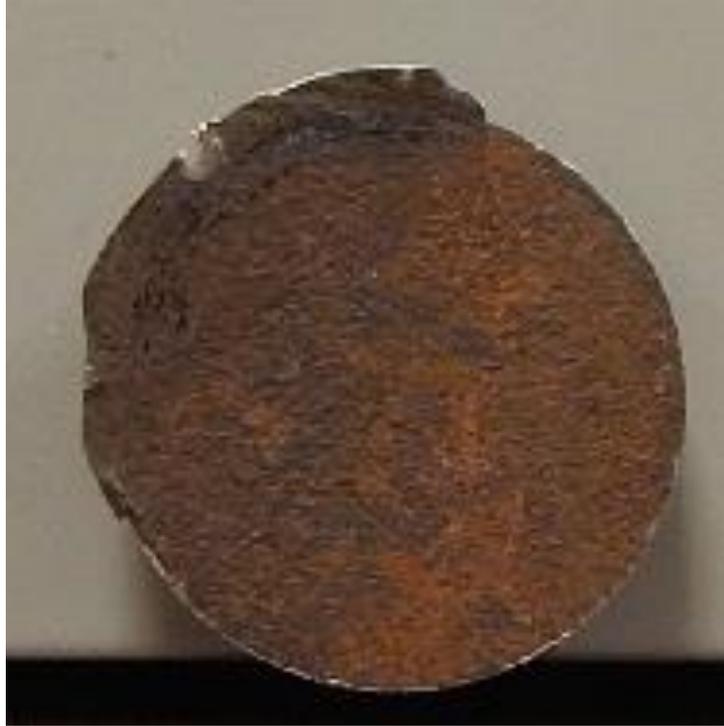
Figure 15. Normal Condition, 30 cm (12 inches), Nikon, E008

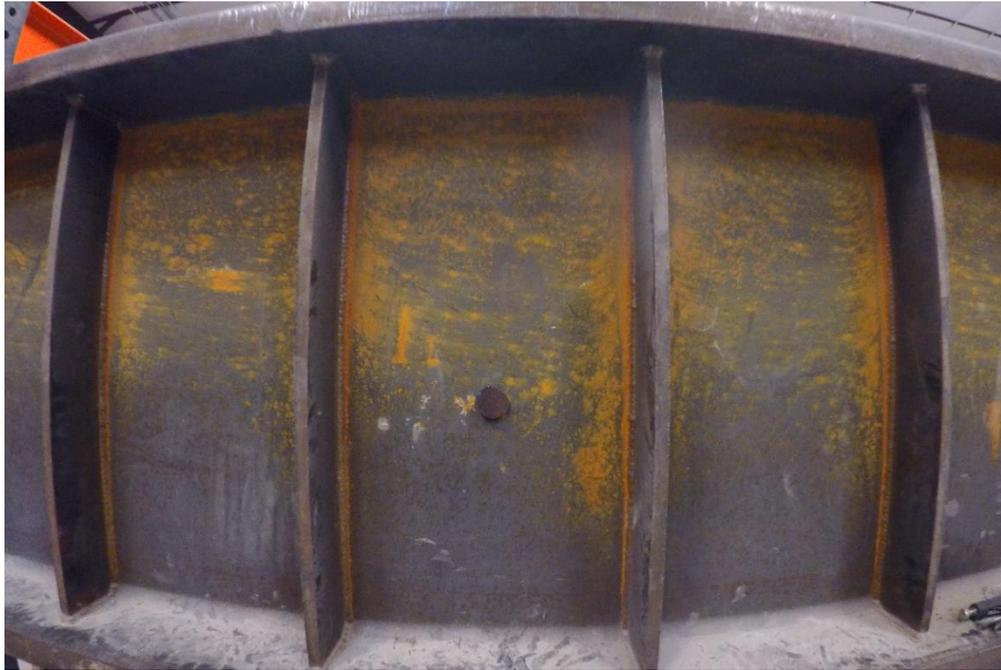
Figure 16. Photo of the Test-Piece Taken by 3DR Iris in the SMASH Lab, E009

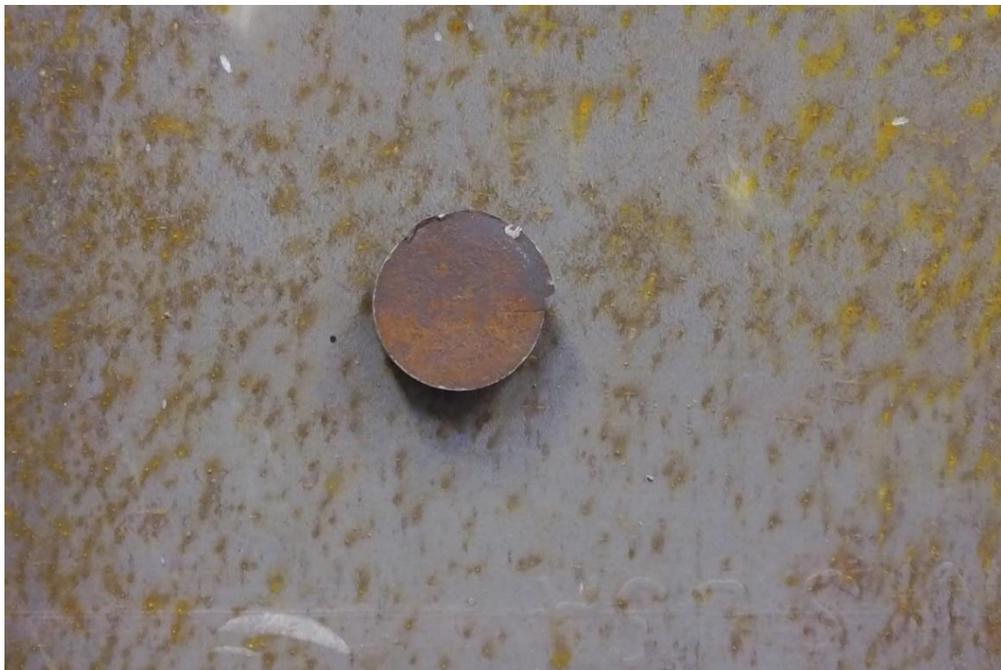
Figure 17. Photo of the Test-Piece Taken by DJI Mavic in the SMASH Lab, Normal Condition, E010

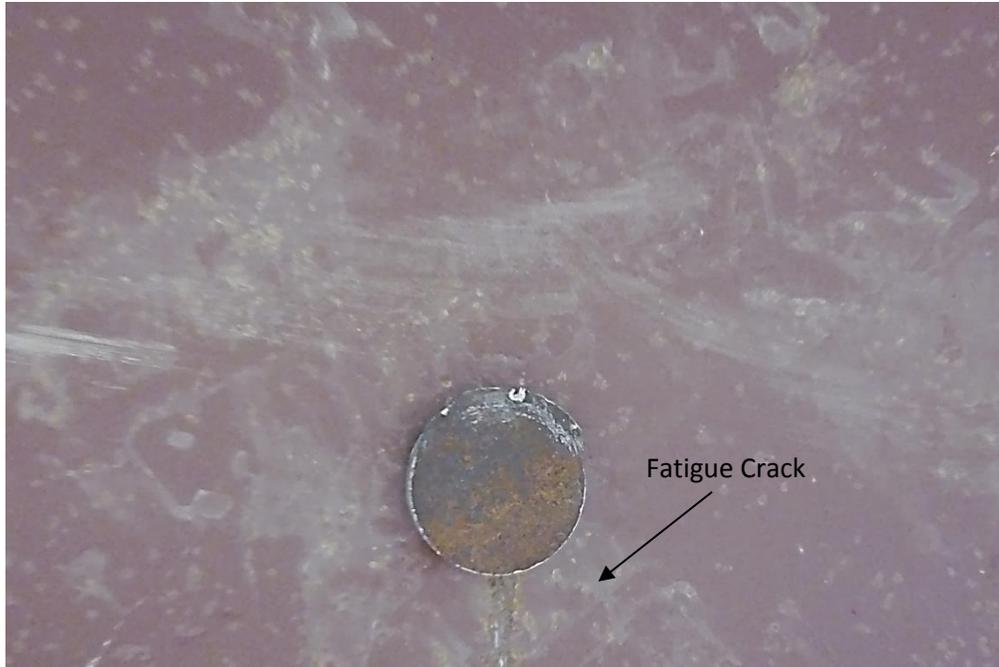
Figure 18. Photo of the Test-Piece Taken by DJI Mavic in the SMASH Lab, Dark Condition, E010

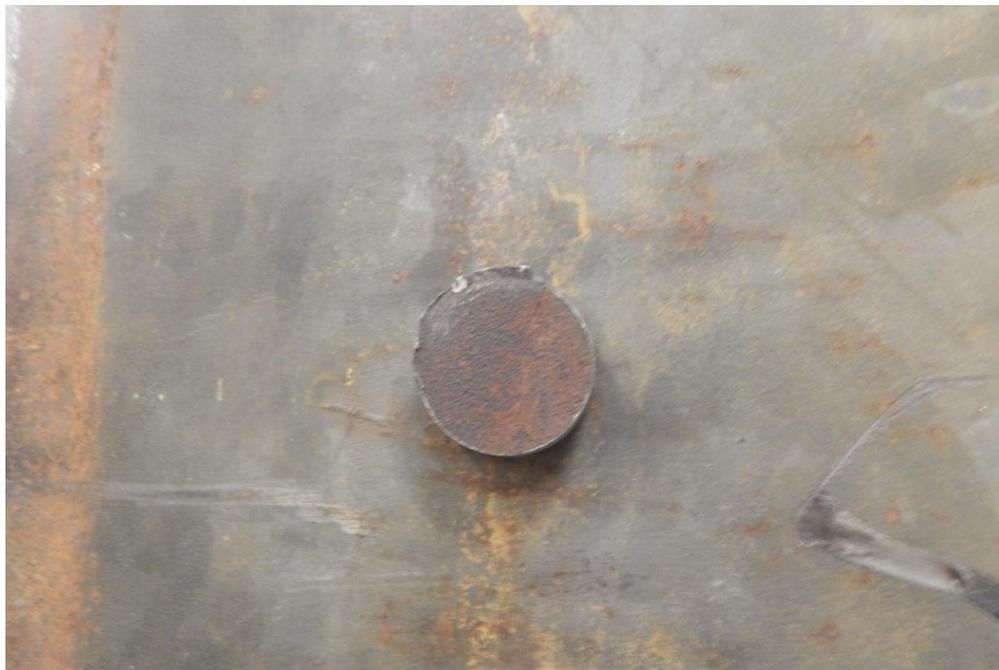
Figure 19. Photo of the Test-Piece Taken by the Goose in the SMASH lab, Normal Condition, E011

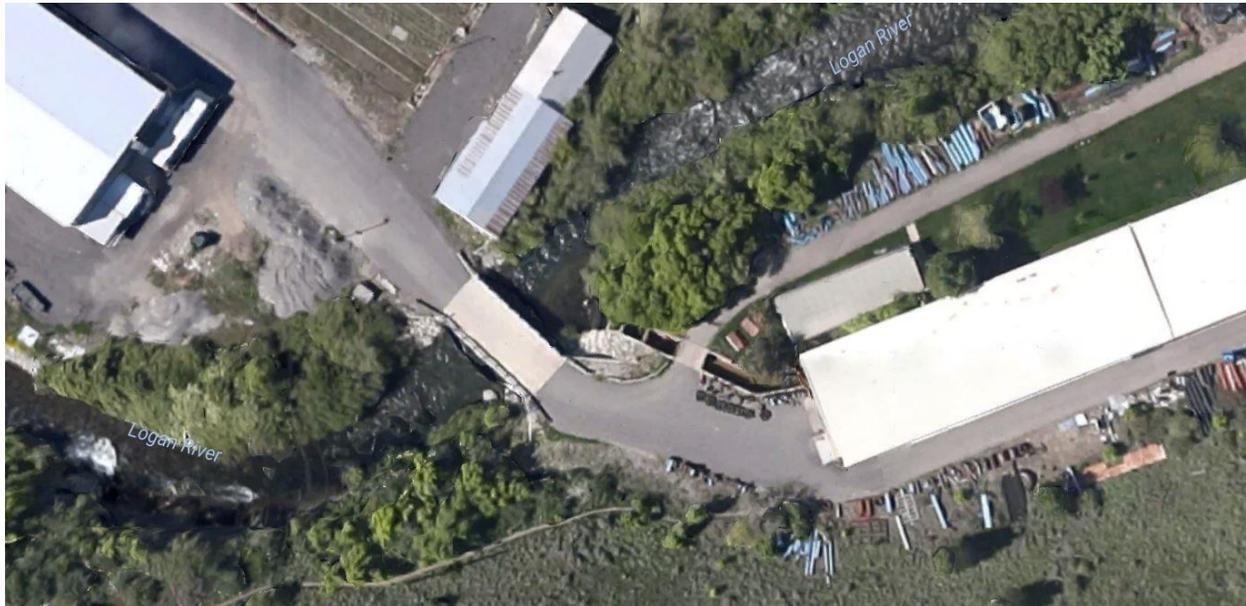
Figure 20. The UWRL Bridge

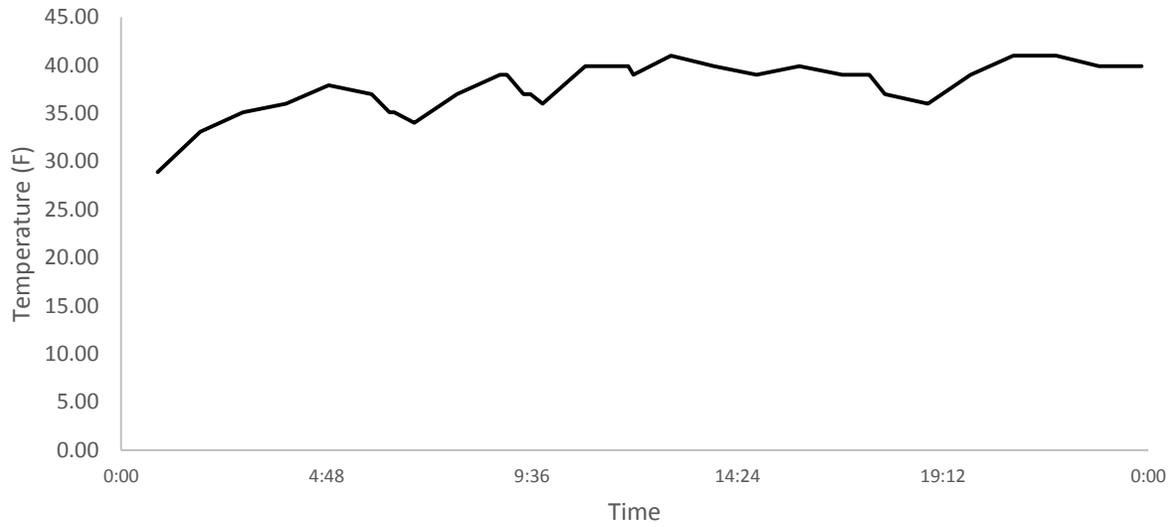
Figure 21. Daily Temperature from January, 10, 2017 at the UWRL Bridge from KUTLOGAN25 Station⁽²⁸⁾

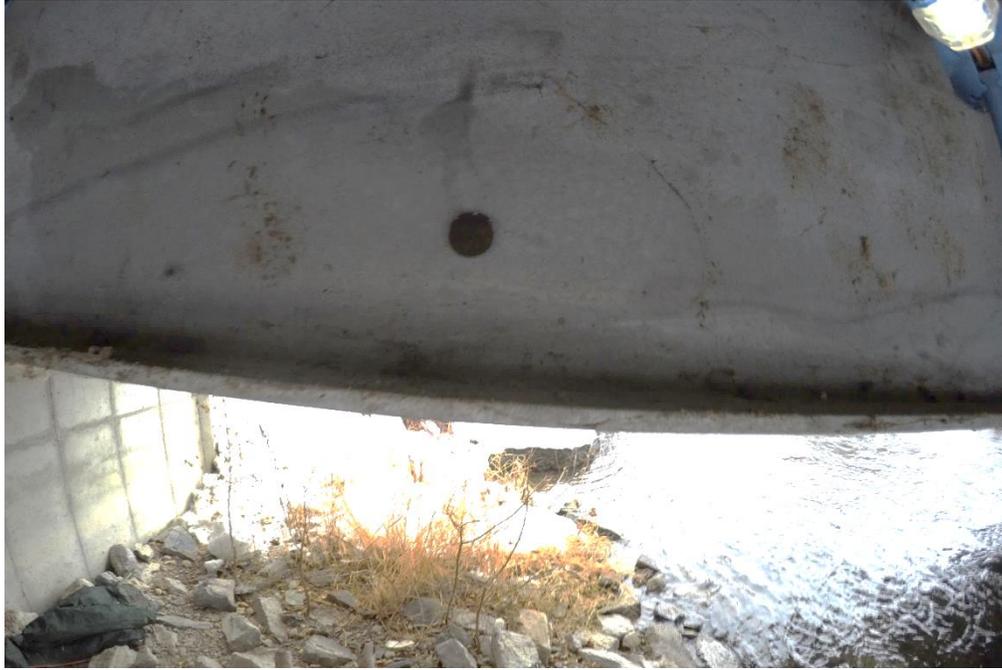
Figure 24. Photo of the Test-Piece Taken by 3DR Iris, UWRL Bridge, Normal Condition, E012

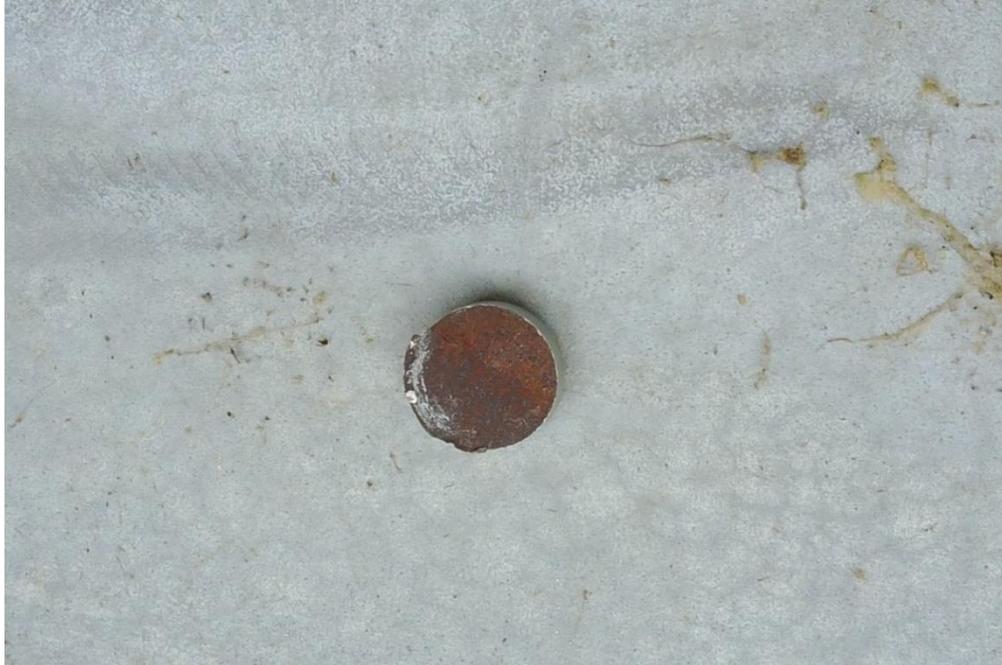
Figure 25. Photo of the Test-Piece Taken by DJI Mavic, UWRL Bridge, Normal Condition, Normal Camera Angle, E012

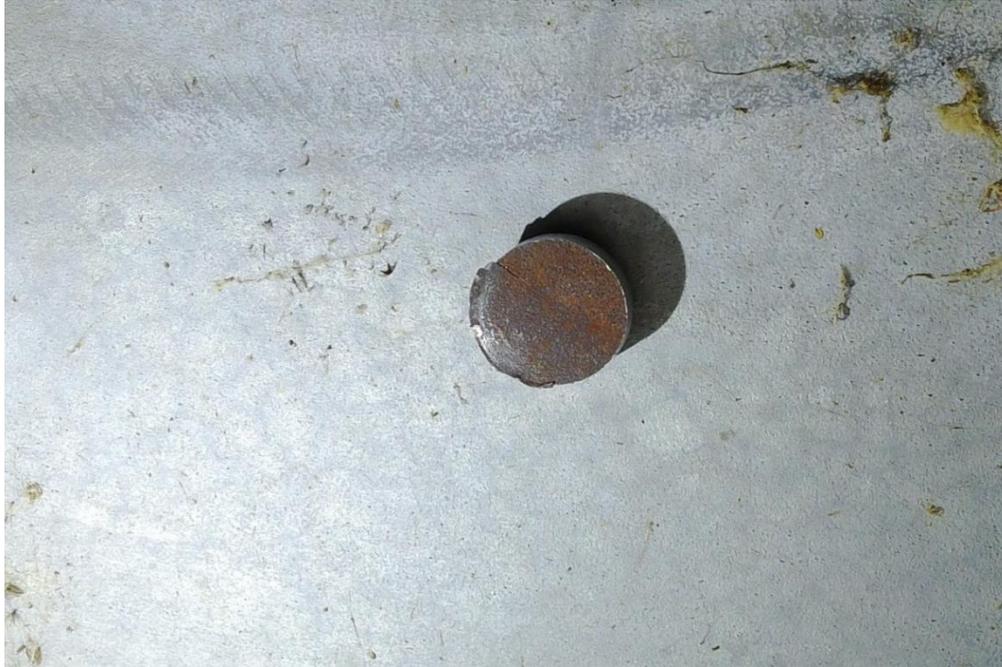
Figure 26. Photo of the Test-Piece Taken by DJI Mavic, UWRL Bridge, Bright Condition, Normal Camera Angle, E012

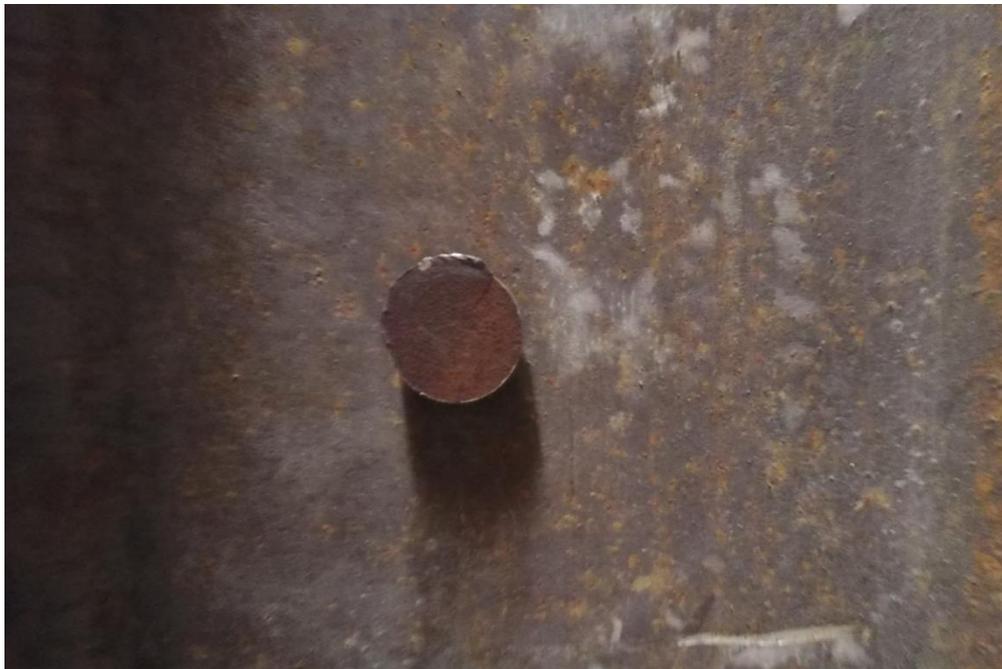
Figure 27. Photo of the Test-Piece Taken by DJI Mavic, UWRL Bridge, Dark Condition, Normal Camera Angle, E012

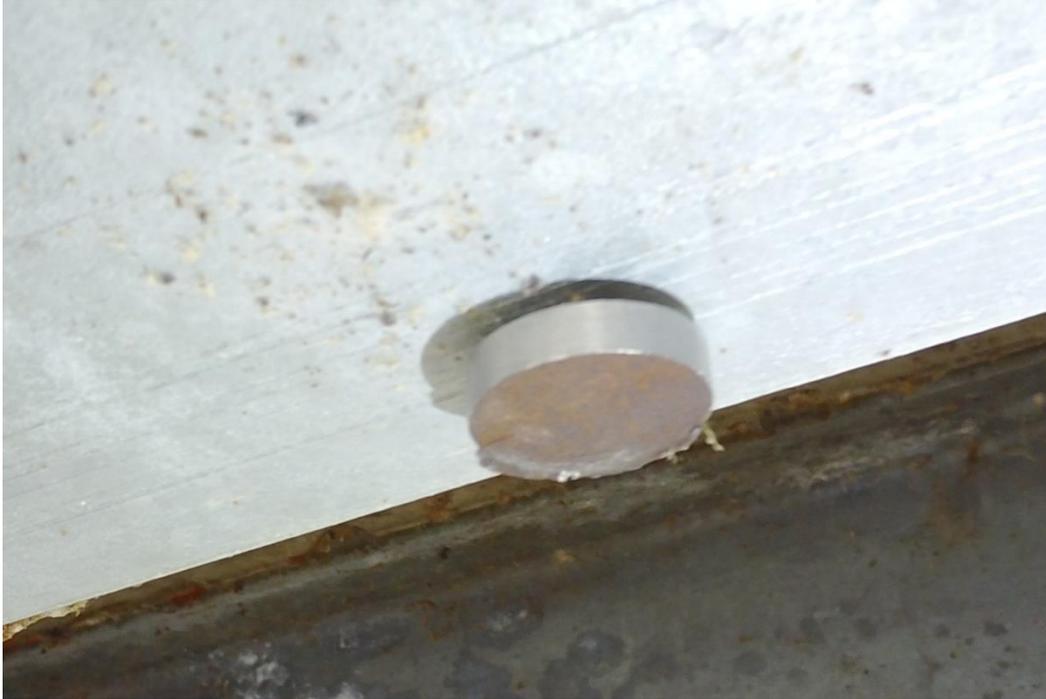
Figure 28. Photo of the Test-Piece Taken by DJI Mavic, UWRL Bridge, Bright Condition, Oblique Camera Angle, E012

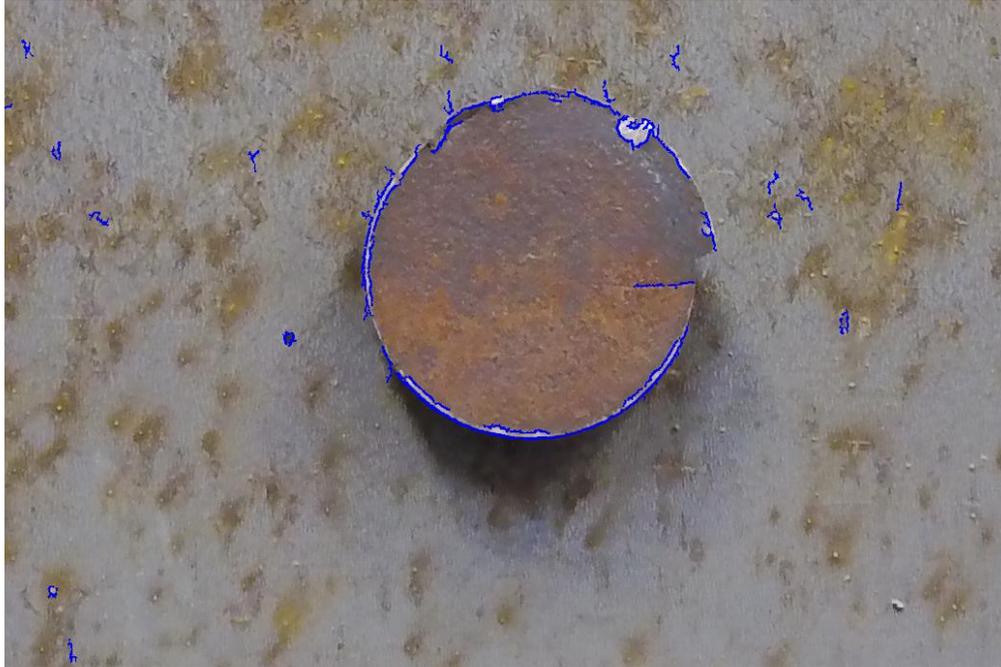
Figure 29. The Detected Crack Using Image Processing Techniques on the SMASH Lab Images (Laplacian of Gaussian), E014

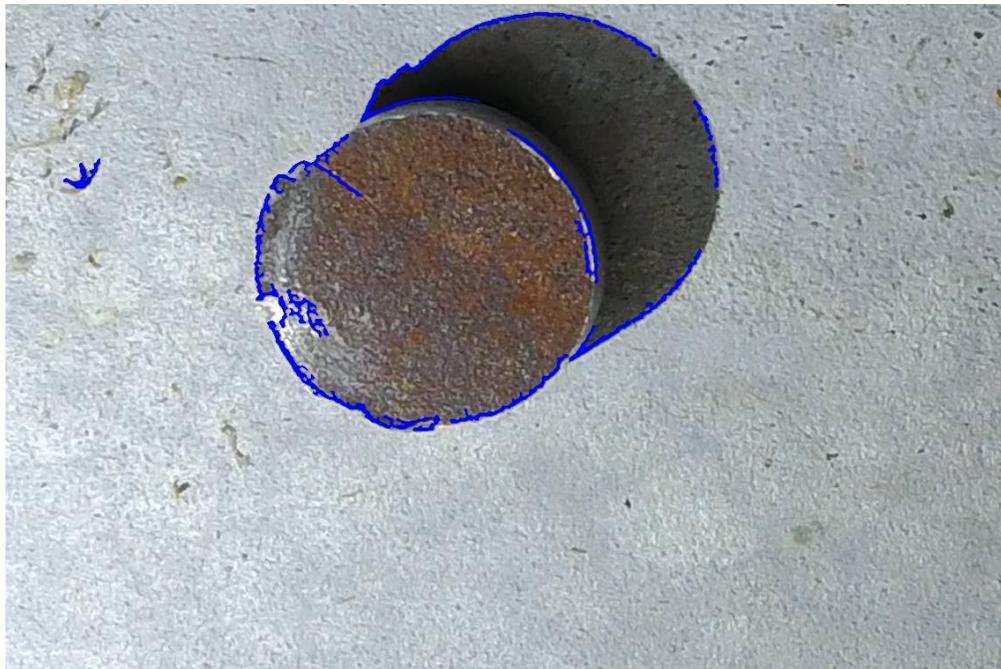
Figure 30. The Detected Crack Using Image Processing Techniques on the UWRL Image (Laplacian of Gaussian), E014

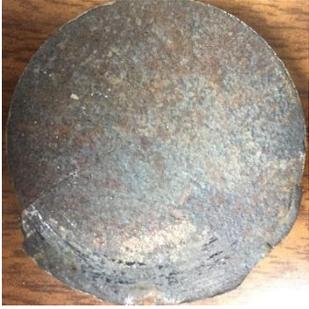
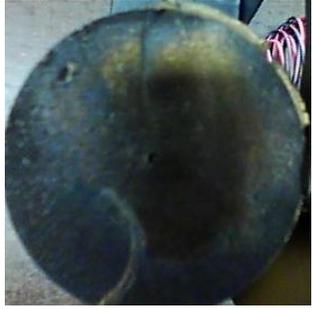
Specimen	Side A	Side B
S02

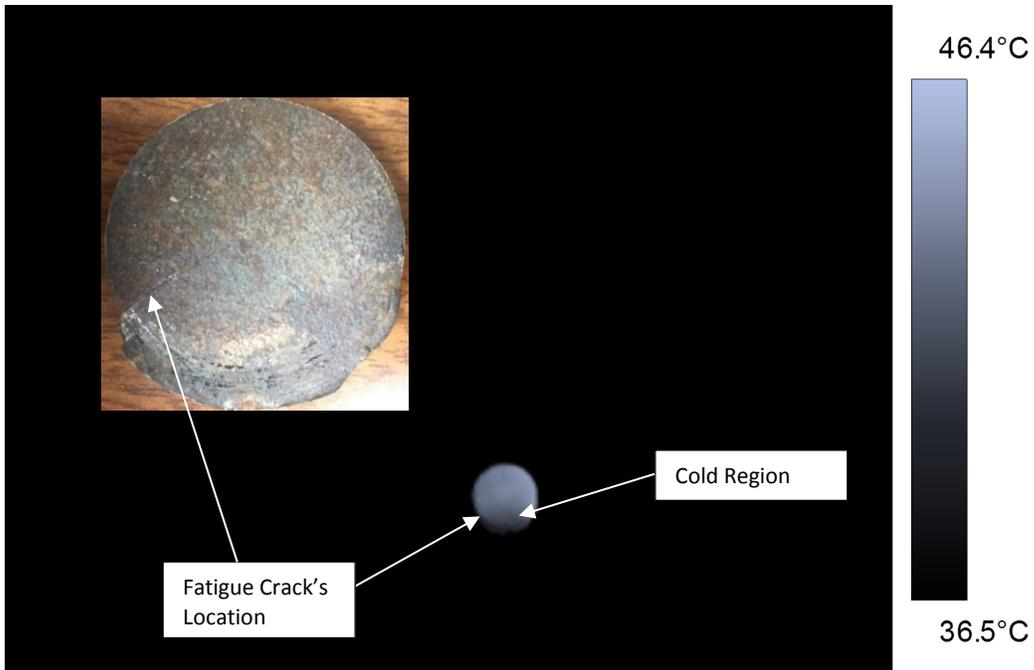
Figure 33. Thermal Image of the Side A of Test-Piece 1, 75 cm (30 in) Camera Distance, E017

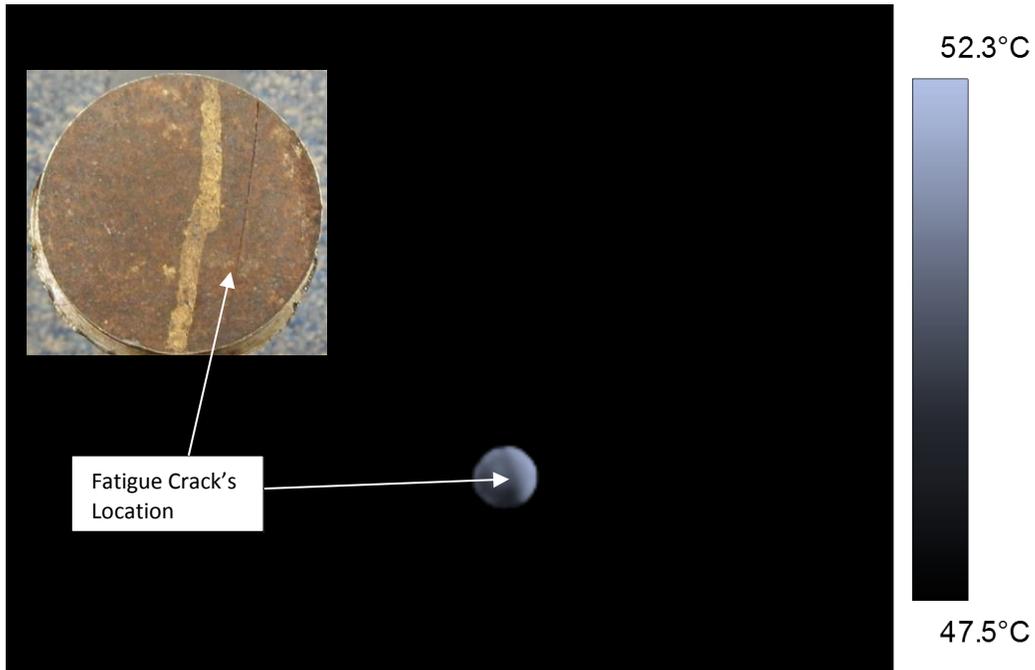
Figure 34. Thermal Image of the Side A of Test-Piece 2, 75 cm (30 in) Camera Distance, E018

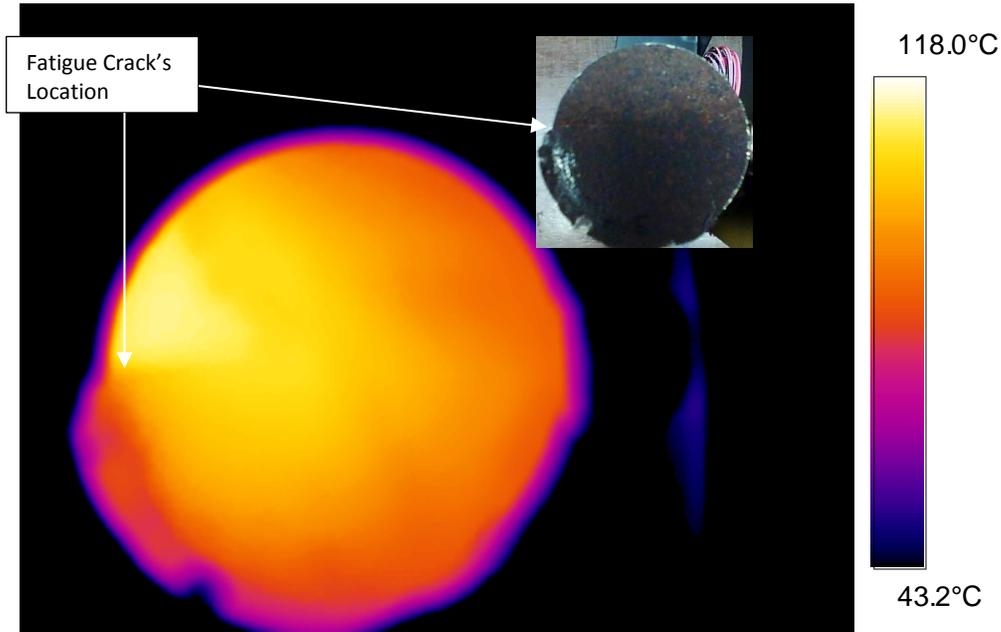
Figure 35. Thermal Image of the Side A of Test-Piece 1, 5 cm (2 in) Camera Distance, E019

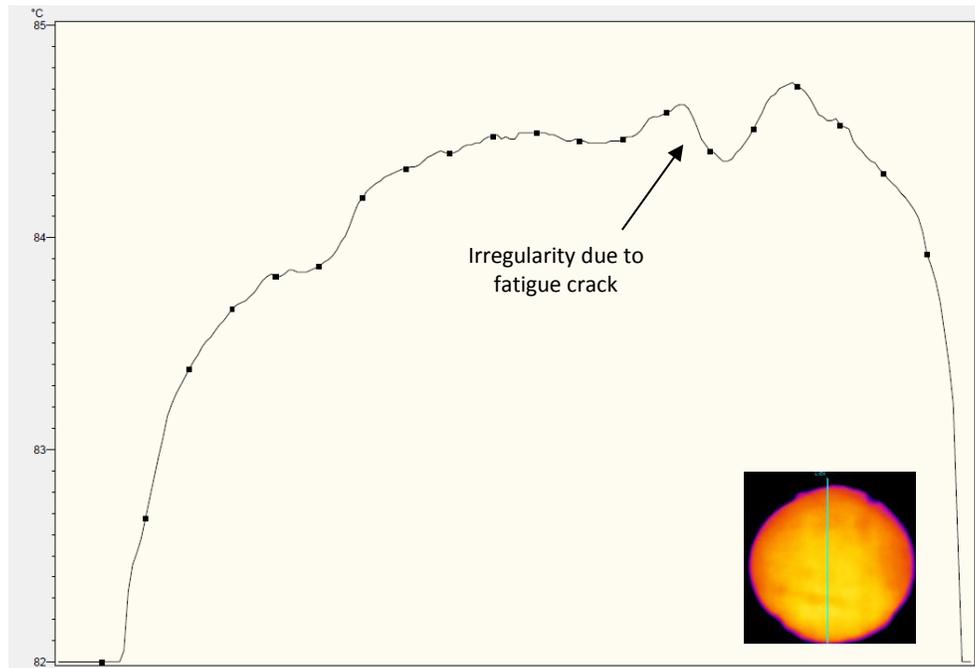
Figure 42. Temperature Along the Profile Line for the Side B of Test-Piece 2, 5 cm (2 in) Camera Distance, E020

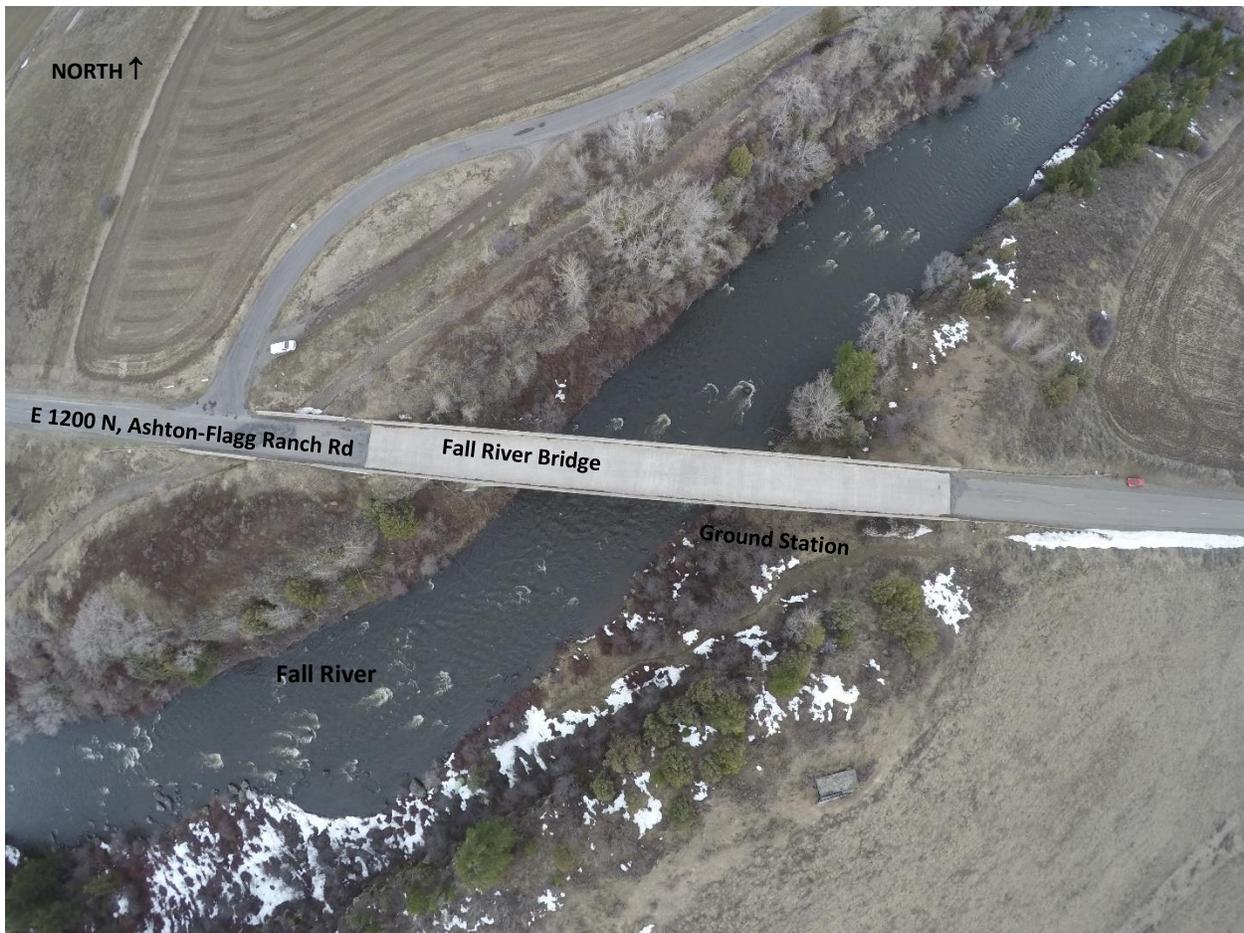
Figure 43. Aerial Image Captured by 3DR Solo (Courtesy of Dan Robinson)

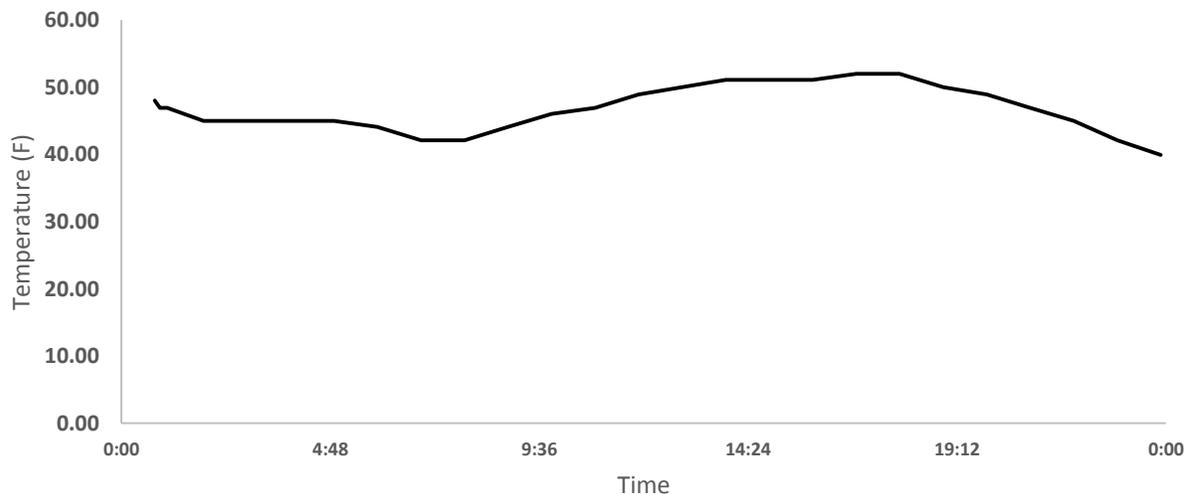
Figure 44. Daily Temperature from March 22, 2017 in Ashton from KIDASHO8 Station ⁽³¹⁾

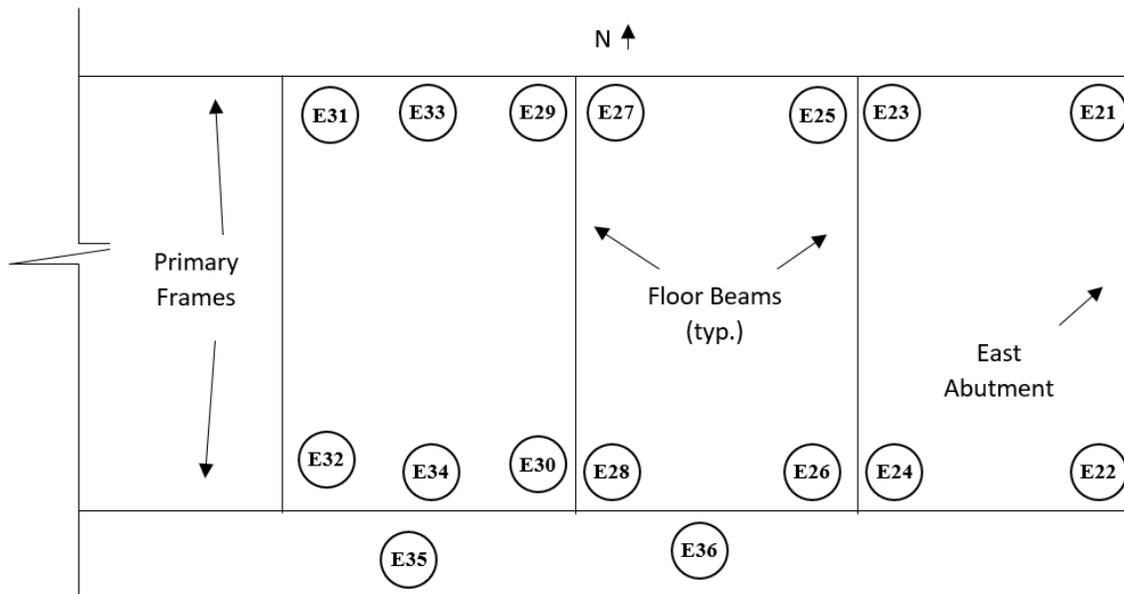
Figure 50. Plan View Drawing of the Bridge and Experiment Numbers of Inspection Locations.

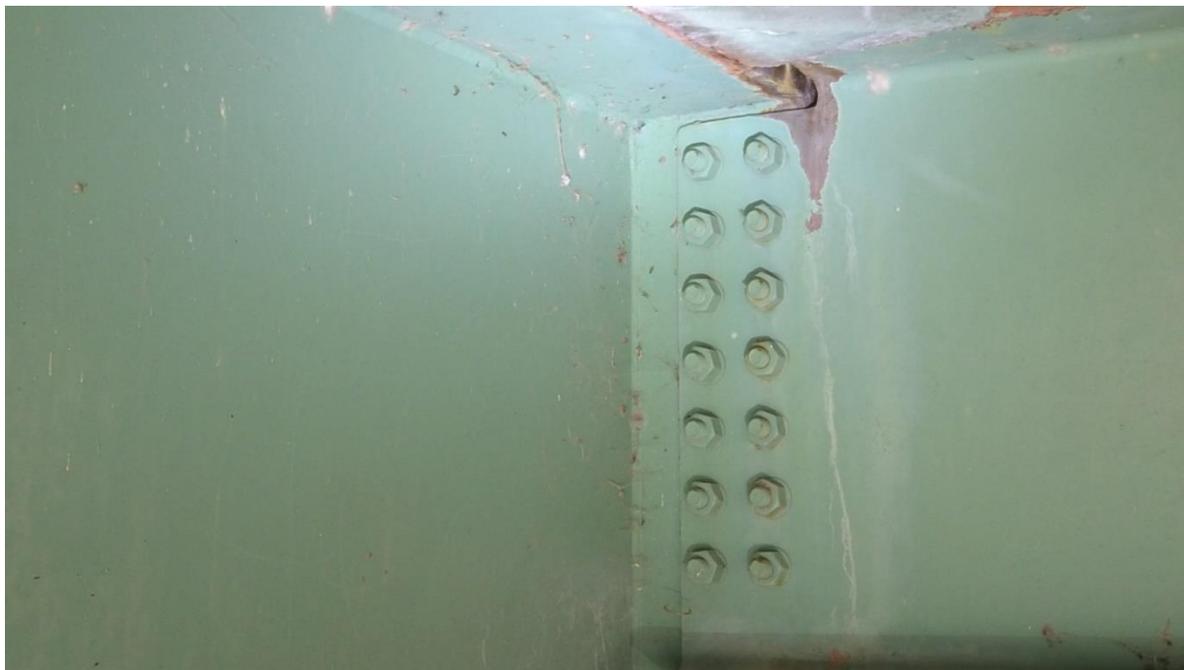
Figure 51. First Floor Beam on East, Northern Corner, No Noticeable Crack, E021
