**Your Safety • Your Mobility
Your Economic Opportunity**

Fatigue Crack Detection Using Unmanned Aerial Systems in Under-Bridge Inspection

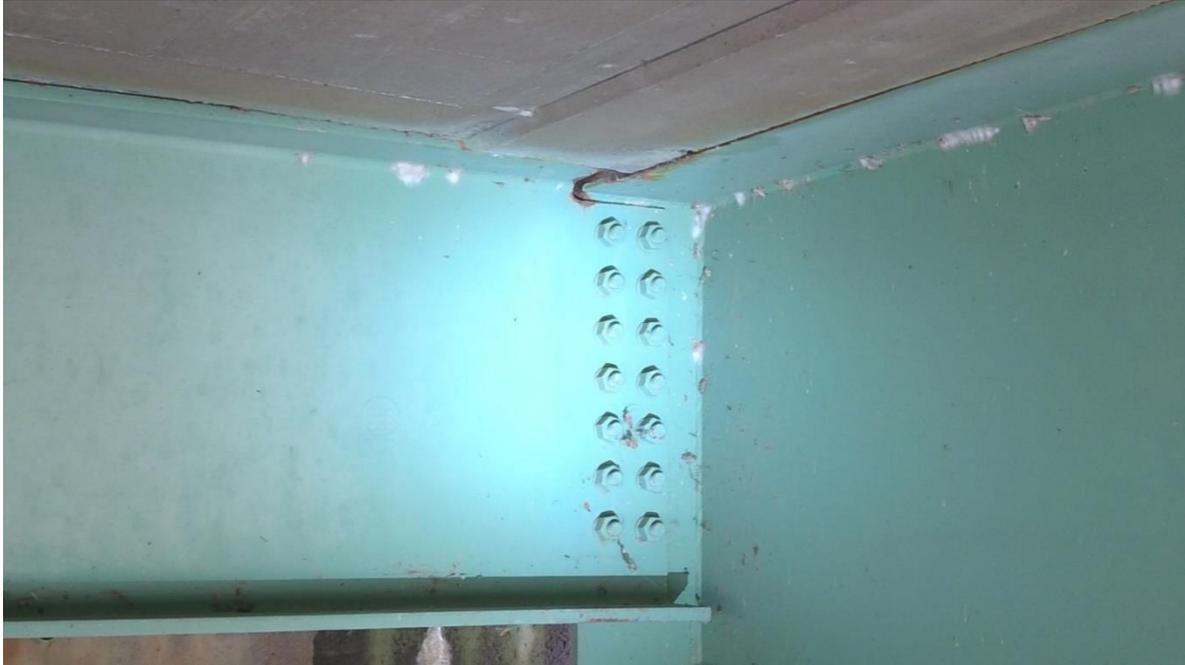
Figure 52. First Floor Beam on East, Southern Corner, Debris on the Weld, E022

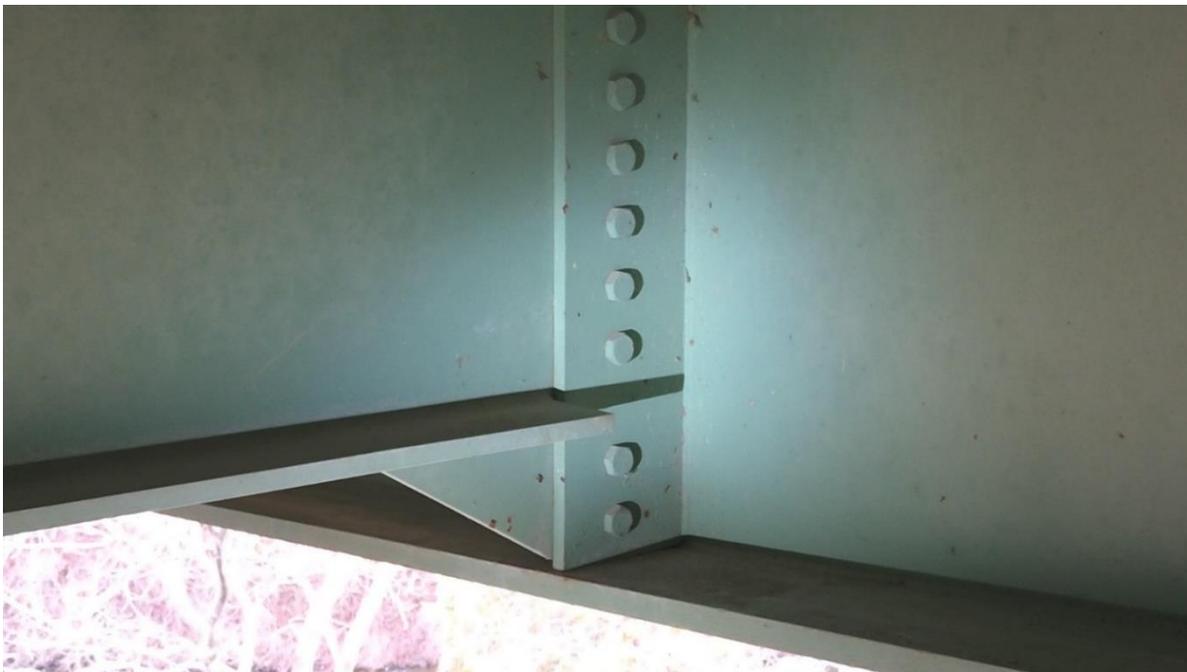
Figure 53. No Cracks on Second Floor Beam on East, Southern Corner, E023

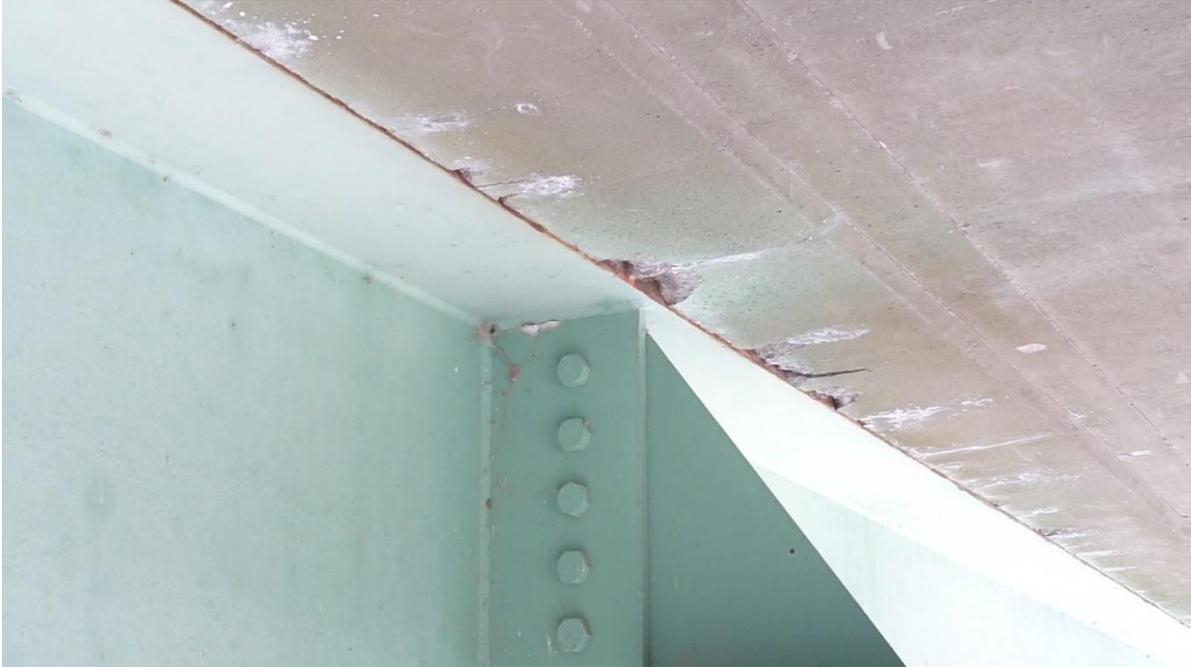
Figure 54. No Cracks on Second Floor Beam on East, Southern Corner, Minor Deck Spalling, E024

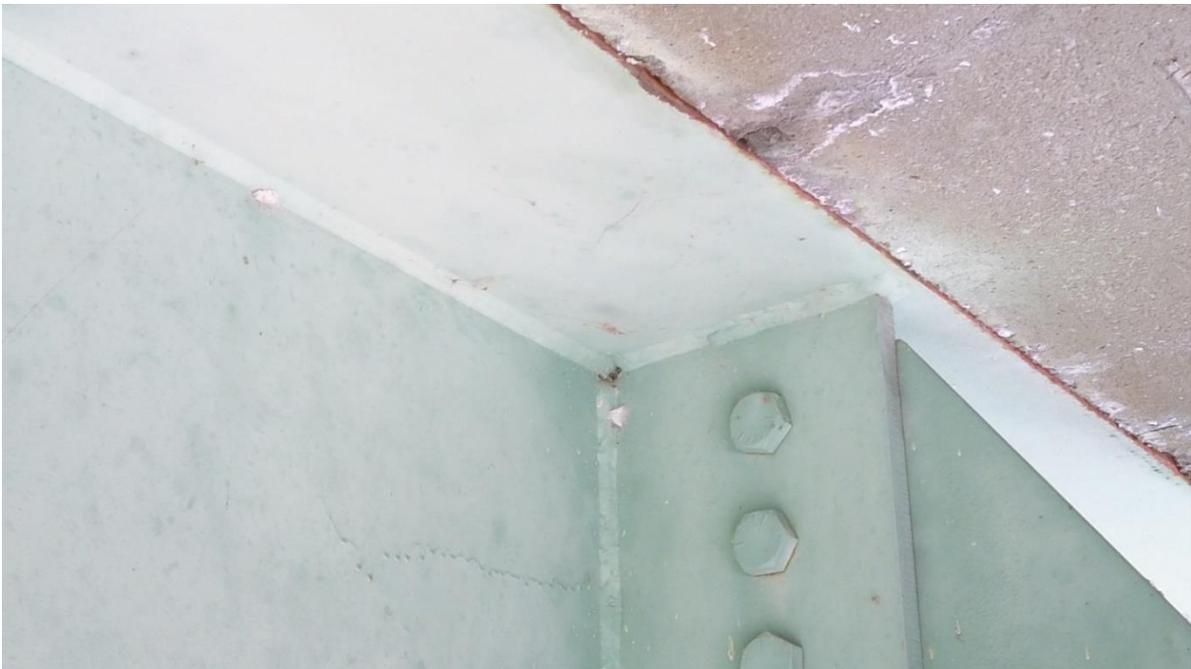
Figure 55. Third Floor Beam on East, Mild Rust, Northern Corner, E027

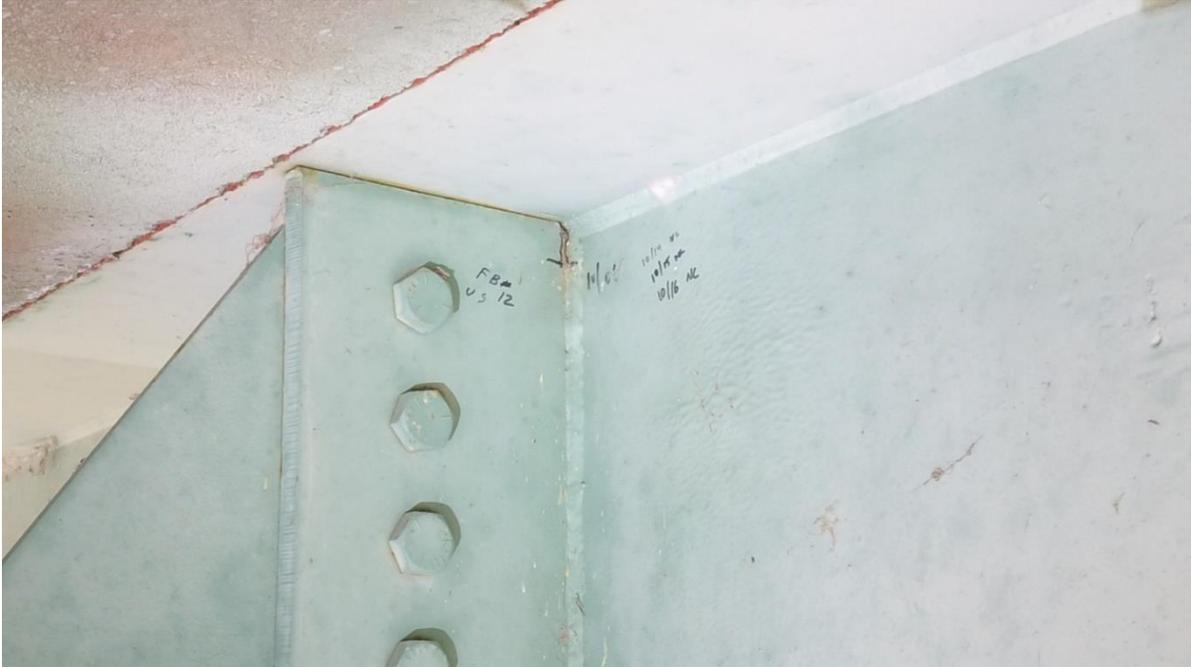
Figure 56. Defect (Crack) on the Fourth Floor Beam, E031

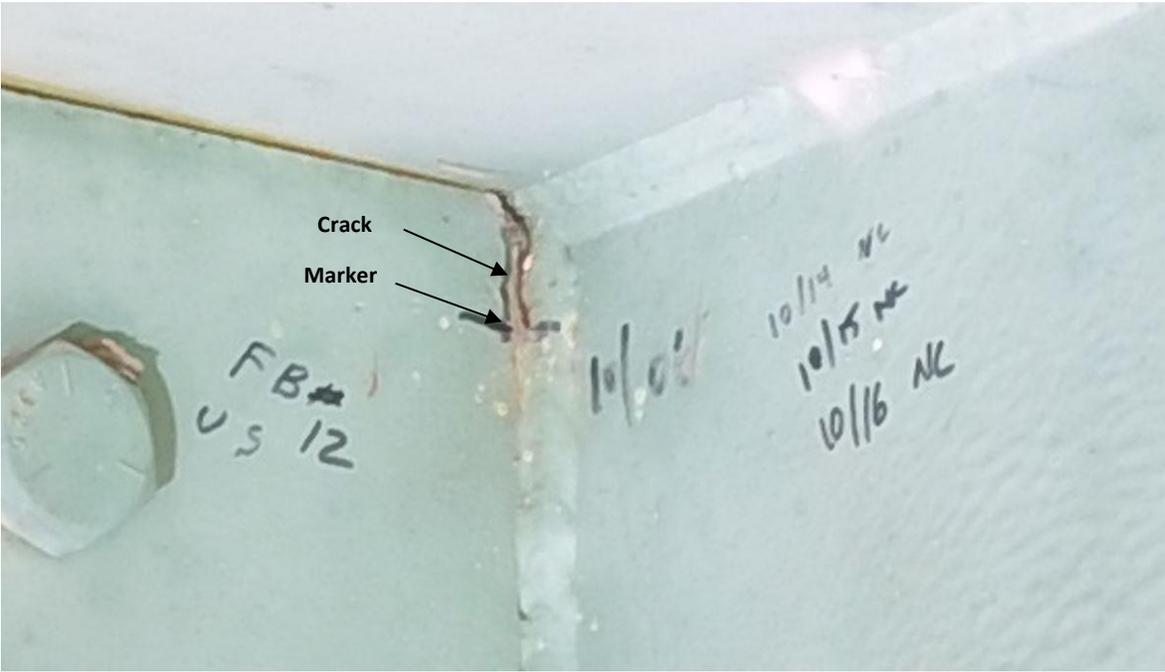
Figure 57. Zoomed Image From the Fatigue Crack, E031

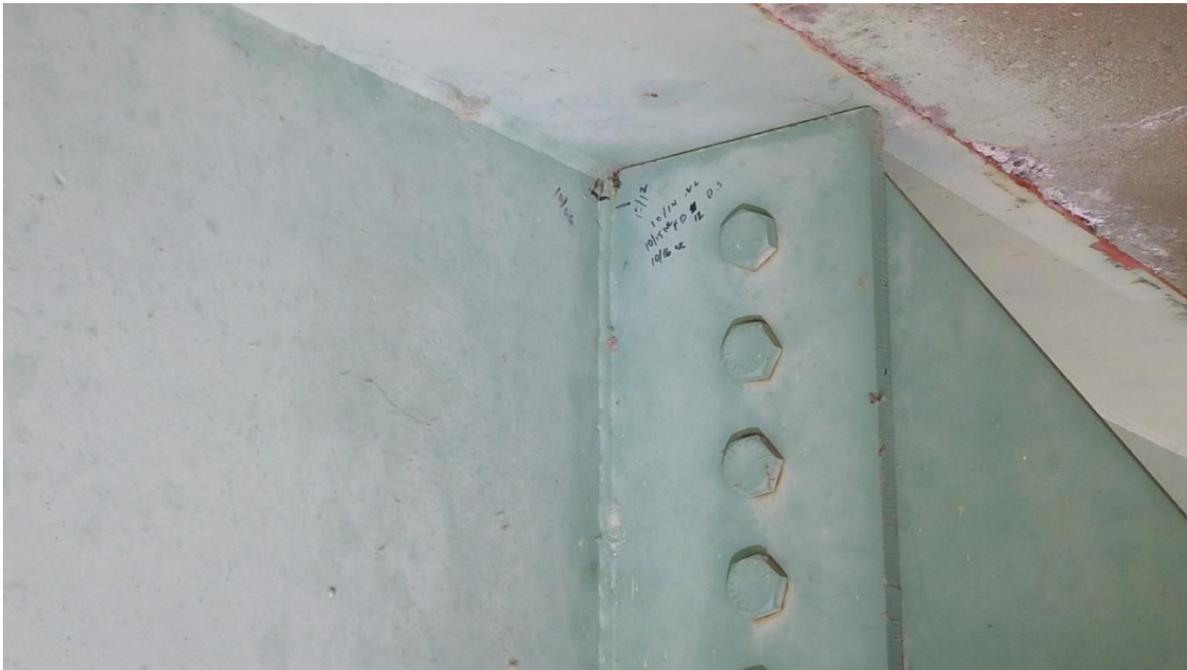
Figure 58. Defect (Crack) on the Fourth Floor Beam, Southern Corner, E032

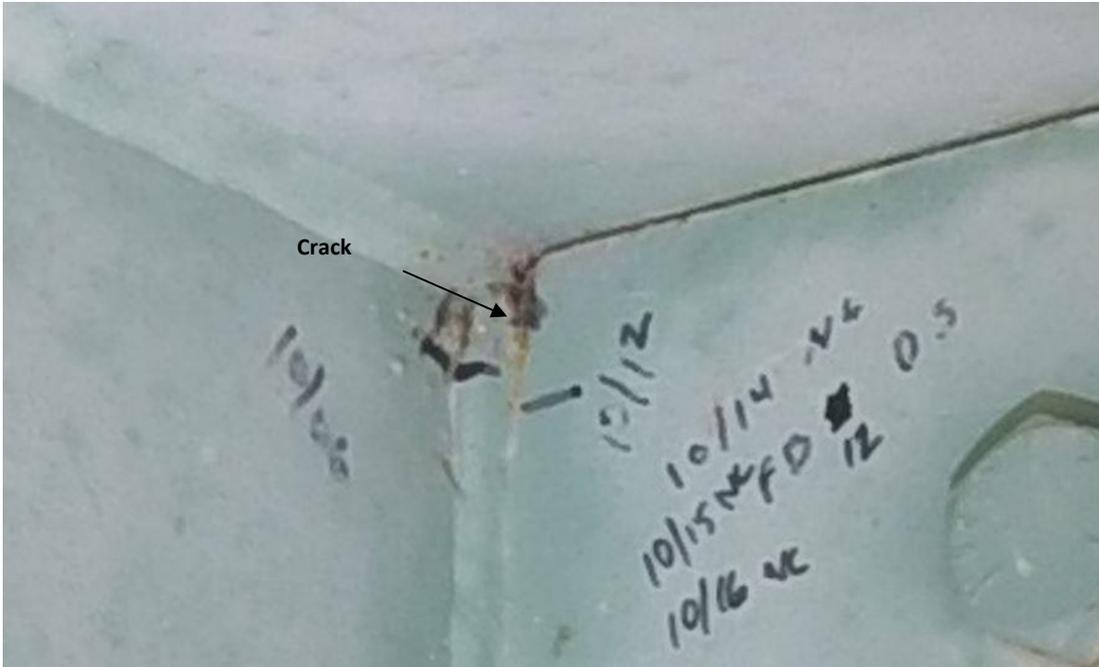
Figure 59. Zoomed Image from the Fatigue Crack on the Fourth Floor Beam, Southern Corner, E032

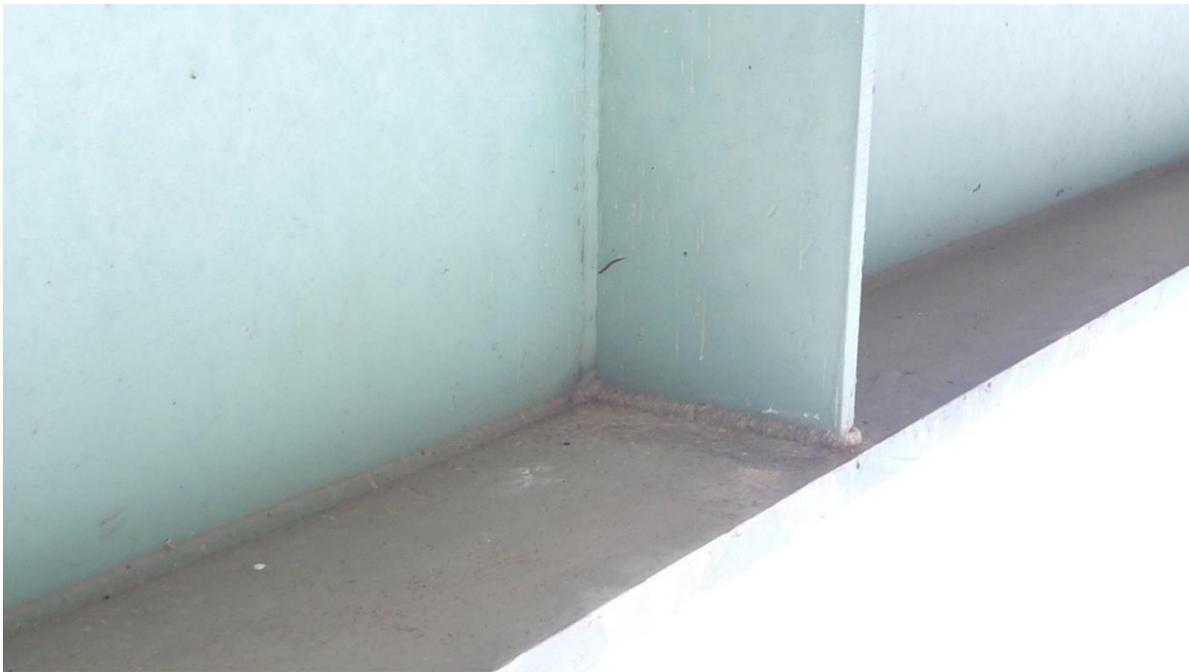
Figure 60. No Defects (Crack) on the Fourth Floor Beam, Southern Corner, Bottom Flange Weld, E032

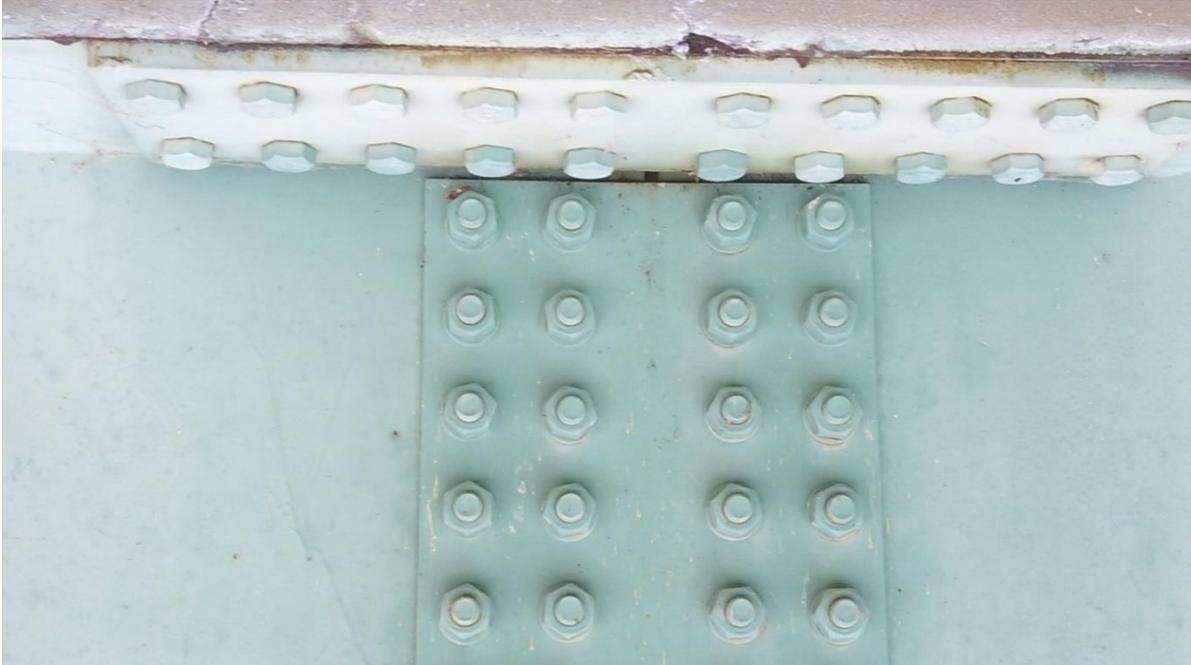
Figure 61. Minor Corrosion on Top of the Northern Girder Splice (First Splice from East), E033

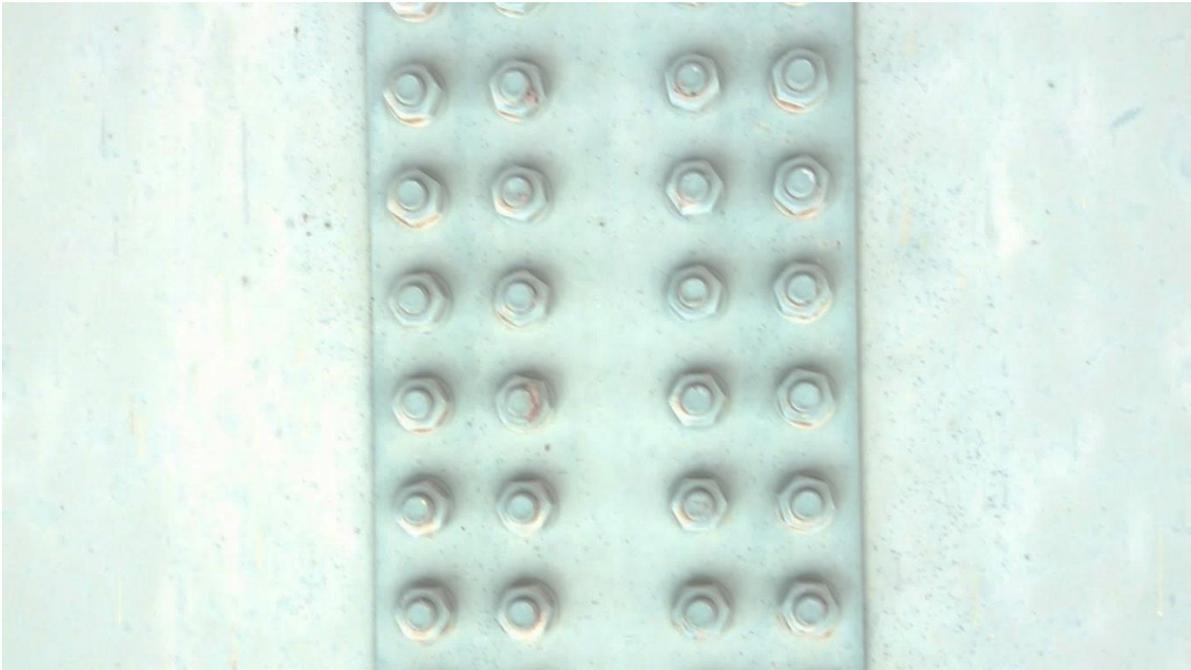
Figure 62. Minor Corrosion on the Plate and Nuts, Southern Girder Splice (First Splice from East), E034

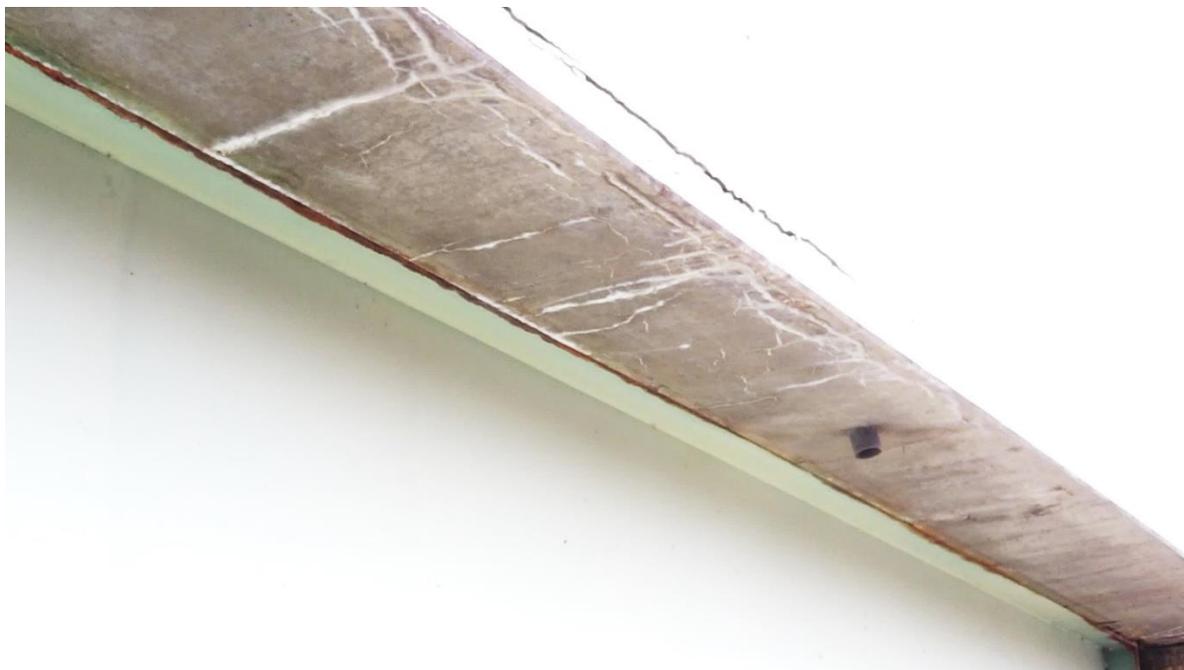
Figure 63. Cracks, Possible Delamination, and Efflorescence on the Southern Bearing, E035

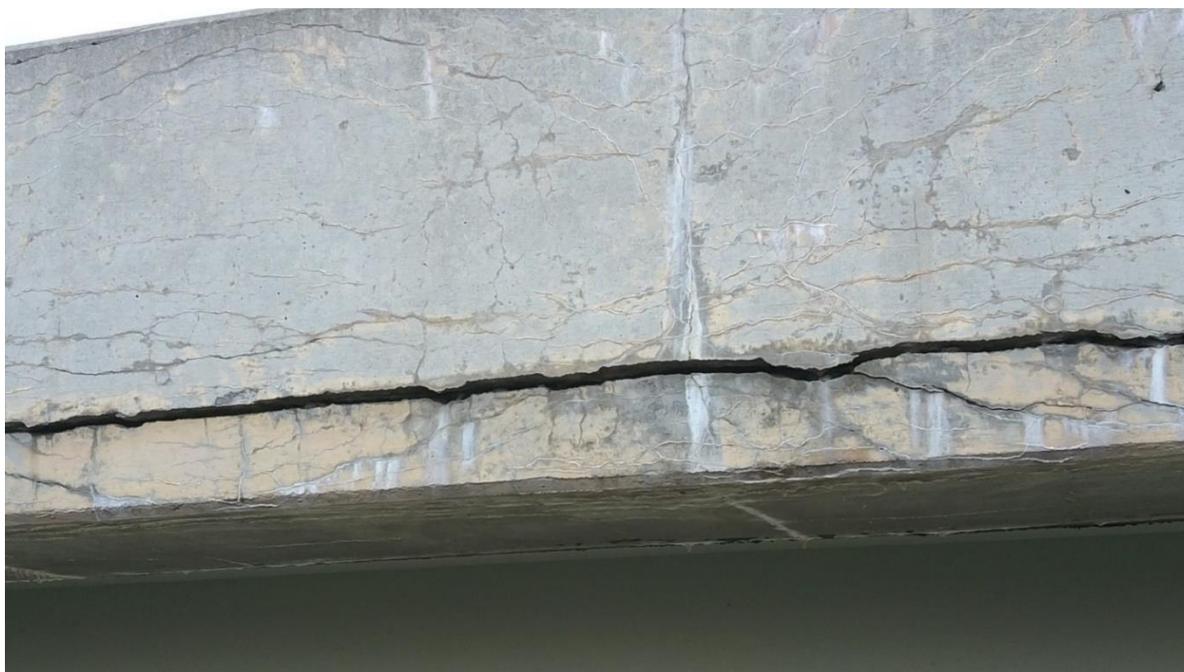
Figure 64. Cracks and Possible Delamination on the Southern Barrier, E036

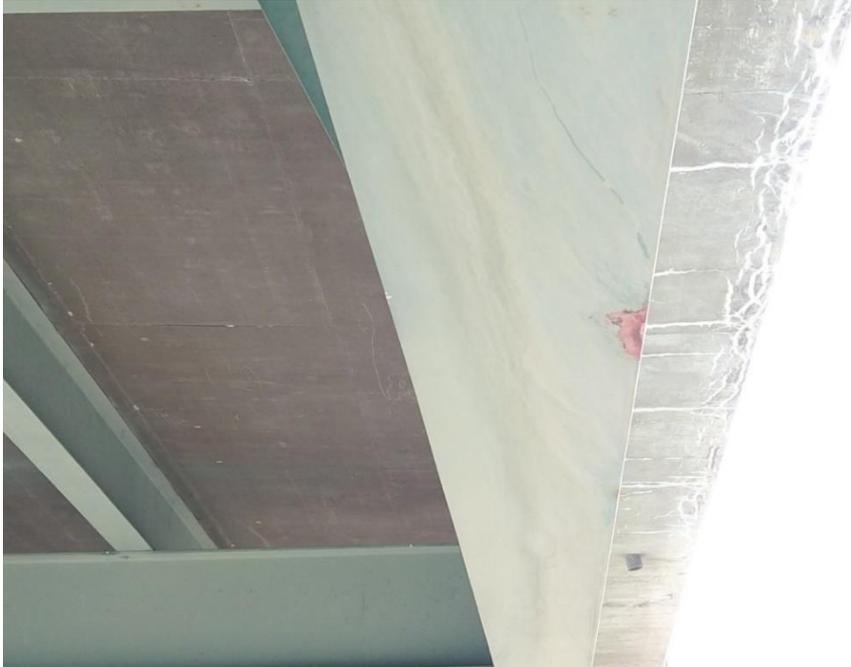
Figure 65. Minor Corrosion on Bottom Flange of the Southern Girder, E035 and E036

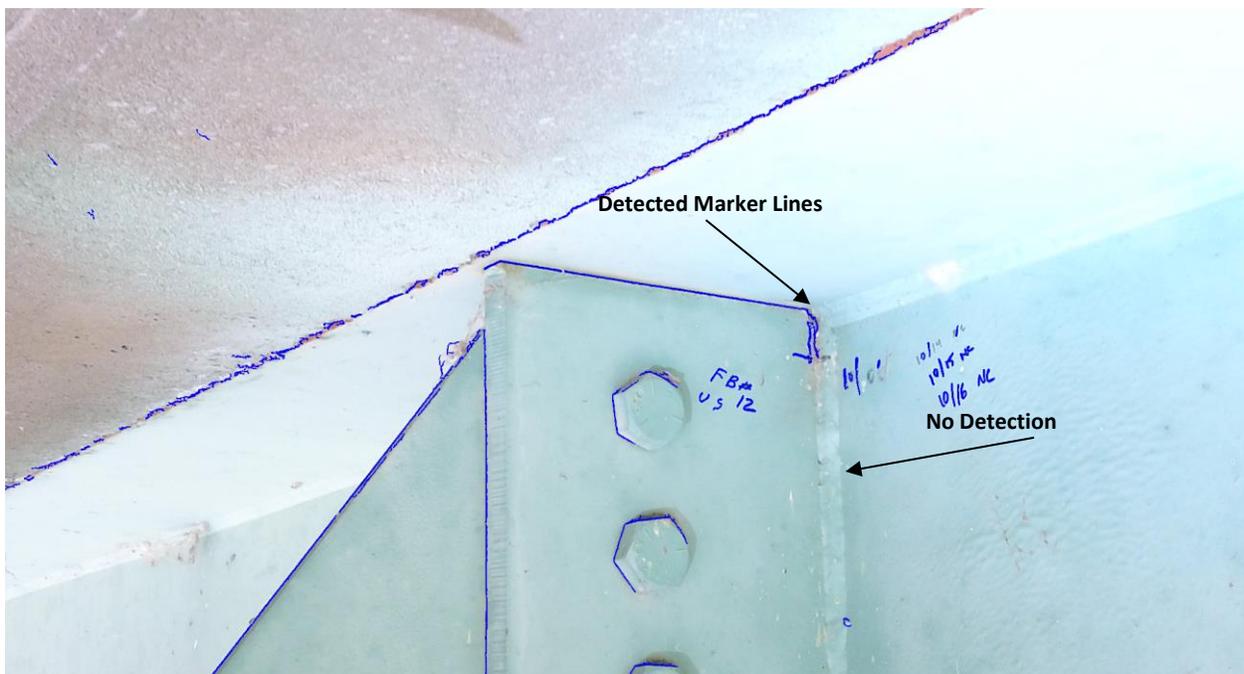
Figure 66. Image Processing on Captured Image with Crack, E037

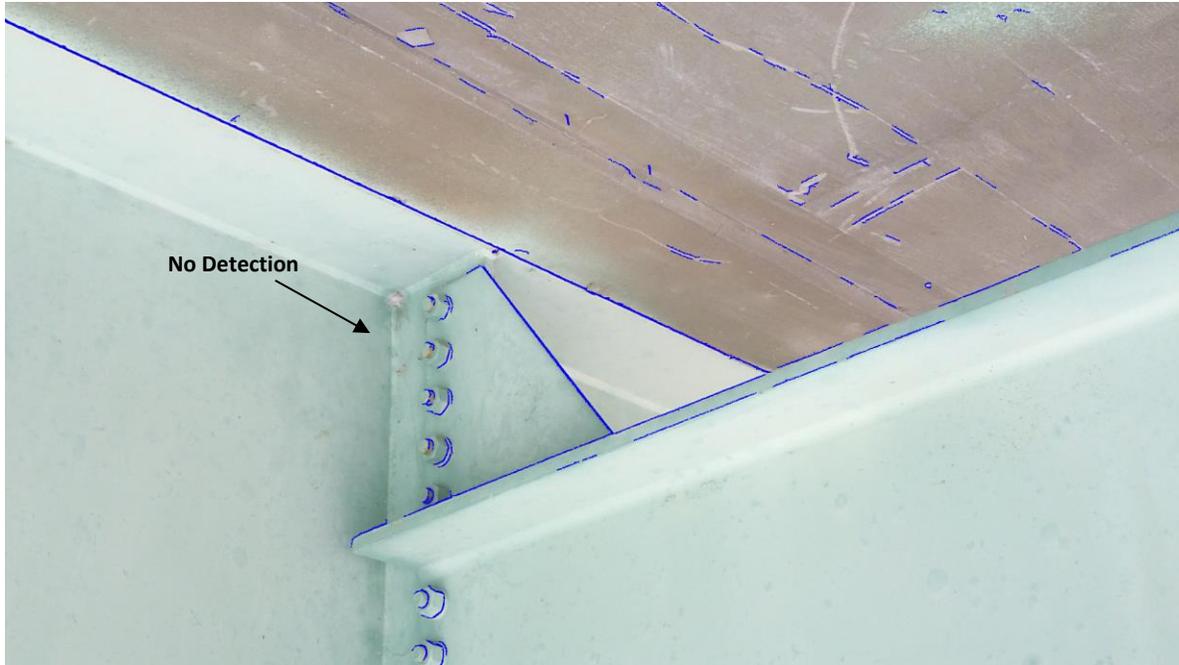
Figure 67. Image Processing on Captured Image without Crack, E037
