**DPW PROJECT 18908
DISTRICT #6 SALMON COMPLEX
IDAHO DEPARTMENT OF TRANSPORTATION (ITD)
SALMON, IDAHO**

**ASBESTOS-CONTAINING BUILDING MATERIAL AND LEAD PAINT
SURVEY AND ASSESSMENT REPORT**

SUBJECT: DPW PROJECT #18908
DISTRICT #6 SALMON COMPLEX
IDAHO DEPARTMENT OF TRANSPORTATION (ITD)
SALMON, IDAHO

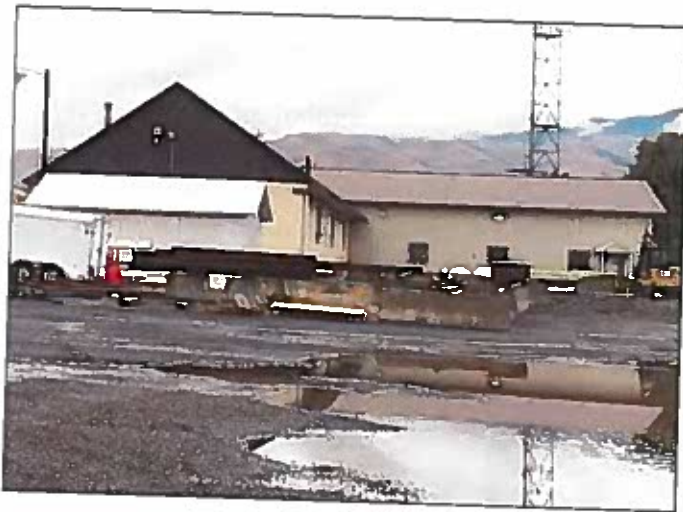
1. View of the addition attached to the rear of Building 6141. No ACM was observed within the rear addition of the building.

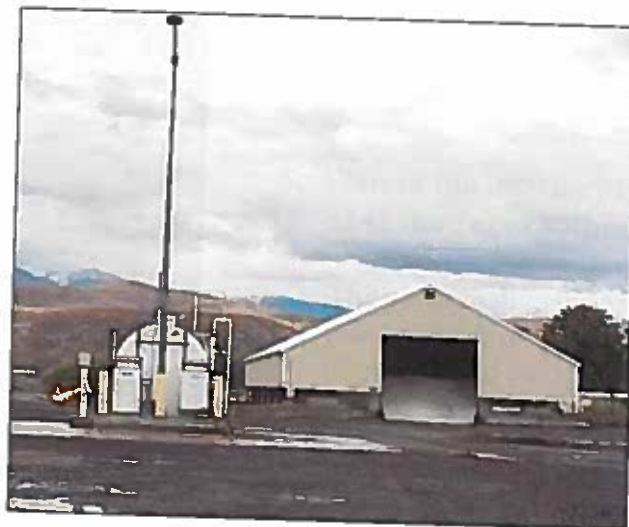
2. View of the salt storage shed Building 6144 and the fueling station located on the south east side of the Building 6141. No suspect ACM was observed within these structures.

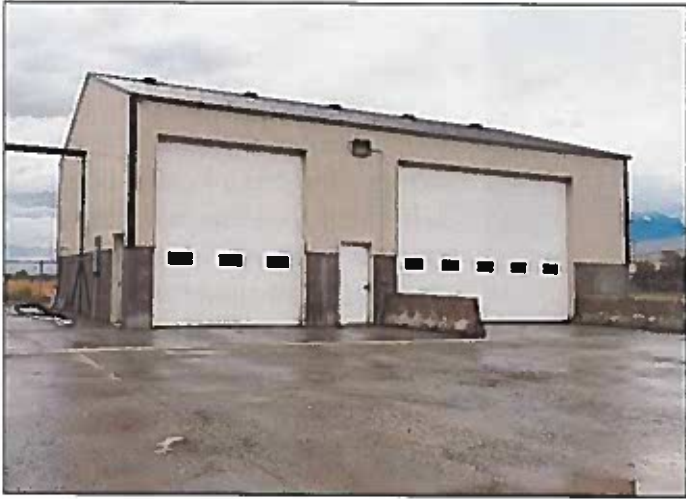
3. **View of the brine storage Building 6142 compound located on the north east side of the Building 6141. No suspect ACM was observed within this structure.**

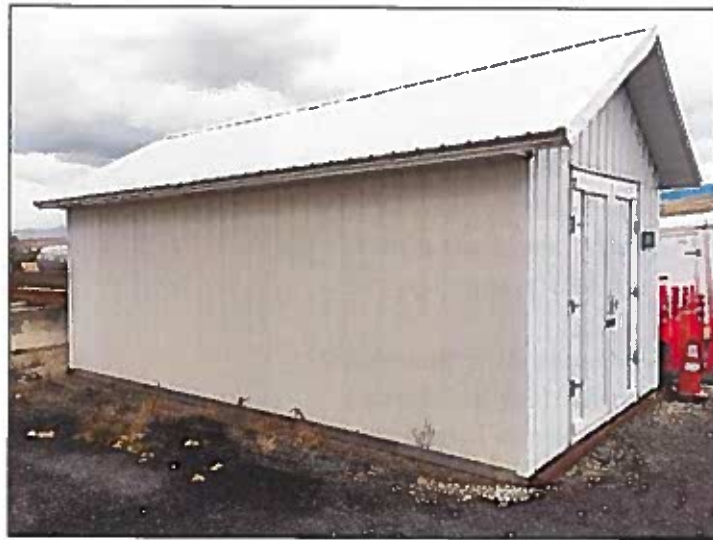
4. **View of the bridge department storage Building 6143 compound located on the east side of the Building 6141. No suspect ACM was observed within this structure.**

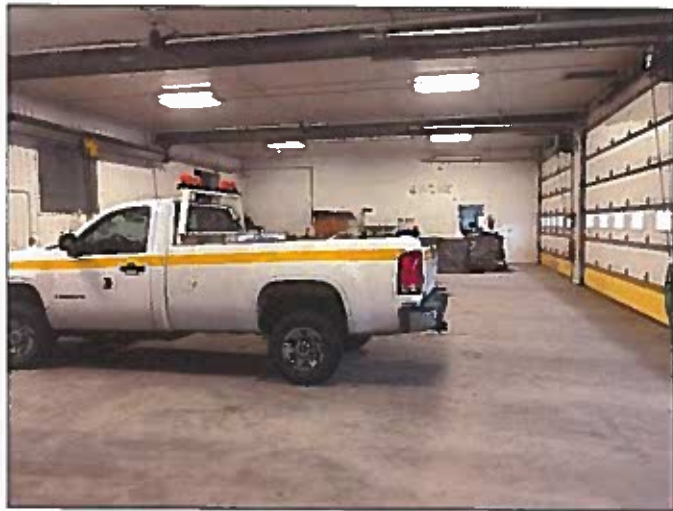
The following non-friable drywall joint compound was found on interior walls and ceilings (3% Chrysotile) and residual amounts of non-friable beige/green 9-inch vinyl floor tiles (3% Chrysotile) were identified within Building 6141.

These materials were found to be in good-to-fair condition and can be managed in place. The non-friable asbestos-containing materials, if not managed properly, may become damaged (airborne), which poses a potential health threat to the building occupants and state employees.

5. **View of the interior of Building 6141 shop area within the original section of the building. The sheetrock ceiling within this area contains asbestos drywall joint compound.**

Place the asbestos-containing materials in an operation and maintenance program and maintain in-place until the materials can be removed and disposed of properly. Control access to the materials, ensuring that the materials are not subjected to sanding, grinding, cutting, drilling, and/or abrading, until a competent abatement contractor can abate the asbestos-containing materials. Prior to demolishing the building, the asbestos-containing materials should be removed by a licensed and competent asbestos abatement contractor.

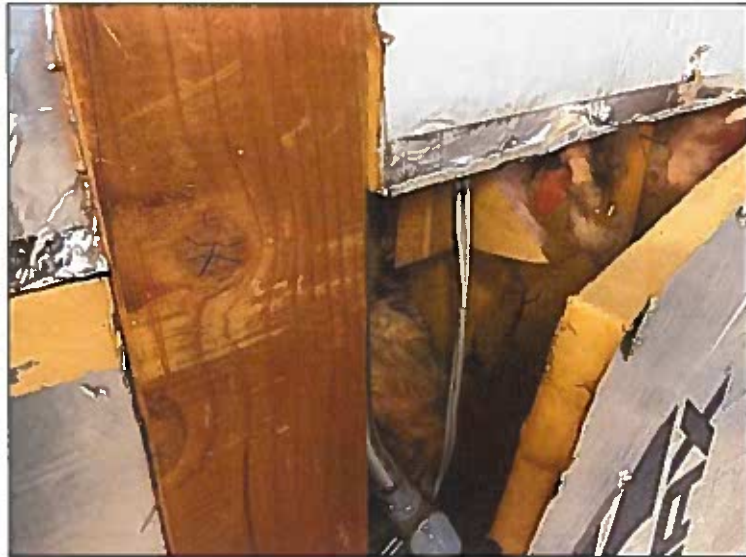
6. **View of the non-asbestos rigid foam board foil covered insulation and batt insulation found within walls of the loft area new shop; this material is similar to that found in the addition to Building 6141.**

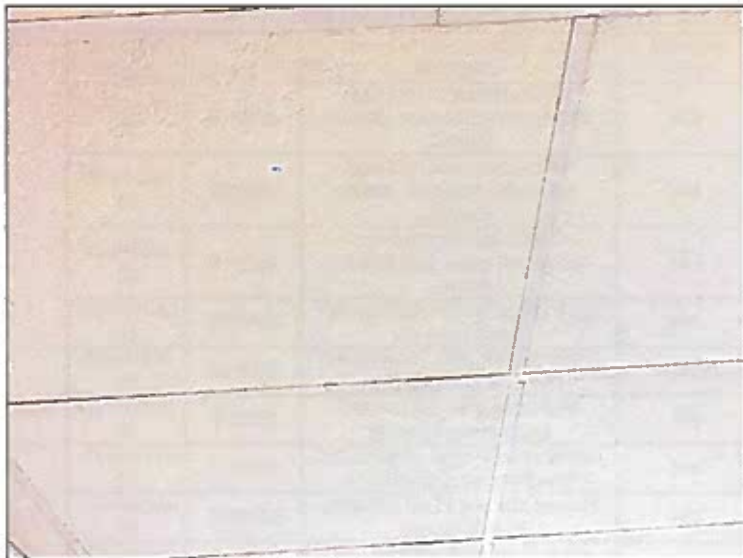
7. **View of the non-asbestos 2'x4' ceiling tiles found within the large office and break room of 6141.**

Drywall with asbestos-containing joint compound was found above the ceiling tiles.

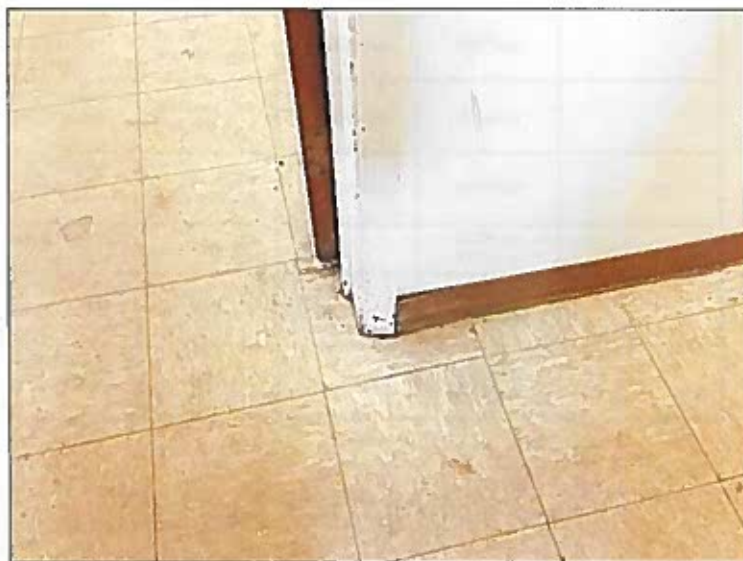
8. **View of the non-asbestos beige 12-inch vinyl floor tile found within the large office space, restroom and hallways in the original section of Building 6141.**
