IDAHO TRANSPORTATION DEPARTMENT

Subject: 2023 5010-1 Airport Inspection conducted August 31, 2023.
(04141.311A Atlanta Atlanta Airfield)

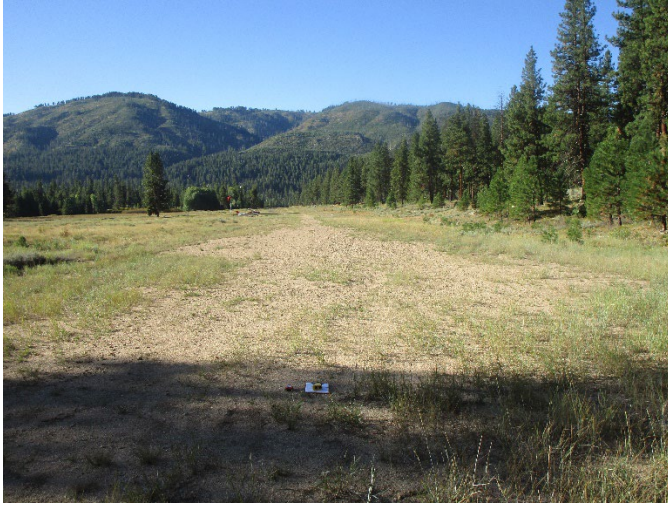
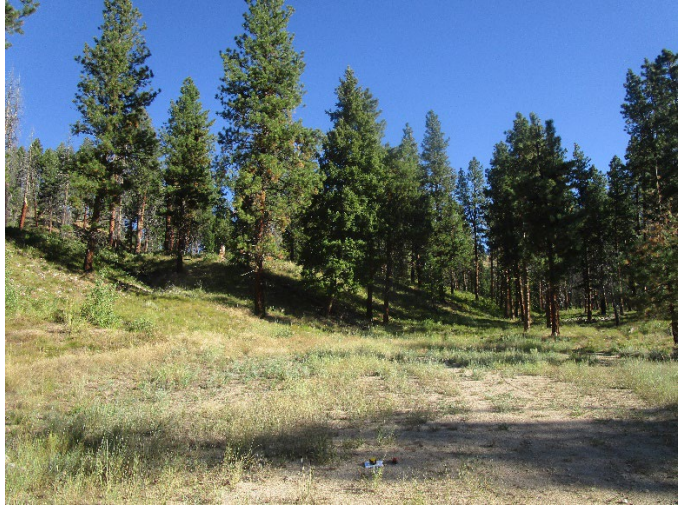
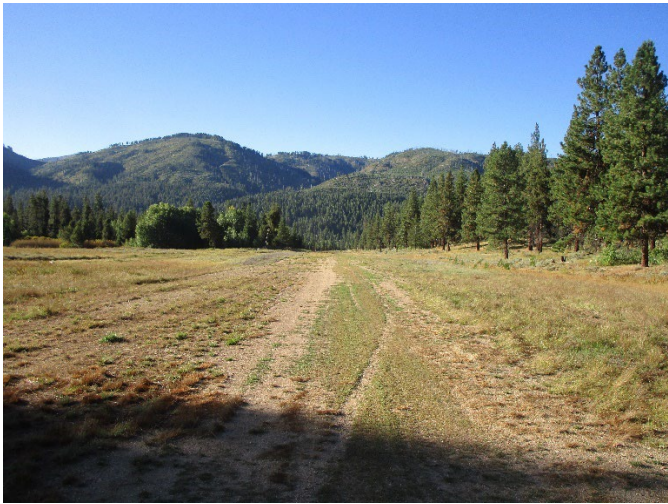
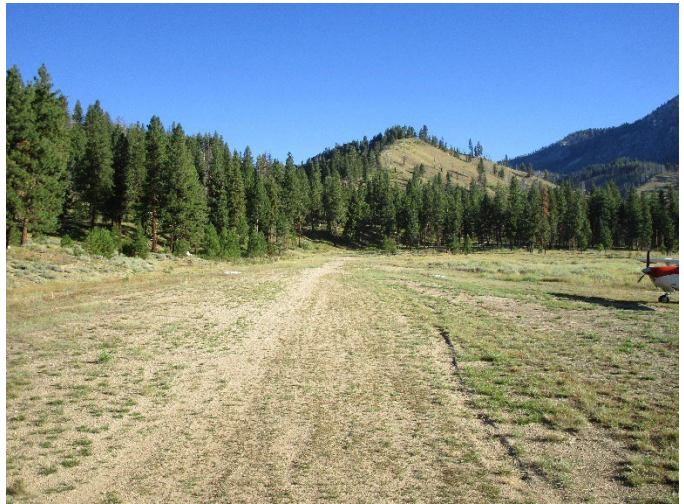
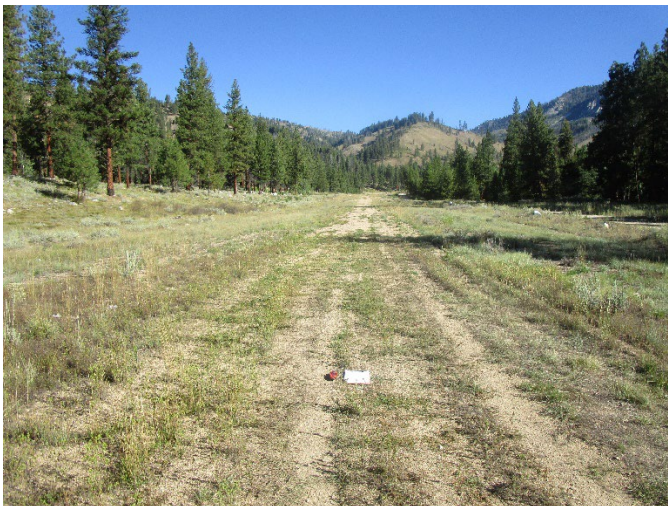
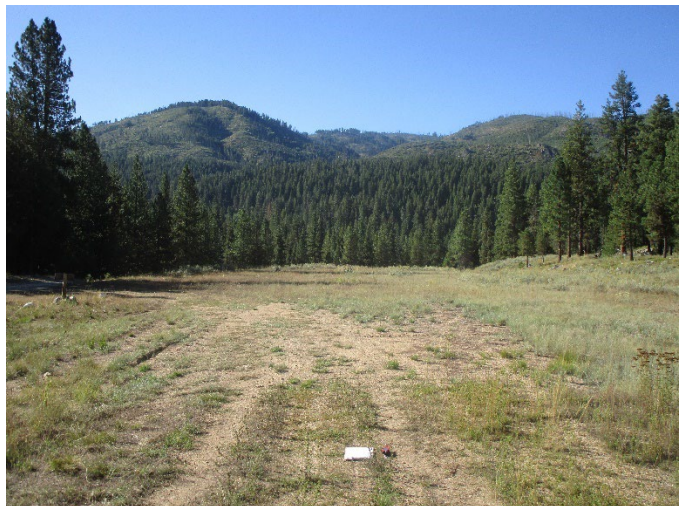
Runway (16-34): During this inspection I found the runway surface to be in fair to good condition, with some roughness due to the presence of clump grass and some loose rocks. Grass had been mowed 3 to 4 days prior to my arrival at the facility, so overall it was looking good. During the ground roll test, grass coverage was uniform, short, and had a consistent feel all throughout - it displayed no major undulations or deformities. During my walk around I saw very little or no rodent activity on the airfield. All signs on the airfield were in good condition, readable and in the upright position. There were no changes to the controlling obstructions, rwy alignment, and the approaches at this airport - both remain relatively the same and unchanged in the past three years.

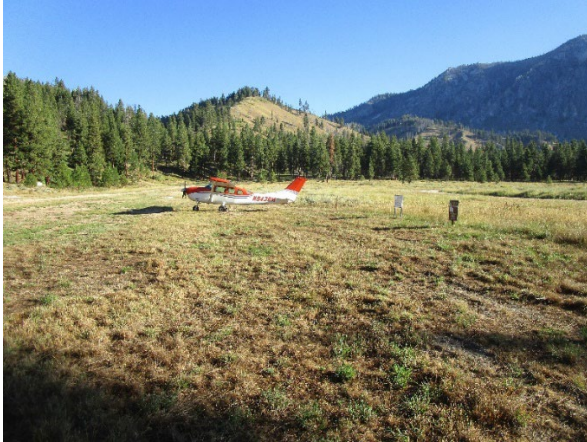
Tiedowns: There were two tie down spots, located just to the North of the windsock, and both had chains visible. The turf surface was in fair condition and a bit on the rough side due to the presence of clump grass.

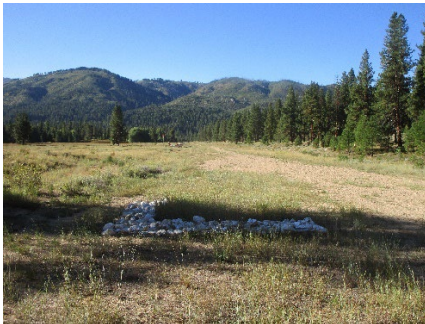
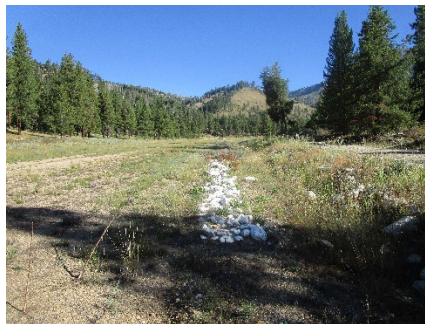
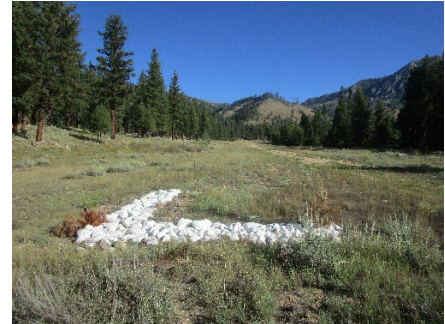
Boundary Markers (BMs): The painted rock boundary markers were in great shape, had excellent paint coverage, and good visibility from the air; there was very little vegetation growing through them. The most noticeable growth was taking place on the side markers and at the north end of the rwy – R16 - those BMs had more grass than any other on the airfield.

1. Mow, clear, and spray the grass inside and around the boundary markers to increase their visibility from the air.

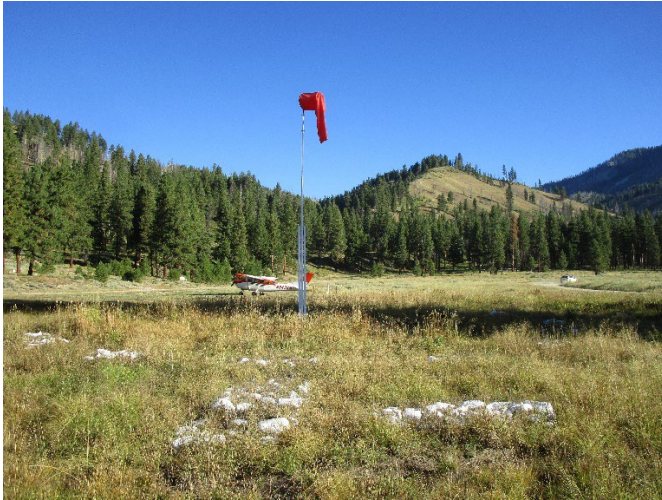
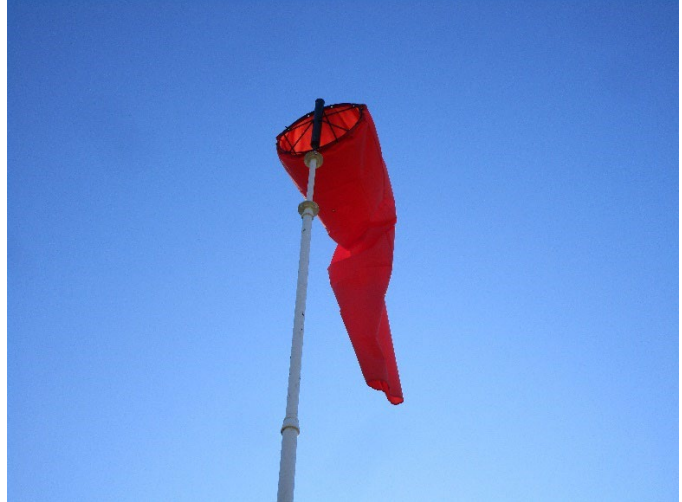
Windsock/Standard/Segmented Circle: I rated the windsock condition as good. The windsock standard was in excellent mechanical condition - solid, functional, and painted white. The non-standard segmented circle present was in good condition, had great paint coverage, and was very visible from the air. I noticed some vegetation growth between the rocks, which is not a big deal yet, but maybe next year when time permits, have it sprayed to keep it clean and visible.

2. Mow, clear, and spray the grass inside and around the segmented circle to increase its visibility from the air.

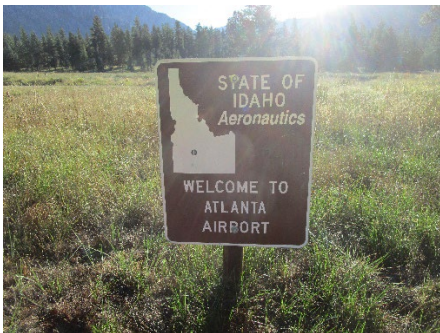
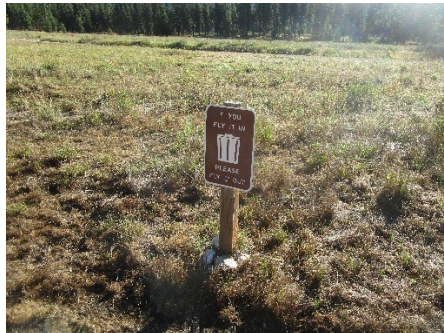
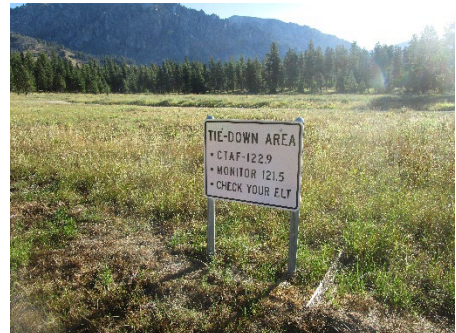
Miscellaneous/Services: All airport-related signs were upright, legible, and firmly mounted. I saw no other significant changes or safety concerns with this airfield. If you have any questions stop by and see me. Have a great day.
