IDAHO TRANSPORTATION DEPARTMENT

SUBJECT: 2023 5010-1 Airport Inspection conducted May 31, 2023.
(04235.9*A Lucille Big Bar USFS)

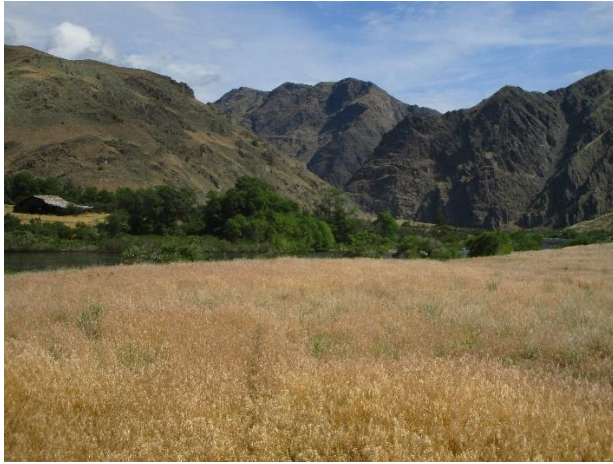
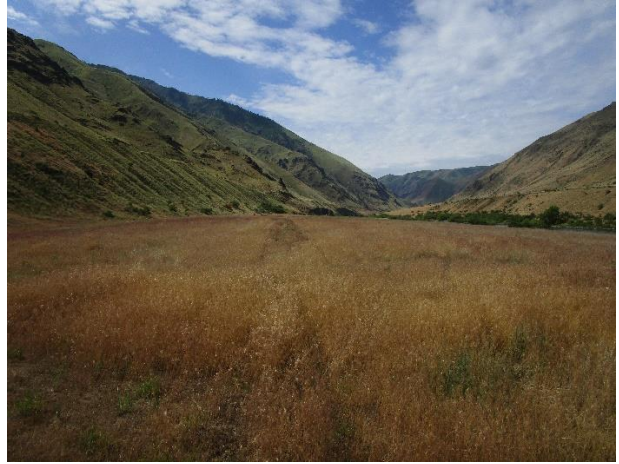
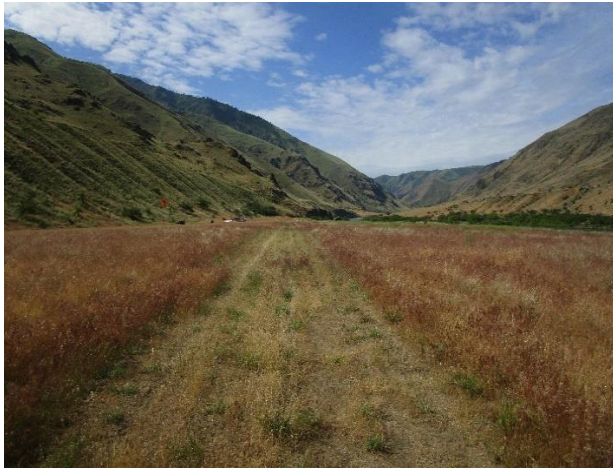
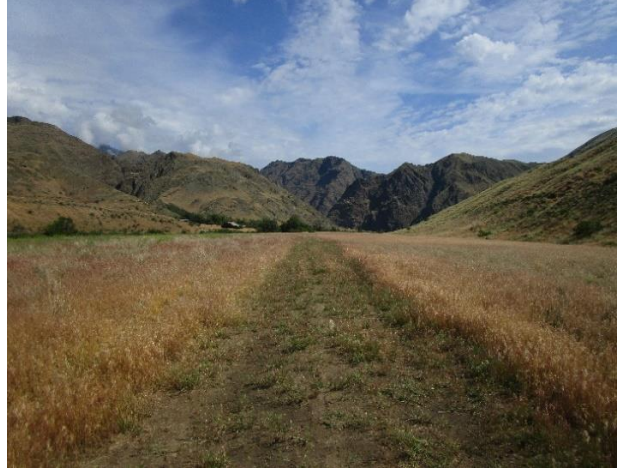
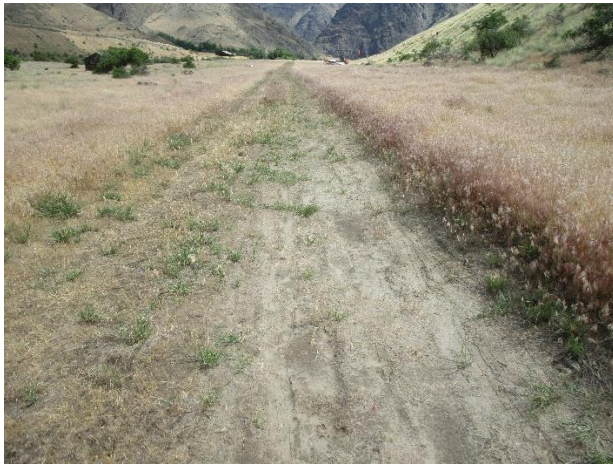
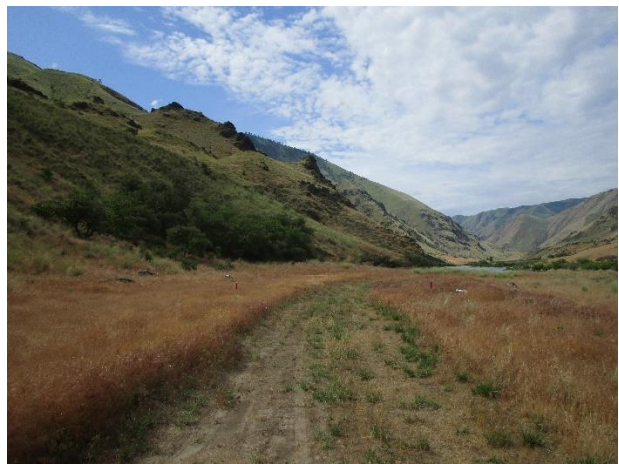
Runway 17-35:

Continues to be in fair condition. The rwy. is not the smoothest surface and presented a few undulations during landing; take-off was equally rough. Rwy. end 35 - first 150ft of the rwy. is very rough due to sloping & uneven terrain; it has serious undulations. The strip could use a mowing as vegetation/grass was growing almost everywhere and is 18 to 20" tall, especially at both ends of the rwy. Outside the 15'-18' center portion used for landing & take-off, there are a bunch of larger size rocks hidden in the taller grass on the sides of the rwy. – some are painted white, and some are not. Not sure how many rocks are within the perimeter of the rwy. & inside the boundary markers (BMs), but remember that the airport owner/sponsor is responsible for maintaining the surface within those BMs and liable for all that could happen inside that area. The approaches at both ends continue to remain the same and with the same controlling obstructions as listed in the Airport Master Record.

1. Mow the rwy. area to match your declared dimensions on the Airport Master Record,
2. Redo the BMs and be consistent with VFR Airports Design Guidelines (if interested, I have info that I could share with you on this).

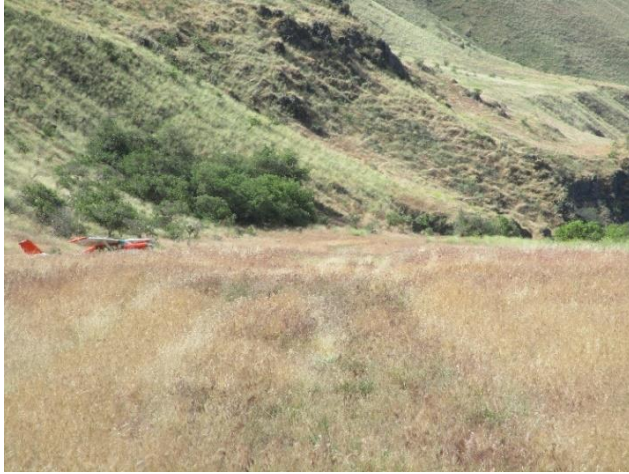
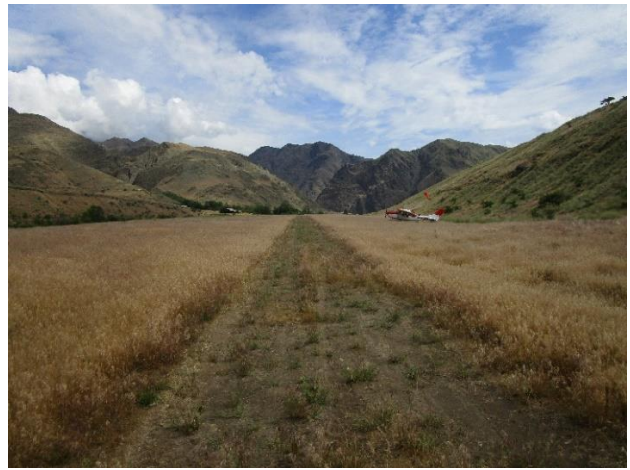
Tie downs:

The tie down area was not clearly marked, but in the vicinity of the windsock both to the North & South of it, there is enough space to park at least 4-6 airplanes. I saw no chains present anywhere. The area was fair and with tall grass that made it difficult to see what you're taxiing over.

1. Place a visible sign to indicate where the tie-down area is,
2. Mow this area to make it easier for acft. to see where to park and avoid rocks.

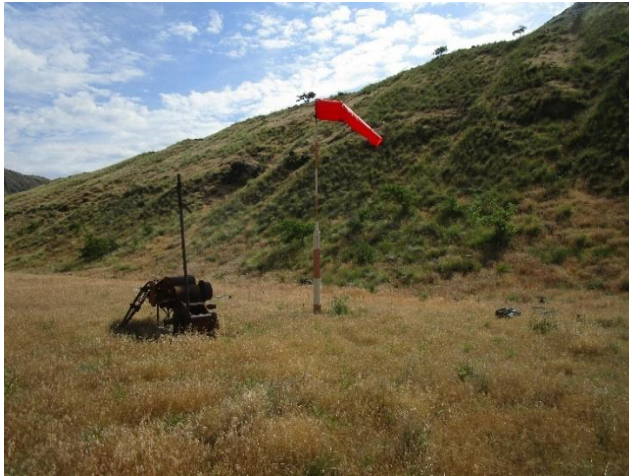
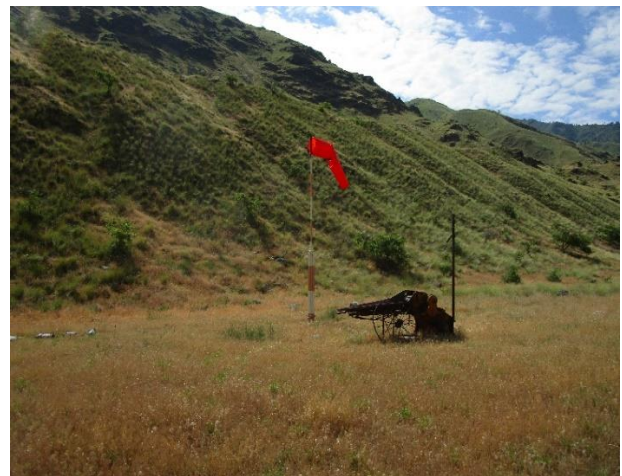
Windsock/Standard:

The windsock was in good condition and displayed no rips or tears. The windsock standard was in good condition and displayed good white/orange paint. There was no segmented circle present at this facility.

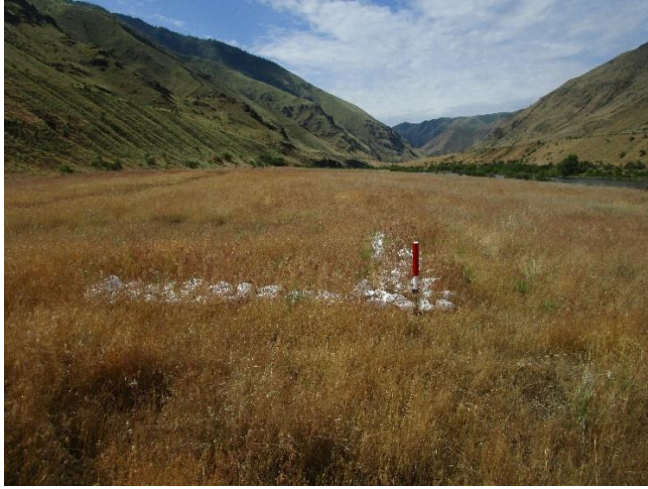
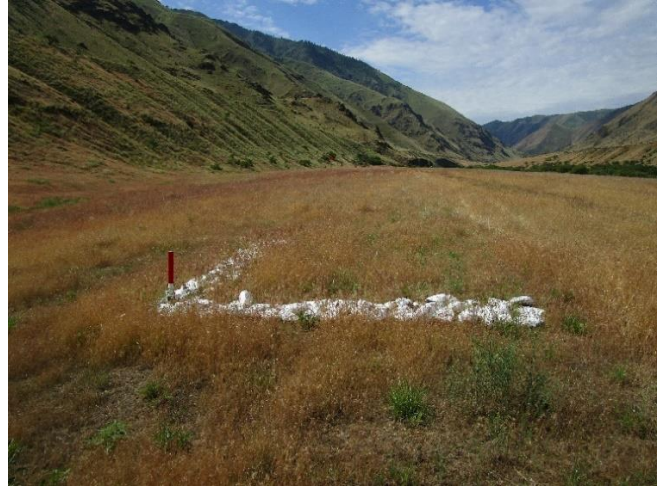
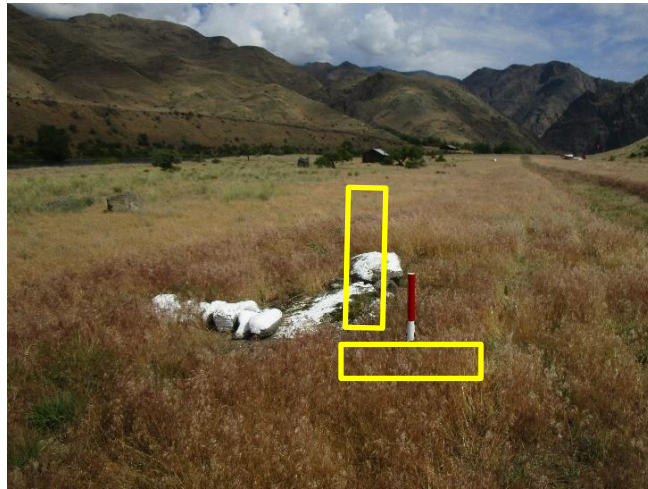
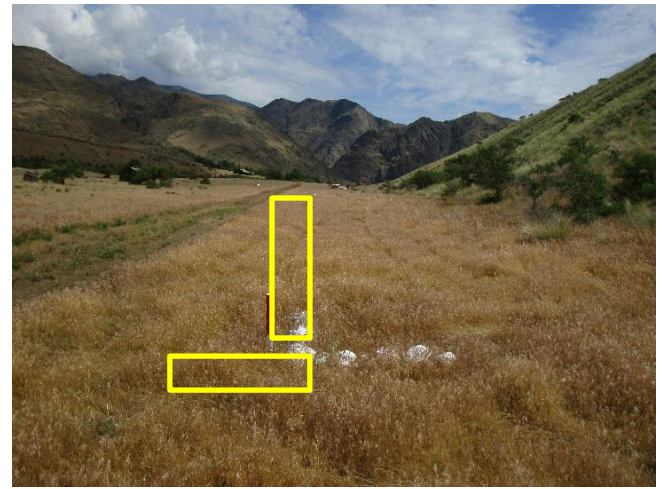
Boundary Markers (BMs):

The existing non-standard rock BMs located at rwy. end 17 are good, in place and have good paint coverage. Grass growth is encroaching, and the rocks are being taken over (through & around the rocks) by tall grasses (15-18" tall) and other vegetation. At rwy. end 35 the rock BMs are installed incorrectly "└┐" vs the normal inward L shape "└┐".

1. Grass should be pulled/mowed/cleaned out/sprayed to sterilize the area of all the BMs and not have to contend with the grass growth on a yearly basis,
2. Redo the BMs at rwy. end 35 to resemble a normal inward “|_ _|” shape vs the now _| _|” (follow the yellow markings in the pics above for proper positioning) and relocate the red reflectors to the outside corner of the Ls.
