IDAHO TRANSPORTATION DEPARTMENT

Subject: 2023 5010-1 Airport Inspection conducted March 31, 2023
(04158.*A Burley Burly Municipal)

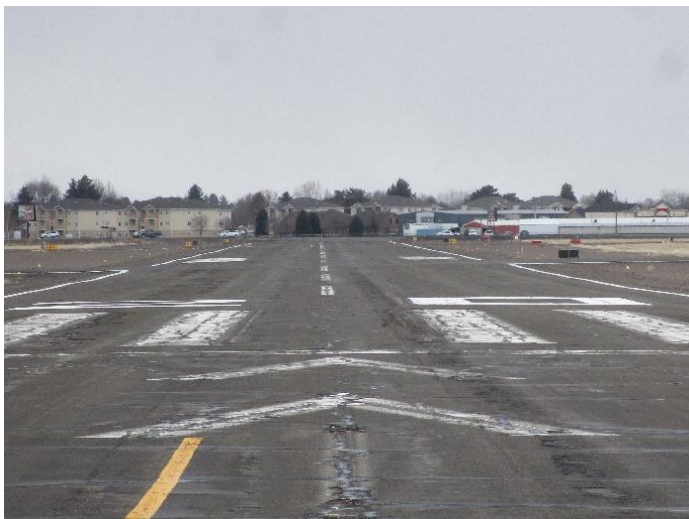
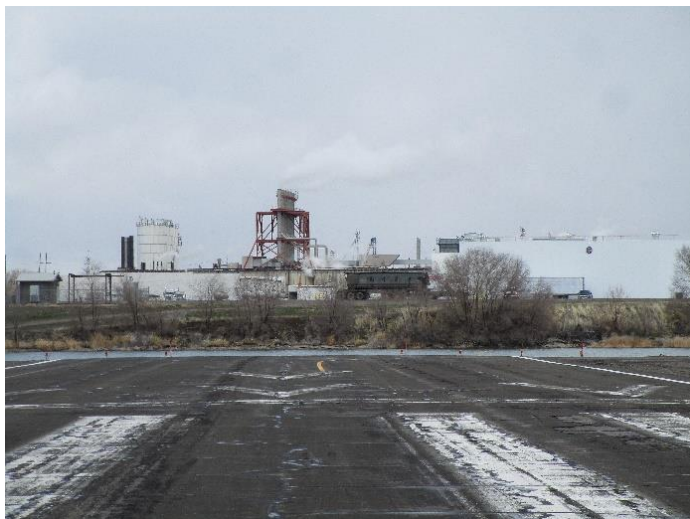
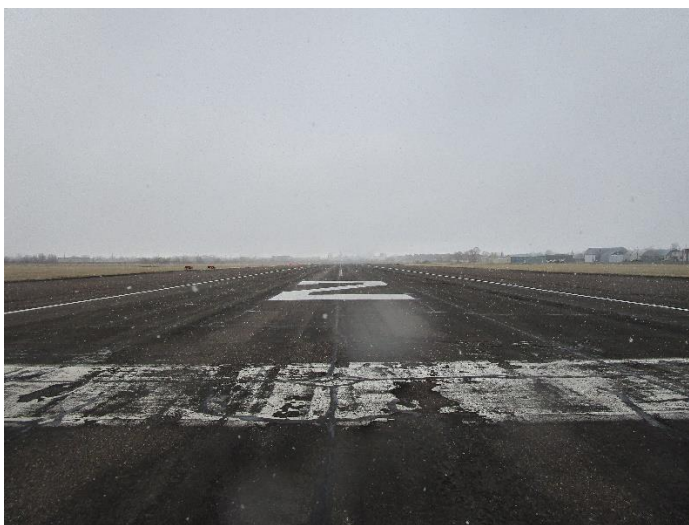
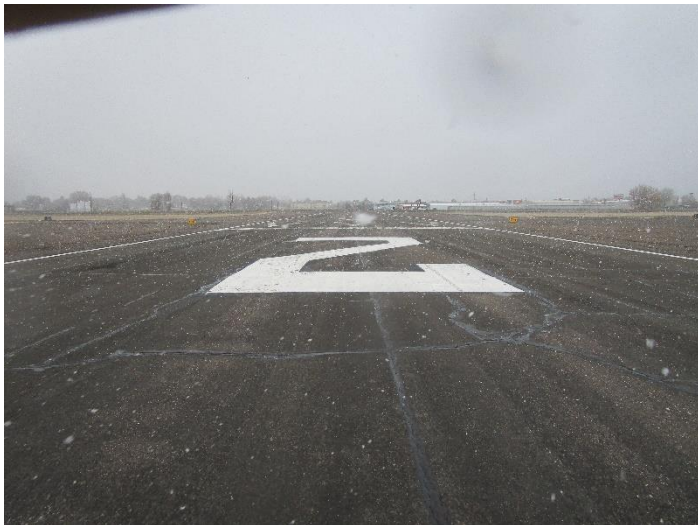
RWY 2-20

Overall, in their current state, both runways appear to be in fair to poor condition. Numerous old cracks exist, both longitudinally and transversely. It is noticeable that sometime ago a slurry fill treatment was applied to those cracks, but due to weather and time, that fill has shrunk and the gaps/cracks reappeared. The top superficial layer of asphalt is losing its integrity, crumbling, and becoming loose in places. This is very evident and more pronounced toward the runway ends and within the touch down area. In addition, the snowplows contribute to this process as scrape marks are visible and have scraped small portions of the asphalt as well. All the runway markings are also fair. Much of the white paint in the numbers, displaced threshold arrows, threshold bar, and centerline has faded and/or worn off. While the runway markings are somewhat, still visible from the air, they could use a fresh coat of paint. In their current state and without any maintenance, the pavement surfaces will continue to deteriorate and will get worse and worse with time. I wish there was an easy solution/fix to the pavement condition at Burley, but all surfaces need to be re-done.

1. Add fresh paint to runway markings – numbers, treshhold bar, center line, and displaced treshhold arrows
2. Replace burnout light bulbs and fix broken light fixtures to both runways

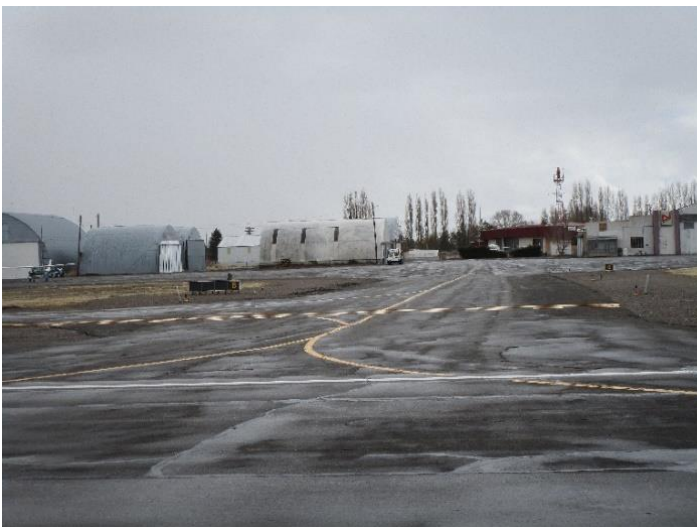
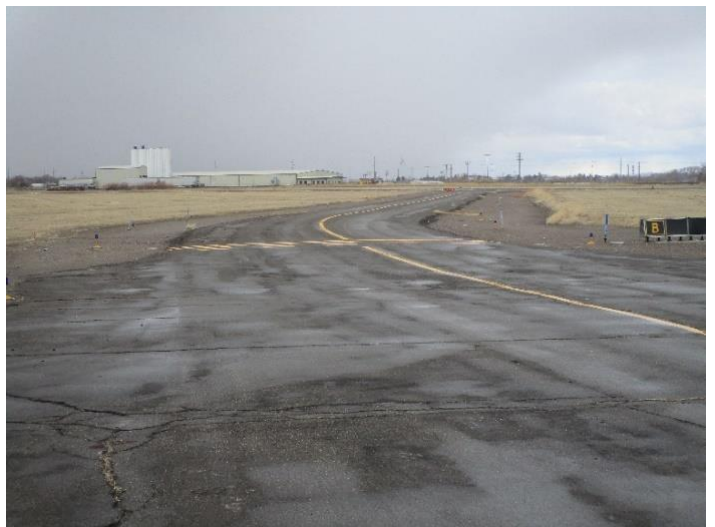
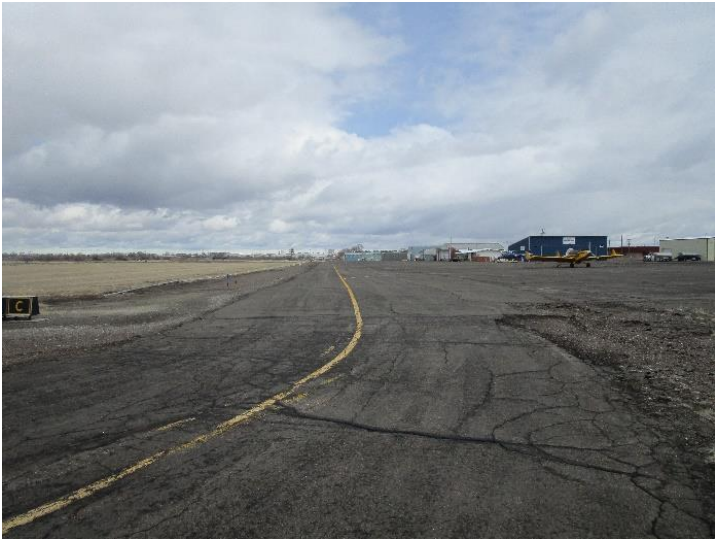
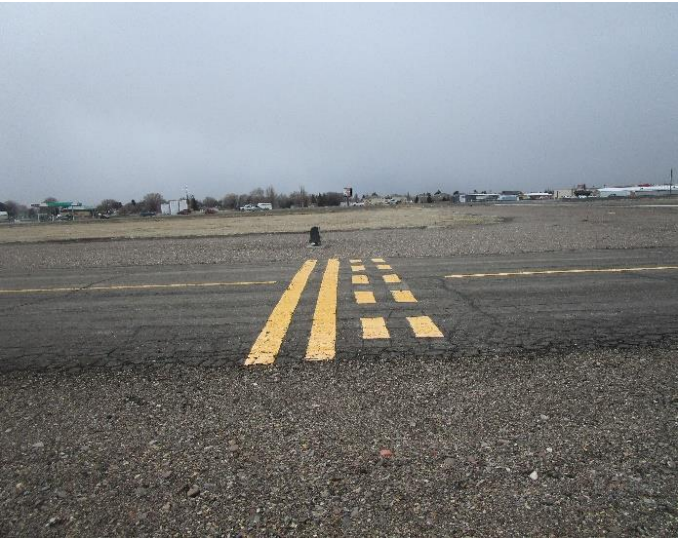
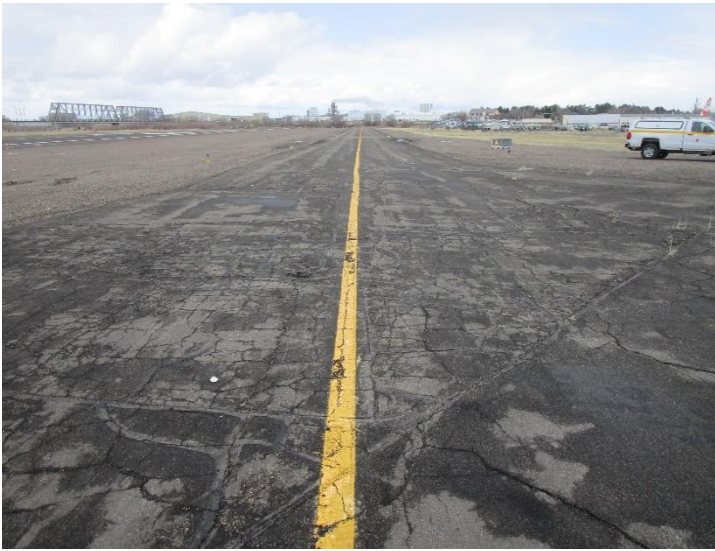
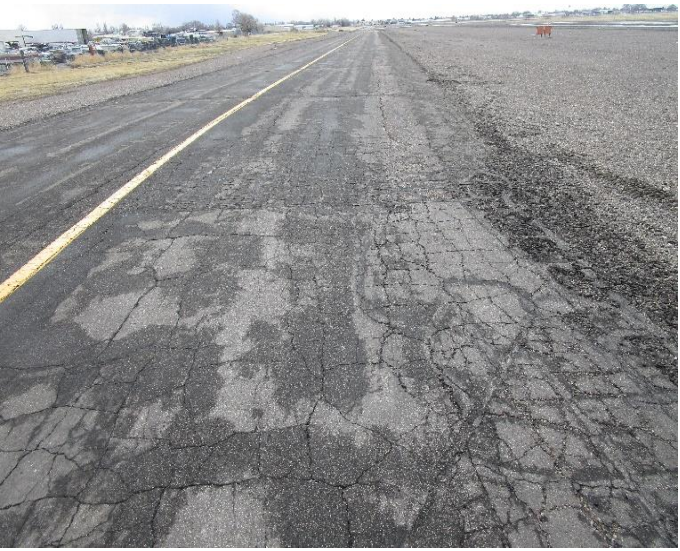
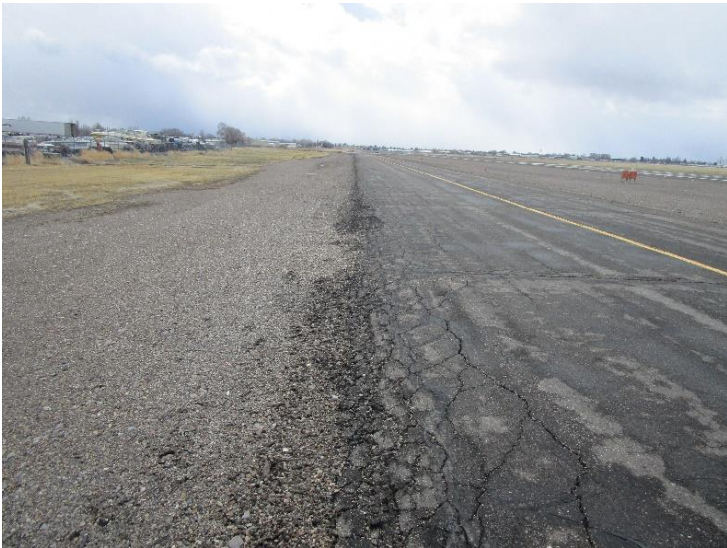
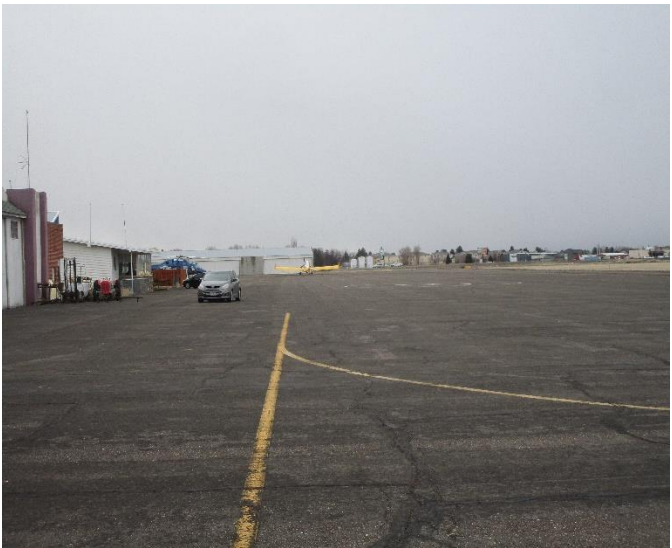
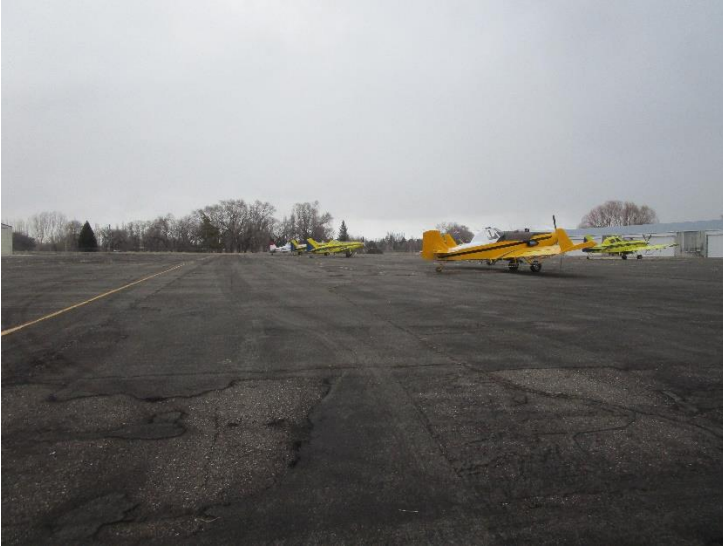
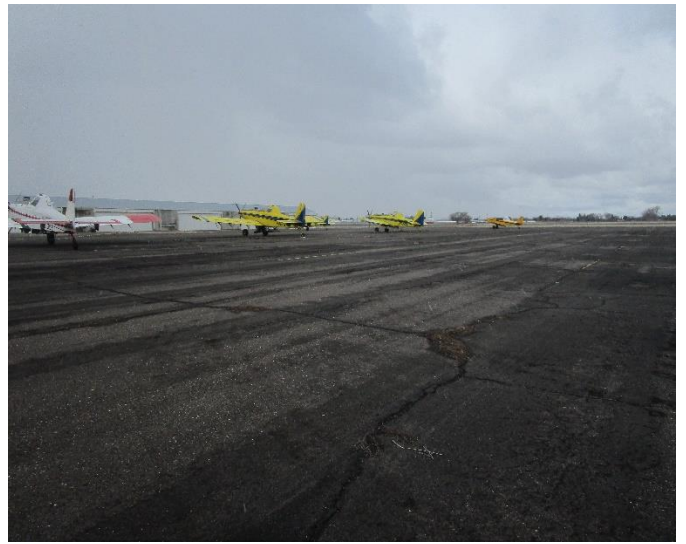
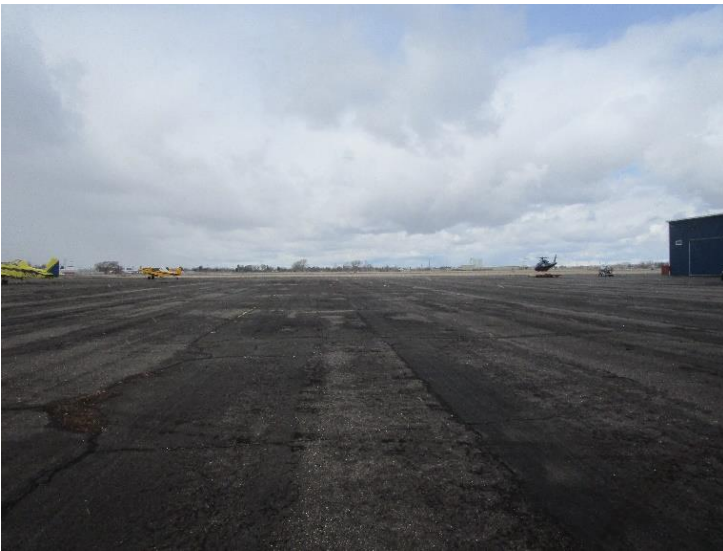
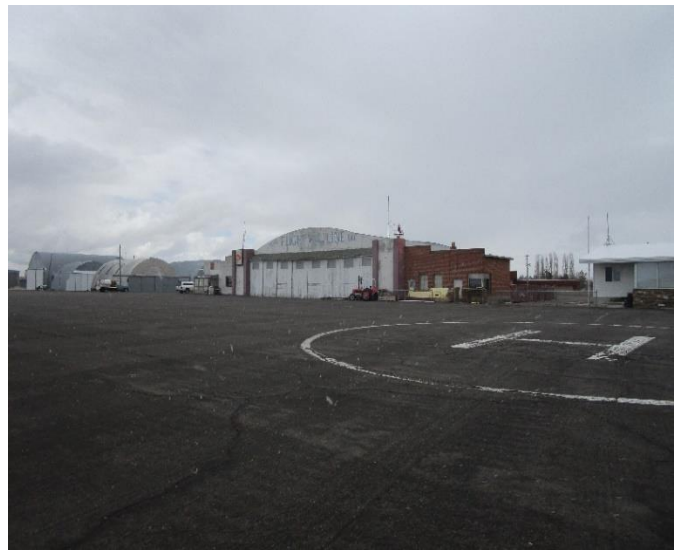
The ramp areas are in fair to poor condition as well. The pavement surface is plagued with an incredible amount of alligator cracking, which shows the age, wear and tear, and the lack of preventive maintenance at this airport. Tie down area is in fair to poor condition and so are the taxiways. On the taxiway edges, you will see that the pavement is unravelling and coming apart in too many places. Markings are a mixed bag of some good, some fair, and some poor. Of the approximately 58 parking spots that I counted in front, to the south and north of the FBO, 8 of them that had chains or tie-down ropes present and available. The paint markings on the parking aprons is fair.

1. Repaint the tie-down area markings

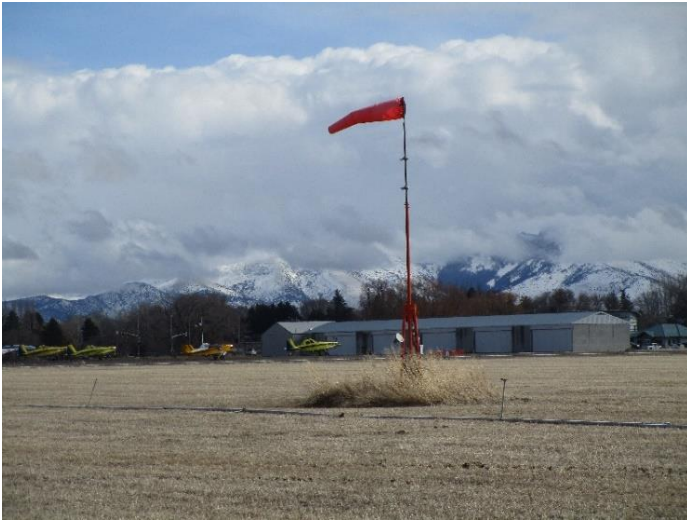
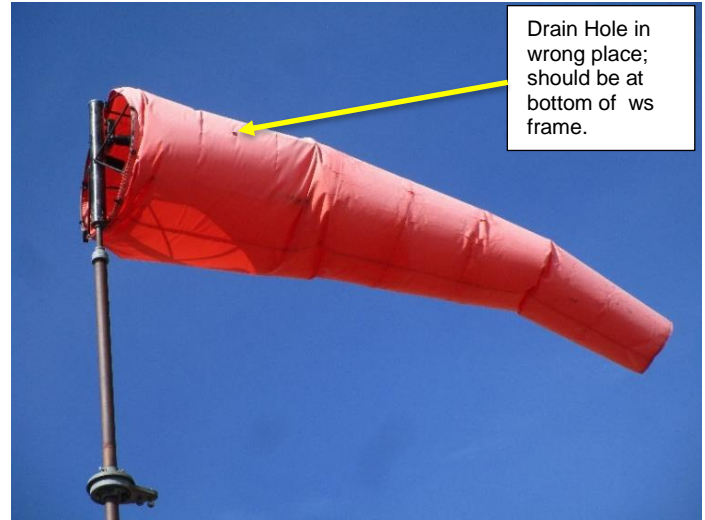
I rated the windsock in good condition, as it displayed no tears and showed just minor fading. The only thing I noticed was that the drain hole was installed in the wrong position - on the side of the windsock vs on the bottom where it should be for proper water drainage. This type of installation will only shorten the life span of the windsock as it does not allow for proper rainwater drainage and it weakens the material, which will eventually tear. The metal windsock standard was in good mechanical condition - solid, functional, and with good orange paint coverage. There was no segmented circle present at your facility.

1. Install the next windsock properly on the frame – have the drain hole at the bottom of the windsock.

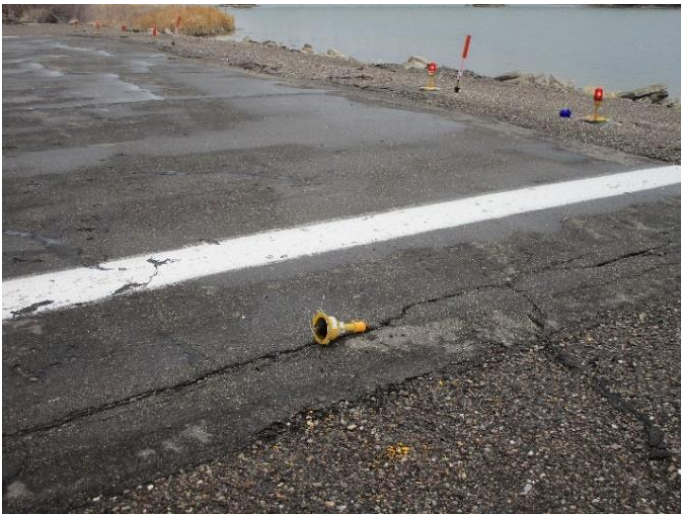
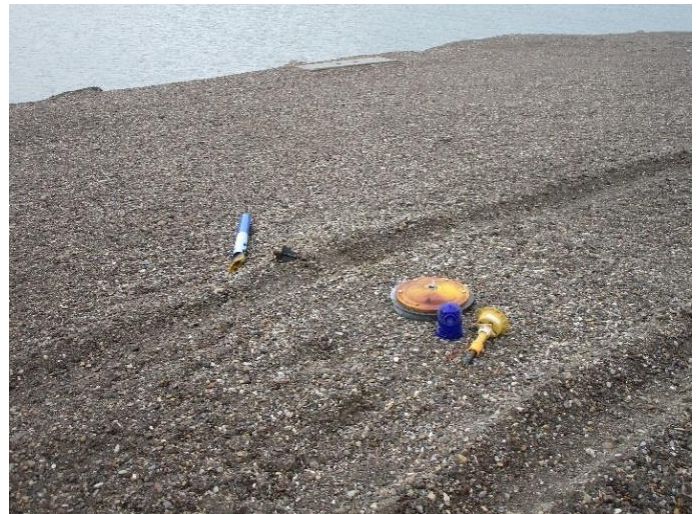
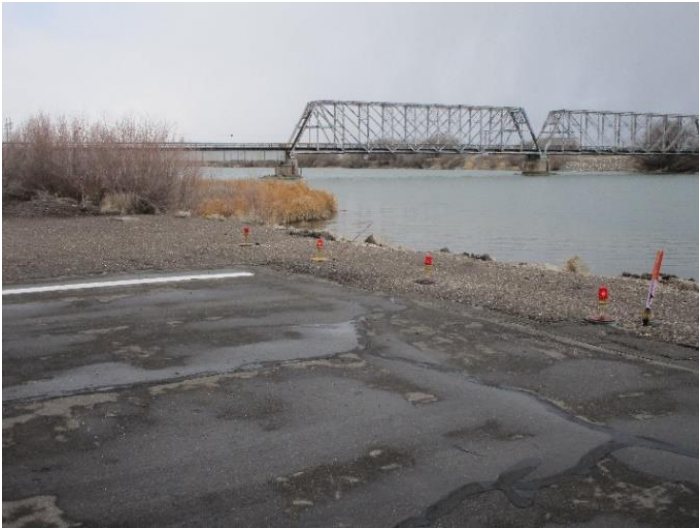
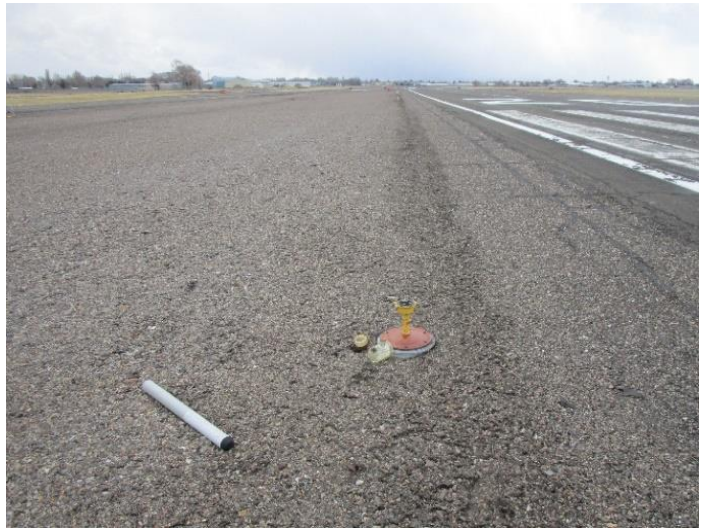
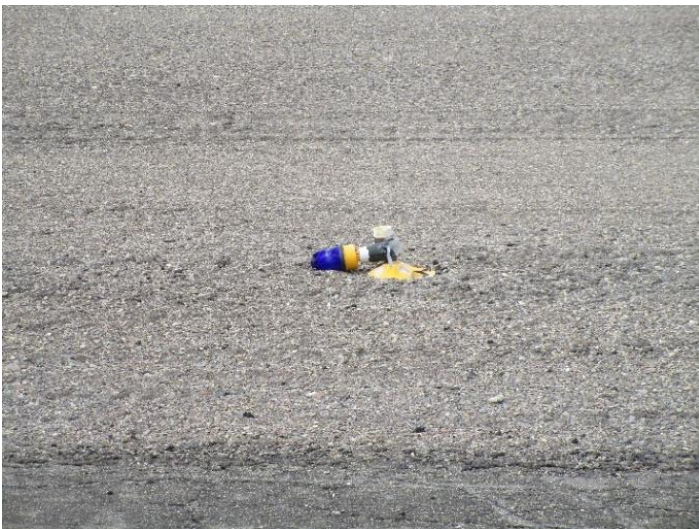
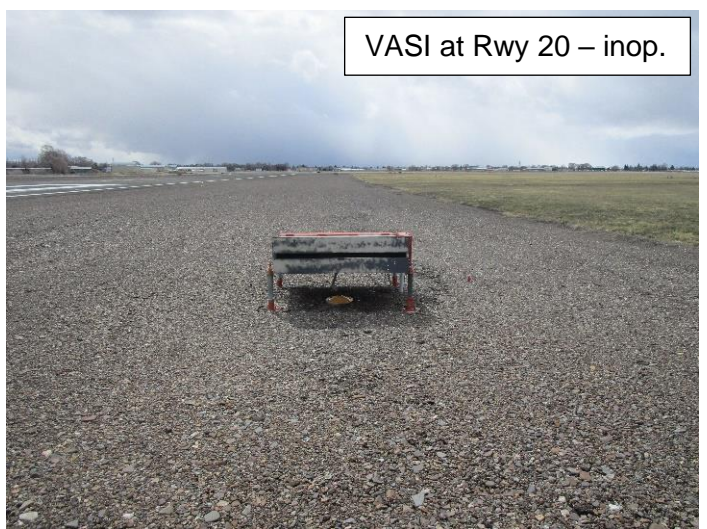
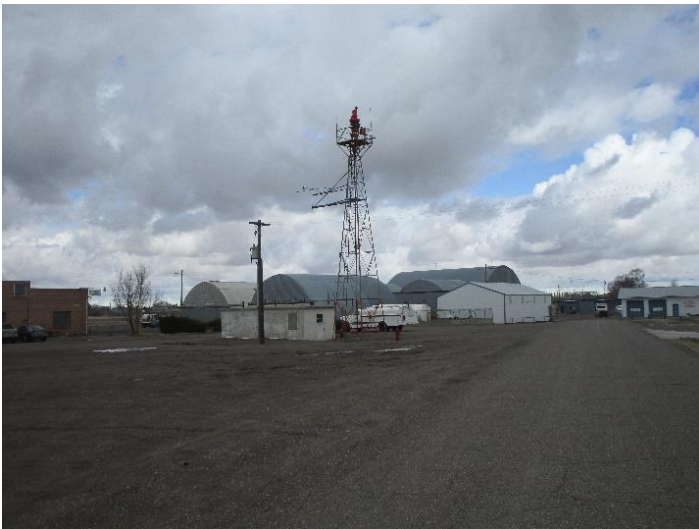
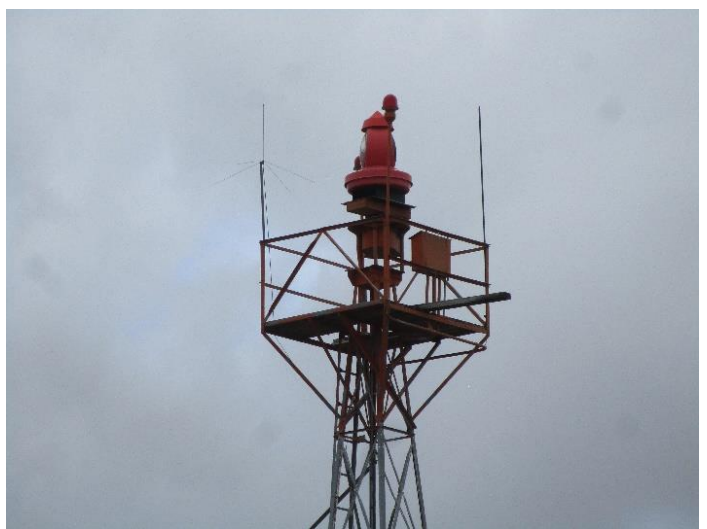
Your airfield has lighting available on both runways and taxiway lights at each fillet. However, this area shows the most distress, as many of the lights are physically broken. While driving around the facility this is what I counted in terms of broken lights: Rwy 2-20: 10 lights out, Rwy 6-24: 10 lights out, Taxiway A: 6 or more lights were either broken fixtures or burnt out light bulbs (see pics below). The rotating beacon appears to be in good working order and the lattice tower shows good integrity. The paint on the structure is old, but still visible, and resembles the traditional aviation white and orange markings. I was not able to verify its functionality during this visit (I will take your word for it). Rwy 2 VASI and REILS were both in good physical and working order and I was able to verify and check their functionality. Rwy 20 VASI lights were inoperative, same as three years ago.

1. Replace all the burnt-out bulbs and fix all broken light fixtures on runways and taxiways.

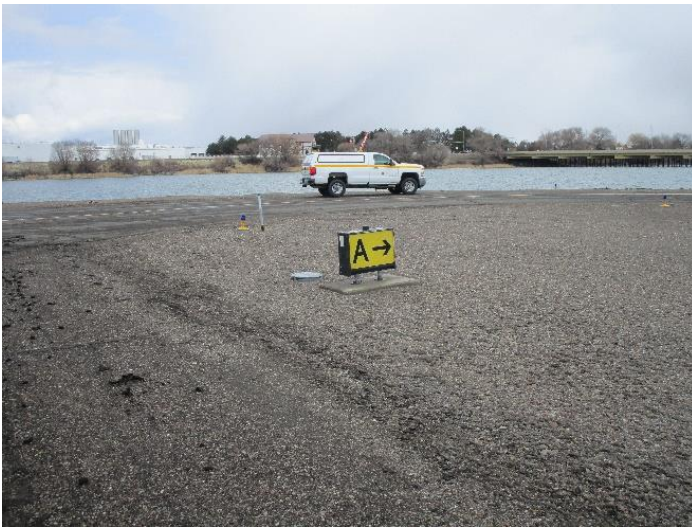
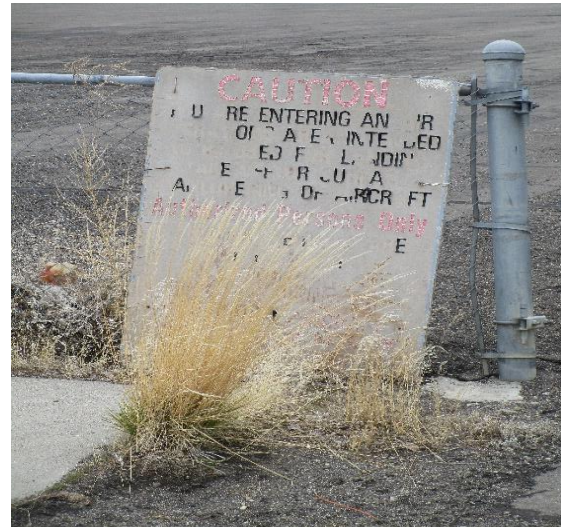
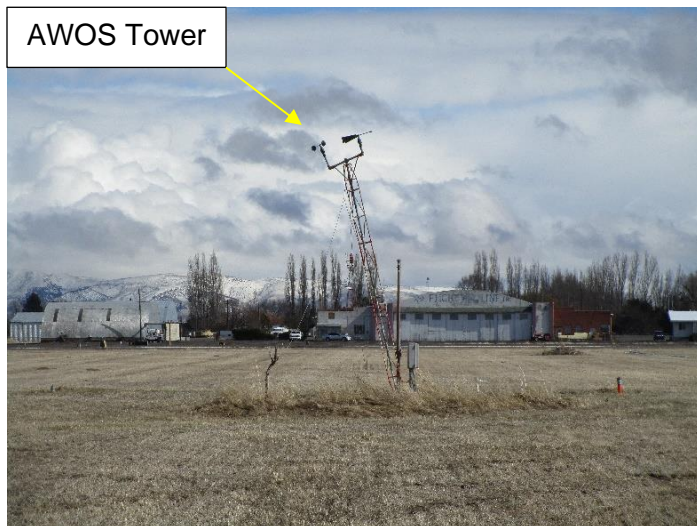
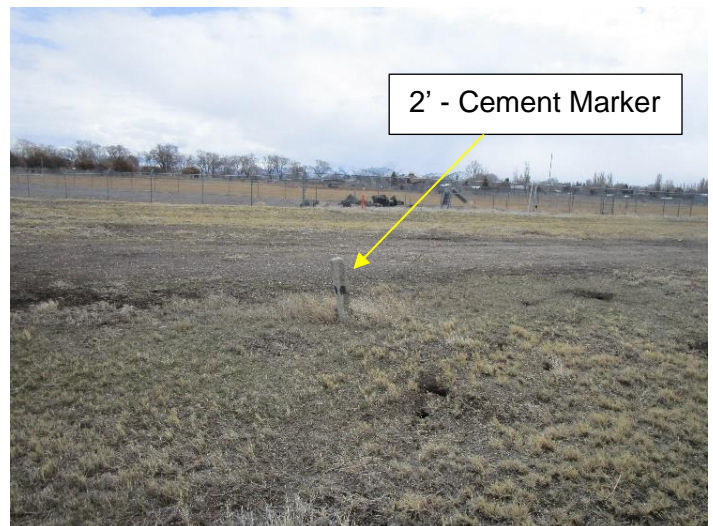
All airport-related signs were in the upright position, legible, and appeared to be in good working order except for the "Caution" sign located on the fence at the entrance onto the airfield. It is not readable and should be redone properly. One thing that I would like to bring to your attention is the 2 ft tall, cement, phone cable marker that you still have in the primary surface of Rwy. end 24 (left side of the displaced threshold). In its current form it should not be there; perhaps a smaller structure that is 3" or less above the ground, could be installed, as the FAA requires that anything within the primary surface area has to be installed on a frangible coupling device or no more than 3" above the ground. This 2' cement post is not. In addition, the AWOS antenna needs some attention as one of the three support guy wires is missing/broken and the whole structure is leaning to the N. I think that if uncared for, due to wx and time, the whole thing will eventually collapse. Also, consider taking it down if no longer in use.

1. Redo sign at the entrance – make the message be readable and visible.
2. Straighten and secure weather station tower so it will not fall over, or completely remove if no longer serving a purpose,
3. Lower the 2' cement marker so it is only 3 inches above ground maximum or replace with a marker of sorts that is maximum 3" above the ground or install it on a frangible coupling device as per the FAA requirements.
