IDAHO TRANSPORTATION DEPARTMENT

Division of Aeronautics
1390 W Gowen Road, Boise ID 83705

SUBJECT: 2023 5010-1 Airport Inspection conducted June 13, 2023.
(04142. 51A Big Creek Ranger Station Cabin Creek USFS)

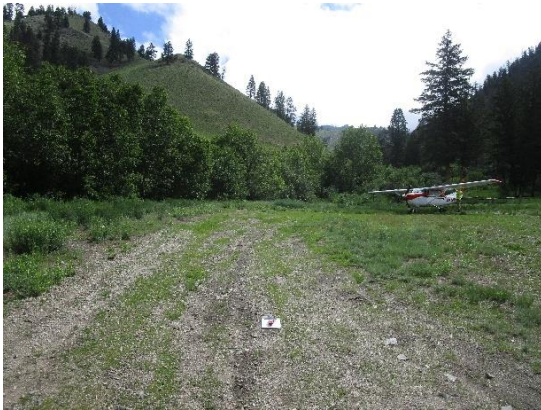
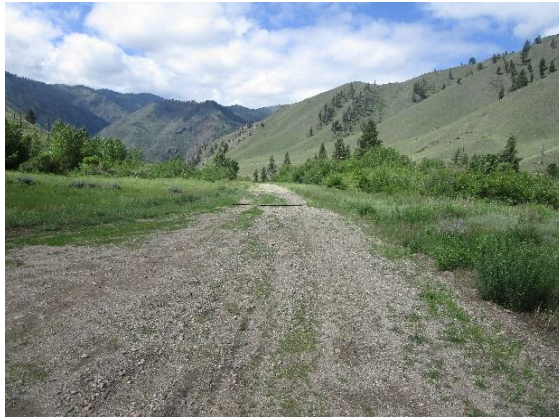
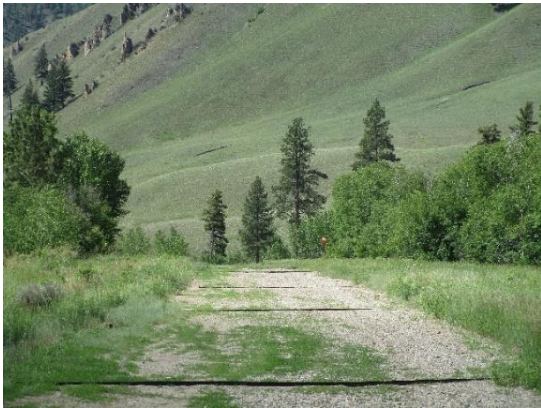
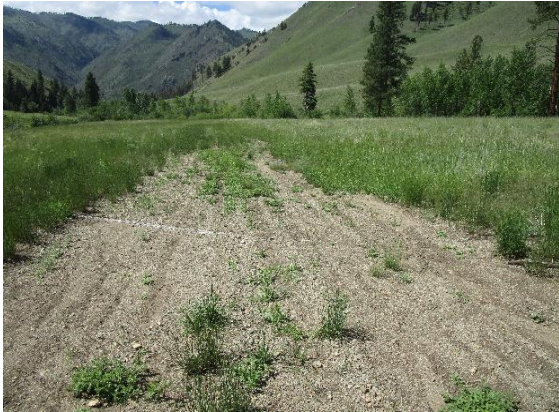
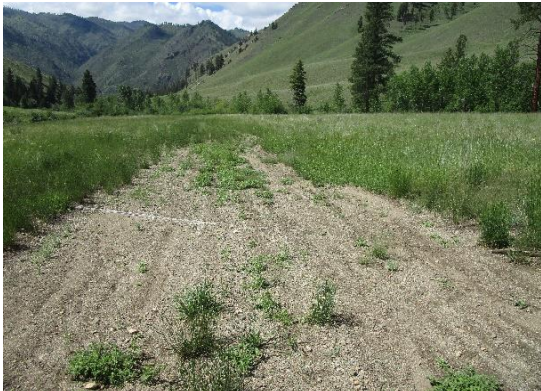
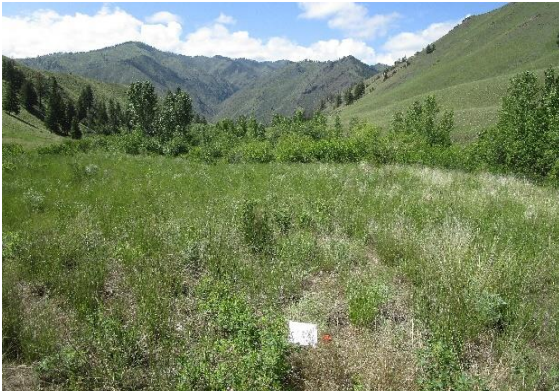
Runway 2-20: Not much has changed at this airfield in the last three years and since I did the first inspection back in 2020. The turf-dirt runway surface continues to be in fair condition, with the surface somewhat rough the entire length. Loose rocks of various sizes (up to 3-4”), continue to be present at this facility. The upper end (rwy. 20) appears to be a bit rough caused by propeller blast and the removal of fine materials every time a plane takes off. There are several water deflection rubber bars that were showing a considerable amount of wear and tear (especially at rwy. end 02). Currently, in their present shape I do not believe those damaged rubber flaps are serving a purpose anymore as the top edges have come apart so badly that water flows right over them. Here, forward visibility during take-off has always been

a challenge due to the midfield curvature in the rwy. and trees blocking the view of the far end of the rwy. Landing & departing aircraft have to exercise extreme caution to see hikers, stock and aircraft near the parking area when they take off. The controlling obstructions at both rwy. ends remain the same - trees with rising terrain. The trees identified as Part 77 obstructions - 3 years ago, are still there today (see below pics). Since this is a one way in, one way out type airstrip, cutting those trees down at rwy. end 02, would be a tremendous benefit for the flying public. Their removal would open the approach and increase the safety margins for both arriving and departing aircraft considerably (see attached pics from 2020 and 2023).

1. Mow the grass at rwy. end 02,
2. Fix/replace the broken water diversion flaps,
3. Perhaps install some Boundary Markers at rwy end 02,
4. Cut down the trees at rwy end 02 that have been identified as hazards 3 yrs ago and again this year.

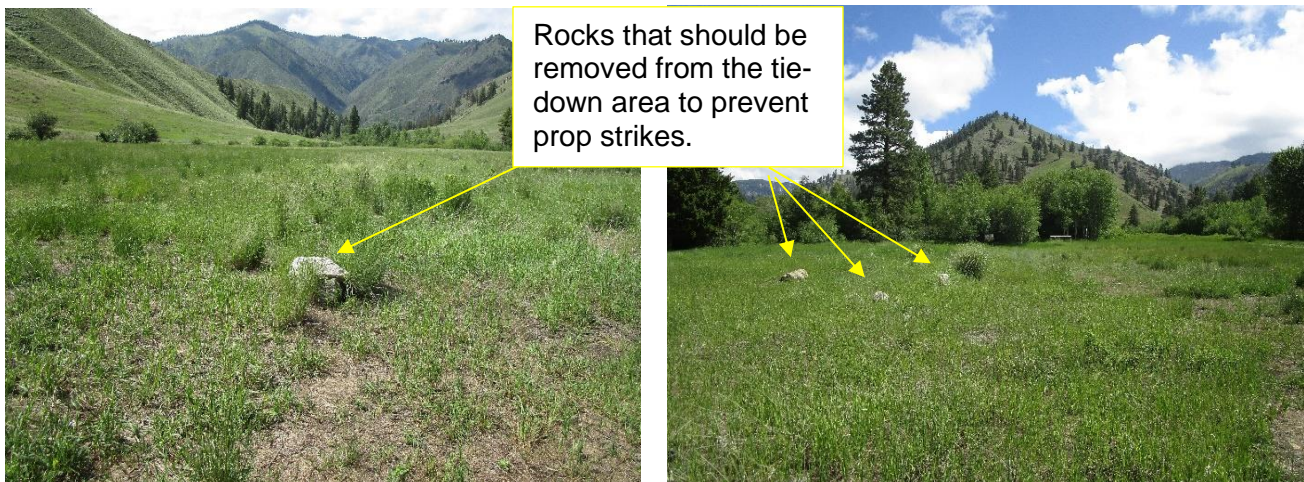
Tie-Down Area: Tie-down area was rough due to tall, bunch grasses (15-18" tall), and big rock boulders hiding in the grass. There is room to park several airplanes in this tie-down area; I saw no securing devices present at this airfield – ropes or chains.

1. Tie down area needs to be mowed,
2. Rock boulders need to be removed from this area to ensure the safety of arriving aircraft/ running motors (potential hazard for prop strikes (possibly they could be used to create a non-standard segmented circle around the windsock)).

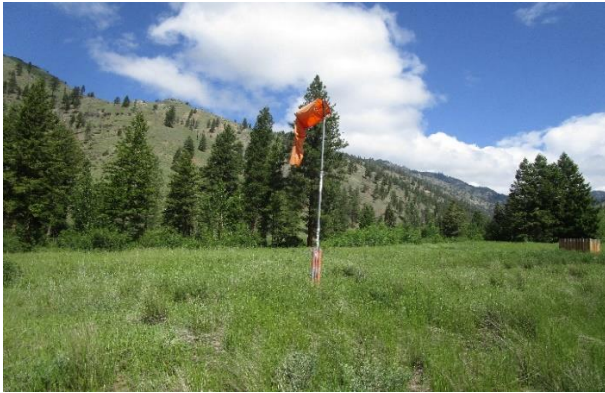
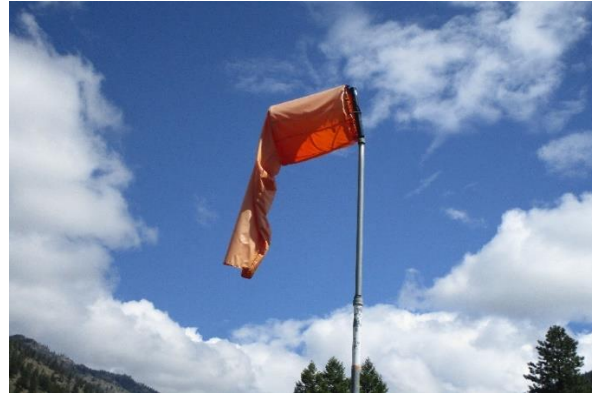
Windsock: The windsock was in good condition and displayed no rips or tears. It had good color and was visible from the air. The standard was in good mechanical condition and it had remnants of orange and white paint; it needs new orange & white paint. There was no segmented circle of present here. A segmented circle of any kind would only improve the visibility of the navigational device from the air and better aid pilots in identifying the wind conditions on the ground.

1. Ensure that the windsock is installed properly with the drain hole to the bottom of the windsock frame and not to the side
2. Repaint the standard with either orange and white, all orange, or all white,
3. Build a non-standard segmented circle out of rocks and paint them white.

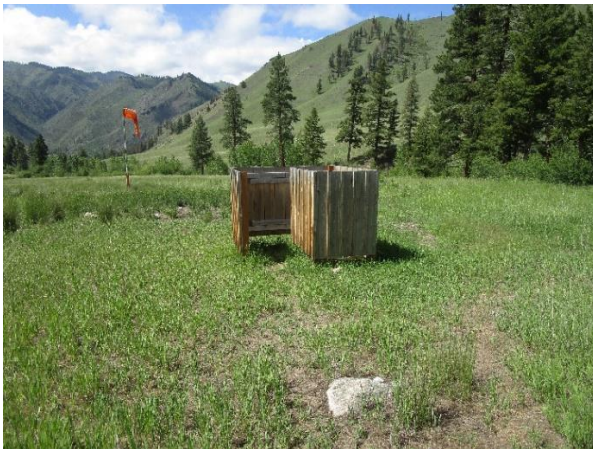
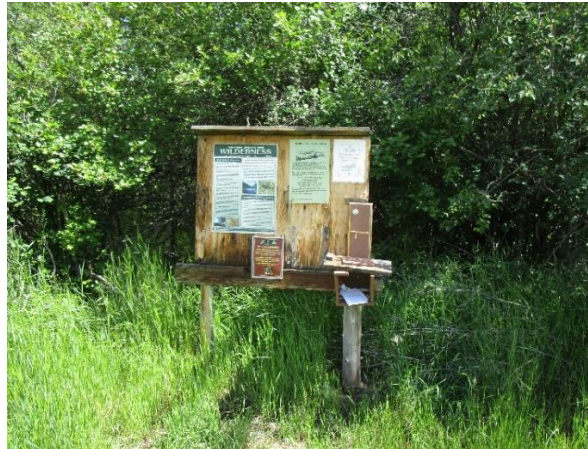
Misc/Services: The outhouse added a nice touch of convenience out in the middle of nowhere – it was clean and well supplied with the necessary TP. All informative USFS signs were in good order and serve the public well. I saw no other significant changes or safety concerns with this airfield. If you have any questions, or need any additional info regarding this report, please do not hesitate to call: 208-334-8895. Take care and have a great day.
