IDAHO TRANSPORTATION DEPARTMENT

SUBJECT: 2023 5010-1 Airport Inspection conducted June 21, 2023.
(04178.2A Coolin, ID Cavanaugh Bay Airport)

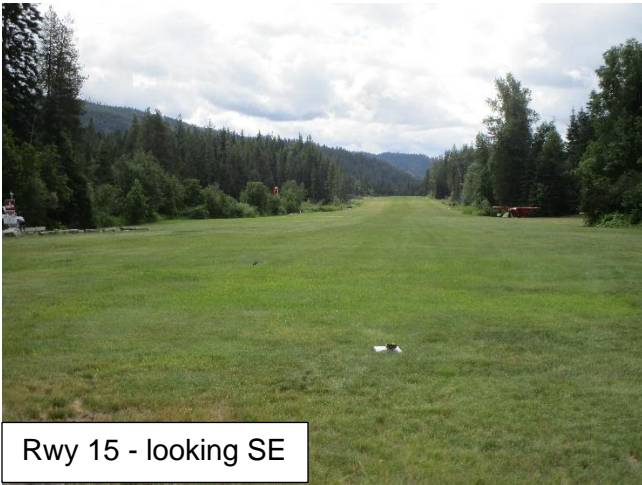
Rwy 15 - looking SE

At the time of the inspection the turf runway continues to be in very good condition, with a firm and even turf surface where the grass is evenly spread throughout the entire rwy. area. At rwy. end 15, the residential area between the edge of the rwy. and Priest Lake has some trees on the rwy. extended center line that need to be looked at (see pic below with red markings). With as much rain as they get up north these trees will grow and will become a more serious issue in the near future, so anything you can do to have them mitigated/cut down, will totally open up the approach/departure corridor and increase the safety margins for Cavanaugh Bay. Also, at rwy. end 33 inside the left BM there is a 4' tall bush that is growing right inside the rwy. area - that should be removed and eliminated, if possible. Both approaches continue to remain unchanged and with the same controlling obstructions – trees at both ends of the runway.

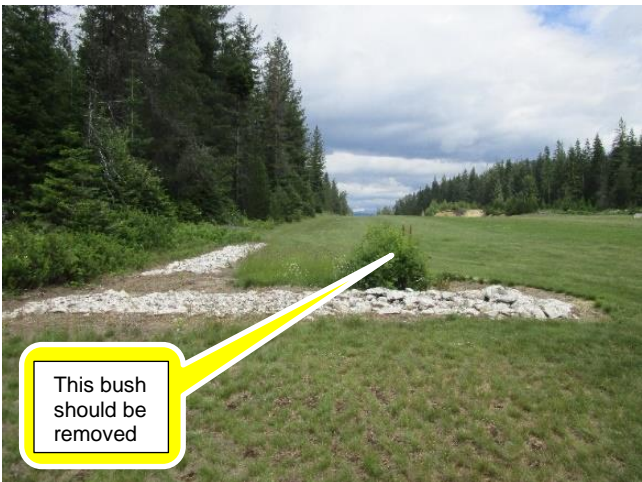
Most of the painted rock boundary markers were in good physical condition and had a good amount of paint coverage. I noticed there is some weeds/grass growth around the edges of the BM at rwy. end 33 and some of the side markers. The shrub growing on the rwy., next to the left side BM at rwy. end 33, needs to be removed as soon as practical – it shouldn't be there.

This bush
should be
removed

1. Remove, spray, and clean out the grass growth from within the rocks and around the edges.
2. Apply a fresh coat of white paint in the next 1-2 yrs.
3. Remove the bush that is next to the left side BM of rwy. end 33 – as soon as it is practical.

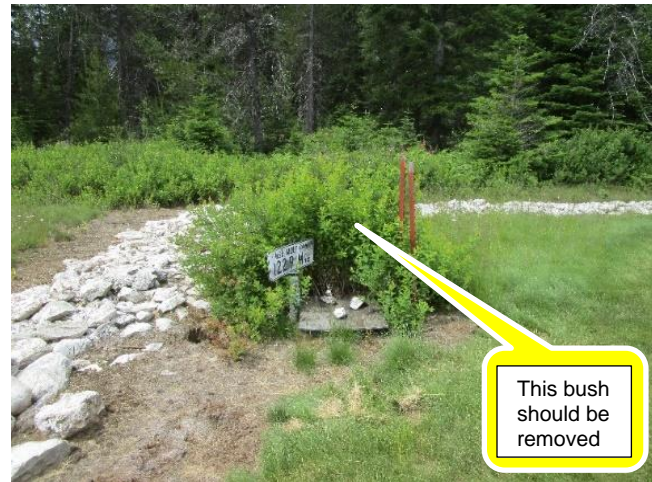
This bush
should be
removed

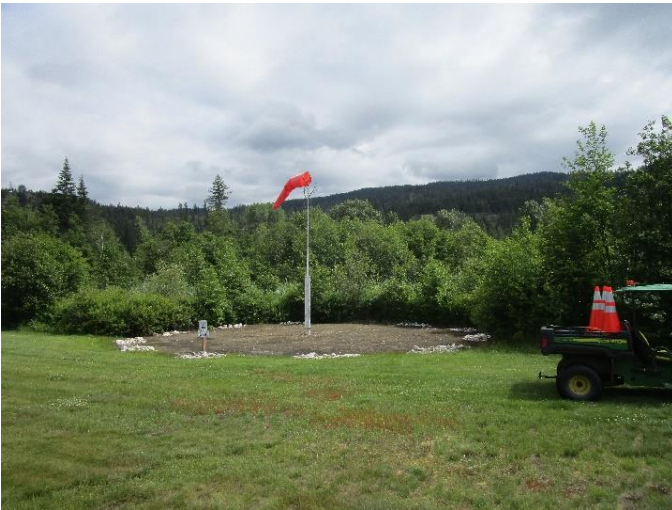
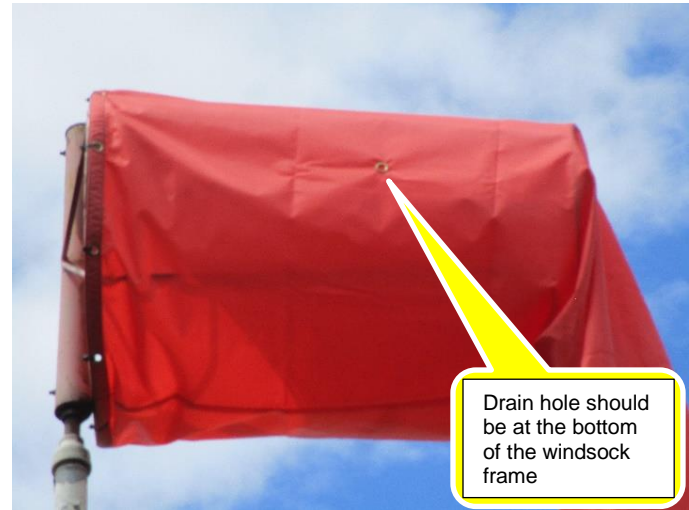
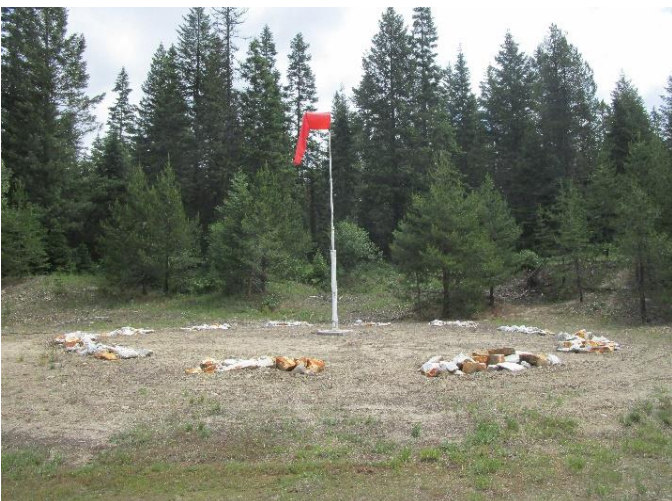
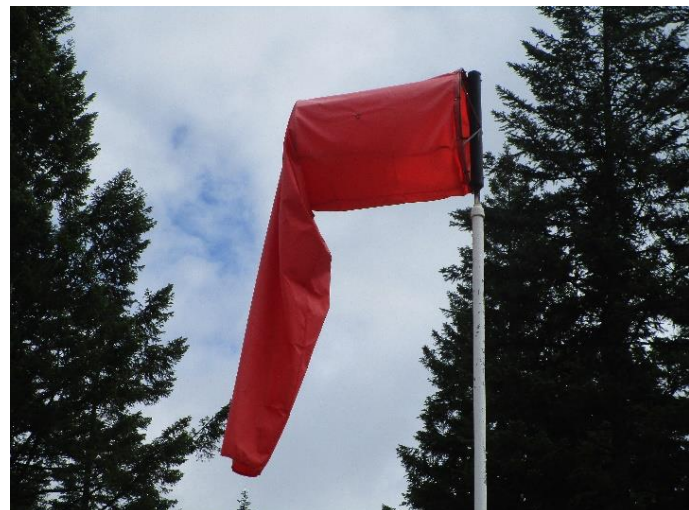
Both windsocks on the facility were in good condition, displayed good color, and had no rips or tears. The only thing I noticed that both windsocks were installed wrong as they had the drain hole installed on the side vs the bottom where it should be to allow for proper rainwater drainage. The standards were in good mechanical order and had most of the paint still on; some peeling/flaking of paint is visible. The segmented circle were in good shape and had good paint coverage.

1. Next time you put up a windsock, ensure the drain hole is at the bottom of the frame vs elsewhere.
2. Keep vegetation away from the segmented circles so they can be visible from the air
3. (windsock closest to the campground area is being encroached on by the shrubs/trees that are growing right up against the rocks).

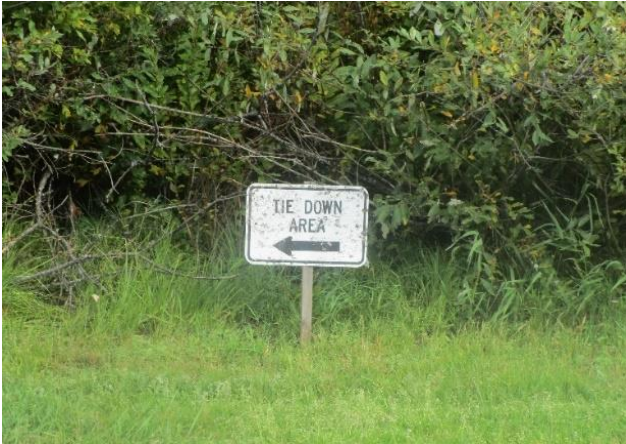
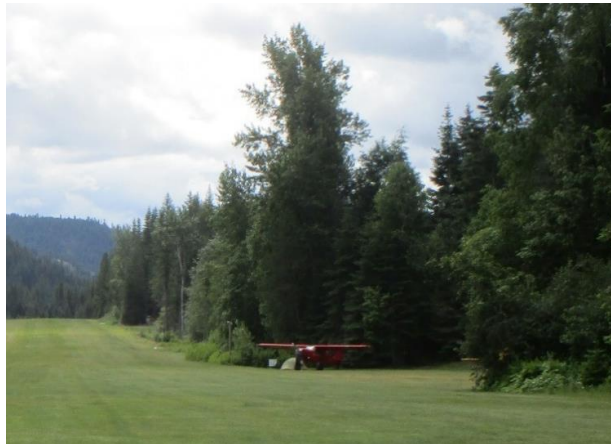
This airfield has the capacity to handle a lot of airplanes in three different parking areas – two to the north end and close to the campground area and one to the south side of the airport. During my visit I counted approximately 20 parking spots and 18 of them had chains present. Area was nicely mowed and had 3 visitors/airplanes parked for overnight camping.

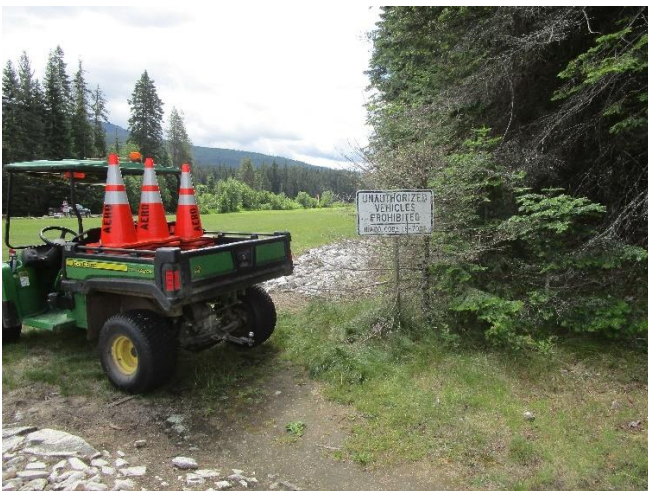
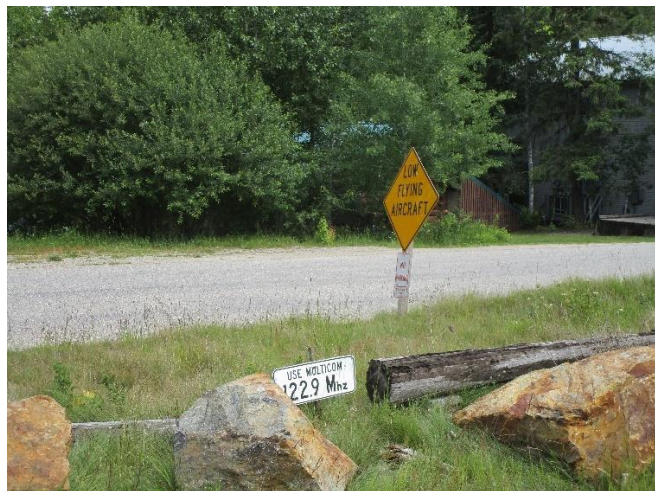
Signs were all in the upright position, visible, and in good physical order. No other safety concerns or issues were observed at the time of the inspection. If you have any questions or concerns, please contact me at 208-334-8895.
