IDAHO TRANSPORTATION DEPARTMENT

SUBJECT: 2019 5010-1 Airport Inspection conducted August 26, 2019.
(04242.1A Copper Basin Mackay)

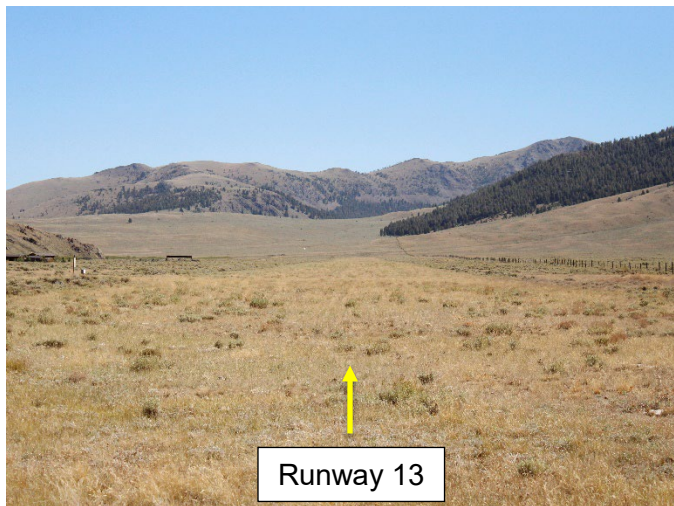
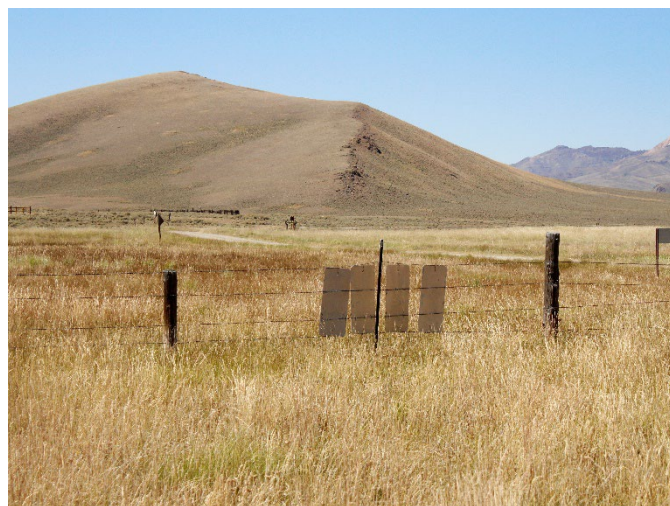
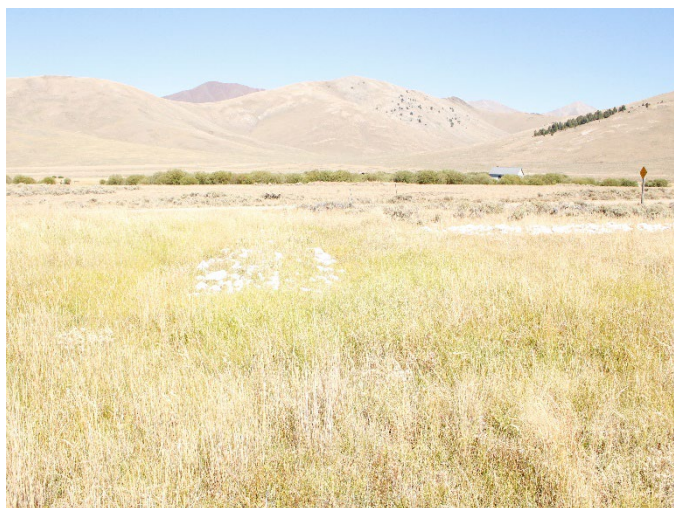
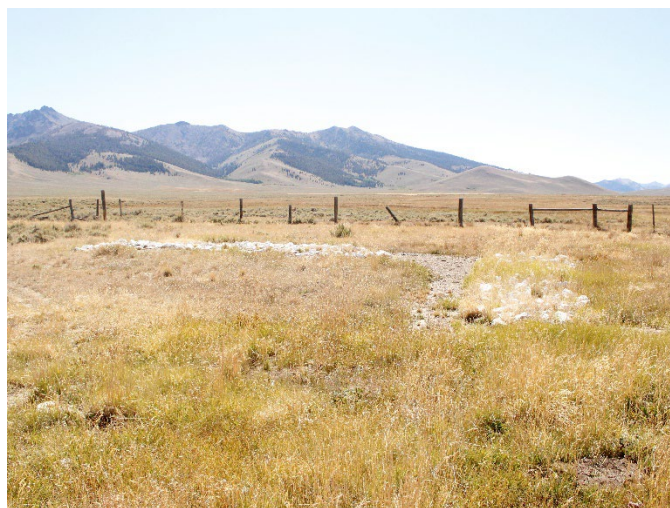
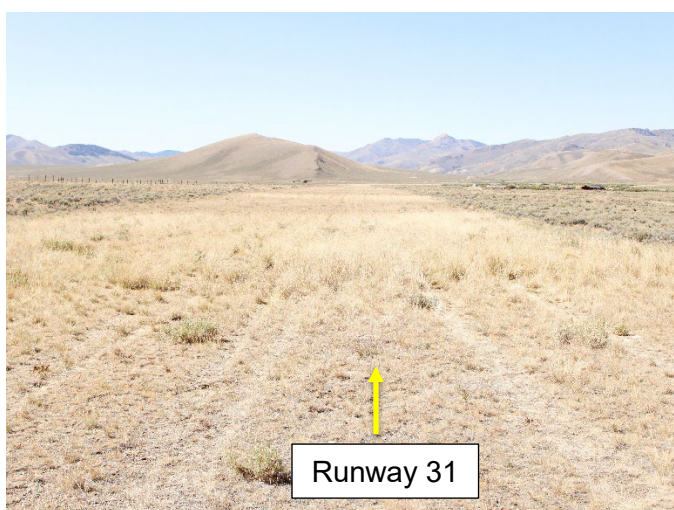
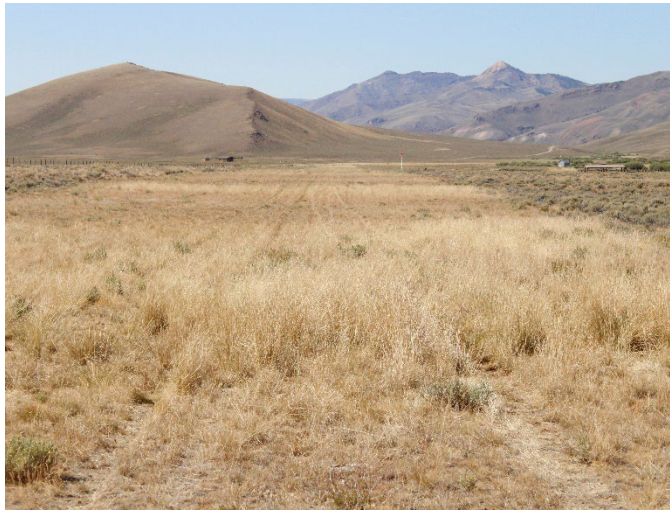
Runway 13-31:

At the time of the inspection the runway surface I found to be in fair condition, with grass height of 15-20", and scattered 12-15" sagebrush plants. The runway was covered with bunch grass root bundles, which is the main reason for the runway roughness, and lots dried up cow pies. No badger holes were noted, in fact very little in the way of rodent activity was observed. The painted rock boundary markers had decent paint coverage and were mostly visible, especially on the SE corner of the airfield (rwy end 31). There was lots of

grass growth in and around the boundary markers particularly on the northwest – rwy end 13, but they continue to be visible from the air.

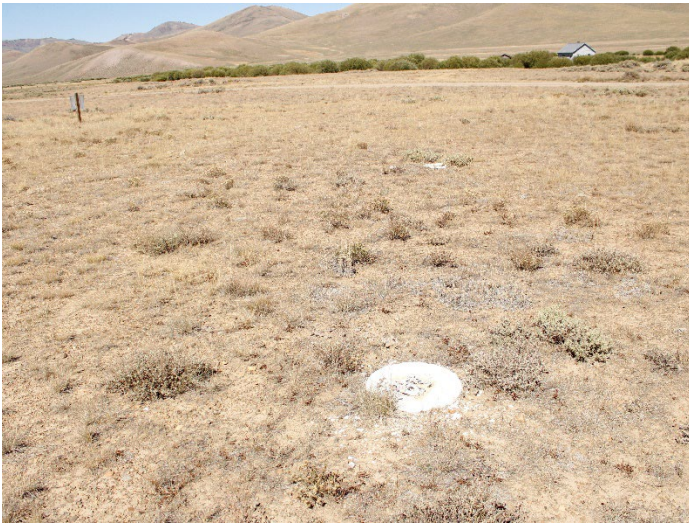
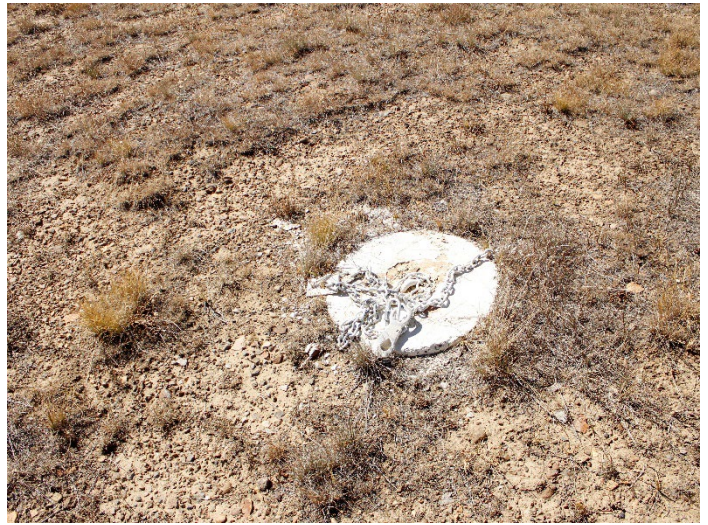
Tiedowns:

There was an aircraft parking area around the midfield and to the NW of the windsock. The surface in this area was a bit rough but not nearly as rough as some parts of the runway. Of the two parking spots I counted, only one had chains available for use.

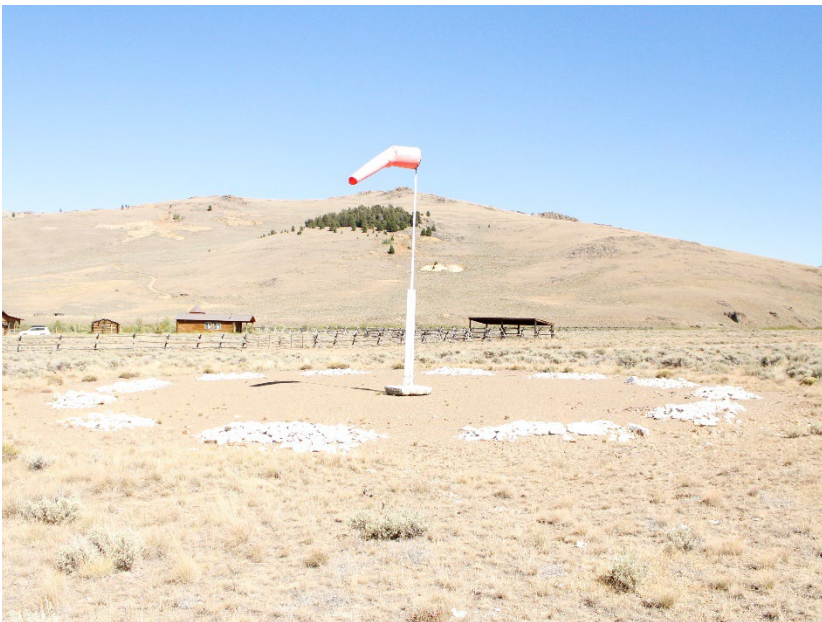
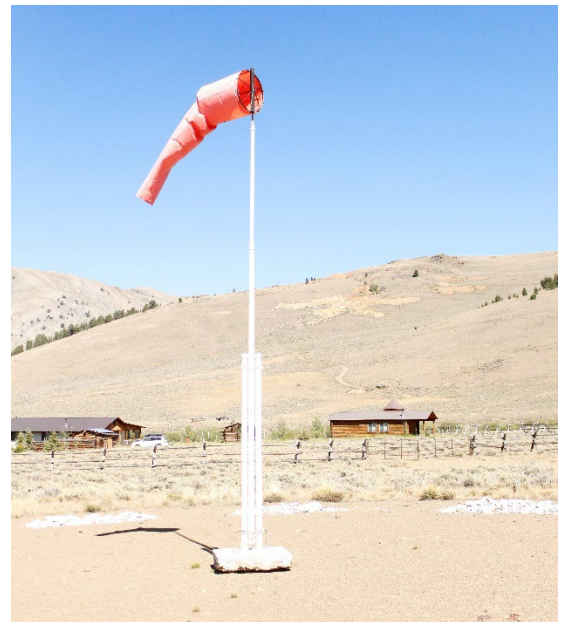
Windsock/Standard/Segmented Circle:

The windsock was slightly faded but in good condition, no rips or tears. The standard appeared to be in good mechanical shape and had good paint coverage. The segmented circle was in excellent shape - had good, distinct, separate pile of rocks, good paint coverage and no vegetation issues to complain of. The immediate area of the seg. circle was very clear and very visible from the air.
