IDAHO TRANSPORTATION DEPARTMENT

SUBJECT: 2023 5010-1 Airport Inspection conducted March 16, 2023.
(04178.6A Council Council Municipal Airport)

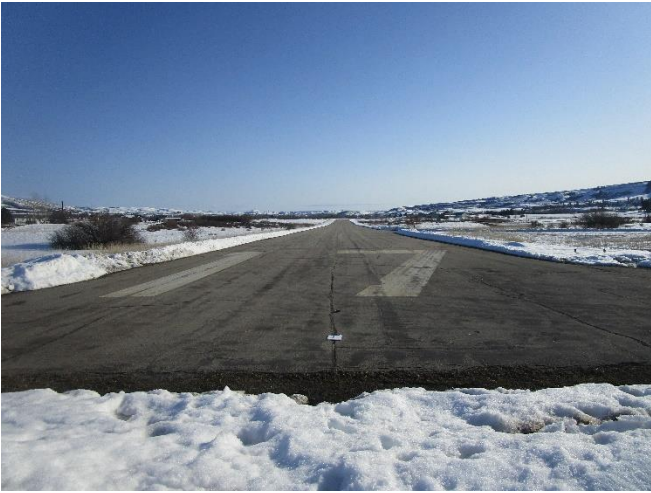
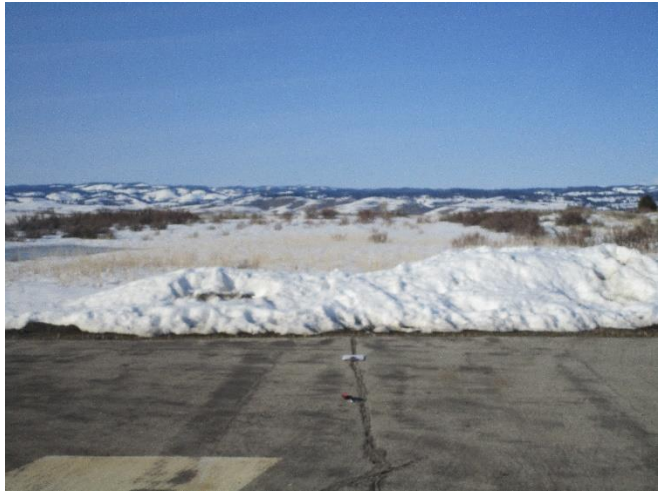
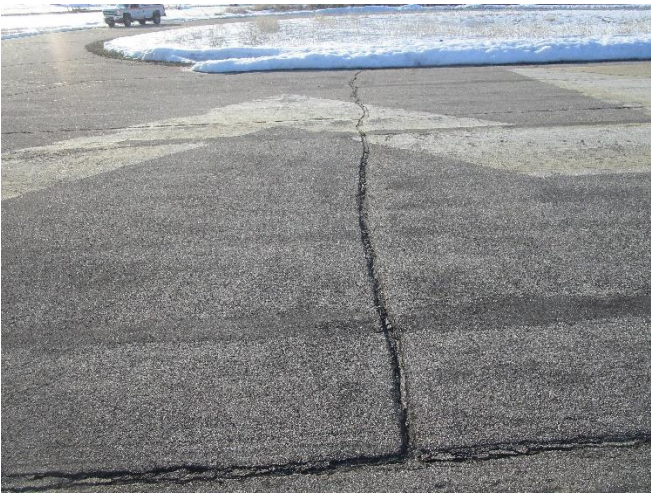
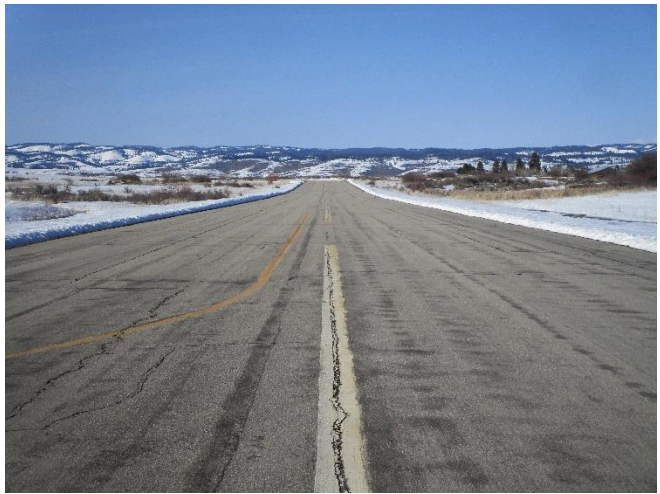
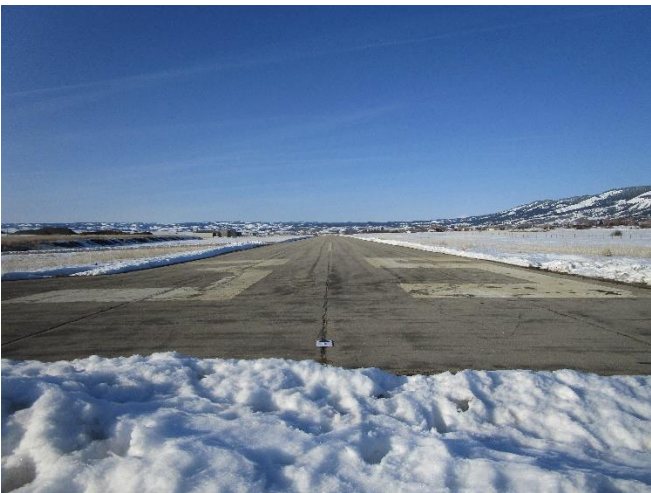
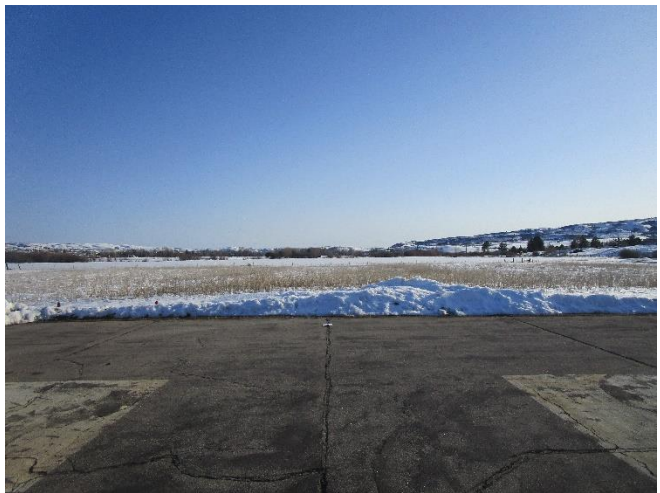
Runway 17-35:

The runway surface continues to display good surface integrity and I rated it in good condition still. Your pavement exhibits a good and strong surface all throughout. Along the edges you can see minor crumbling taking place; rwy. displays fair markings for the numbers and the centerline. The older cracks currently present on both the runway and the parking apron show signs of distress but will go away once you complete your pavement rehabilitation project in 2024; at that point, you will practically have a brand new airport. There were no changes to the runway alignment and both approaches at this airport remain clear and unchanged since the last inspection.

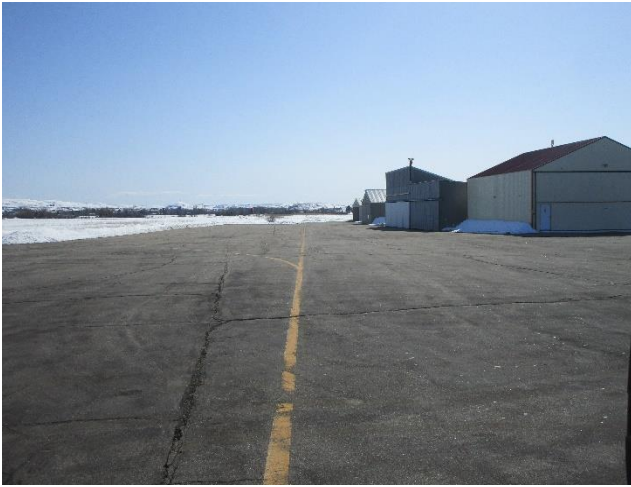
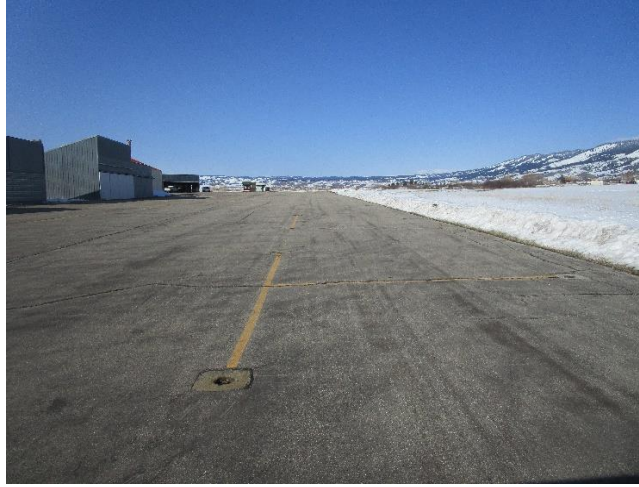
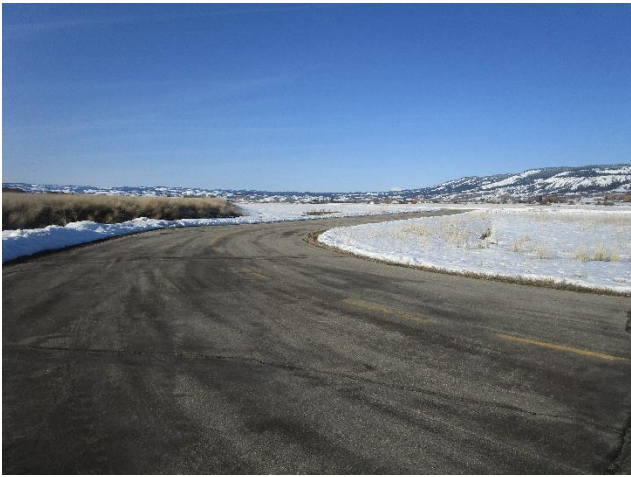
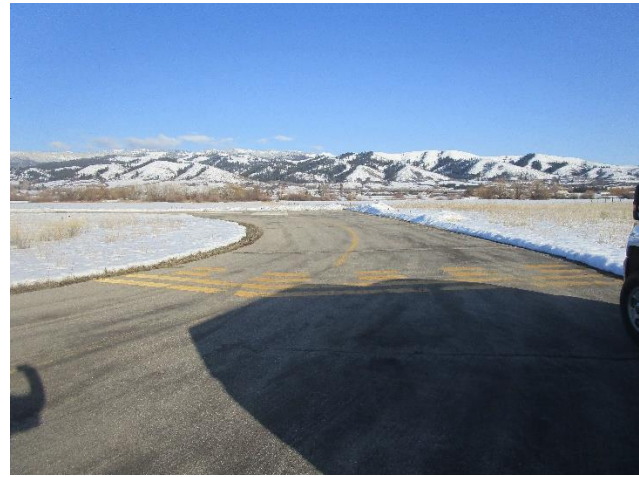
Taxiway/Ramp/Tiedowns:

The ramp area is in good condition with tar-sealed cracks and adequate tie downs; of the 8 designated parking spots, I counted 0 with tie-downs present and available. The ramp displayed decent paint markings as well. There is no parallel taxiway at this facility – just a turnaround loop at each end of the runway. The pavement surfaces on these loops appeared to be in good condition and displayed good paint markings at both ends.

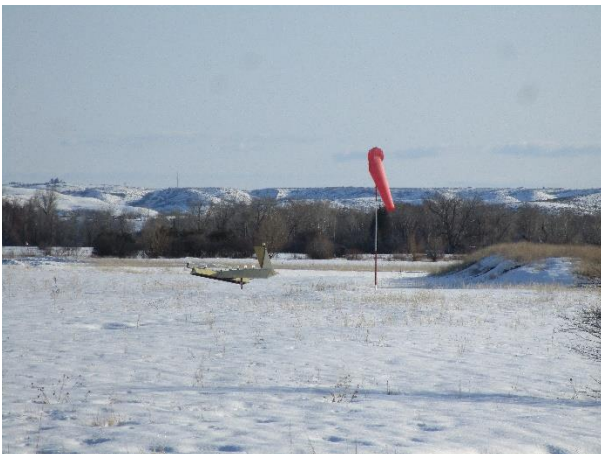
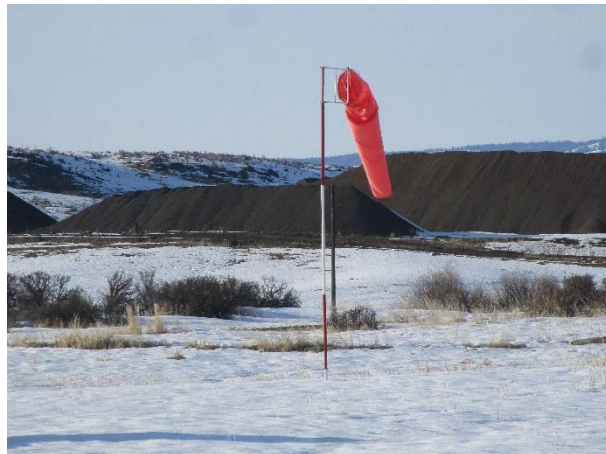
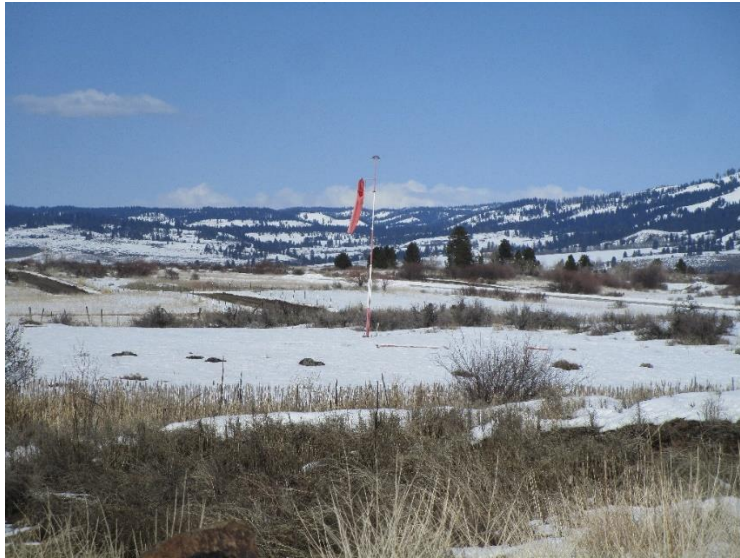
Windsock/Standard/Segmented Circle:

There are two windsocks at this airfield – one next to the tetrahedron and another one outside the perimeter fence and to the north of the hangars/fuel tank/pump area. Both windsocks were in good condition and displayed no tears or fading. Due to the snow coverage in the area, I could not verify the shape and condition of the non-standard segmented circle present. Both windsock standards were in good mechanical condition from what I could see, however they could use a touch of fresh white or white/orange paint. Perhaps next year during the rehab project you could take care of the metal standards as well.

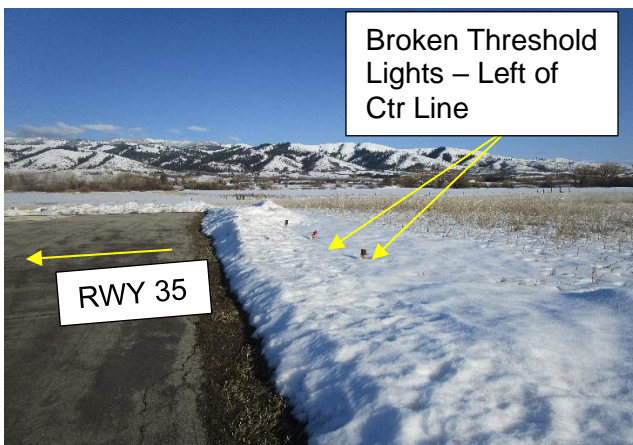
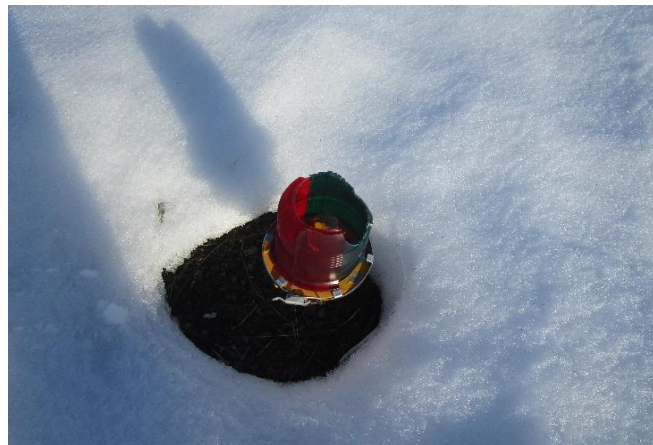
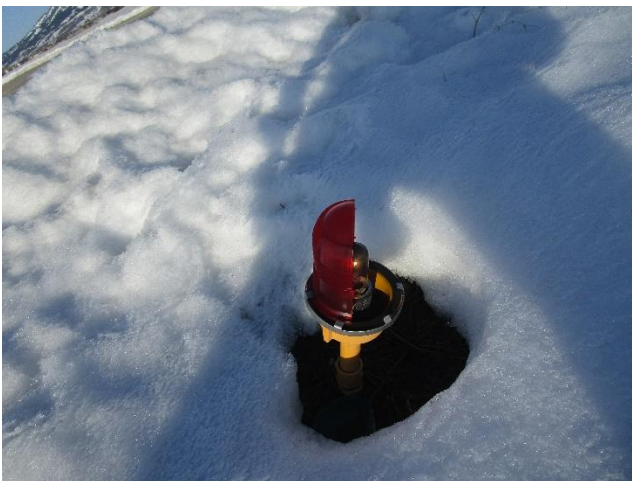
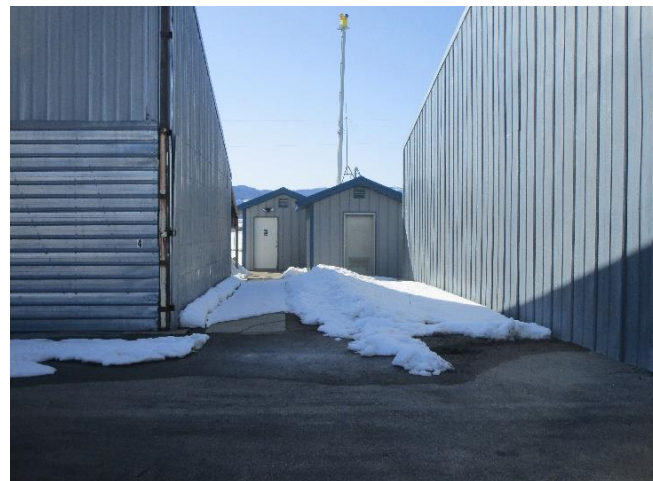
Lighting: During this visit, I was unable to verify if the runway lights work or not. Most of them were covered in snow and I was not able to inspect their physical condition. The only lights that were partially uncovered, where the threshold lights at each runway end. The outside two of the left set of 3 lights at runway end 35 were out of commission and should be replaced as soon as practical – red/green lenses were broken and I think the bulbs were burnt out too. The monopole rotating beacon present at this airport appeared to be in good mechanical order however, I was not able to verify its functionality.

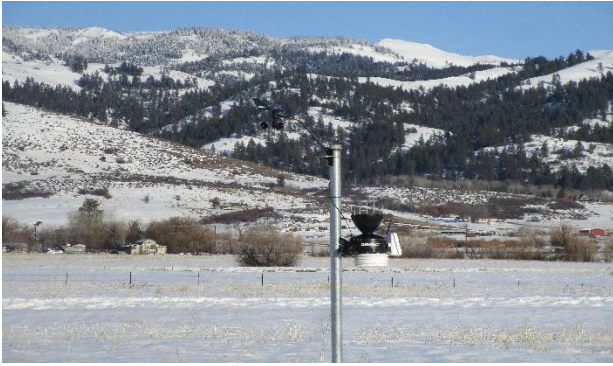
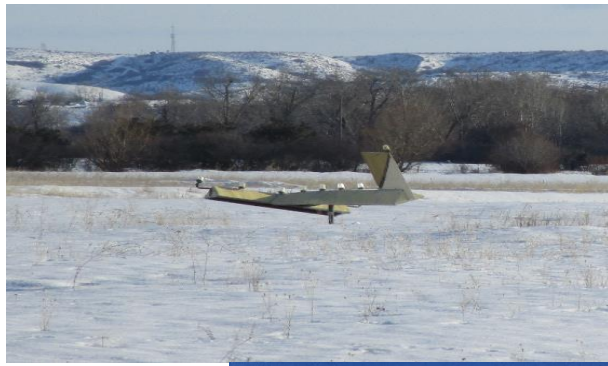
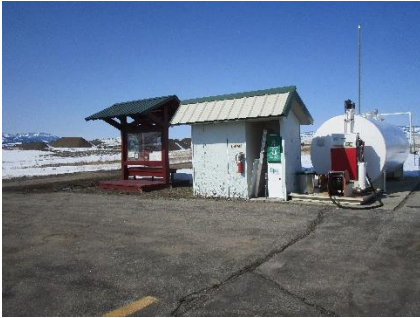
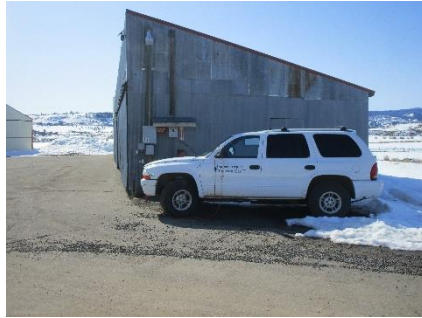
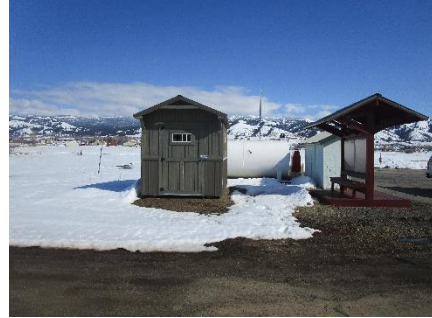
Miscellaneous/Services:

All airport-related signs, weather station, bike shed, fuel pump and bathrooms, all seemed to be in good shape and working order. I saw no other significant changes or safety concerns with this airfield.
