## IDAHO TRANSPORTATION DEPARTMENT

SUBJECT: 2023 5010-1 Airport Inspection conducted July 26, 2023.  
(04179. A Dixie Dixie USFS)

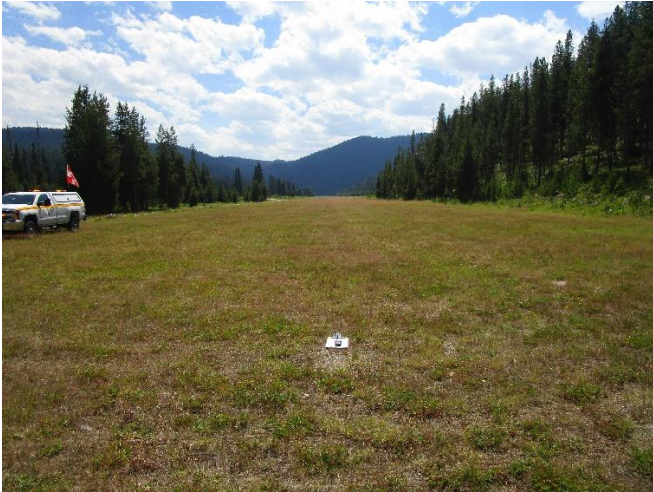
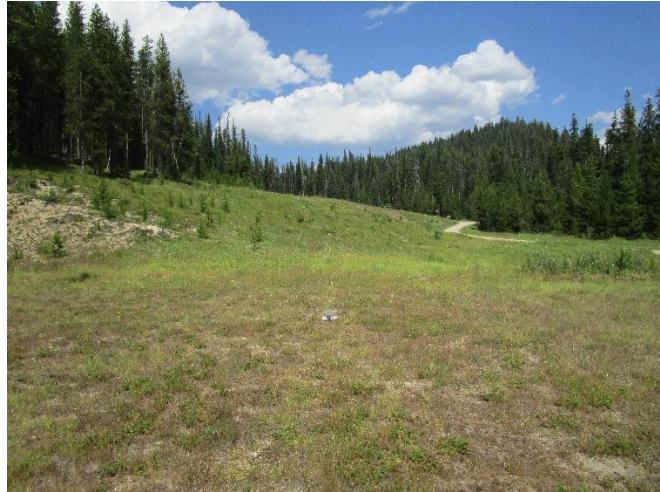
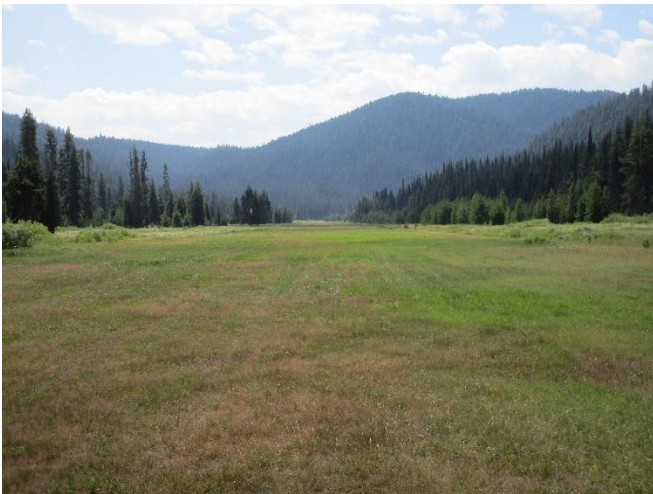
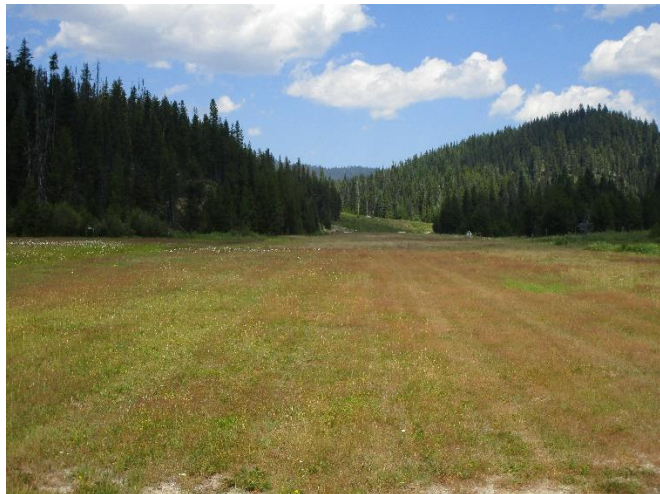
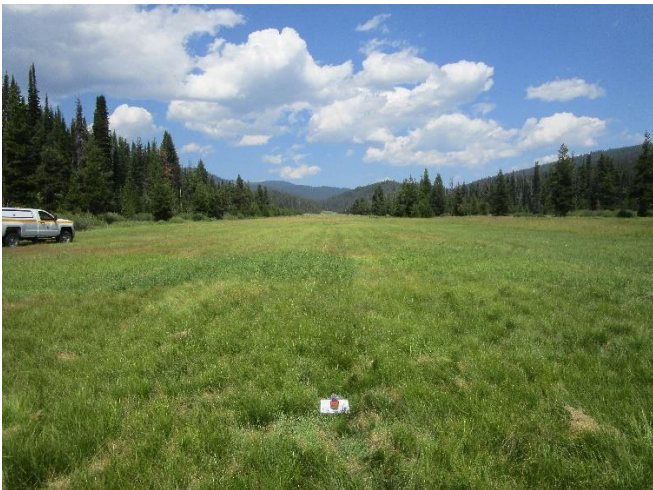
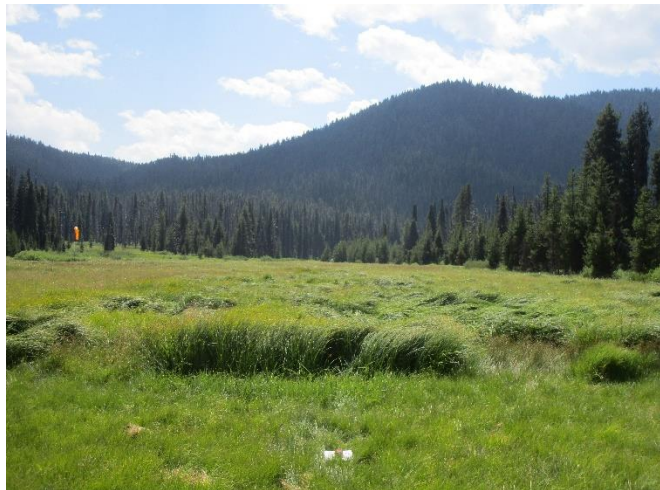
**Runway 18-36:** Overall, the turf airstrip is in good shape and presents a smooth and even surface, with no major undulations to speak of. The rodent activity is visible every so often but is still very insignificant. Overall, the rwy. had good vegetation control - growth was well maintained and by the look of things, at the south end of the runway, you could tell it was recently mowed. Grass did not exceed 8-10" tall. There were no changes to the approaches at this airport; both remain relatively clear and unchanged since the last airfield inspection in 2020.

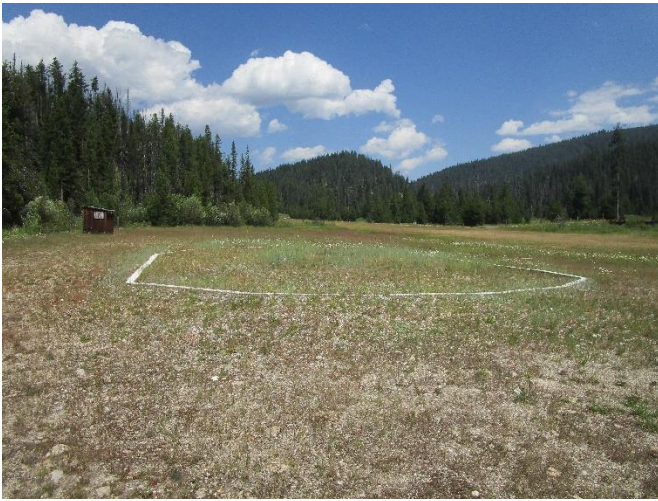
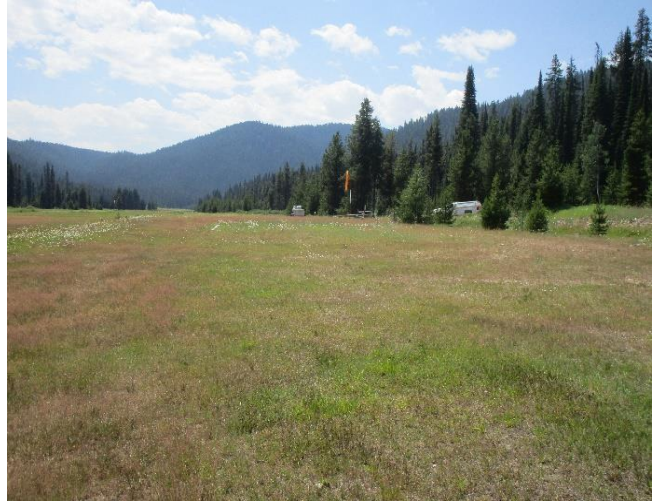
**Tiedowns:** The main aircraft parking area was located at midfield, just north of the USFS helipad and on the west side of the runway. The area was large enough to park a few airplanes (3-4) and it had good vegetation control; no ropes or chains to secure aircraft were seen in the area.

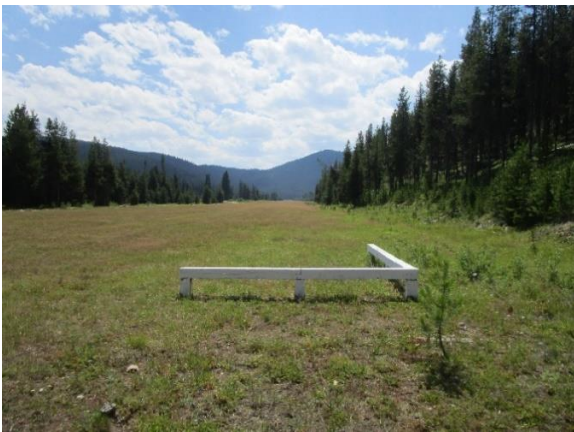
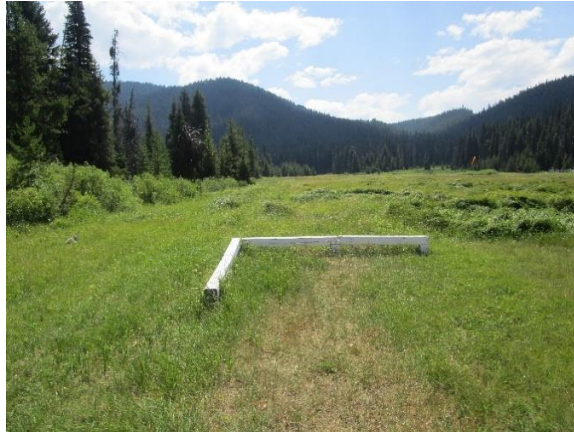
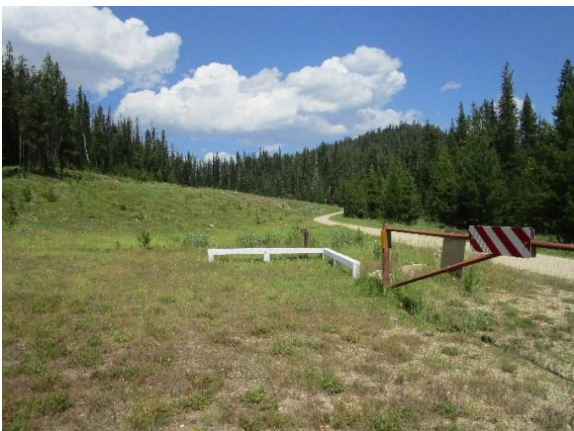
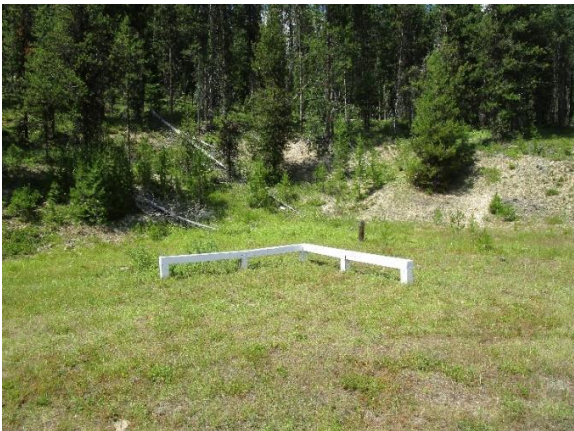
**Boundary markers:** The wood beams boundary markers displayed a small and non-standard size visual aid, but something is better than nothing. Although small, they were made of solid wood and displayed good paint coverage. Still not required but finding a way to enlarge the footprint of the markers would be beneficial as it would make the airfield that much more conspicuous from the air. Vegetation around the markers was in great condition.

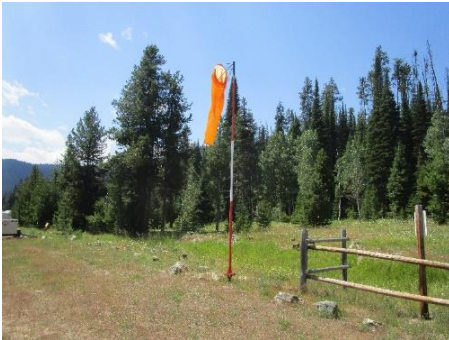
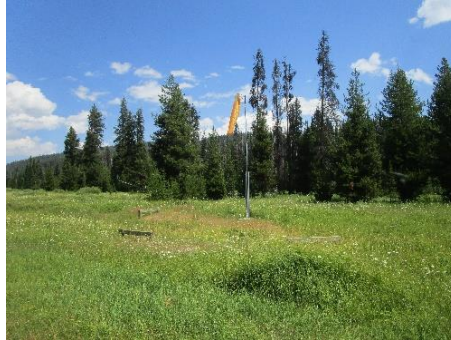
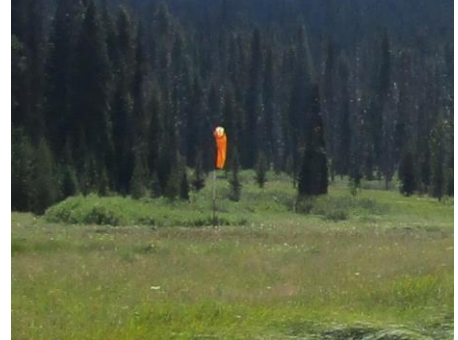
**Windsock/Standard/Segmented Circle:** You have three windsocks at this airstrip. All the windsocks were in good condition and all of them displayed good color, no rips, or tears. All standards were in good mechanical order and displayed great orange and white paint. The windsock located at midfield

and on the east side of the runway, was the only one with the unpainted metal standard and made of galvanized pipe. This was the only visual aid that had some sort of segmented circle made from pressure treated, unpainted wood beams. In its current unpainted condition – the segmented circle blends too much in with the surrounding dry grass and is very difficult to see from the air, therefore, I recommend a fresh coat of either white or white/orange alternating color paint on the structure.

1. Paint the wood beam segmented circle, on the east side/mid-field windsock, with white paint.  
Not visible from the air.

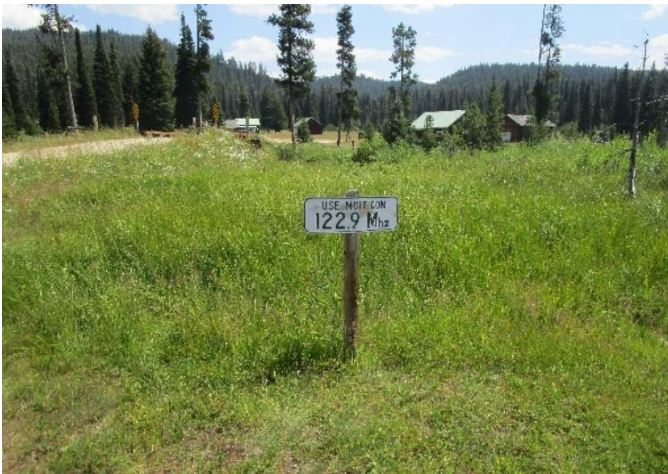
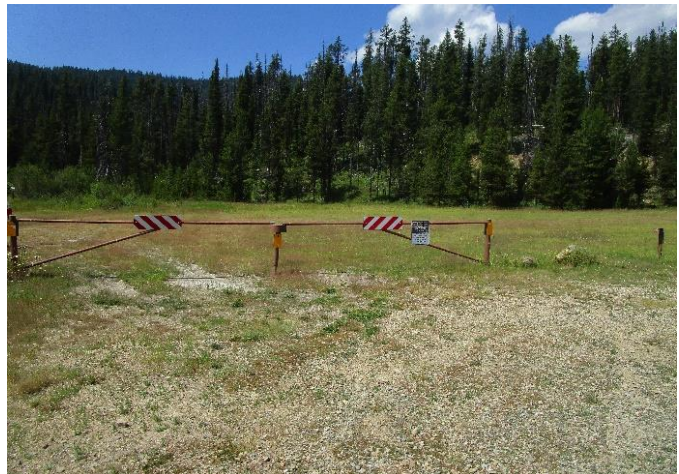
**Miscellaneous/Signs:** All airport-related signs were upright, legible, and firmly mounted on solid stakes. This airstrip is located directly to the west of the USFS work camp facilities and approximately 5 mi South of Dixie, ID. Overall, the airstrip is in good shape and I saw no other significant changes or safety concerns with this airfield. If you have any questions or if I can be of any assistance to you, please feel free to call me anytime. Take care Willy and have a blessed day.
