IDAHO TRANSPORTATION DEPARTMENT

Subject: 2023 5010-1 Airport Inspection conducted May 23, 2023.
(04183.*A Downey Downey-Hyde Memorial Airport)

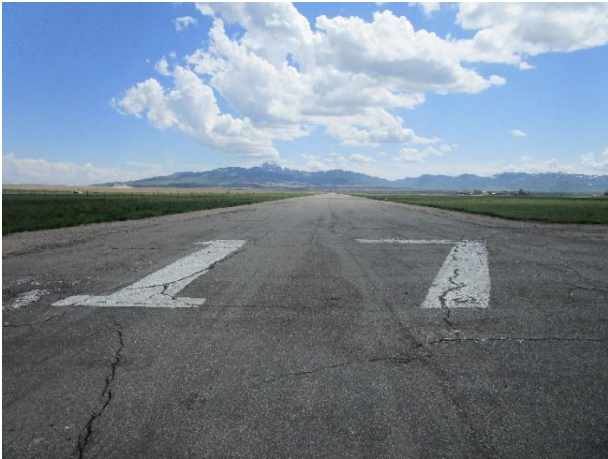
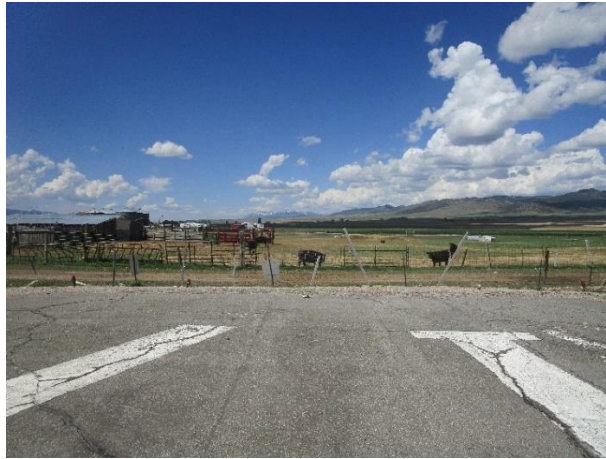
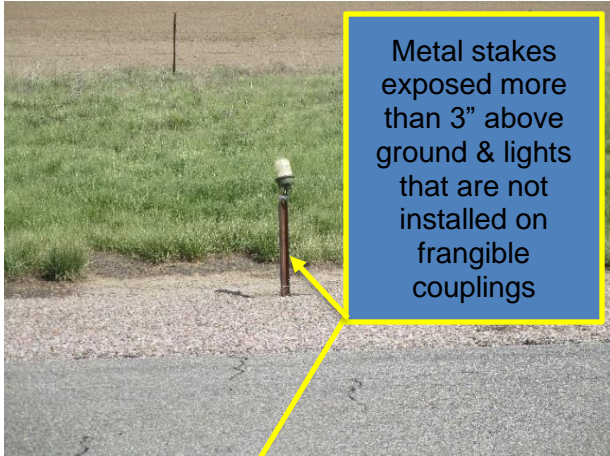
1. Runway surface condition: Fair. Some areas of the asphalt were settling in places toward the edges of the rwy. Lots of spider cracks were visible along the edges as well. In some areas the asphalt is completely braking off and becoming runway debris,
2. Runway Lighting: The runway edge lights appeared to be in good physical condition – I only saw one broken fixture on the east side of the rwy. and closer to rwy. end 35.
3. Many of the lights are not installed properly and on frangible couplings as they should be. Several lights have metal stakes exposed more than 3" above the ground. One of the threshold lights at RE 17 had the wrong color lens – white vs red/green.

Metal stakes
exposed more
than 3" above
ground & lights
that are not
installed on
frangible
couplings

1. Drive down the metal stakes so no more than 3" are exposed above ground,
2. Replace the broken light fixture.

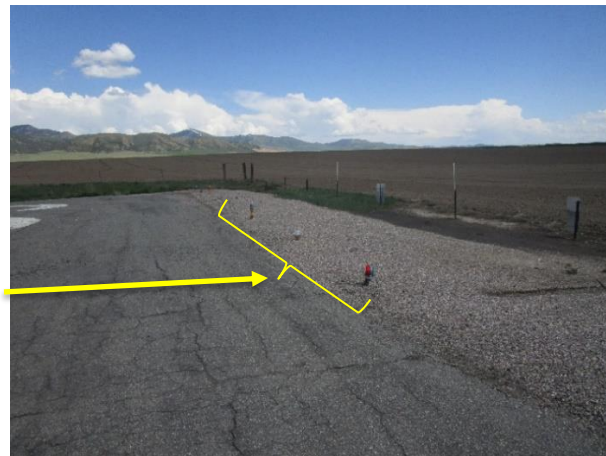
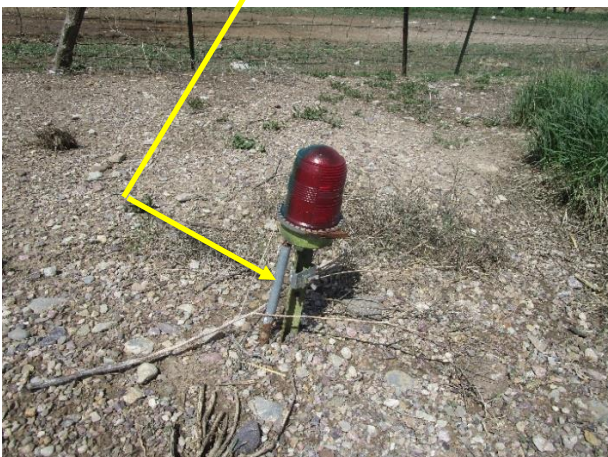
During this visit I was able to verify the functionality of the runway edge lights with my hand-held radio; all lights came on when verified and I saw no broken fixtures. Both approaches remain unchanged and with the same controlling obstructions that are listed in the Airport Master Record – silo tanks to the north and a road to the south.

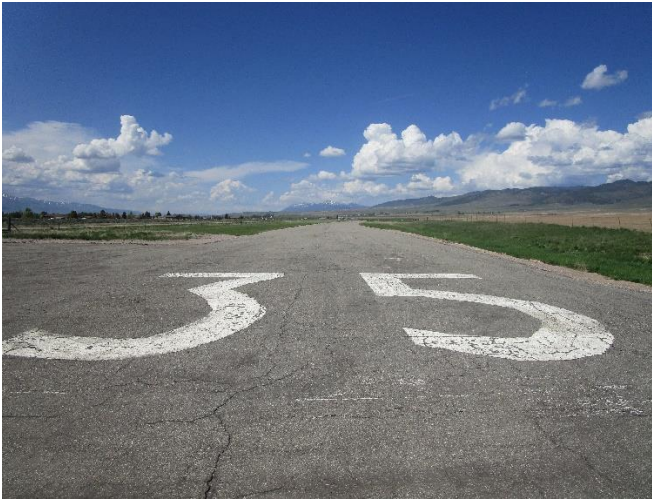
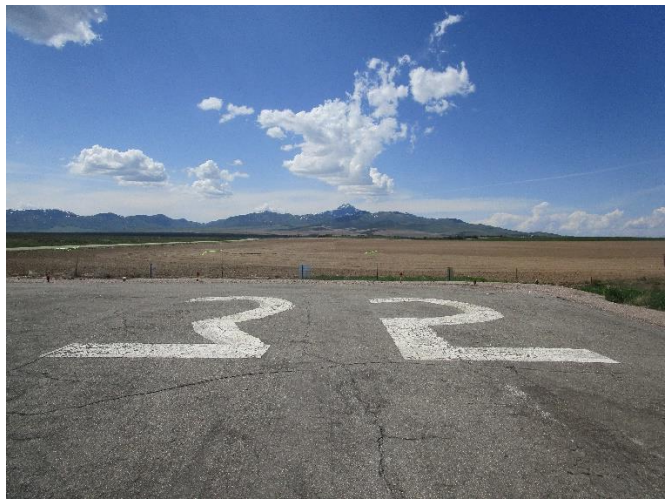
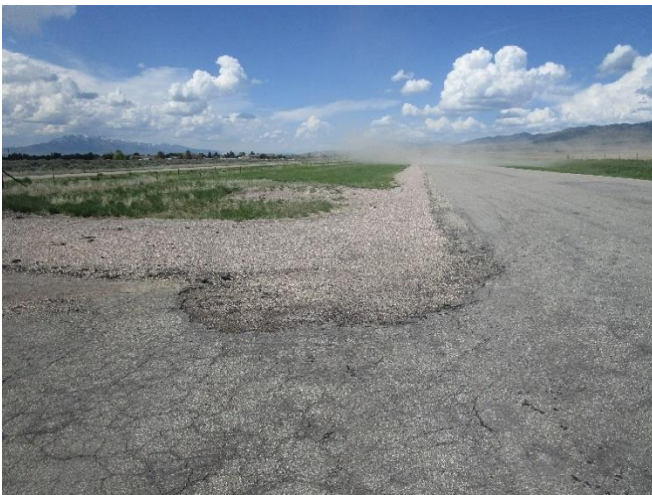
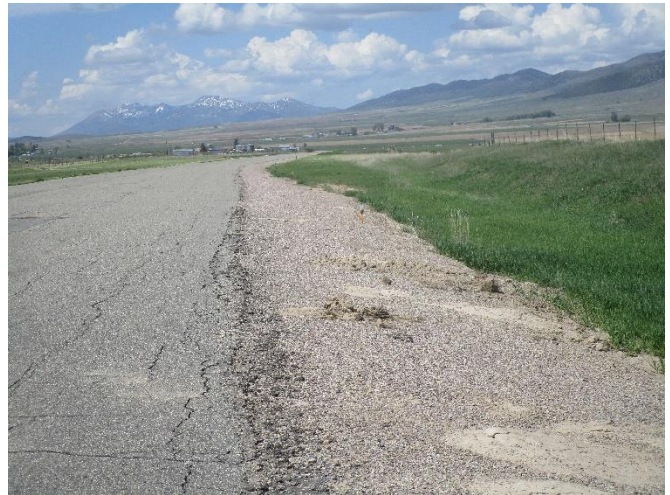
Overall, the runway surface was in fair condition and continues to display lots of cracks throughout. Not much has changed since last time I visited in October of 2020. During my visit I noticed a multitude of small issues that should be addressed; in no particular order they are:

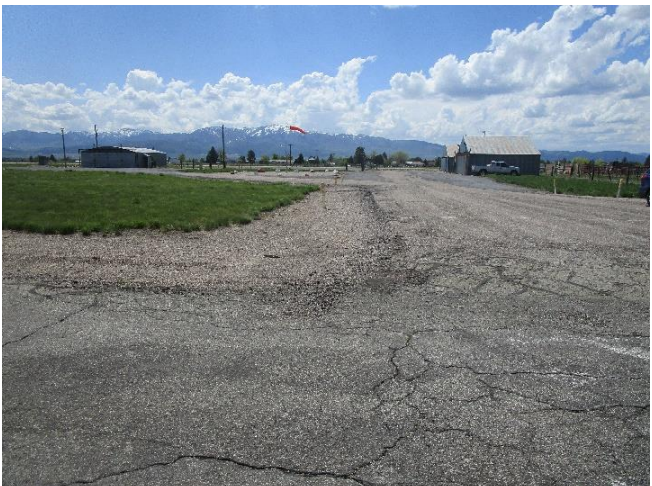
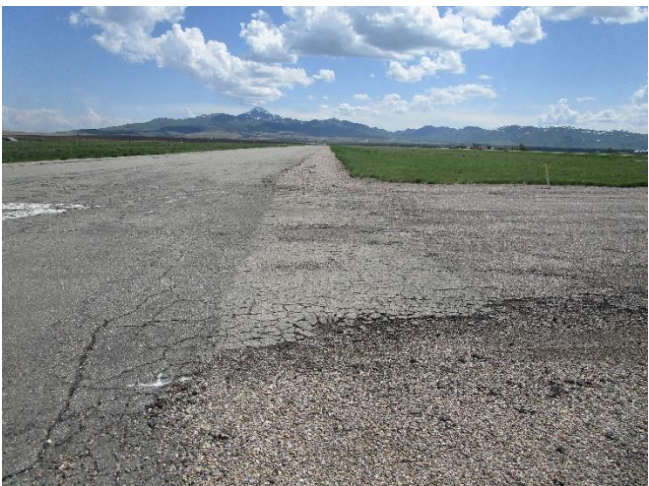
The short, asphalt taxiway was in fair shape and displayed no paint markings. Taxiway edges were lined with blue reflectors, displayed a lot of edge crumbling, and had good vegetation control. The grass-dirt parking ramp area was in fair shape and with decent vegetation control. I saw only one parking spot that had tied-down chains available.

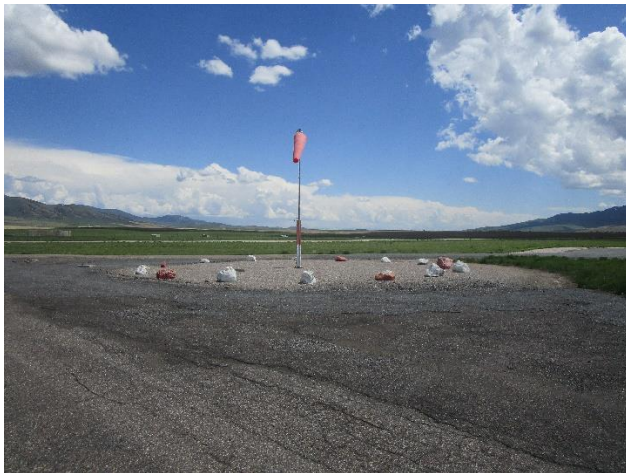
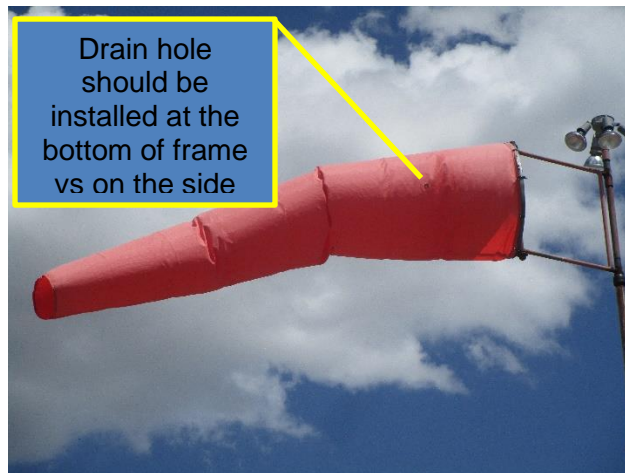
Windsock/Standard/Segmented Circle: The only windsock at this airfield was lit and was located just west of rwy. end 17. The metal standard displayed good white/orange paint and was in good working order. The windsock was in very good condition but improperly mounted with the drain hole to the left side vs at the bottom. The metal standard had a segmented circle made up of large boulders, were painted alternating red & white. The inner area of the segmented circle was covered with small size gravel rock and was free of vegetation.

1. For increased longevity, the windsock needs to be installed with the drain hole at the bottom vs on the side of the windsock frame.

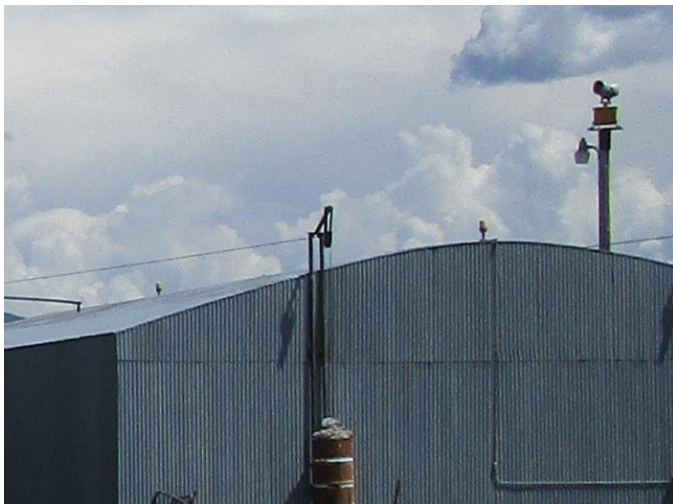
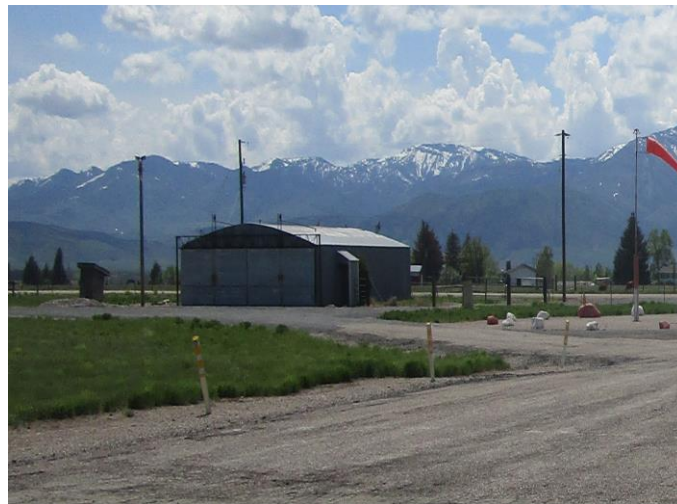
Miscellaneous/Services: There was a rotating beacon present on the airfield. I was able to verify its functionality with my hand-held radio via CTAF. I saw no other significant changes or safety concerns with this airport. If you have any questions or if I can be of any assistance to you, please feel free to call me directly at 208-334-8895. Have a great day.
