IDAHO TRANSPORTATION DEPARTMENT

SUBJECT: 2023 5010-1 Airport Inspection conducted August 22, 2023.
(04185.A Dubois Dubois Municipal Airport)

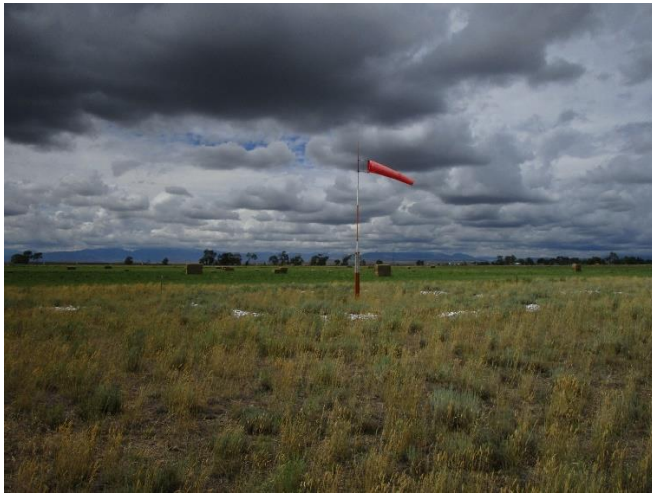
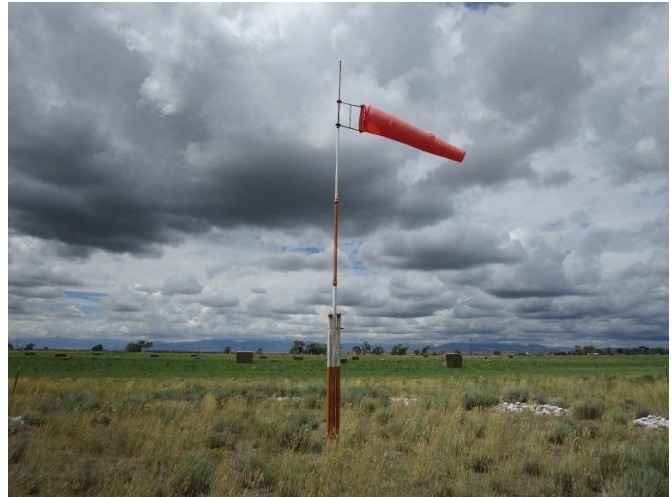
Windsocks/Standards: There are two windsocks at this facility – one on the rotating beacon and one at midfield on the west side of the rwy. The windsocks were in good condition and displayed no rips or tears. The standards were in good mechanical order and with plenty of orange and white paint on both. The only segmented circle at the midfield windsock, was constructed of river rocks that appeared to be in good condition but unpainted. This area was not very well kept and was overgrown by weeds, grass, and sage brush.

1. Clean the vegetation in and around the segmented circle area and paint the segments white to make the area more visible from the air.

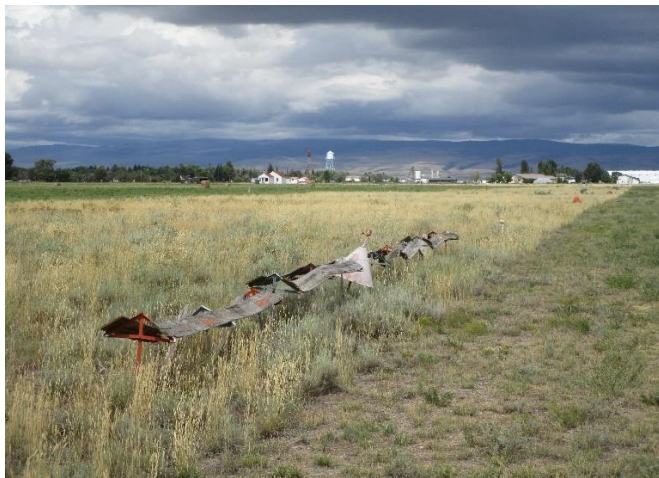
Boundary Markers (BMs): The non-standard BMs around the perimeter of the runway, continue to look run-down, broken, and unmaintained. Paint is no longer present and they're barely visible from the air; they no longer serve the purpose they once did.

1. Either fix, repair and properly position the BMs to reflect the actual rwy. dimensions reported in the Airport Master Record or, if they no longer serve a purpose, have them removed from the premises.

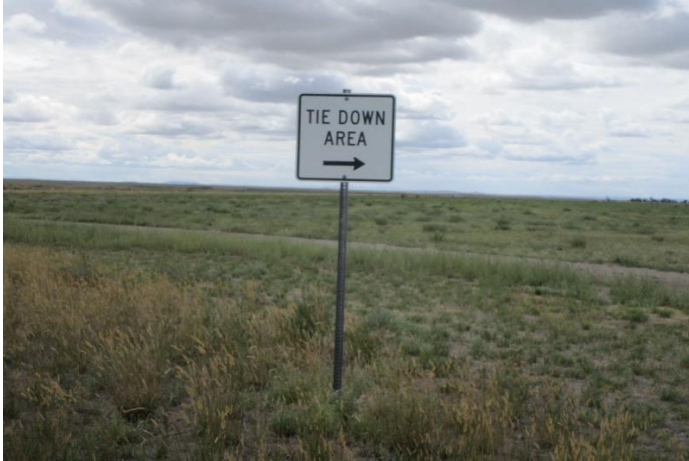
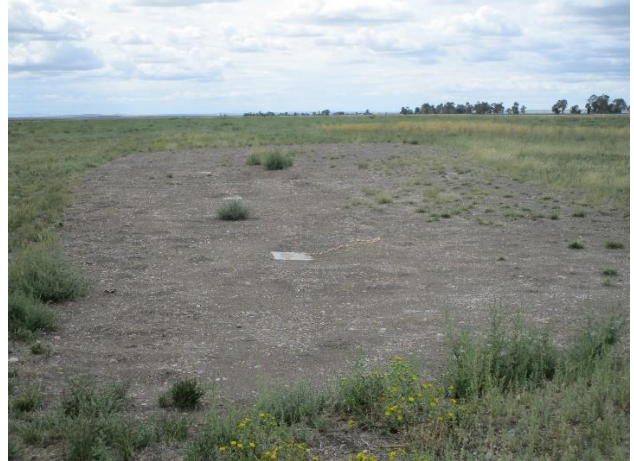
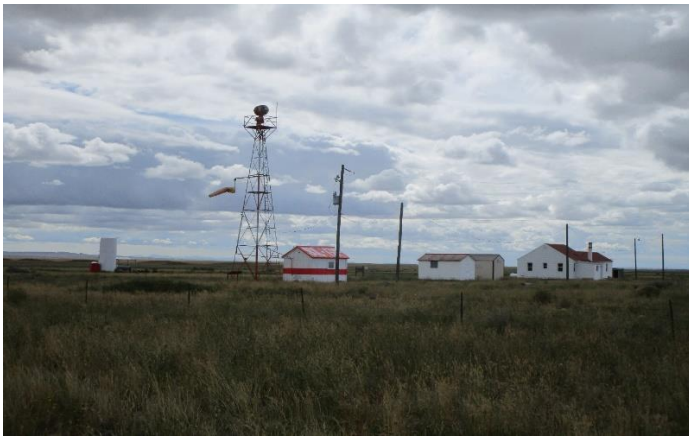
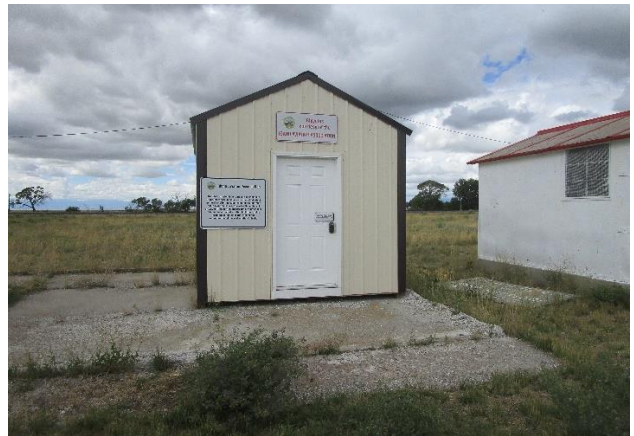
Miscellaneous/Services: Tie down area appeared to be in fair condition and there was enough space to easily park 9-12 airplanes, but only saw tie down chains present at 4 of them. I did notice there was a sign present pointing to the parking area; vegetation was mostly under control and not much bunch grass to gripe about. The rotating beacon, the two sheds between the beacon light and the pilots lounge appeared to be well-maintained and had good paint and care.
