Mike Cook, Airport Manager Idaho County Airport (GIC) 320 W. Main St. Grangeville, ID 83530

Subject: 2023 5010-1 Airport Inspection conducted July 25, 2023.

(04204.*A Grangeville Idaho County Airport)

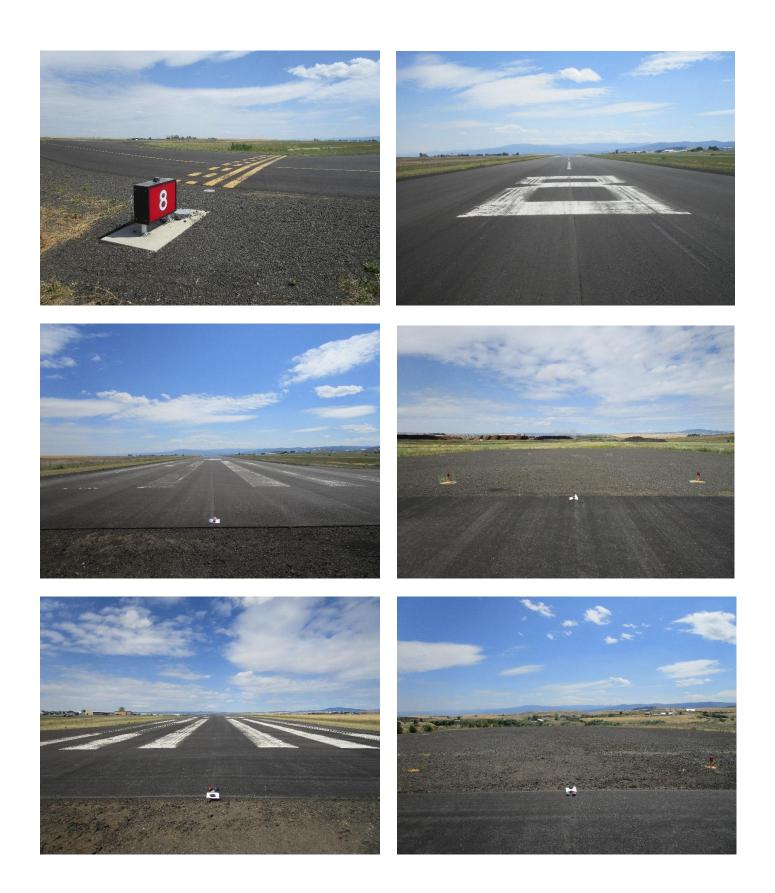
At the time of the inspection, almost three years after your runway rehab project, the pavement continues to be in good condition all throughout. Besides the very faded threshold, markings at rwy. end 8, the rest of the rwy. and markings were in good shape. Pavement continues to hold well and shows good integrity - runway edges were strong and with no evidence of visible cracking or crumbling. The rwy. edge lights had good vegetation control and were all in good shape. All lights worked as requested when verified. Both sides of the runway, taxiways, and fillets appeared to be well cared for and maintained. There were no changes to the approaches at this airport; both remain relatively clear, unchanged and with the same controlling obstructions as listed in the Airport Master Record.

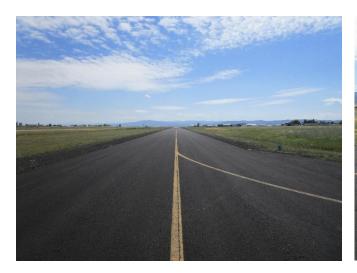
<u>Taxiway/Ramp/Tiedowns:</u>
The taxiway areas were all in good condition - surface, markings, vegetation control, and lights were all in good shape and it showed the work you guys put into your facility. The pavement surface in the ramp tie-down area continues to show its age and is well defined by many cracks with vegetation

growth coming though and many low spots where water accumulates. The cumulative wear and tear of everyday use continues to show its age and its effects on your pavement condition in this area.

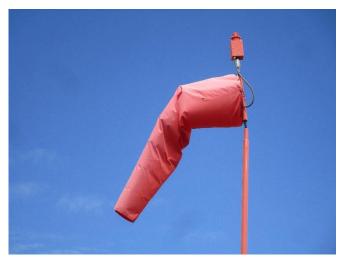
I noticed there are three windsocks at this airport – one on the private hangar to the south of the ramp area (close to USFS facilities), another one surrounded by a beautiful segmented circle, just North of the USFS spaces, and the newest one located out in the crop field – just N of the runway. All windsocks were in good condition. All the standards appeared to be in good mechanical order - solid, functional, and displayed good orange color. Of the three windsocks at your airfield, the one closest to the USFS facility was equipped with a very nice cement panels painted in alternating white and orange paint. The vibrant white and orange paint and the dark grey crushed rock inside the circle, made the area very conspicuous from the air; the whole area was well maintained and clear of vegetation.

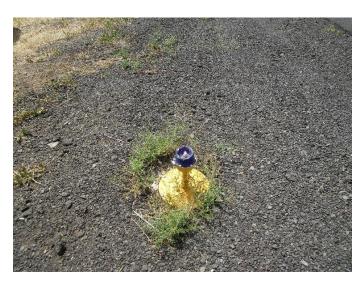
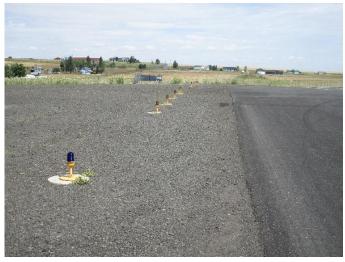
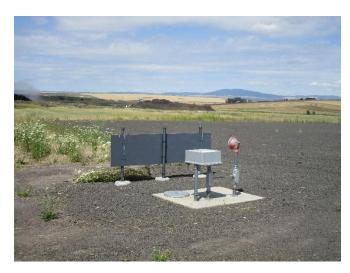
The lights at this airfield were all in good condition and with only one broken taxiway fixture and one missing threshold light fixture - both at rwy. end 26. All lights worked when requested and verified via the hand-held radio. The runway displayed good vegetation control all around the lights and the nearby signs.

- 1. Replace the broken glass lens of the taxiway light –left side of rwy. end 26.
- 2. Replace the missing threshold light the right side of the rwy. end 26

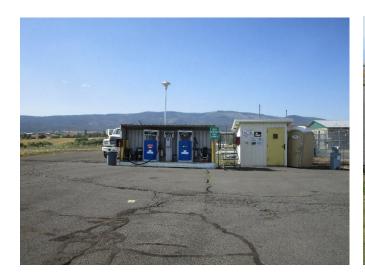
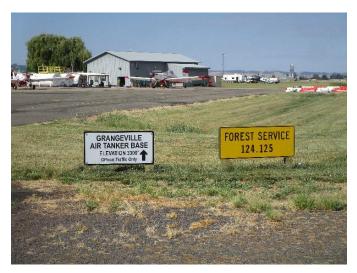
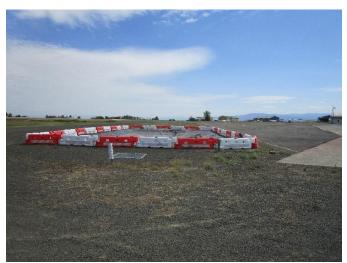
<u>Miscellaneous/Services:</u> All airport-related signs were upright, legible, and seemed to be in good working order. The rotating beacon appeared to be functional and in good condition, but I was not able to verify it during this visit, however, I did speak with a local pilot and he vouched/indicated that it was working.
