IDAHO TRANSPORTATION DEPARTMENT

Dan Conner, Manager
Johnson Creek Airport
P O Box 7129
Boise ID 83709

SUBJECT: 2023 5010-1 Airport Inspection conducted June 30, 2023.
(04360.2A Johnson Creek Yellow Pine)

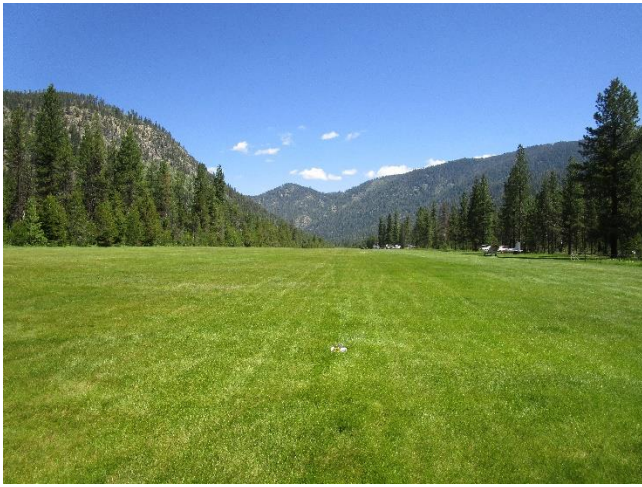
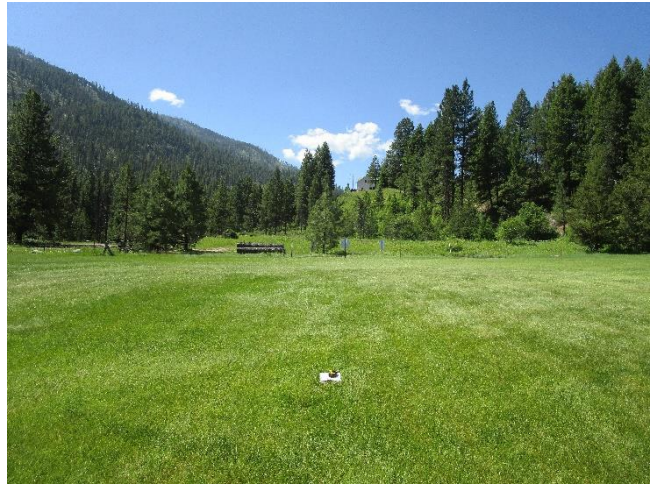
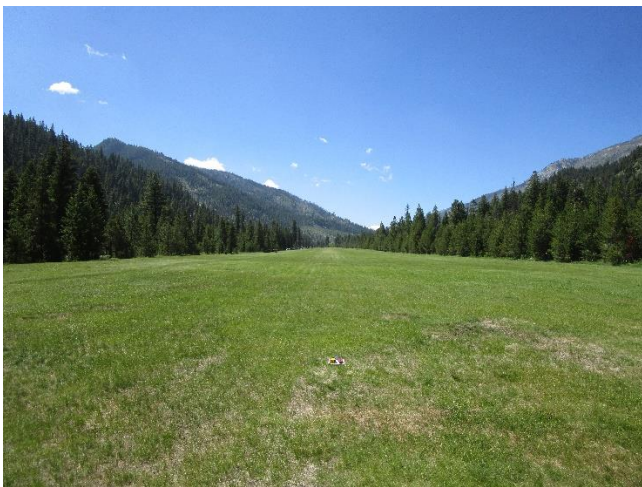
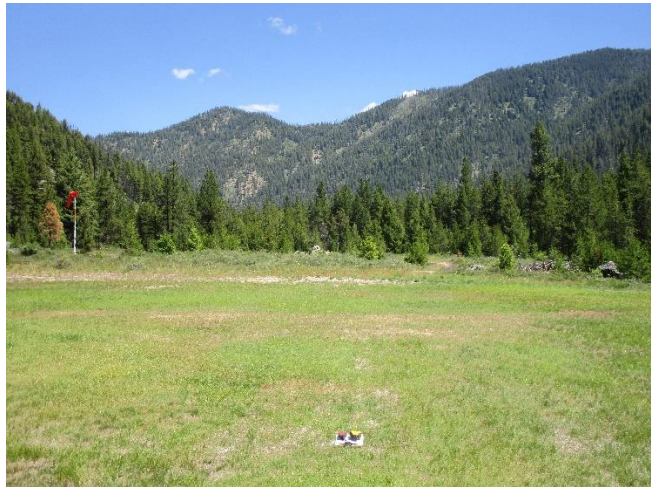
Runway: 17-35

At the time of the inspection, the runway surface was in excellent condition and provided for a very smooth roll out for both landing and take-off. The surface had no undulations, grooves, rodents, or vehicle ruts. Overall, the runway displayed good, solid surface that was very well mowed and maintained; I saw no rodent activity. During my visit I met the new caretakers and saw there was a great deal of activity going on at the airstrip - the construction project for the caretaker's house was in full swing and there were approximately 10-12 airplanes parked on the airfield. Every visitor present that I spoke with were extremely pleased and happy with the facility and the amenities available. Both rwy. approaches remain unchanged and with the same controlling obstructions as before.

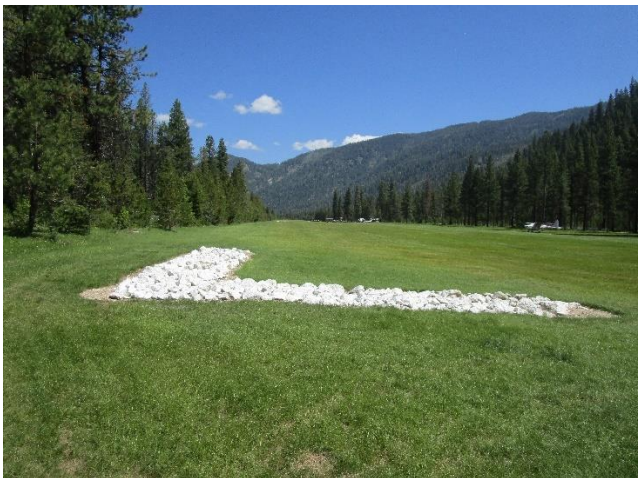
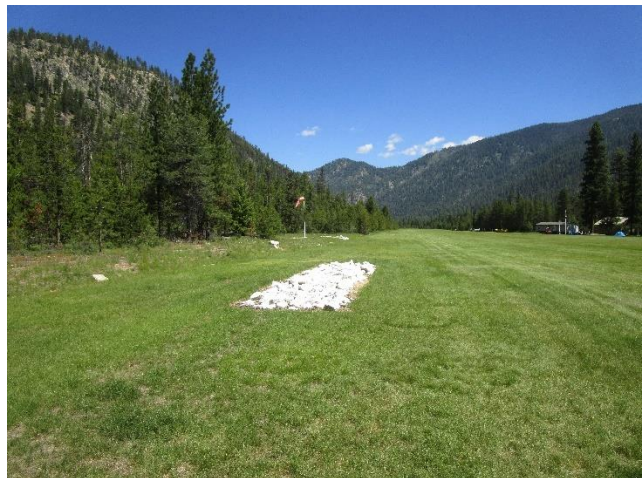
Boundary Markers (BMs):

The painted rock boundary markers were in great shape and had excellent paint coverage; there was no vegetation growing through or around them. They were very visible from the air.

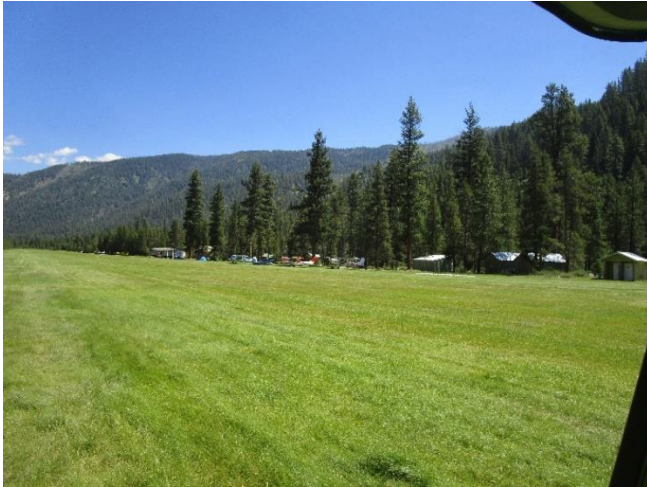
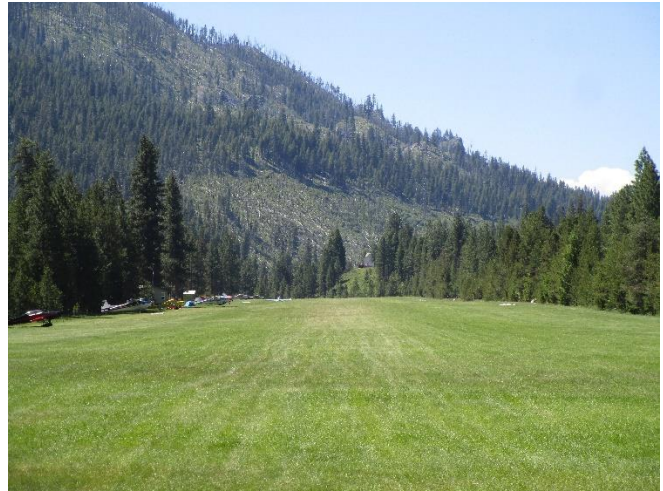
Tiedowns:

There is a lot of room to park airplanes here on both sides of the rwy. Surface was in good condition and with good grass growth coverage. Driving up and down the runway, I noticed only the East side has tie down chains. I counted forty spots and they all had chains present and available for use.

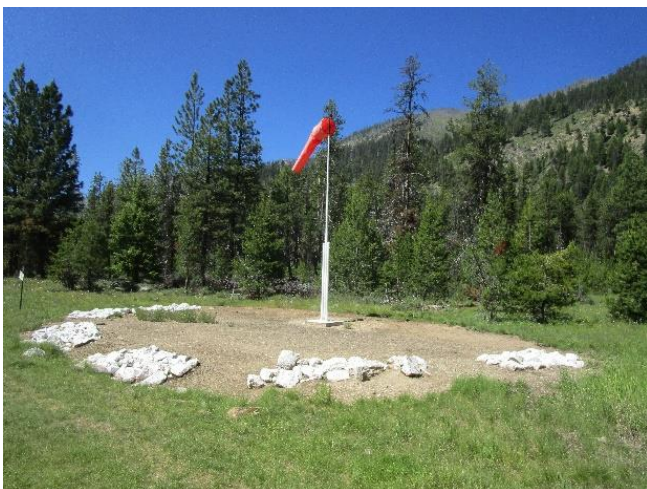
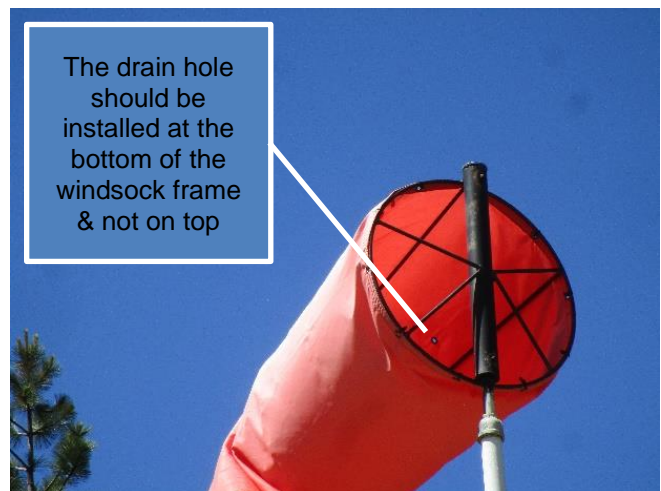
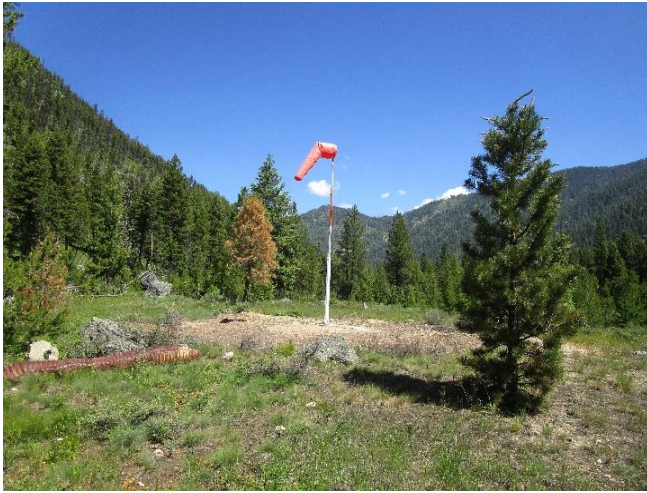
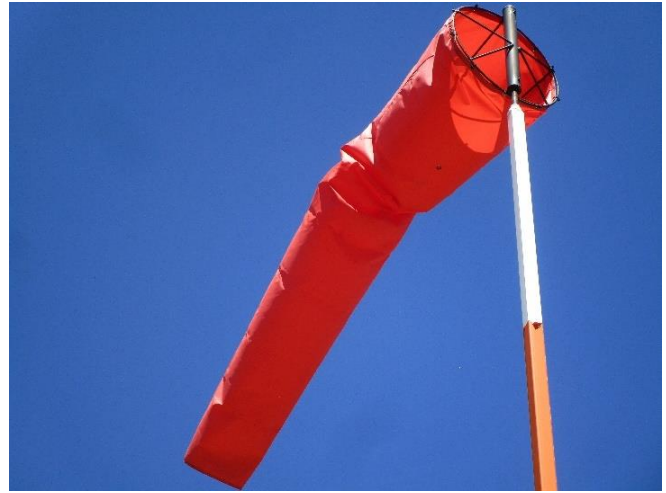
Windsock/Standard/Segmented Circle:

There are two windsocks at this facility. I rated the midfield windsock condition as good. The windsock standard was in excellent mechanical condition - solid, functional, and painted white. The non-standard segmented circle present was in good condition, had great paint coverage, no vegetation, and was very visible from the air. The drain hole was improperly installed – it was on the right-side vs the bottom. The second windsock located at rwy. end 17 was also in excellent condition - both sock and standard. No segmented circle present at this one and the windsock was installed correctly.
