## IDAHO TRANSPORTATION DEPARTMENT

SUBJECT: 2023 5010-1 Airport Inspection conducted June 1, 2023.  
(04230.A Landmark Landmark USFS)

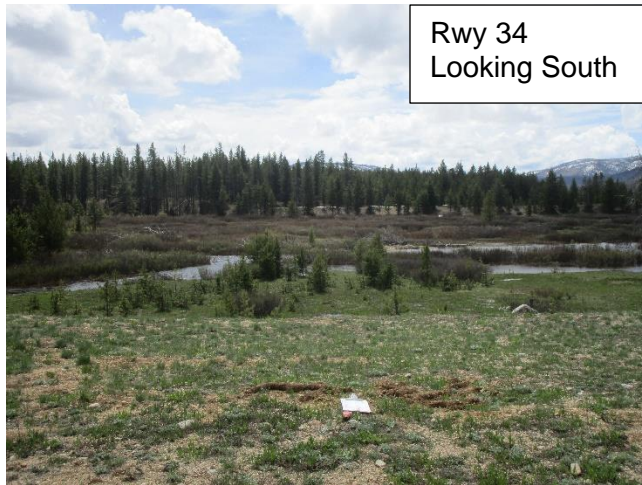
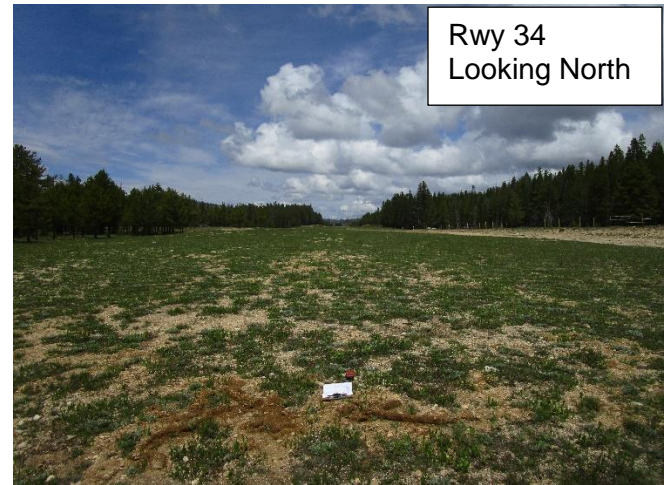
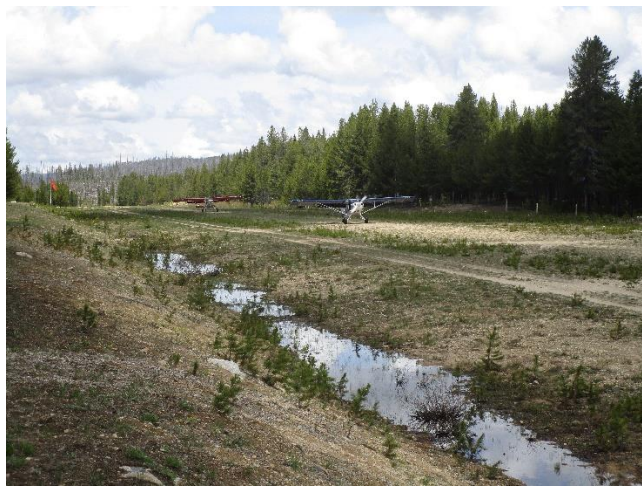
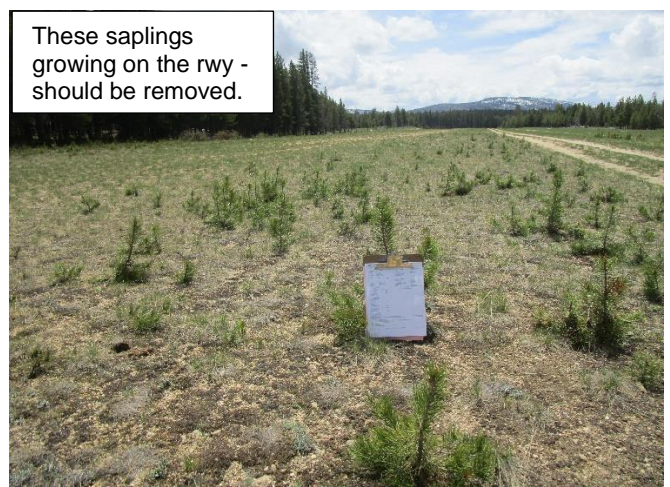
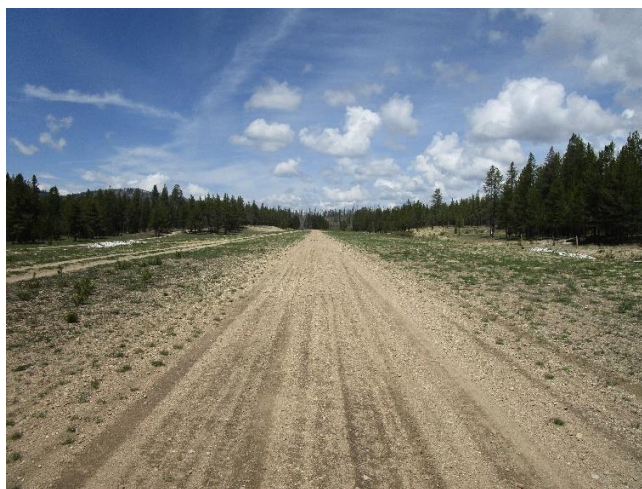
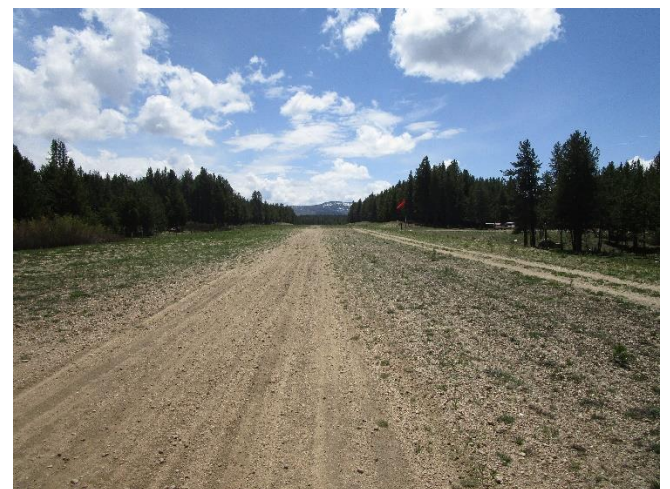
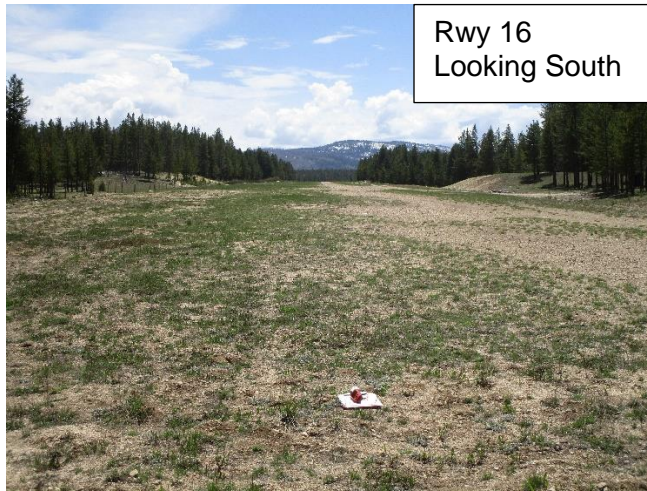
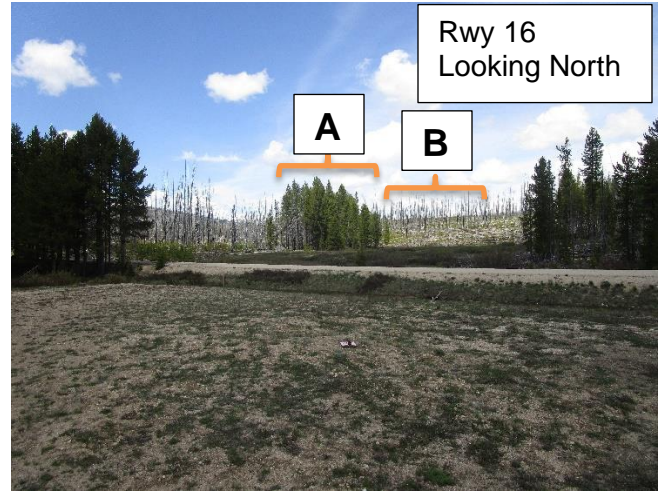
**Runway 16-34:** Overall, the runway surface remains in fair condition with some loose rocks still present in the center portion of the runway. The center 15ft portion of the runway is the area of dirt, sand, and rocks that appears to get the most use for take-offs and landings. I noticed that several areas adjacent to the center portion, on both sides of the runway, display lots of saplings - up to 20-22 inches tall, growing in the middle of the rwy. If left uncared for, these baby trees will grow and present a serious challenge down the road. A crew should investigate this and pull all those little saplings out sooner rather than later. Organizations such as IAA and RAF are always looking to help and take care of airfields on a volunteer basis...someone from your organization should reach out to them and ask for some help. The approach at rwy. end 34 is very much unchanged since last time I visited. Rwy. end 16 on the other hand, has a patch of green trees directly on extended center line (Area A) and a lot of dead trees standing on final approach, still (Area B). All efforts to knock down as many of those trees, starting with the ones closest to the runway end would be tremendously helpful in providing a safe passage for both arriving and departing aircraft. There were no changes to the approaches at this airport; both remain relatively unchanged since the last inspection.

1. Remove the many saplings growing on the runway,
2. If possible, remove as many of the dead snags located on final approach to Rwy. 16 (Area B), and the tallest of green trees closest to the rwy., on rwy. extended center line (Area A).

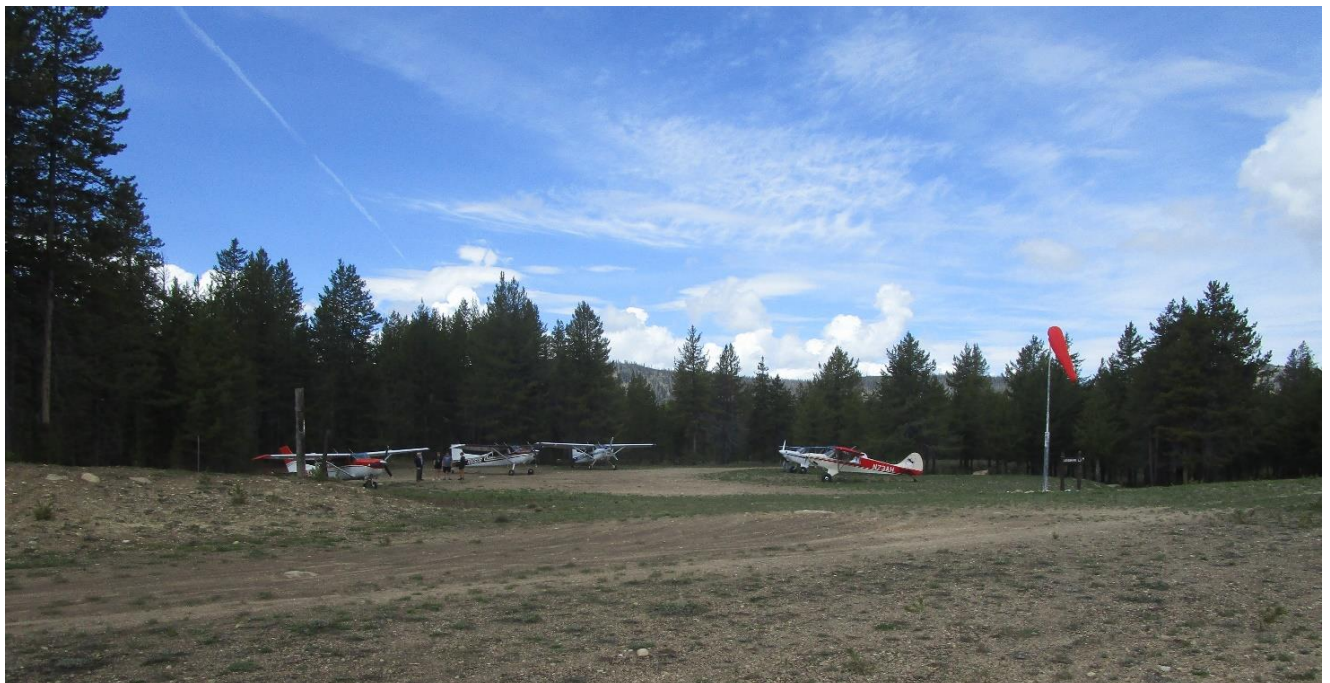
**Tie downs:** The two tie downs pads located at midfield and behind the windsock, were easy to find and both had chains present. The area was nice and even, and very accessible. You could easily fit 4-5 airplanes there, as that is how many came in after we landed and parked.

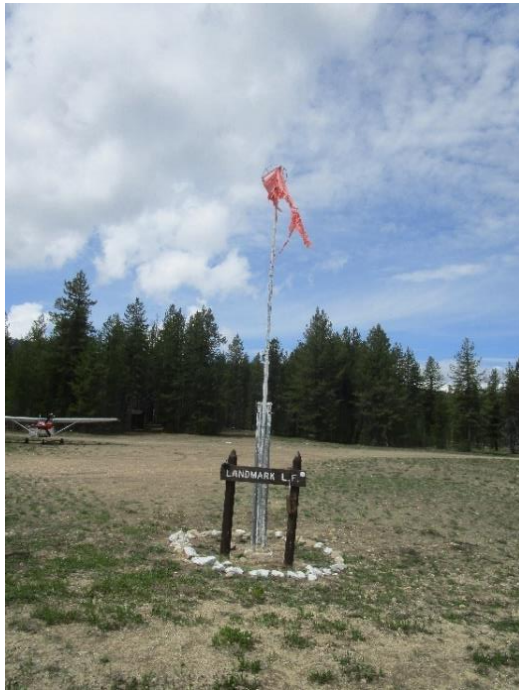
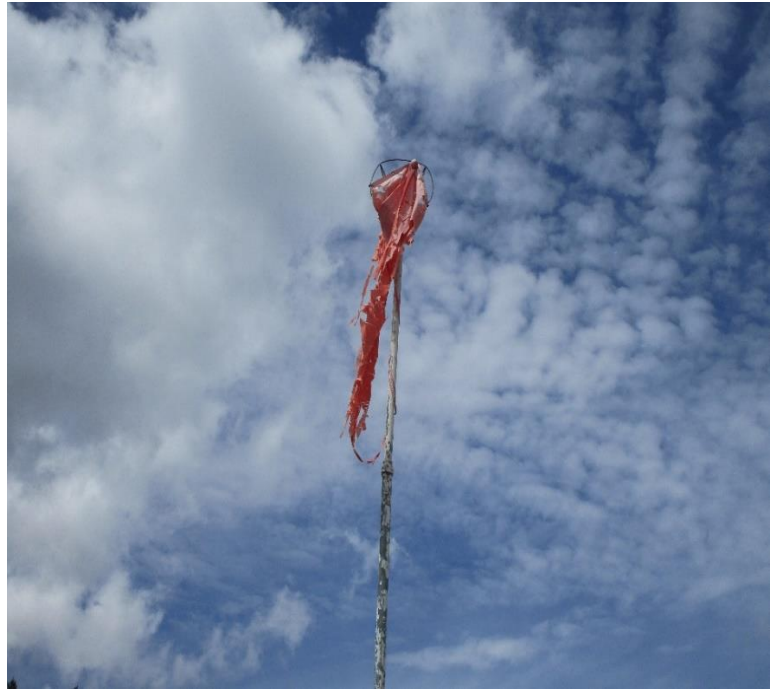
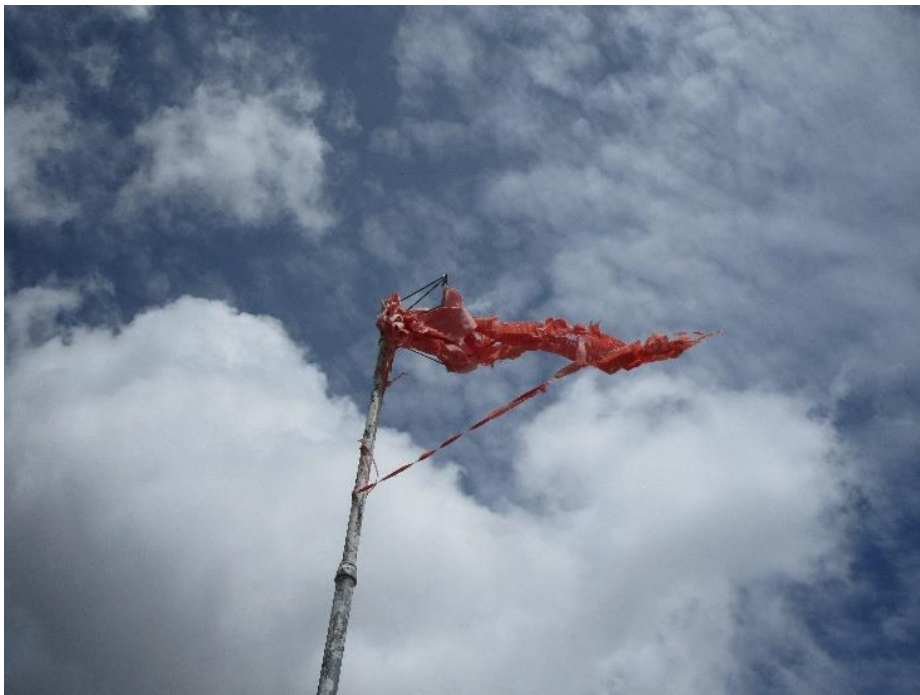
**Windsock/Standard:** The windsock was completely shredded and tangled up in the frame/metal standard. I replaced it with a brand new one. The windsock standard is in fair condition overall and with most of the white paint gone as it is peeling off. There was a problem with the bolt in the lower section of the standard. The holes no longer line up at the bottom and the bolt does not go through all the way to secure the standard in place. After I replaced the windsock, I did my best to get the bolt in as much as I could but was only able to get it through halfway – just enough to keep the standard in the upright position. The non-standard segmented circle rocks were painted white (approx. 60% paint left) and are still too small in diameter; perhaps a slightly larger circle 20-30' in diameter and with larger segments, would make for a better navaid that is more conspicuous from the air.

1. Repaint the metal standard in white paint
2. Re-build the segmented circle to be of a larger diameter (12-15ft) and with wider segments (2'x3'each)...(fyi - if you need more info on how to do this get with me at your convenience and will show you how).

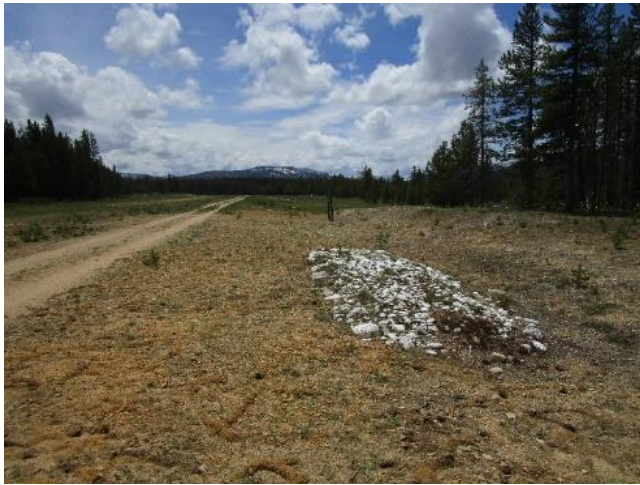
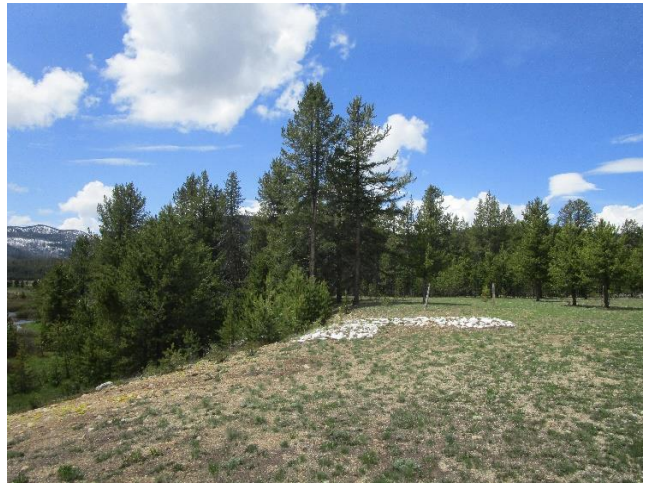
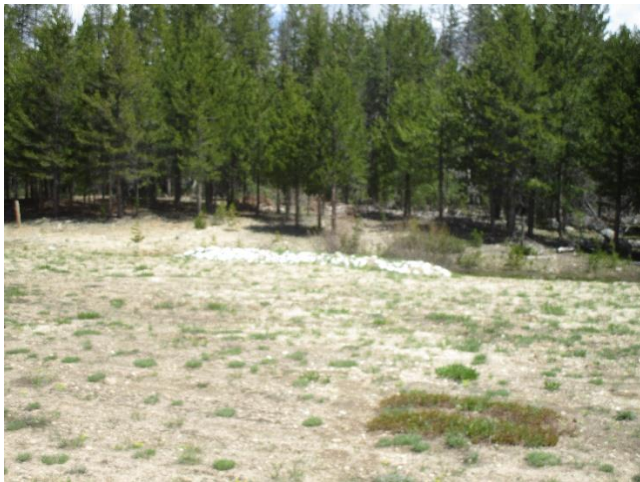
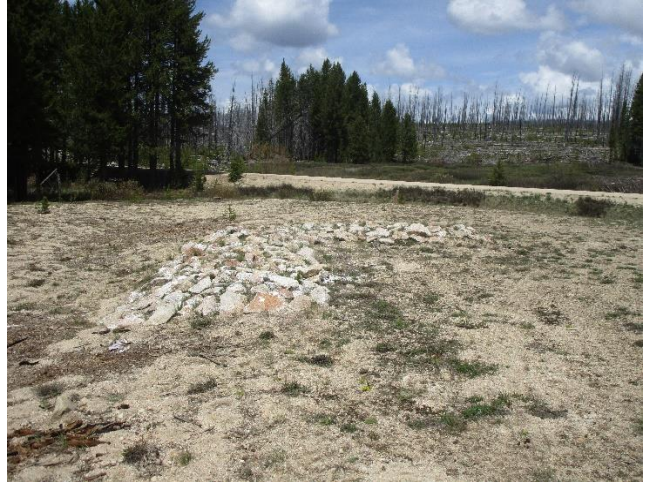
**Boundary Markers (BMs):** All rock boundary markers had good integrity and were together as they should be. There is a lot of vegetation growing through the rocks and encroaching that is making the BMs blend in with their surroundings too much. In their current condition, they were identifiable from the

air some, but do need some fresh white paint – especially at rwy. end 16. The new white paint would totally enhance their visibility form the air.
