## IDAHO TRANSPORTATION DEPARTMENT

Subject: 2022 5010-1 Airport Inspection conducted July 26, 2022.  
(04242.A Mackay Mackay Airport)

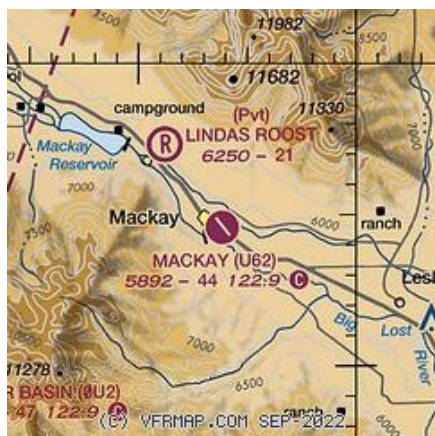
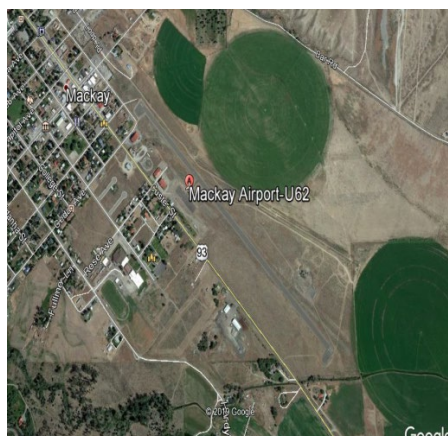
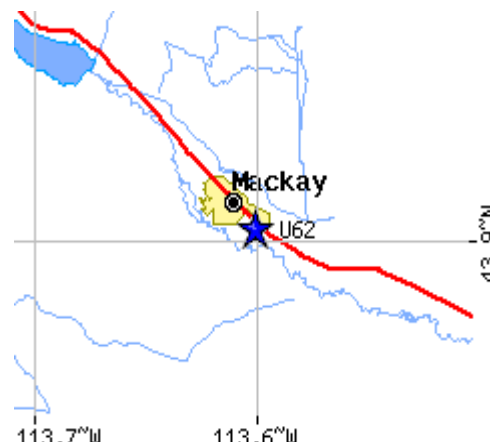
**Runway:** The runway surface continues to be in fair condition. The roughness caused by the exposed aggregate that was there 3 years ago is still there today. The runway continues to display many cracks with 12-16" tall grasses growing through them. In fact, not much has changed since the last time I inspected the airfield three years ago. The markings on the runway are still in poor condition. The numbers and centerline display a lot of fading and are very difficult to see, especially from the air. There were no lights associated with this runway. Vegetation on the edges of the runway was fair, but does need some attention – especially in the first few hundred feet of runway end 30. The controlling obstructions at both runway ends remain the same/unchanged.

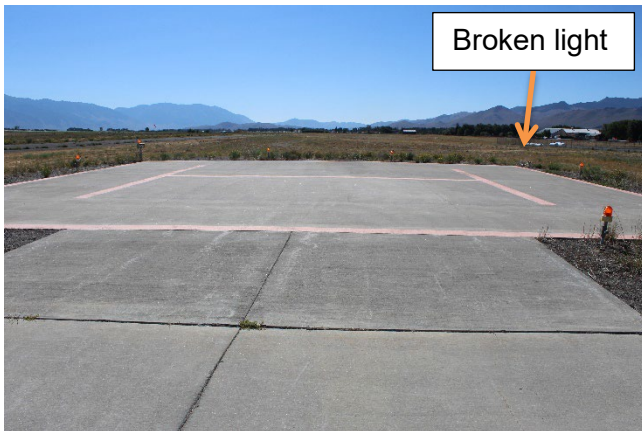
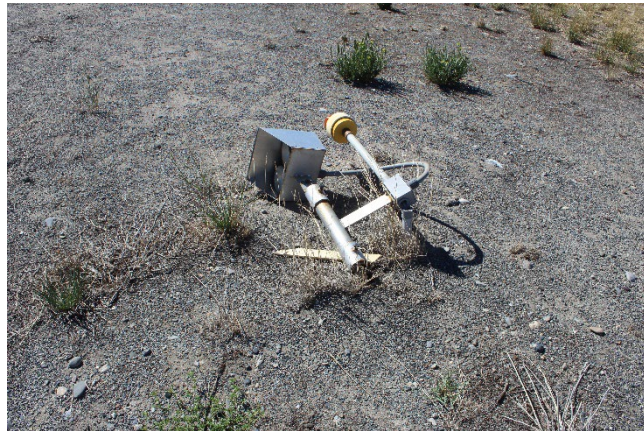
Your helipad surface was in good condition. Markings were decent and all the lights were in the upright position, with the exception of one (see pics). I left one new windsock with the city clerk at the City Hall office for you to use. Hopefully your maintenance folks can go out there and replace the windsock – it needs it. Please feel free to call me anytime should you have any questions, updates, or need any airport supplies.
