SUBJECT: 2021 5010-1 Airport Inspections conducted 22 July 2021.

(04214.\*A Mahoney Creek Airport – 0U3 Mahoney Creek USFS) (04244.5\*A Indian Creek Airport – S81 Indian Creek USFS)

## Mahoney Airstrip (0U3)

## Indian Creek-USFS (S81)

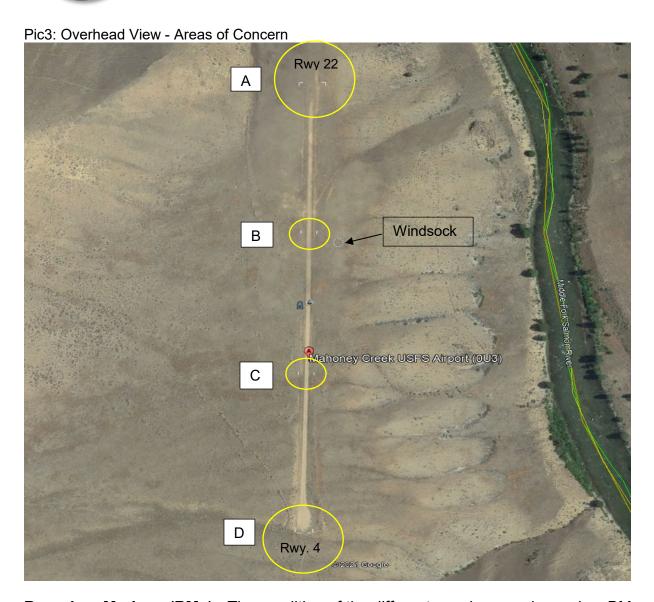
Your runway dimensions reported to the FAA (on the Airport Master Record) and the flying public are: 2150'L x 15'W. However, your BMs in their current position offer a much wider area to use for landings and take-offs than reported. The idea is - you want to stay as close to what the Airport Master Record shows for a couple of reasons: first, as the airport owner, your agency is legally responsible for everything that happens within the BMs, and secondly you have that much more area to maintain/put work into. Picture 3, identifies four different areas you want to look at - address the placement of the BMs located at A, B, C, & D.

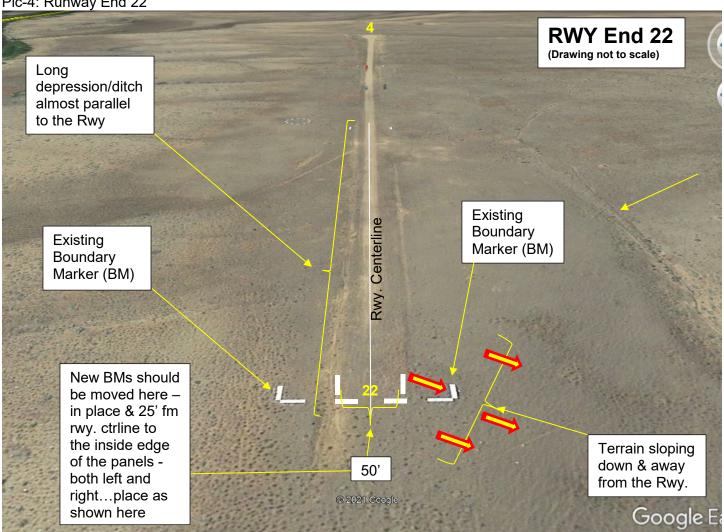
Pic-4: Runway End 22

**Boundary Markers (BMs):** The condition of the different wooden panels used as BMs on this airfield is good; however, the condition is not the issue as much as the placement of those markers. Currently, the markers are installed incorrectly and placed too far away from the centerline (see details in pic 4), which is inconsistent with the runway information reported on the FAA's Airport Master Record and certainly not in accordance with the Idaho Transportation Department - VFR Airports Design Manual.

- Area A (Rwy 22)-Pic 4: In-place, bring the BMs towards the rwy center so you would have no more than 25' max from the inside edges to the rwy, centerline, left and right as indicated in pic 4.
- Area B & C-Pic 5: in-place, bring all BMs towards the rwy center to have no more than 20' from the inside edges to therwy, centerline, both - left and right,
- Area D (Rwy 4)-Pic 6: bring the BMs forward 30' from current position and 25' apart from rwy. centerline – see explanation in pic 6.
- The size of the BM panels should be a minimum of 15'Lx4'W, but not smaller; larger is ok (20'x4' or 30'x5')

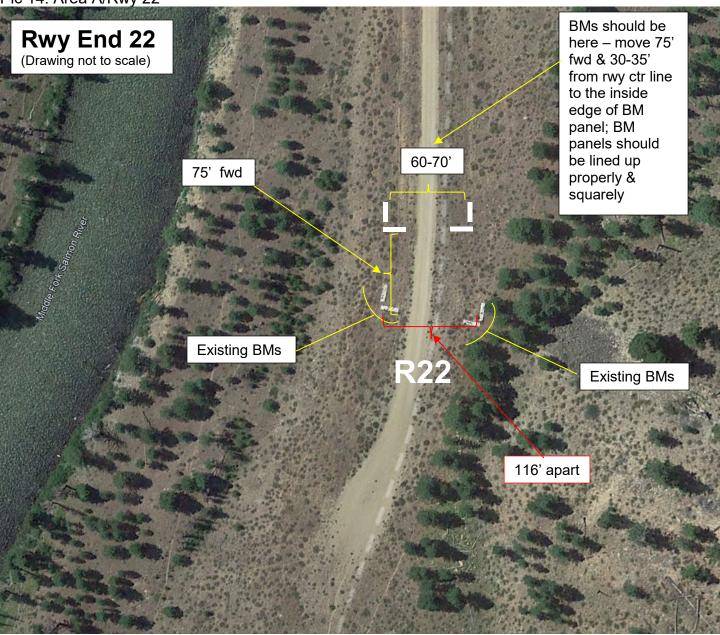
Pic 14: Area A/Rwy 22

Runway 4-22: Similar to Mahoney Airstrip, this airport too, is in good condition considering its wilderness location and remote access. The dirt/sandy surface is incredibly smooth and without any or major undulations that would negatively affect the stability/ground rollout for either arriving or departing aircraft. Small, loose rocks were present all throughout, but more so, closer to the rwy ends. Everything was in great shape, except the BMs – see pics 9, 10,11 & 12, down below for a visual representation. For example, when approaching from the NE on final to Rwy. 22, I was unable to see the BMs during final approach..... it wasn't till the very last second, when I did the little dog leg turn to the left to line up on the straight away for landing (pics 9 & 10), that I saw the right BM. This BM is completely obstructed from pilot's view by the 40-60' tall evergreen trees in front of it. The same goes for Rwy end 4 where the BMs are installed incorrectly as well - left side is on uneven terrain and also obstructed by trees. All the BMs need relocating, simply because currently they are not fully/properly serving the purpose they're designed for and, more importantly, for safety reasons.
