## IDAHO TRANSPORTATION DEPARTMENT

SUBJECT: 2021 5010-1 Airport Inspection conducted July 2, 2021.  
(04167.14\*A Marble Creek Airport (ID8) Salmon, ID)

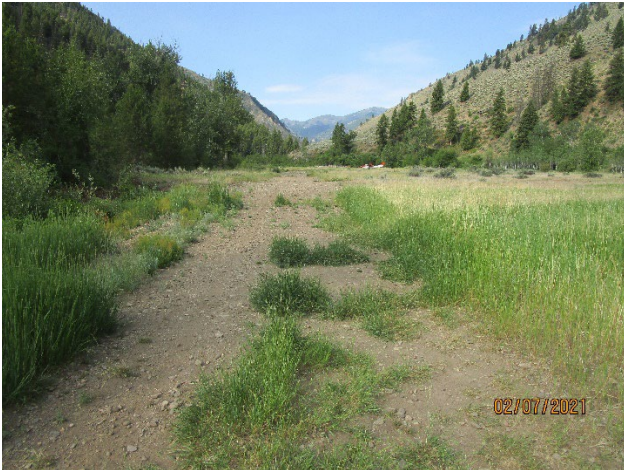
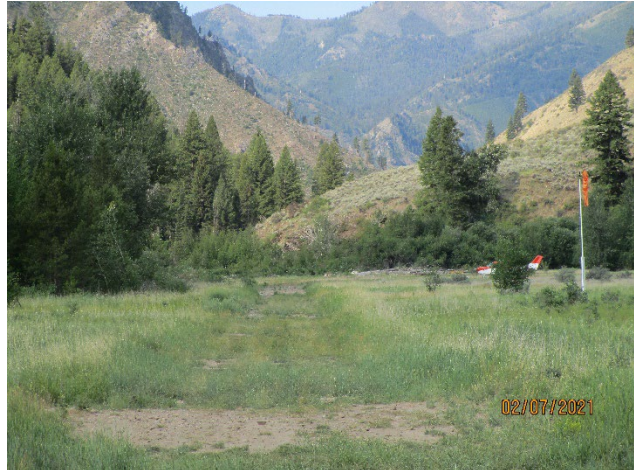
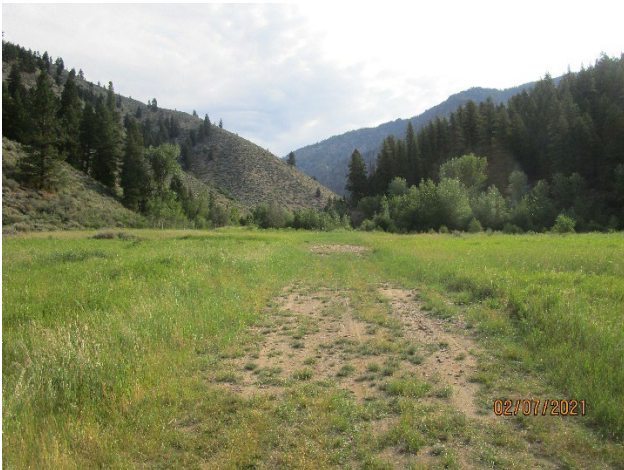
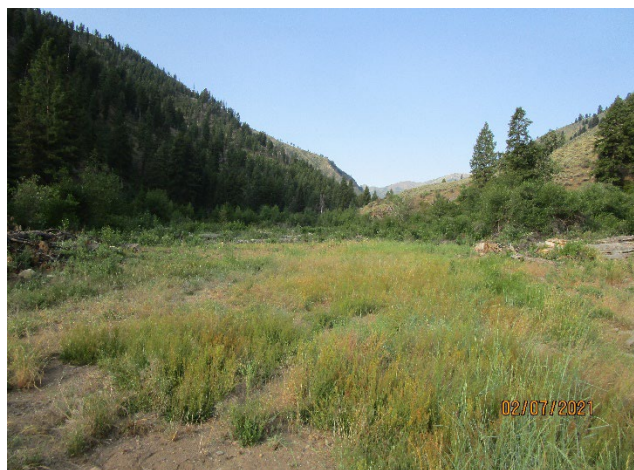
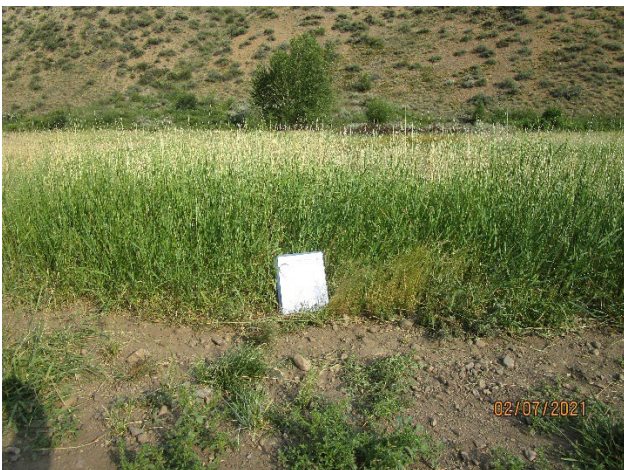
### **Runway (4-22):**

This airstrip continues to be a challenging endeavor to get to – due to its location and the surrounding high terrain. Again, this airstrip is not for the faint of heart and one has to have the right combination of equipment, weather, and training to make it in and out of safely. The runway surface presented itself in fair condition, with quite a few loose rocks - especially in the midfield area, and a bunch of vegetation growing. The rest of the runway surface appeared to be ok, however, vegetation

continues to grow and appears to take over the runway surface and around. The runway is still not marked and it has no boundary markers. While the runway is still visible and one can make it out ok (if you know what to look for), with the oncoming rain season in the fall and all the snow over the winter, it is just a matter of time before the vegetation growth will take over and obscure any resemblance of the runway there. The two piles of wood that I previously mentioned at rwy end 4 have been mitigated some since last inspection, but there is still some wood present and now vegetation is growing and concealing a lot of it. They are still within the runway area and within 50ft from the center-line and need to be removed - your discretion here. Controlling obstructions at both runway ends remain the same/unchanged.

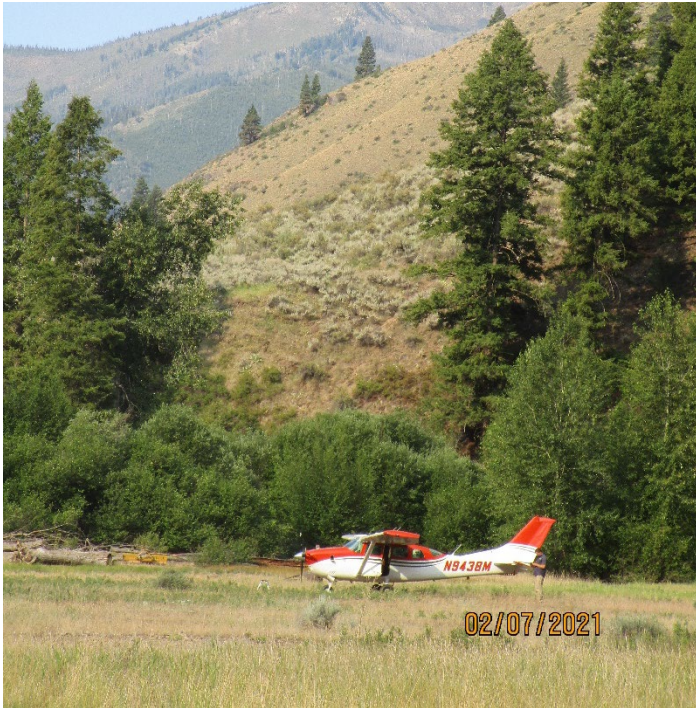
### **Ramp/Tiedowns:**

The main tie down area near the rwy end 04 was adequate and in fair condition. Besides some loose rocks, vegetation was growing good and made it challenging to identify the terrain surface while taxiing to the parking area. Luckily, there were no hidden holes or rocks to deal with.

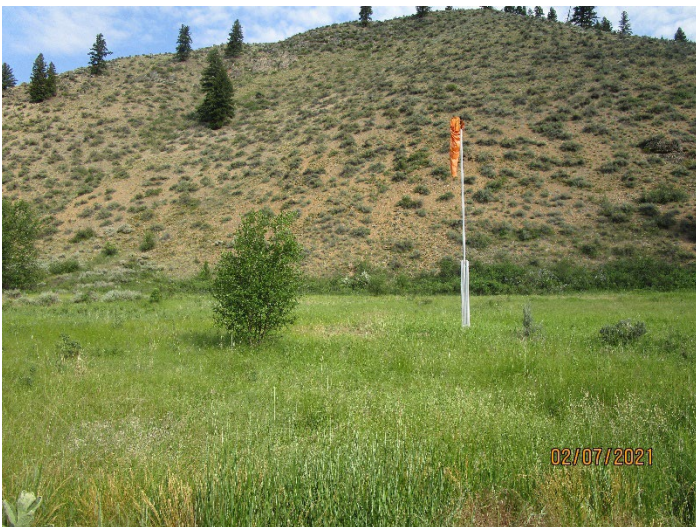
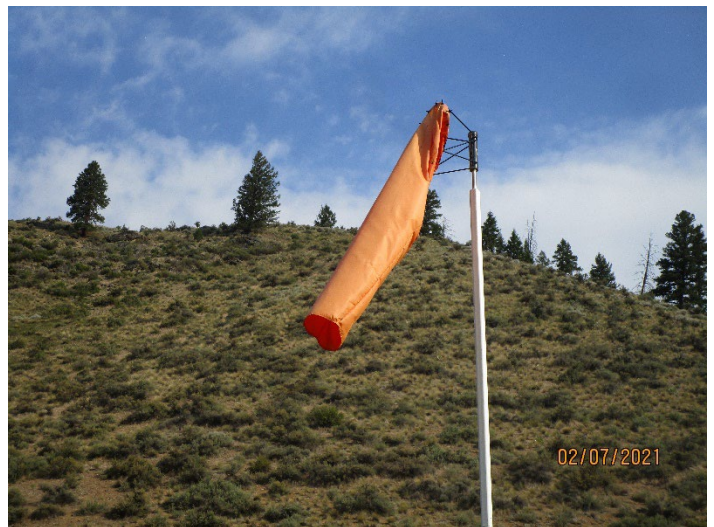
### **Windsock/Standard/Segmented Circle:**

The windsock located on the north side of the rwy appeared to be in good condition – it showed no signs of distress, rips or tears. The metal standard was in good mechanical order and displayed good white paint. There was no segmented circle around the standard at this airstrip; having one would totally make it easier for pilots to identify the location of the airfield.
