IDAHO TRANSPORTATION DEPARTMENT

SUBJECT: 2023 5010-1 Airport Inspection conducted March 16, 2023.
(04255. A Midvale Lee Williams Memorial Airport)

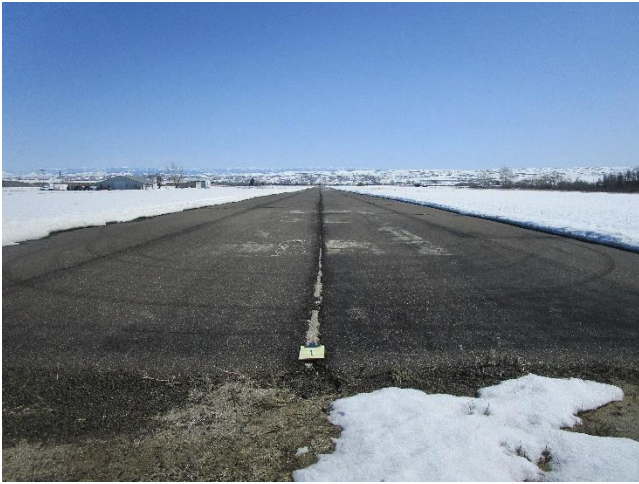
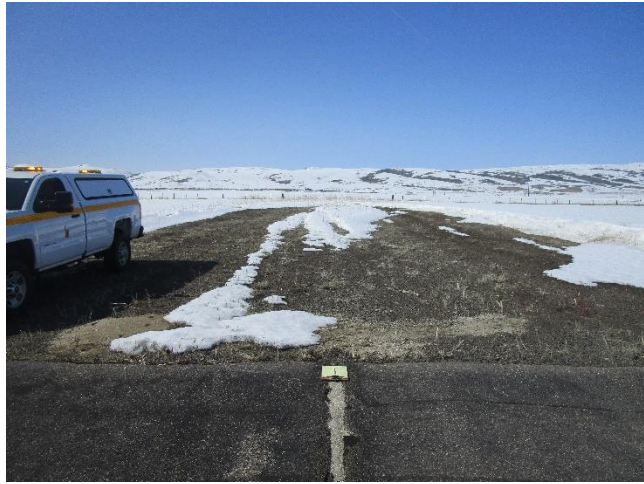
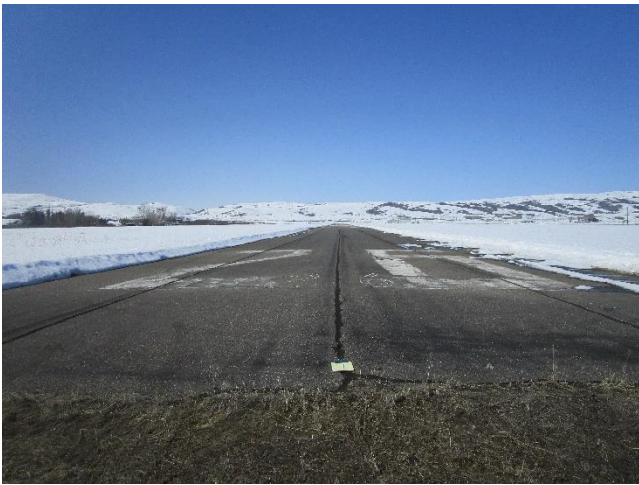
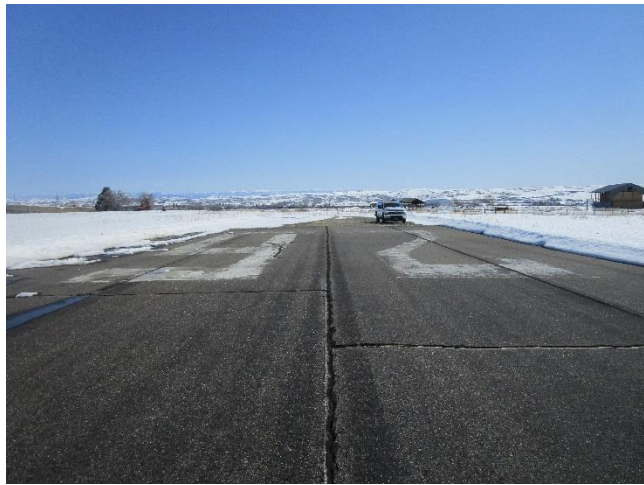
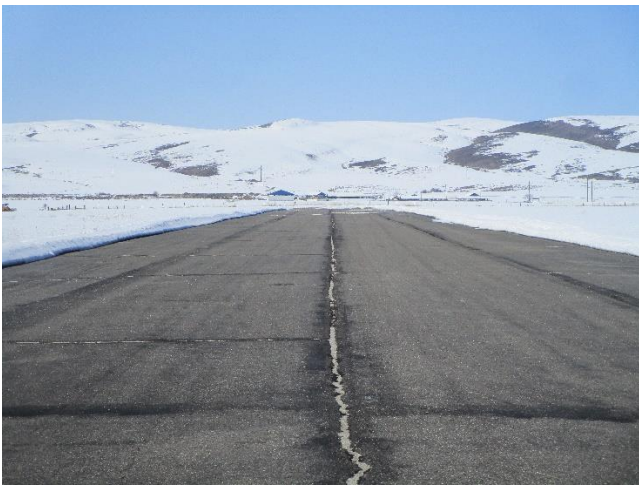
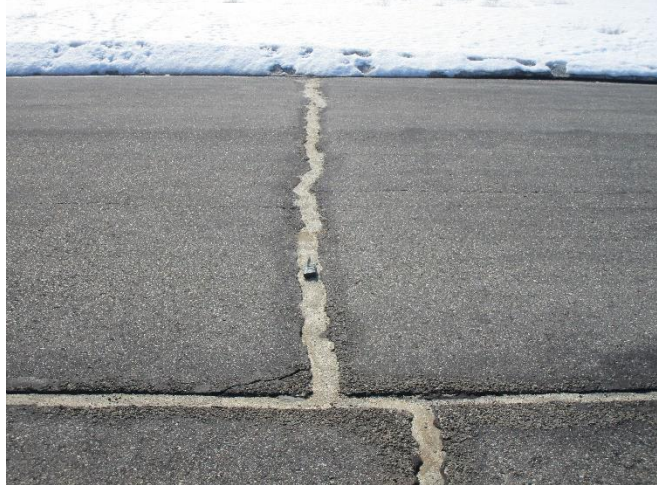
Runway 8-26: At the time of the inspection, the asphalt runway surface was in fair to poor condition. Centerline had one long -1.5" to 2" wide, tar-sealed crack that ran the entire length of the rwy. Also, just about every 20-30' apart, there were many perpendicular cracks, 2-4" wide, covering the entire runway from one end to the other. The previously applied tar seal treatment was almost inexistent as the tar seal had dried up and shrank to the point the treatment was no longer serving a purpose. However, the idea of filling all the cracks with sand wasn't all that bad as it brought up the surface to a more even level and reduced the roughness of the surface typically experienced during take-off or landing ground roll. While this is not exactly a permanent fix, it is still better than just empty, wide cracks. Marking of the runway I rated as fair, there is no centerline, only runway numbers which are very faded (rwy. end 8 is worse than rwy. end 26). Hopefully, later this year after your pavement rehabilitation project is completed, you will have a brand-new airport (exciting news ☺ ☺). The controlling obstructions at both rwy. ends remain the same and unchanged.

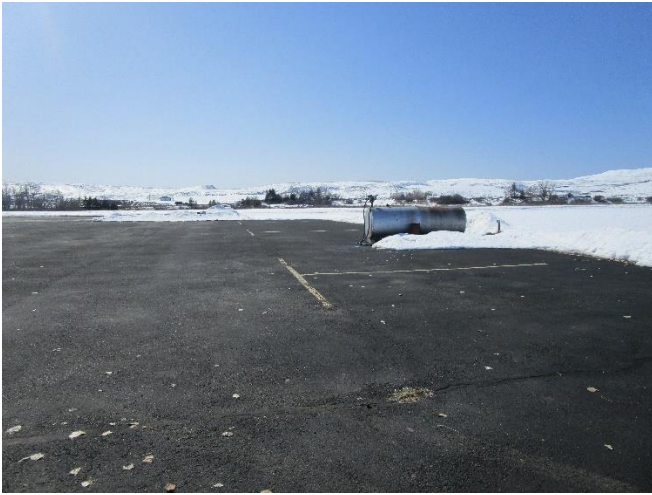
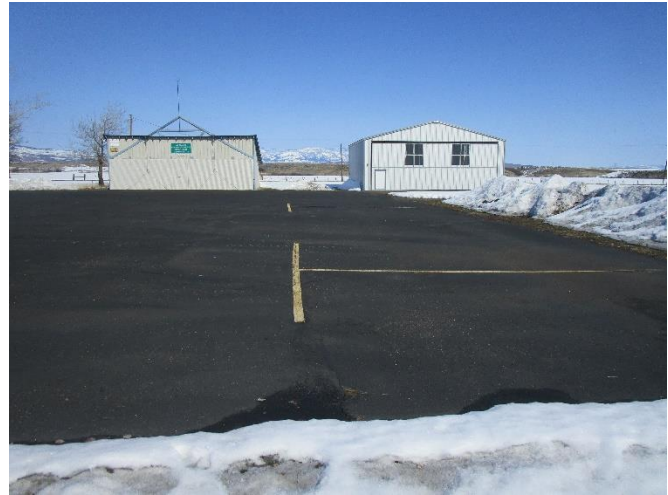
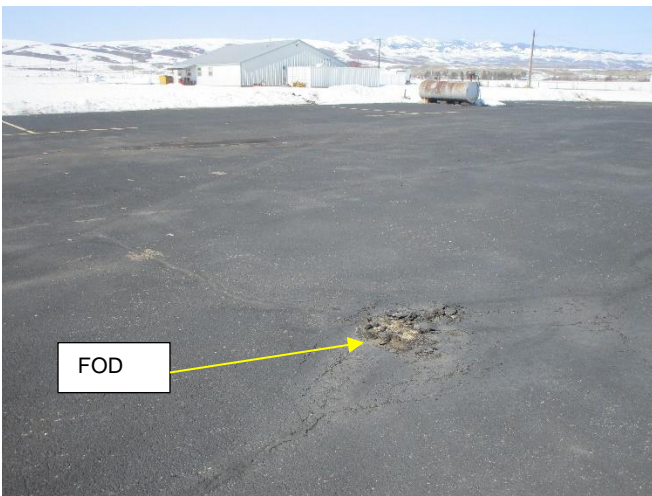
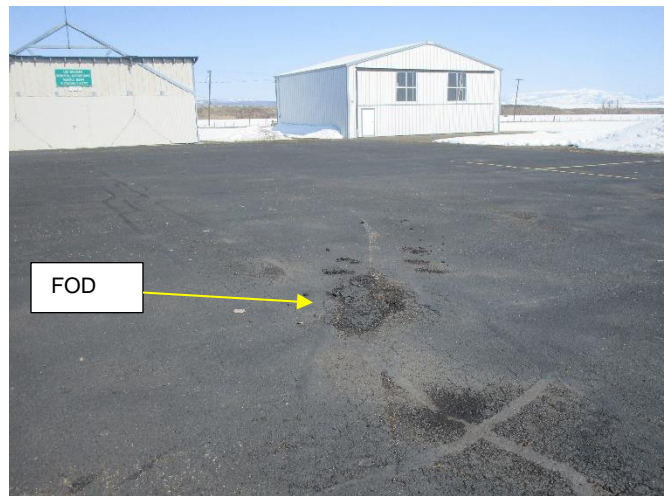
Taxiway/Ramp Tie-Down: There is no taxiway at this facility. Tie down area had mostly good surface and fair paint markings. There are a few areas where the pavement is coming apart and small chunks of asphalt are becoming FOD (foreign object damage) for the area (see pics). Vegetation around the runway and the tie-down area was still under snow cover, but it appears to be well managed and under control.

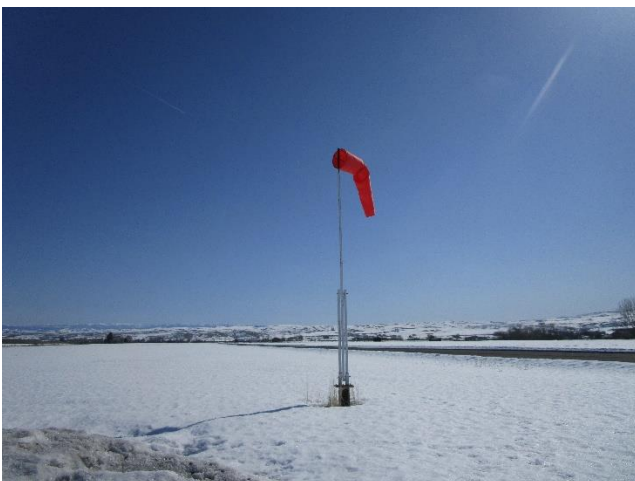
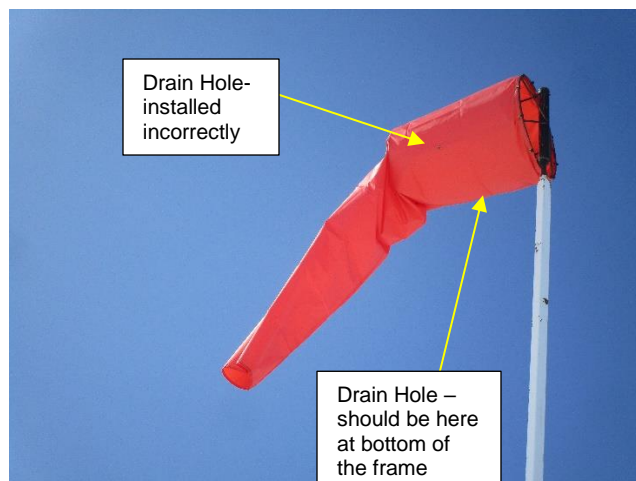
Windsock/Segmented Circle: The standard had good white paint coverage and the windsock was in good condition – no rips, tears or discoloration. I left a new windsock with Garret Bane for you folks to use when needed in the future. The only thing I would suggest is that you install it properly and make sure the drain hole is all the way to the bottom of the frame vs on the side as it is now. Otherwise, your windsock will accumulate rainwater, develop a water belly, deteriorate, and not last as long as it should – at least 15 months, if not longer.
