IDAHO TRANSPORTATION DEPARTMENT

Division of Aeronautics
1390 W Gowen Road, Boise ID 83705

Subject: 2023 5010-1 Airport Inspection conducted August 10, 2023
(04141.5A Midway Atomic City)

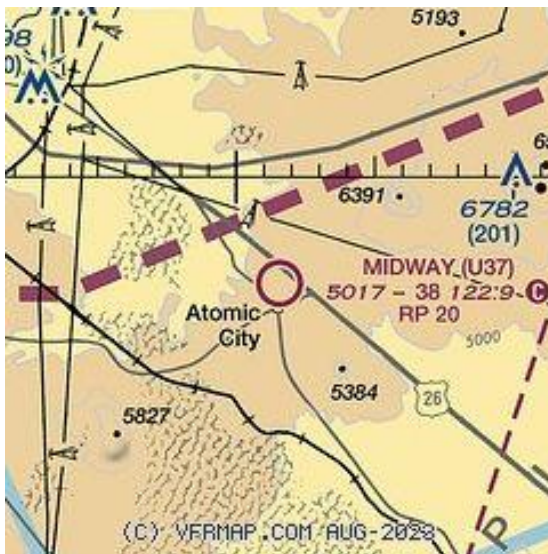
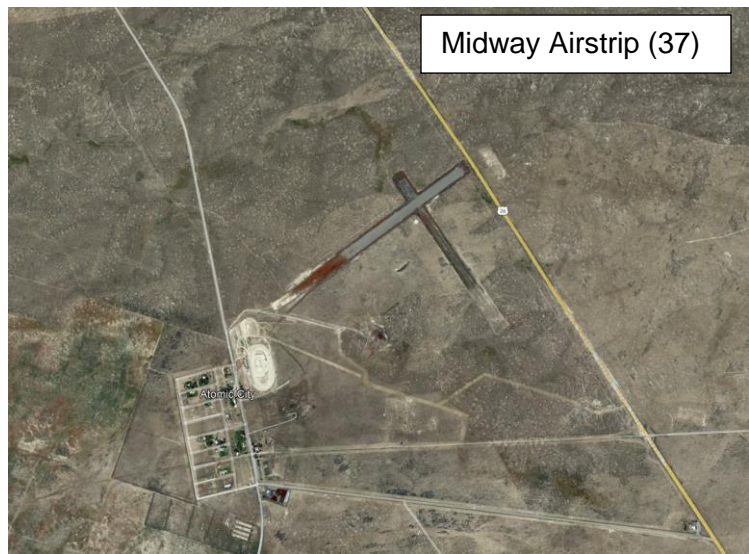
Runway 2-20: At the time of the inspection the runway surface was no different than it was three years ago – half covered with gravel - Rwy 20 and red lava rock at Rwy 02. The surface continues to be in fair condition, and during the ground roll test, surface was still on the softer side from one end to the other. In general, the runway presented an even surface and had some vegetation growth at rwy end 2 that could use some attention – grass was about 24" to 30" tall. There were no changes to the approaches at this airport; both remain relatively clear and unchanged.

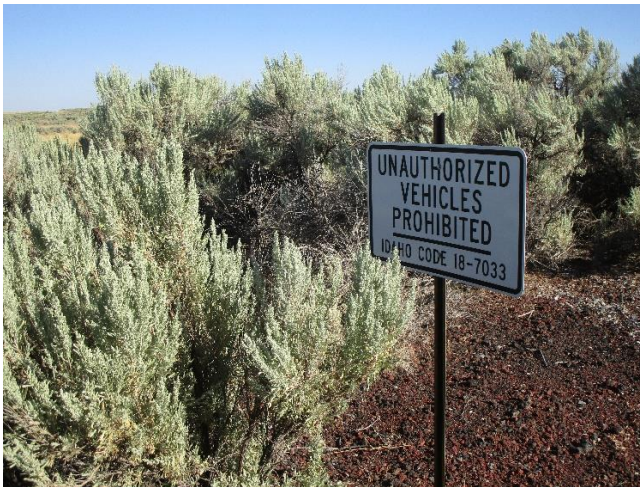
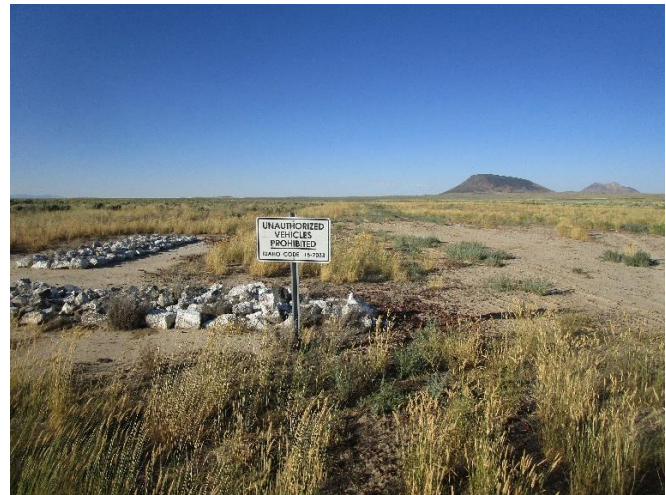
Miscellaneous/Services: All signs present on the facility were upright and in readable condition. I saw no other significant changes or safety concerns with this airfield. If you have any questions or if I can be of any assistance to you, please feel free to call anytime. Have a great day.
