## IDAHO TRANSPORTATION DEPARTMENT

Subject: 2023 5010-1 Airport Inspection conducted February 22, 2023.  
(04273.\*A Murphy Murphy Airport)

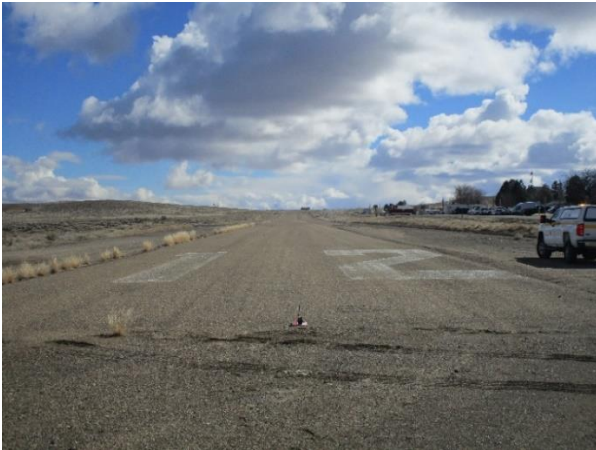
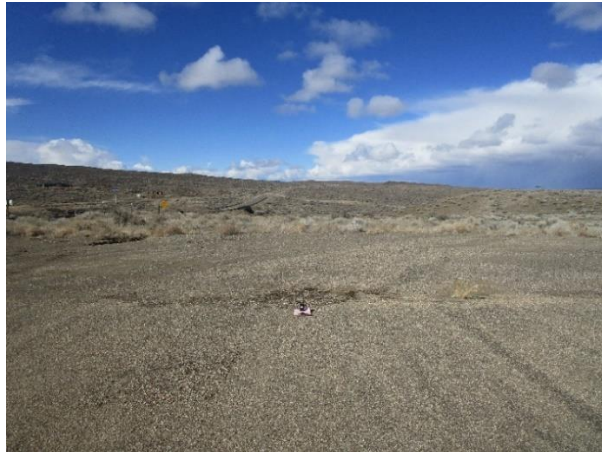
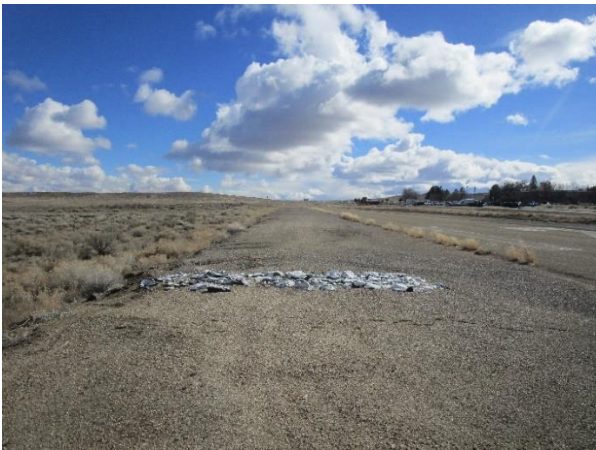
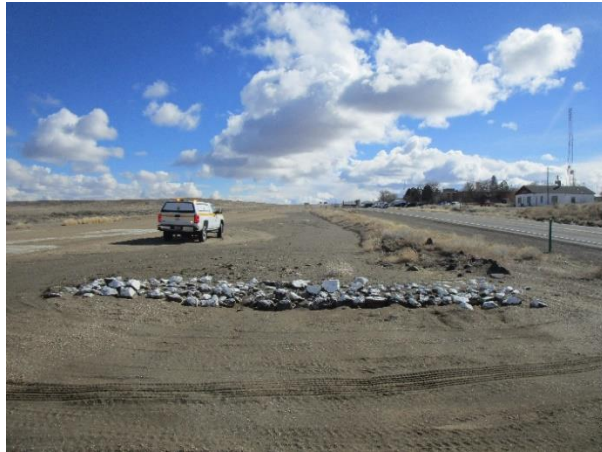
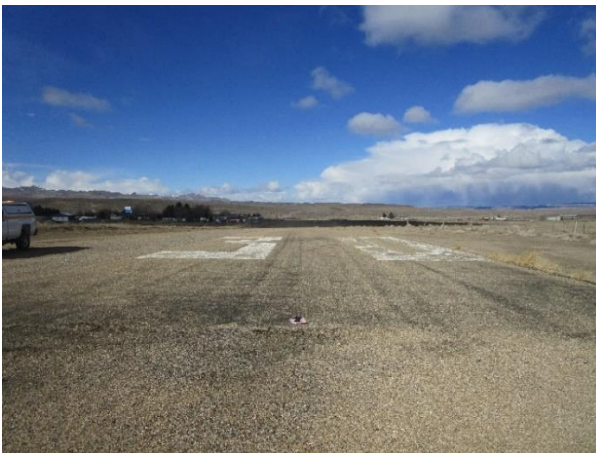
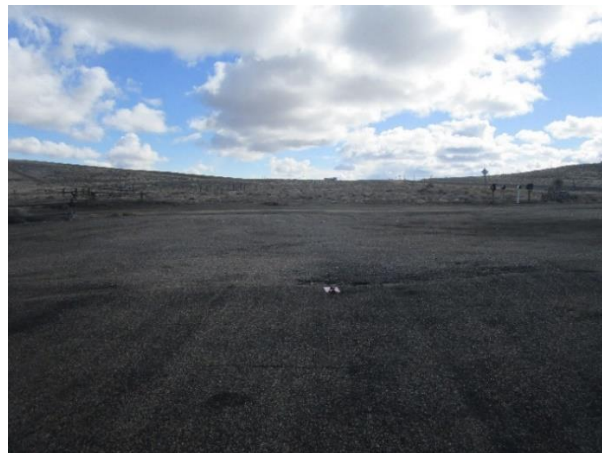
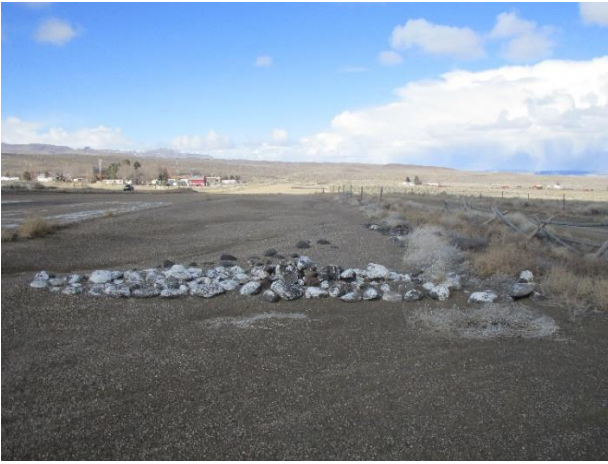
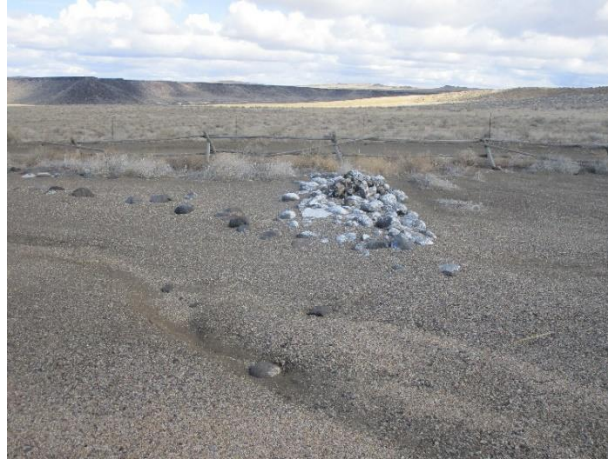
**Runway (12-30):** Not much has changed since last time I visited Murphy, 3 years ago. Your runway continues to show great integrity and a solid but rough runway surface due to exposed aggregate. Still, there were no cracks visible and the runway is in good condition, therefore, I rated it as such. Runway markings – I rated as poor as there is no centerline, but only numbers painted at each runway end. The paint on the numbers is very thin, faded and barely visible from the air. My recommendation from 3 years ago continues to be that you paint fresh new numbers for better runway distinction and visibility. The runway alignment has not changed, and the numbers 12-30 markings are still good. The boundary markers you have in place need some attention in the sense they need re-doing. In their current shape and condition, do not actually serve the very purpose they're designed for. The piled rocks need to resemble more of an "L" shape on both sides of each runway end, of certain dimensions which I did not see (if you would like, you let me know when we

could meet out at the airport and I will show you exactly what needs to be done and how to fix them). There were no changes to the approaches at this airport; both remain relatively clear and unchanged.

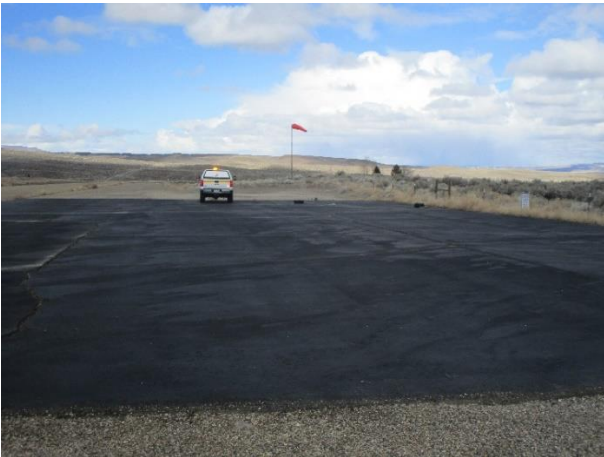
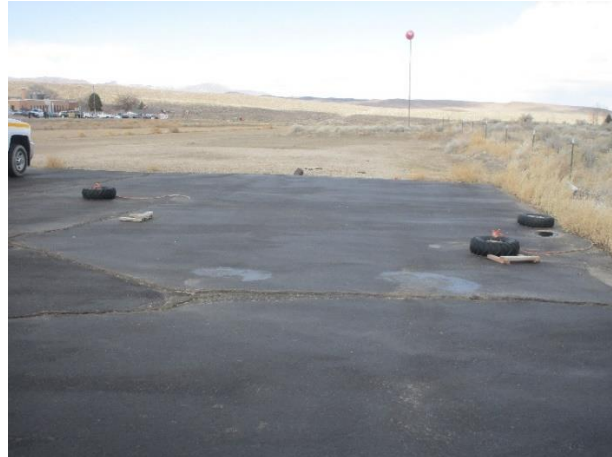
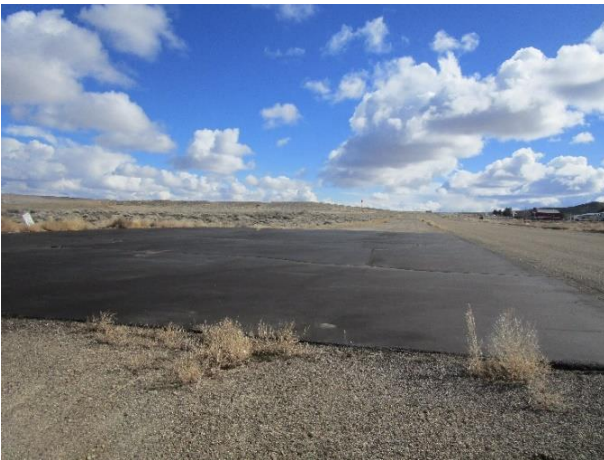
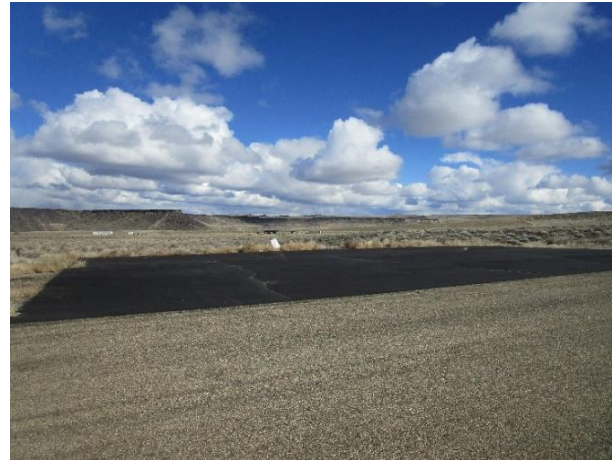
**Taxiway/Ramp/Tiedowns:** The ramp areas continue to be the only portions of pavement that exhibit cracks. The tie down ramp on the north end is in the better condition of the two, with the parking pullout showing several 1.5" to 2" cracks. Chains for transient aircraft were present on both pads in various forms, but usable, nonetheless.

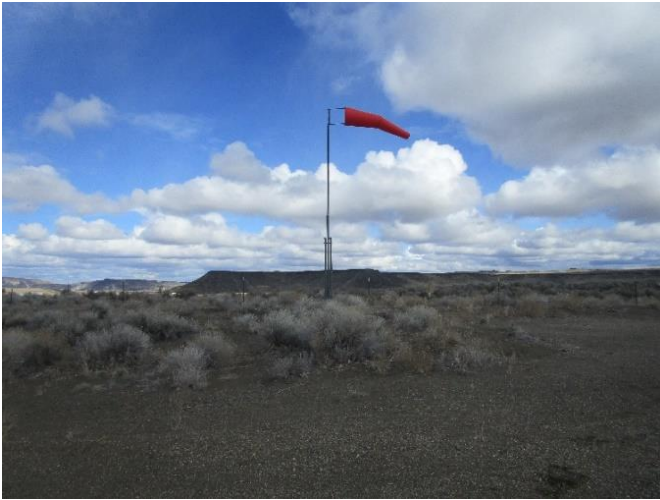
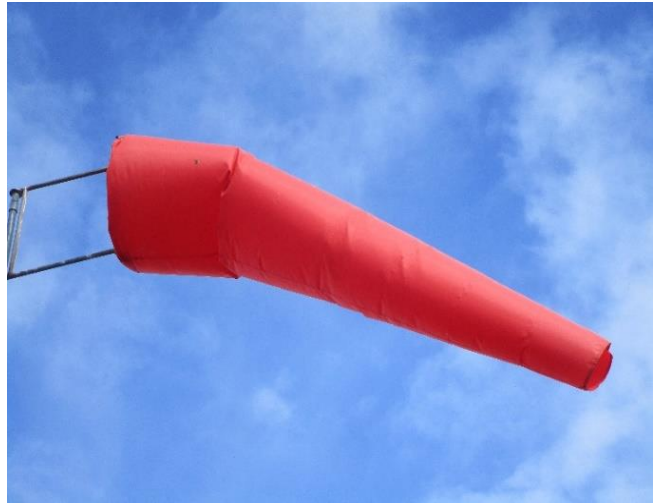
**Windsock/Standard/Segmented Circle:** Besides the fact that the windsock was installed improperly, I rated the windsock condition as good with little or no fading. The windsock drain hole was installed midway up and to the side vs being on the bottom to allow for proper water drainage.

The unpainted, galvanized, metal pipe standard was in good mechanical condition – solid & functional. There was no segmented circle present at this facility.

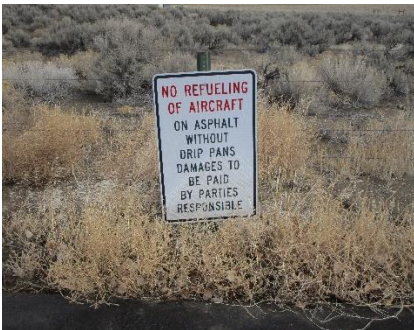
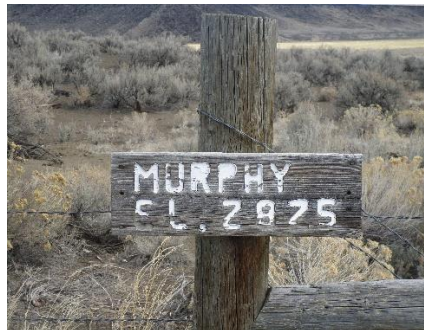
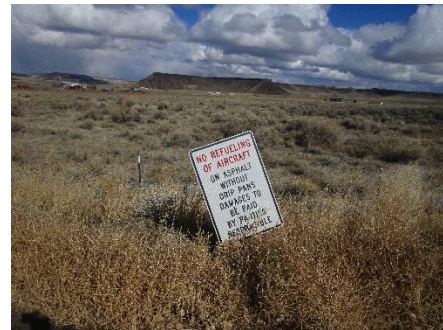
**Miscellaneous/Services:** All airport-related signs were upright, visible, and legible.
