IDAHO TRANSPORTATION DEPARTMENT

Subject: 2023 5010-1 Airport Inspection conducted May 11, 2023.
(04275.5*A New Meadows Airport New Meadows)

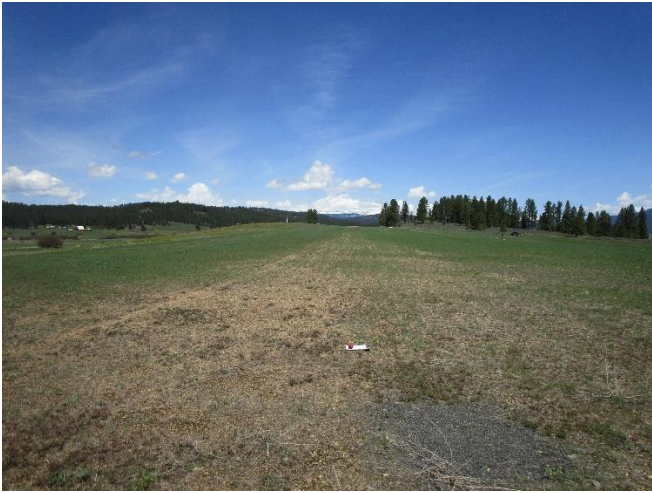
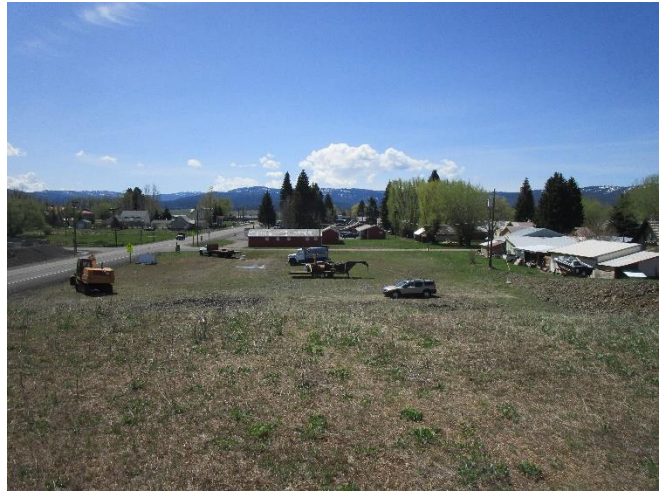
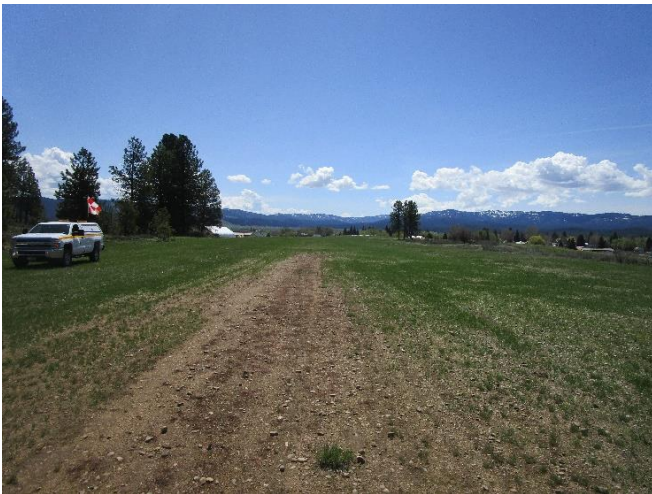
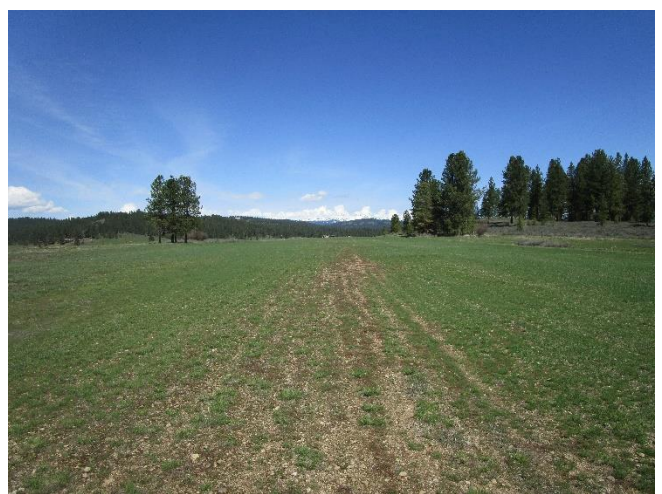
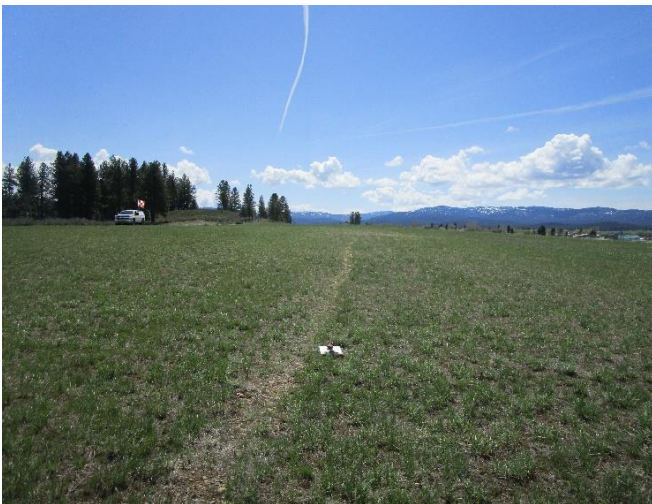
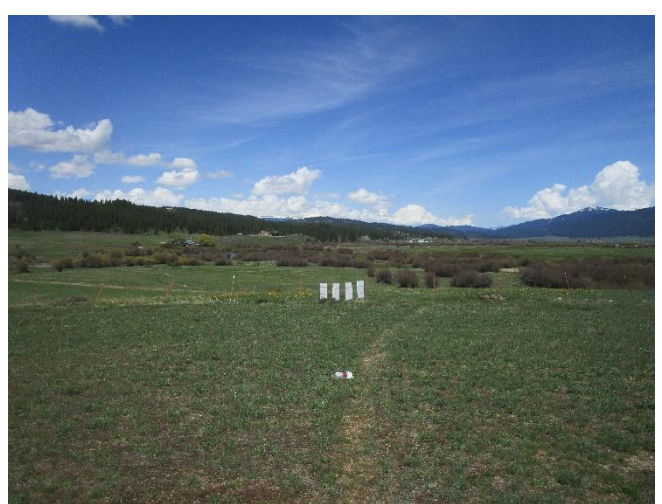
Rwy. 14-32: At the time of the inspection the surface of the turf-gravel runway, was dry, firm, smooth, and without any major undulations. The runway surface does display some minor roughness due to a few spots with loose rocks (up to 3") that are scattered down the centerline at mid-field and in a couple of other spots. Grass coverage (4-5") was uniform and had not been mowed this year. Joe and Justin indicated that they were going to go out there and mow it before the end of the month. However, having been out there, it would not make sense for them to mow it yet; I think that sometime toward the end of June would make more sense as they would have something to mow by then. There were no changes to the approaches at this airport; both remain relatively clear and unchanged.

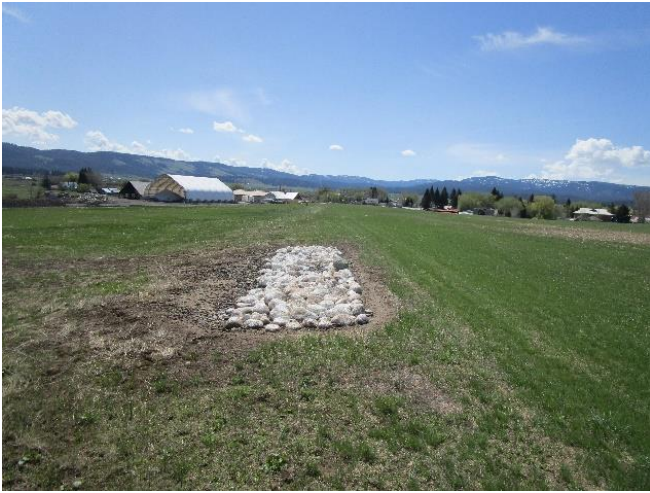
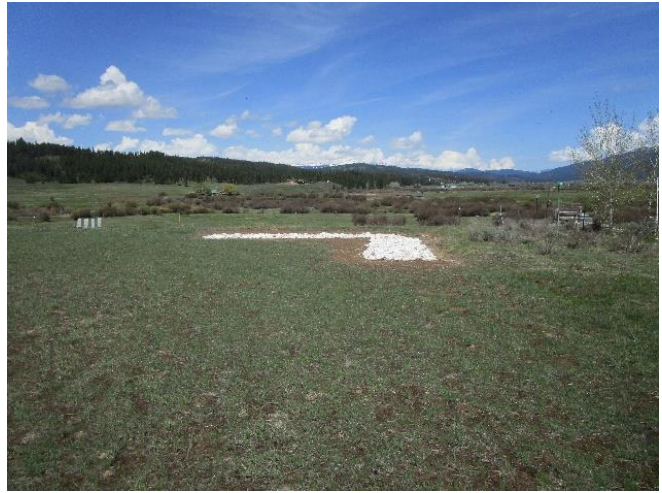
Boundary Markers (BMs): The painted rock boundary markers were in good shape and had good paint coverage (75-80% paint left). They were clear, free of vegetation and visible from the air. Not this year but in a couple of years, some new paint on the boundary markers and the segmented circle around the windsock would help and sharpen things up.

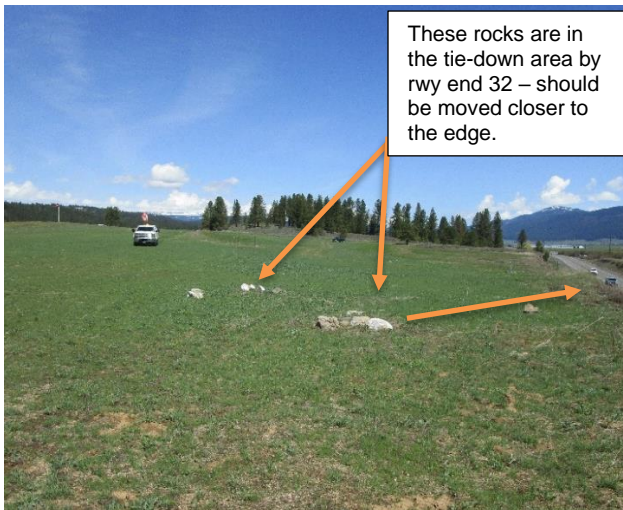
Tie Down Area: The tie-down area near the midfield was slightly sloped away from the runway and of the possible 3-4 parking spots, none of them had tie-down chains present. The other tie-down area, on the right side of rwy end 32, was a bit better and did not slope as much.

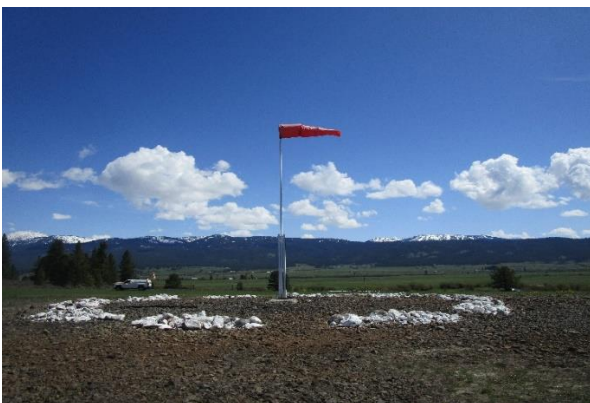
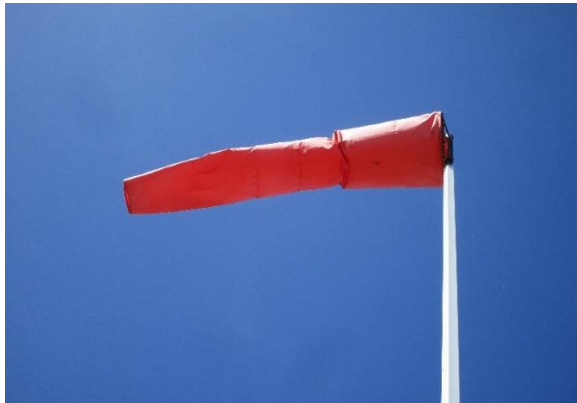
Windsock/Segmented Circle: Windsock at this airport was in good condition; it showed no rips or tears and had good color. The metal standard was in good condition and good working order. It had good white paint coverage and the area around the segmented circle was clear and free of vegetation. The whole navigation aid was in good shape and very visible from the air.

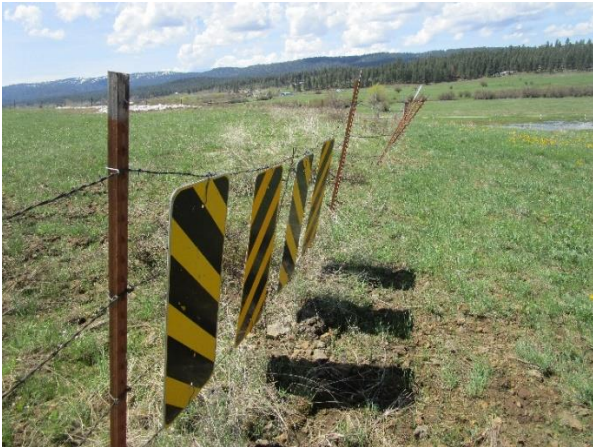
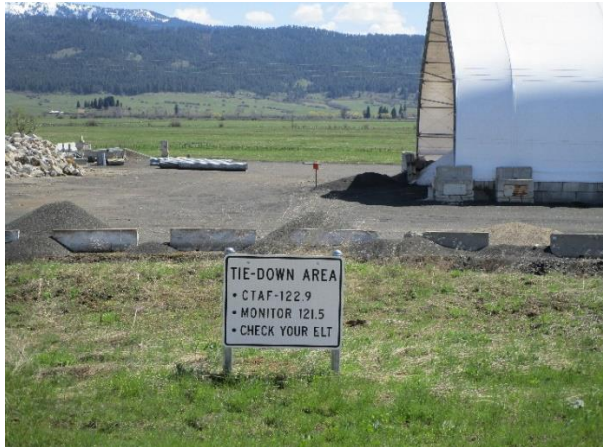
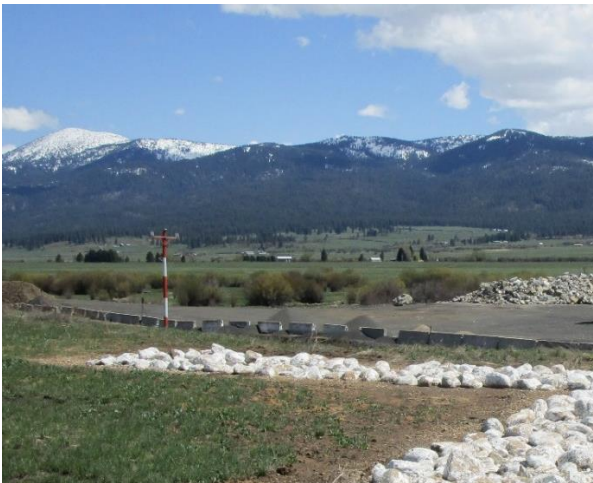
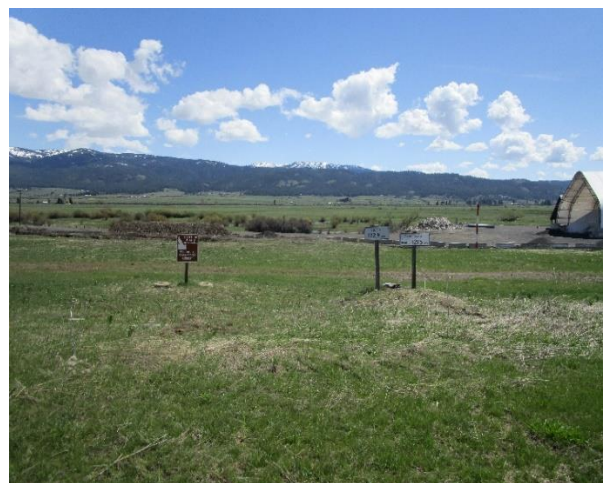
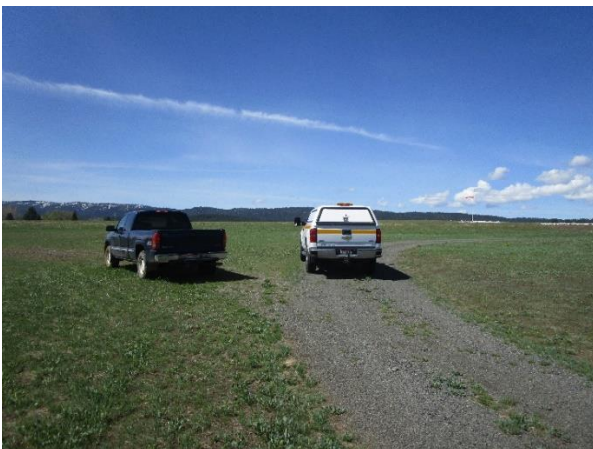
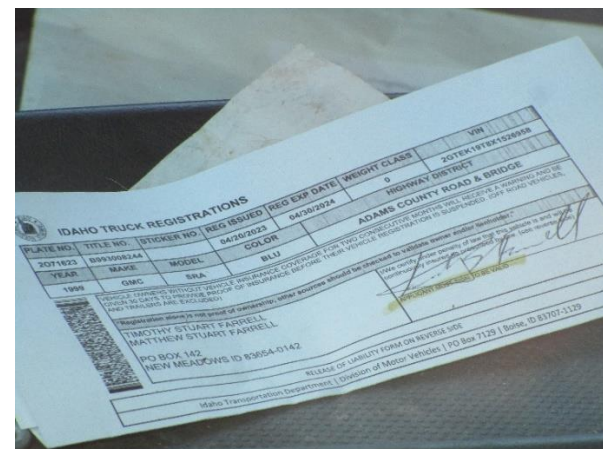
Misc/Other: The Idaho Power poles that are across Highway 95 showed good orange/white paint and were visible to all incoming aircraft. The fence had all the wires up and it appeared to be in good condition for the most part around the airport; the only exception was the portion on the approach to rwy. end 14 where the barbwire fence is leaning away from the airport. All signs were in good shape, visible, and none broken. Overall, I found the airport to be in good condition. The last thing I wanted to mention is the truck that I found parked on the airport behind the closed and locked gate – do you know anything about it? I am not sure what to make of it but here are a couple of picks showing where it is parked on the airfield. Is it supposed to be there?
