IDAHO TRANSPORTATION DEPARTMENT

SUBJECT: 2023 5010-1 Airport Inspection conducted February 27, 2023.
(04284.A) Payette Payette Municipal Airport)

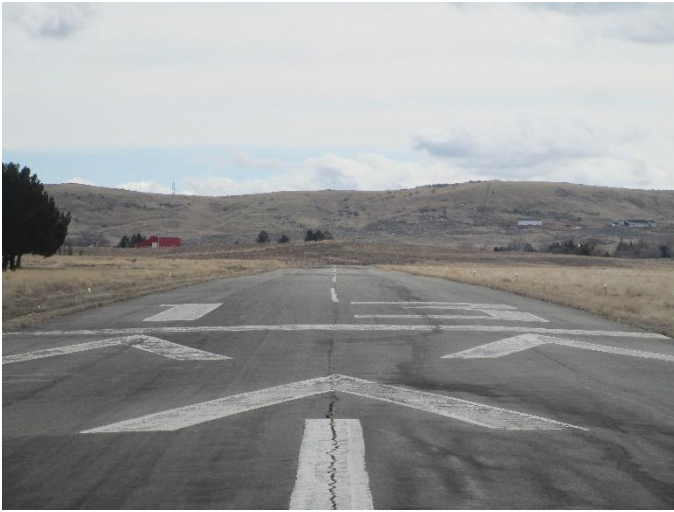
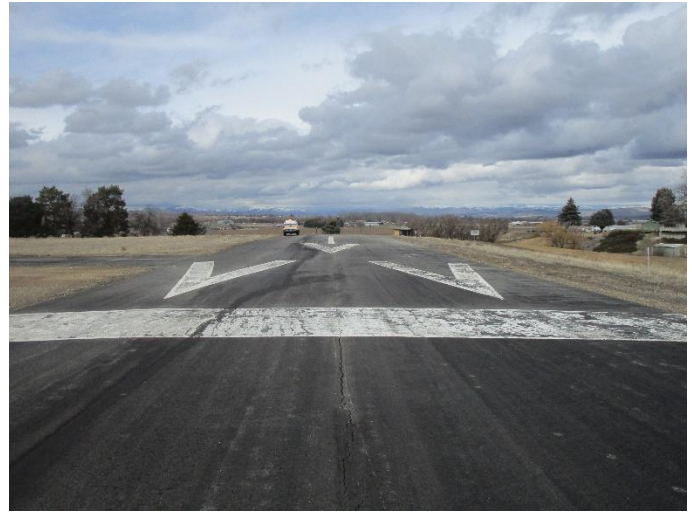
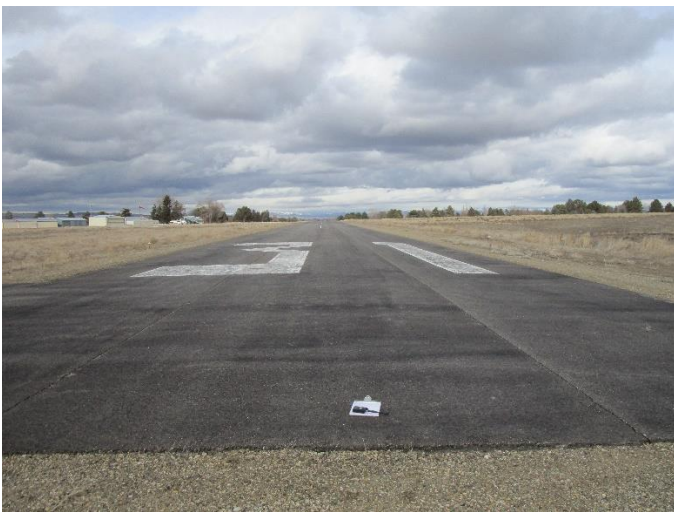
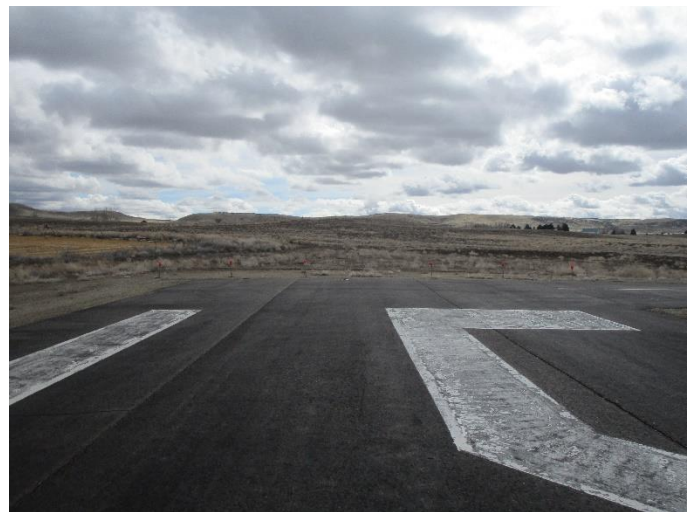
Runway (13-31): At the time of the inspection the runway surface I found to be in good condition. The non-standard centerline, runway numbers and displaced threshold markings, all appeared to be in good condition and were visible from the air; visibility of the airport and its markings was confirmed by two different aircraft passing through the airspace above at the time. Runway lights were all upright and in good working order. Controlling obstructions at both runway ends were unchanged and remained the same.

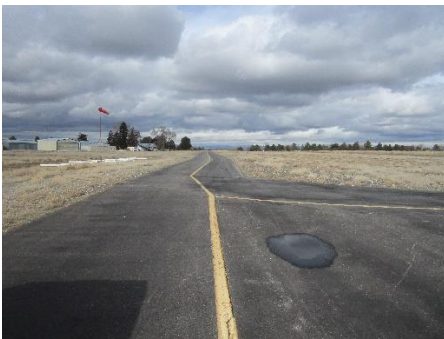
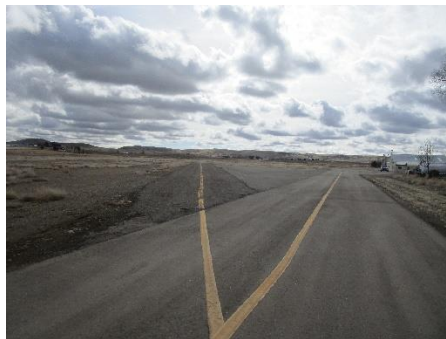
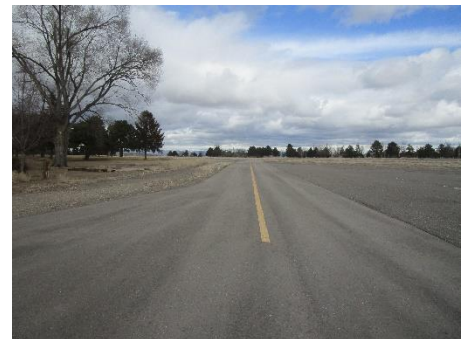
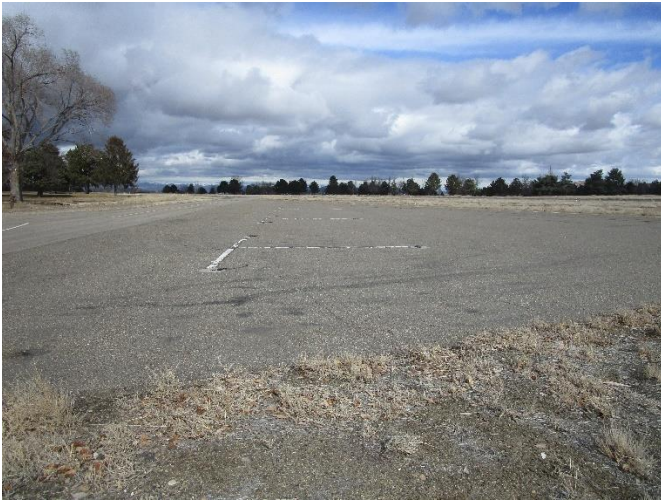
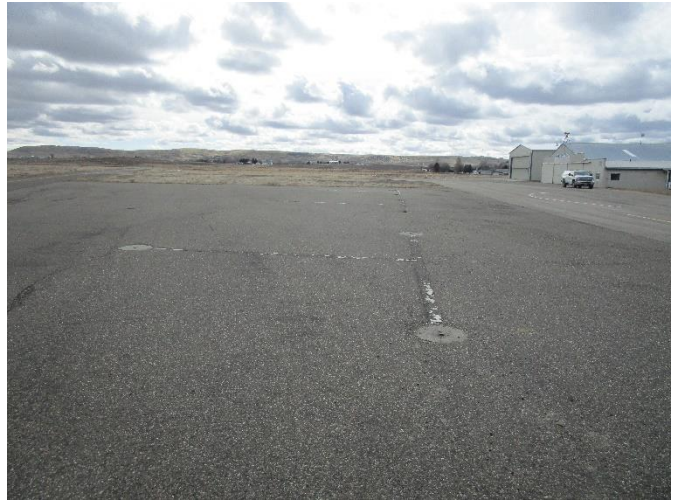
Taxiway/Ramp/Tiedowns The newer section of taxiway remains in excellent condition – with good markings and solid pavement condition. The older, narrower section of taxiway continues to experience edge breakup and has small depressions that are holding water in spots. The ramp tie down area displayed good asphalt surface but had poor markings. Tie down markings are very worn out and have very little paint left – some new paint would improve the looks and visibility of the parking spots. All pads had chains available for use.

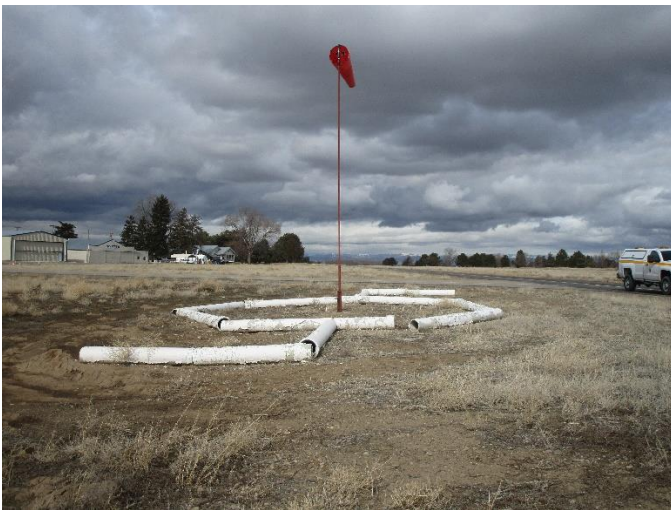
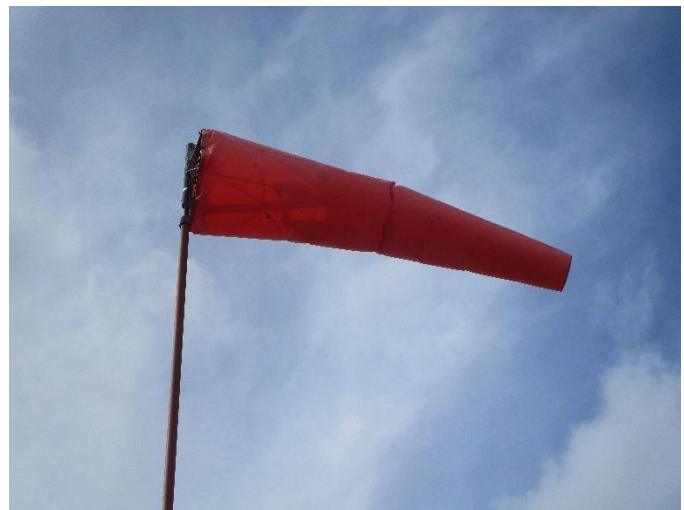
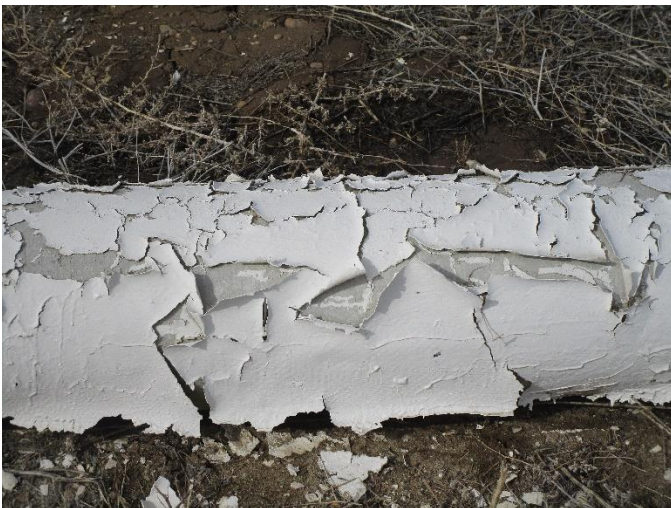
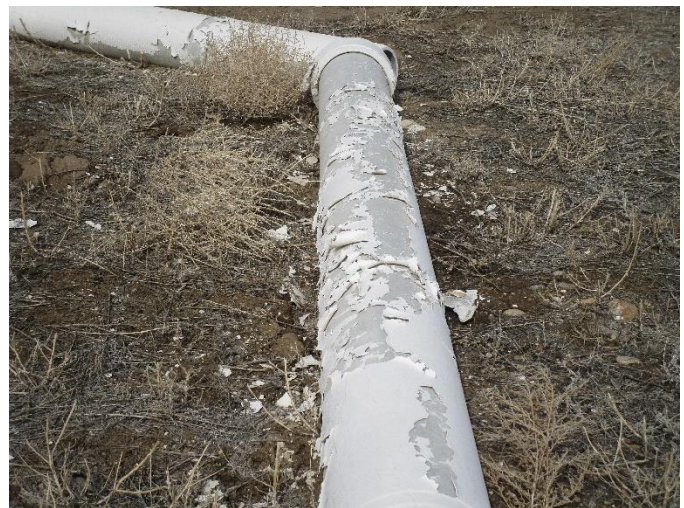
Windsock/Segmented Circle: The windsock displayed good color and material integrity. There were no visible tears or sock discoloration. The metal standard had good orange paint and the pole was sturdy – slightly leaning to the right, as you’re standing on the taxiway and looking west, but nothing significant yet. The segmented circle made up of 12” diameter plastic irrigation pipes, displayed good shape and traffic pattern indication. The paint is in poor condition –badly flaking that could use some TLC - a good scrub/cleaning and fresh paint will give it a better and more adequate indication of the windsock location.

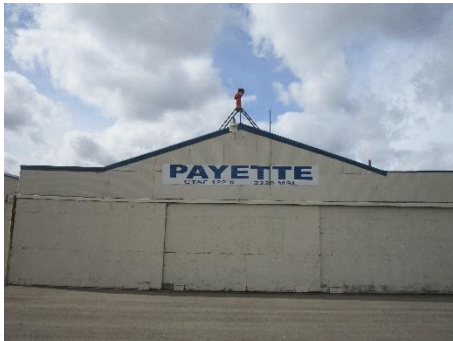
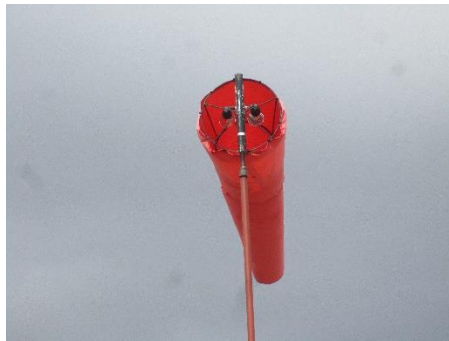
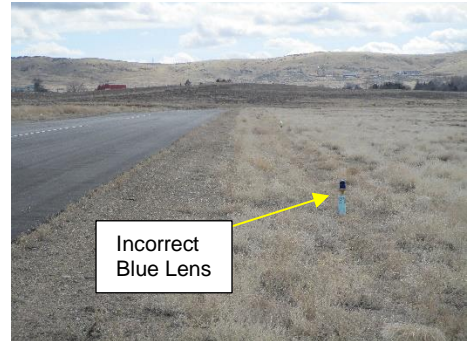
Lighting: During my visit, the runway lights came on when activated on CTAF with my hand-held radio; all of them were in the upright position and working properly. I was unable to verify the working condition of the lights on the windsock pole and the rotating beacon on top of the hangar. One of the runway edge lights- right side of rwy 13, had the wrong color lens on – blue vs clear, and that should be replaced as soon as feasible.

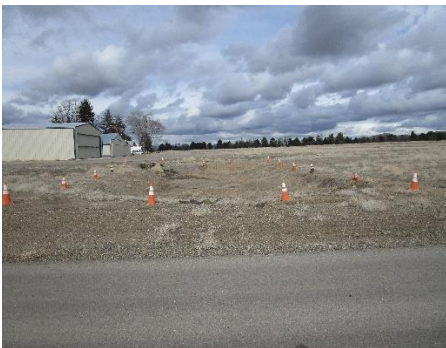
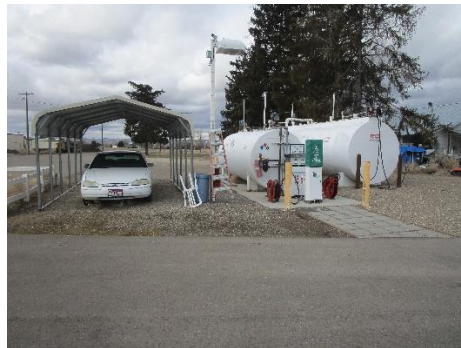
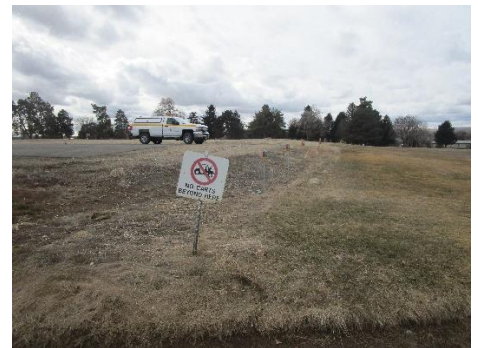
Miscellaneous/Signs/Services: All signs and available services - fuel and courtesy car, appeared to be in good working order. Besides the observations mentioned above, I saw no other safety concerns or issues worth mentioning. Please feel free to call me anytime, should you have any questions, regarding the airfield. Have a great day!
