## IDAHO TRANSPORTATION DEPARTMENT

Subject: 2023 5010-1 Airport Inspection conducted July 6, 2023.  
(04285.7\*A Pine Pine Airport)

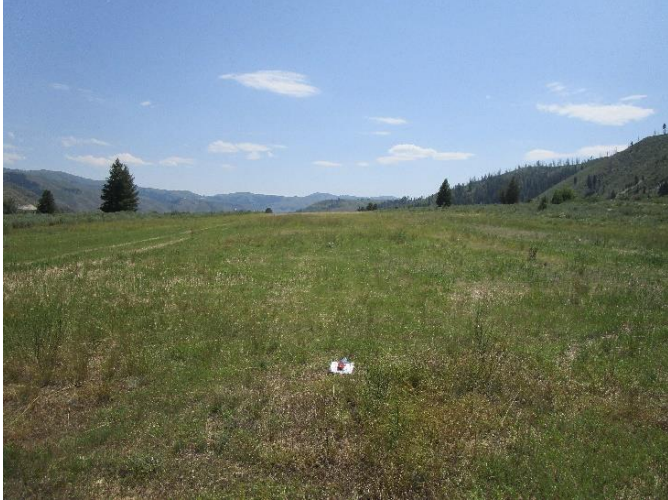
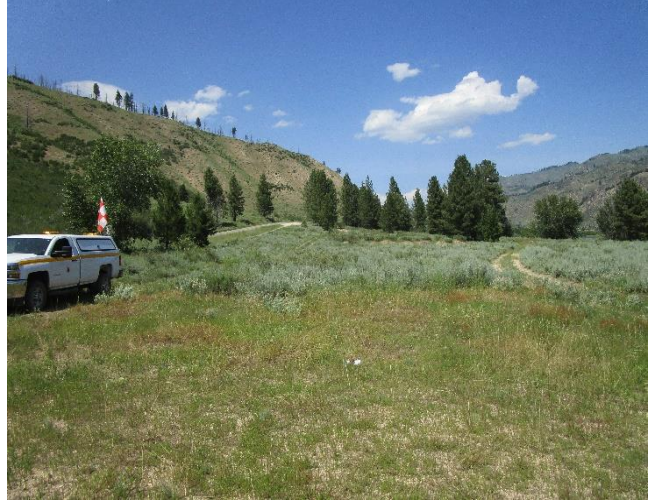
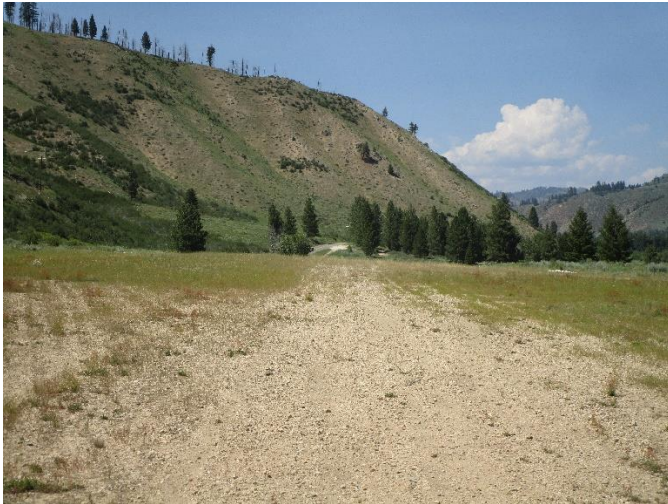
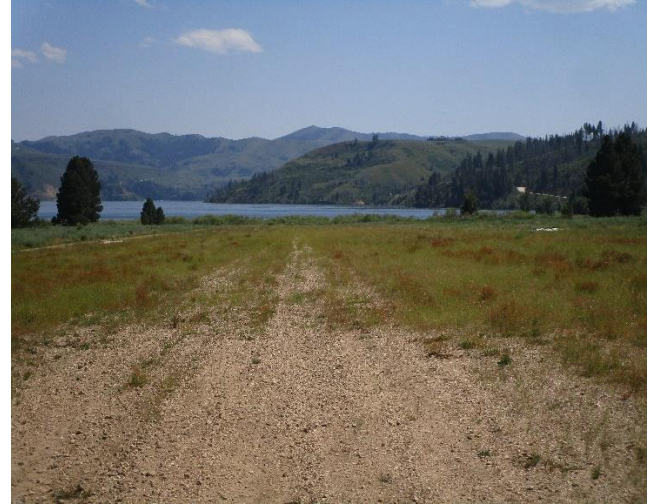
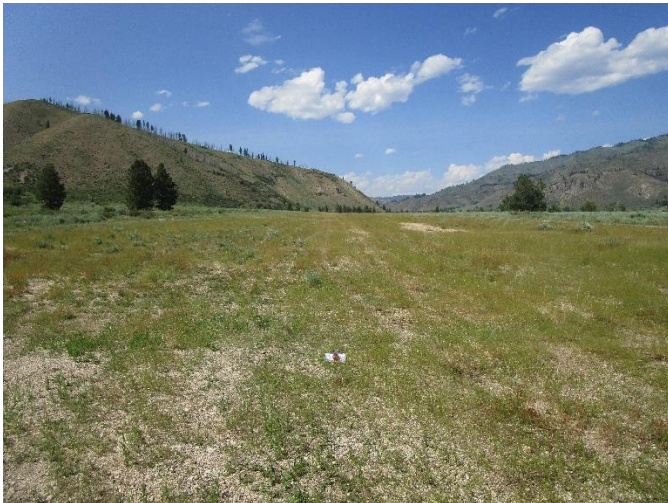
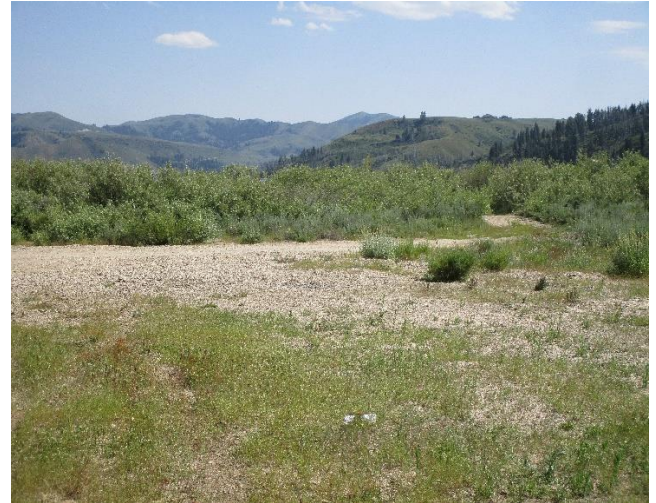
### Runway 16-34:

My review of the 5010 Airport Master Record and the physical inspection revealed that the airport is in decent condition with no significant maintenance discrepancies. The rwy. was in fairly good shape, with a very few signs of water damage on the south end of the rwy. The normal small ruts you typically see caused by spring water run-off were not there this year. I saw no changes to the approaches at Rwy. 16. However, the tree that was the controlling obstruction at Rwy. 34 is now gone and the new controlling obstruction is now a 12' road at 80 ft. on center line.

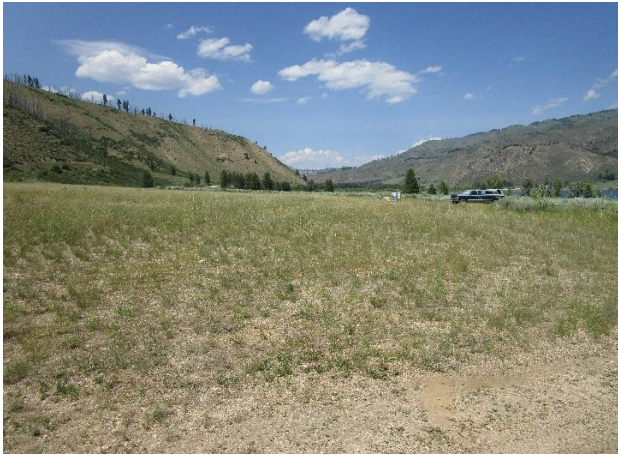
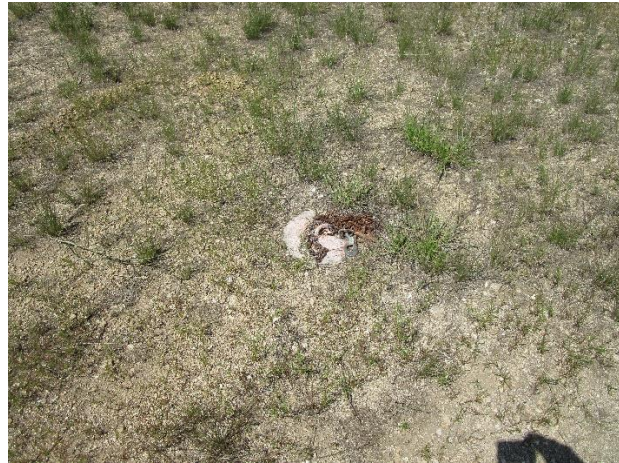
**Tie downs:**

The tie-down parking area was in fair condition due to its roughness caused by the large area of clump/bunch grass. There was enough room to park 4-6 small aircraft, but I only saw two sets of tie-down chains present.

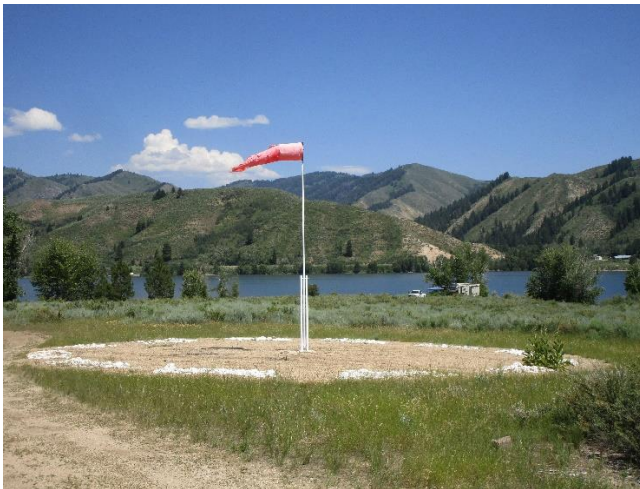
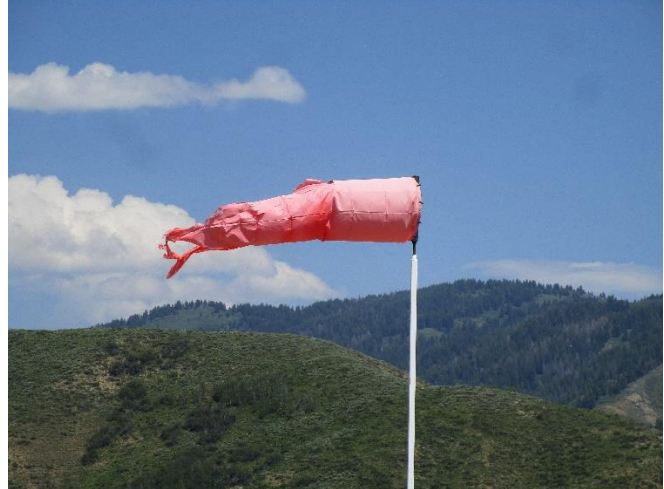
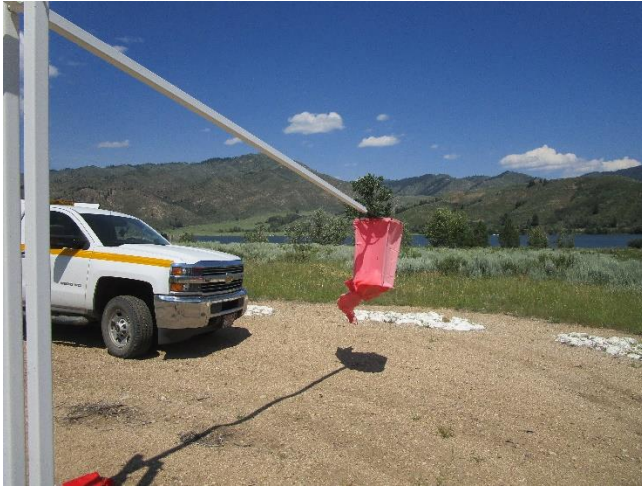
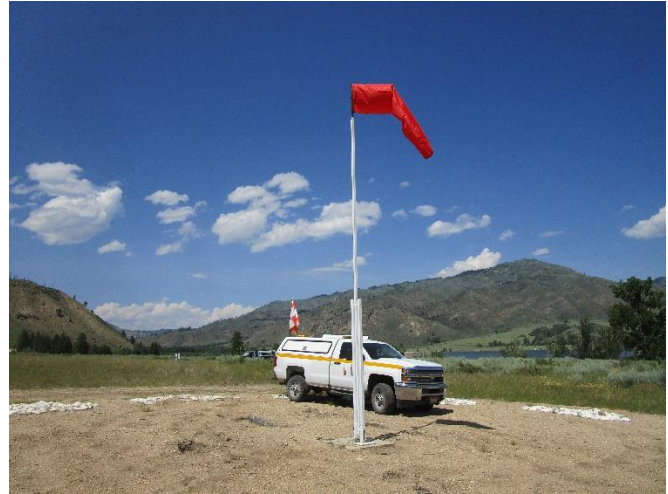
**Windsock/Segmented Circle:**

When I got to the airport the windsock was in poor condition. Due to a long winter and strong winds, half of the windsock was torn away – it was ripped to shreds and the bottom half of it, was completely gone; I replaced the old sock with a new one. The metal standard was in good condition and displayed good white color. The segmented circle was also in good condition and was almost entirely clear of any vegetation. There was one larger bush growing inside the segmented circle and to the south of the standard.

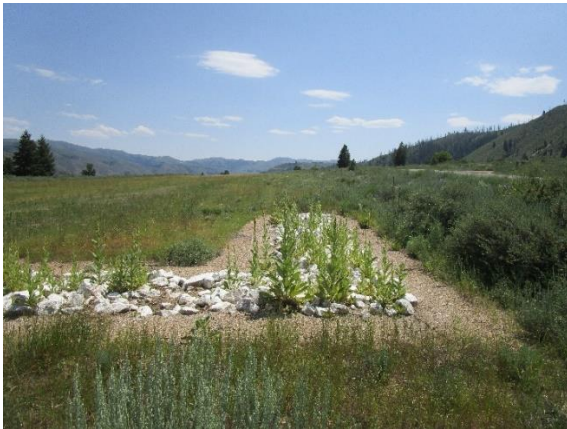
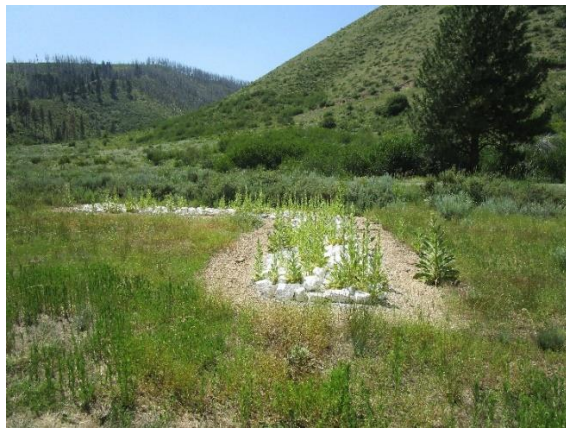
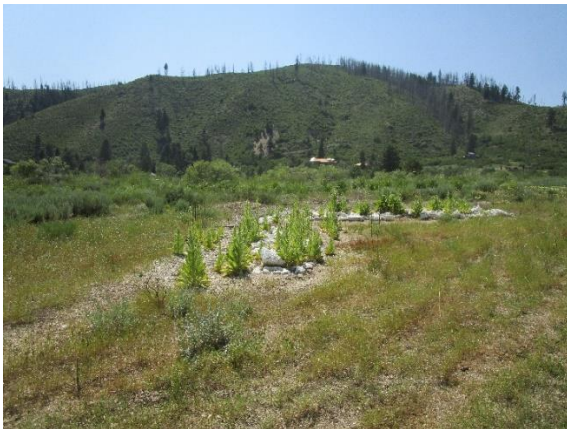
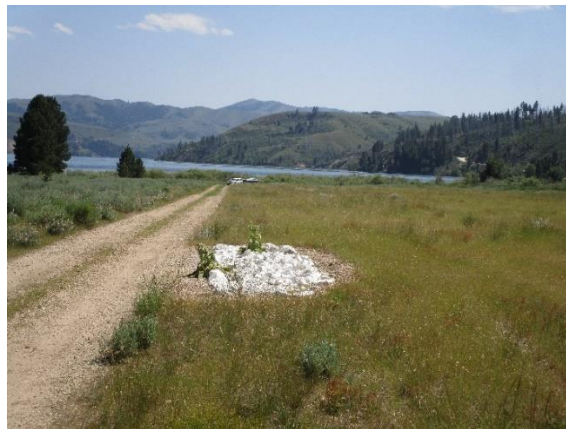
### **Boundary Markers (BMs):**

Boundary markers made of rocks were all together and displayed good paint, however, some of them had a decent amount of vegetation growing through the rocks and around them - both ends of the rwy. had particularly more vegetation growth than the side BMs. Regardless of the vegetation, the runway was still visible from the air.

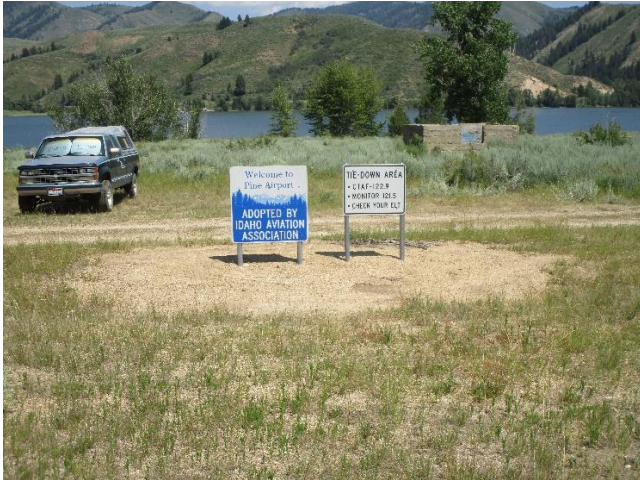
**Misc./Services:**

All signs were in good shape – all visible/none broken. Overall, I found the airport to be in fair condition. No other safety concerns or issues were observed at the time of the inspection. If you have any questions or concerns, please reach out or call my office.
