## IDAHO TRANSPORTATION DEPARTMENT

SUBJECT: 2023 5010-1 Airport Inspection conducted June 29, 2023.  
(04294.01A Porthill, ID Eckhart International Airport)

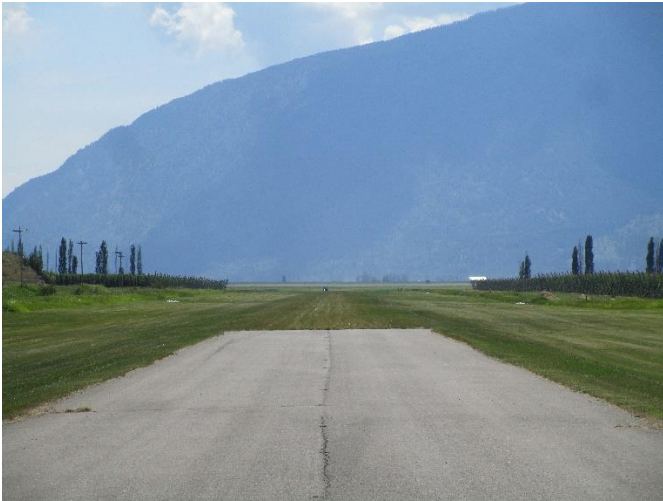
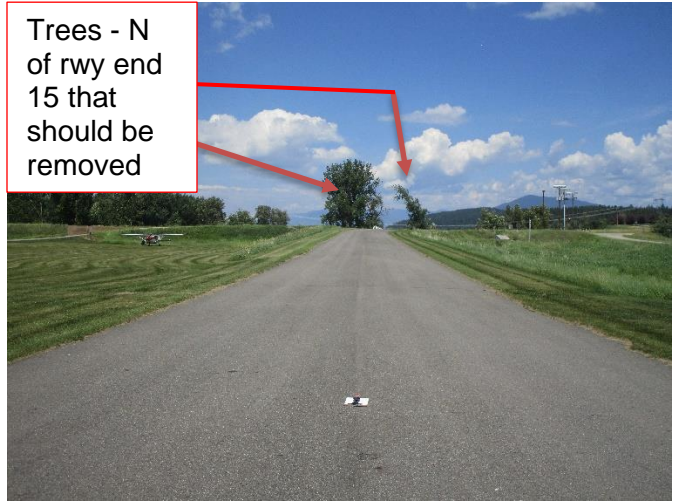
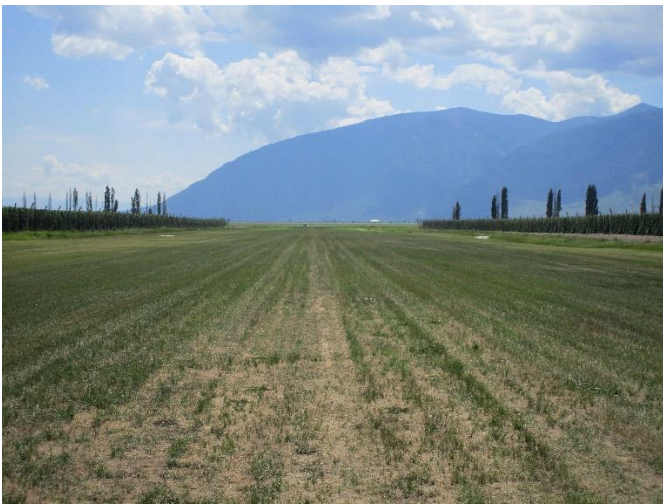
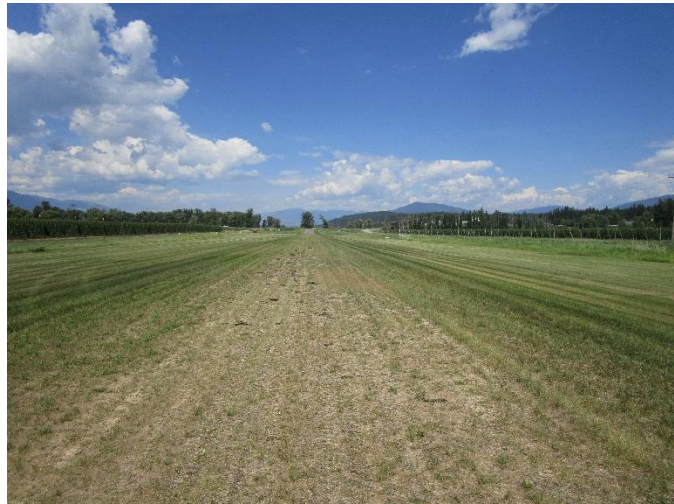
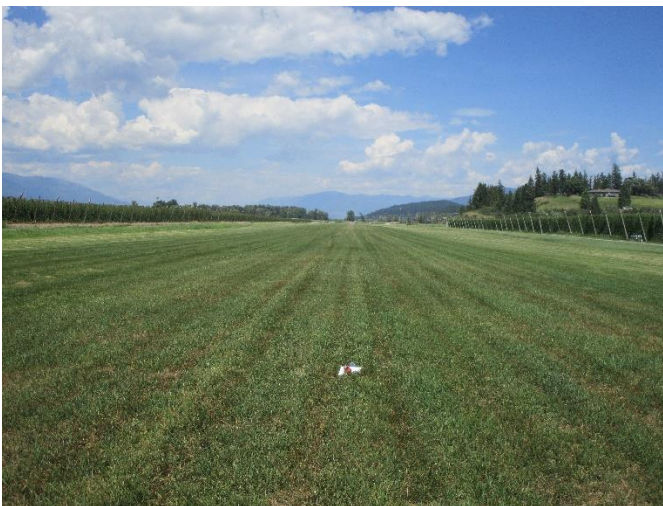
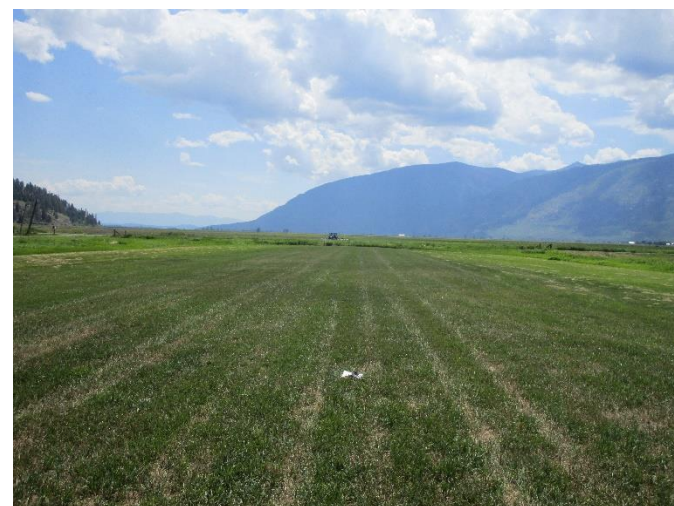
At the time of the inspection, I found the turf runway 15/33 to be in good condition. The grass appeared to be well cared for and freshly mowed – it was mowed just a couple of days before I got there. The turf appears to be good and thick and looks healthy all throughout the entire length of the runway. The one thing I would like to mention again, is the 75 ft cottonwood tree that is dead smack in the middle of the final approach to Rwy. 15. Currently the tree is 670' away from the edge of the rwy. and it measures roughly 75' tall. When we landed, we had to come in from the North as the winds called for that approach and we got mighty close to that cottonwood tree. Anything and everything you can do to have it cut down would be a major safety improvement for all users of this airfield. As it stands now, that tree is penetrating the 20:1 slope by 40+ ft. and you know the saying "it is not a problem until it becomes one". So, I think it would be in everybody's best interest to have the two trees to the North of the rwy. (see pic with red markings below) completely removed.

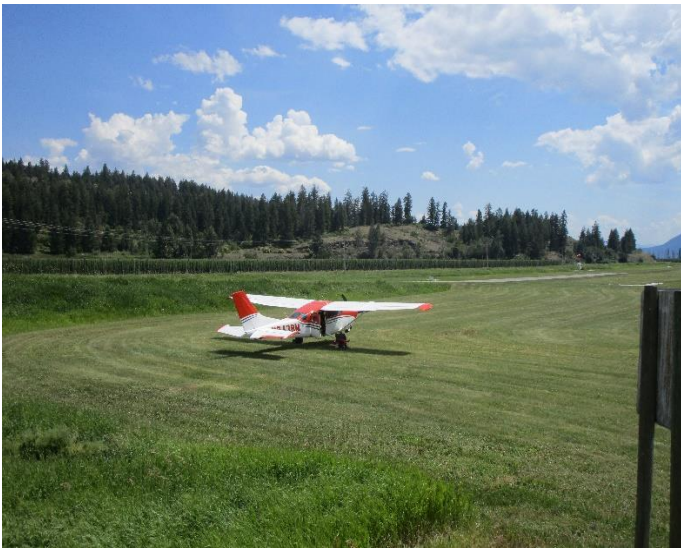
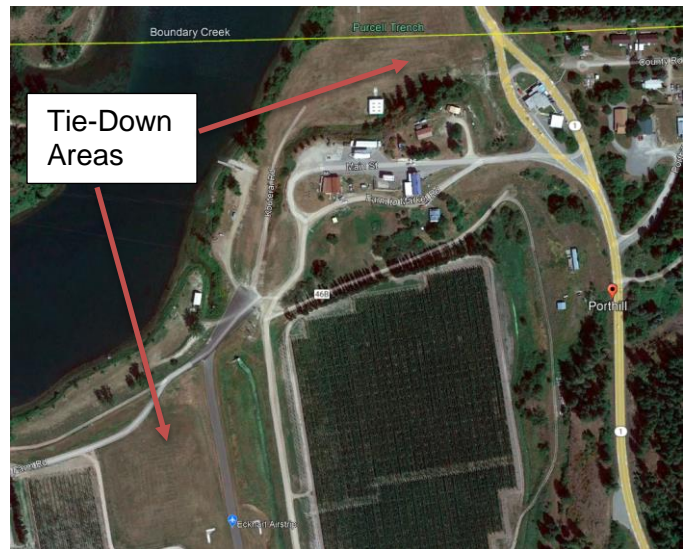
All tie-down spots are painted and easily identifiable. Of the 6 lower parking spots I counted, 6 had tie-down chains present. The upper two spots up by US Customs looked good and they had chains as well.

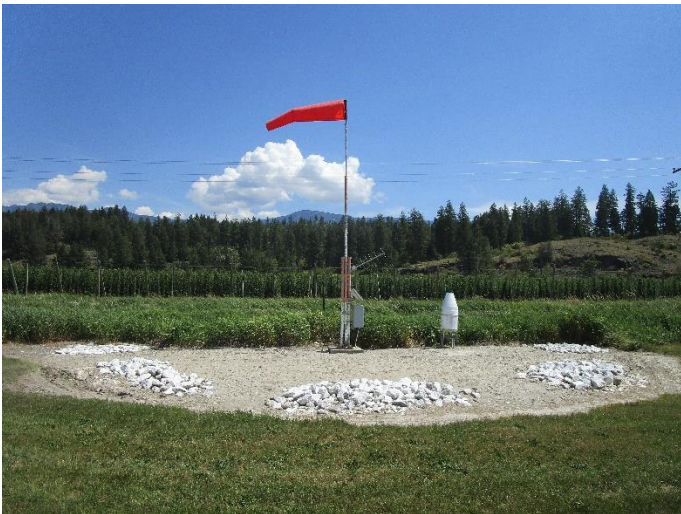
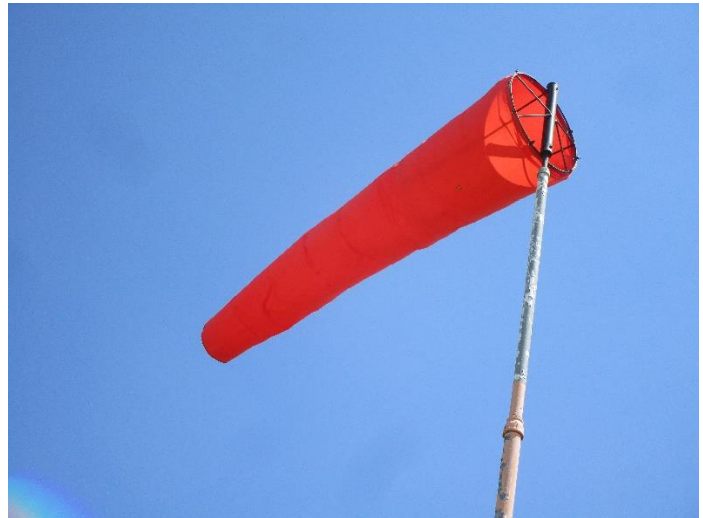
The only windsock located on the east side of the airfield and closer to rwy. end 15, appeared to be in good condition and displayed good orange color - no fading. The sock was properly installed and showed no rips or tears. Both the standard and the half-segmented circle were all in good condition. All of them were easily recognizable, had decent paint, and visible from the air.

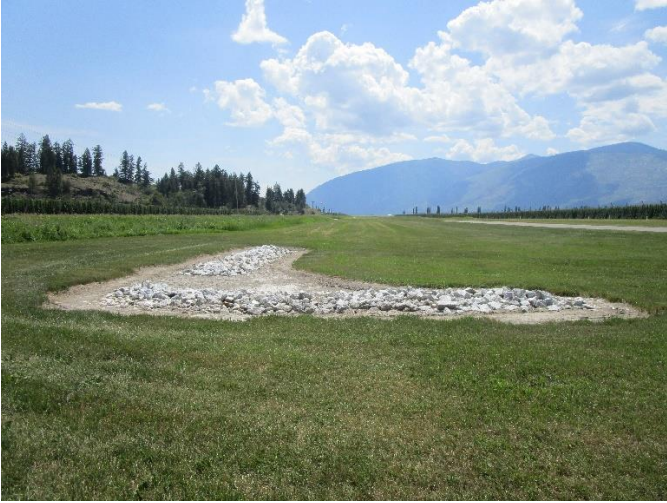
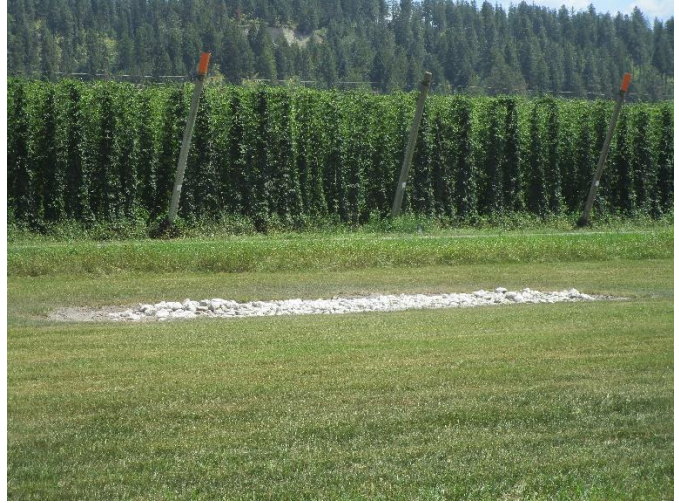
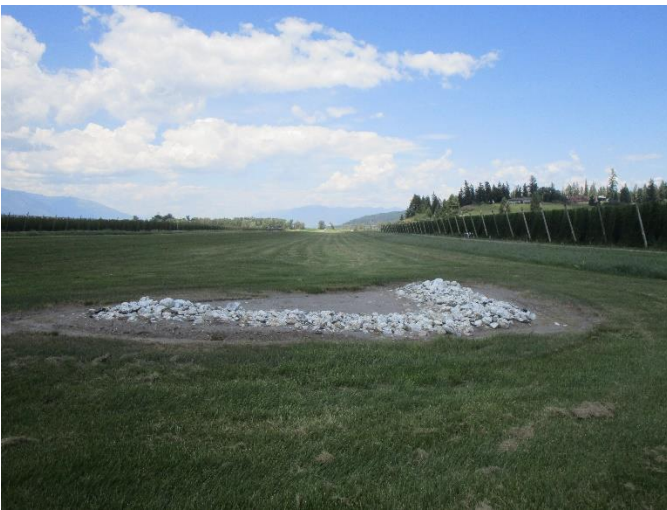
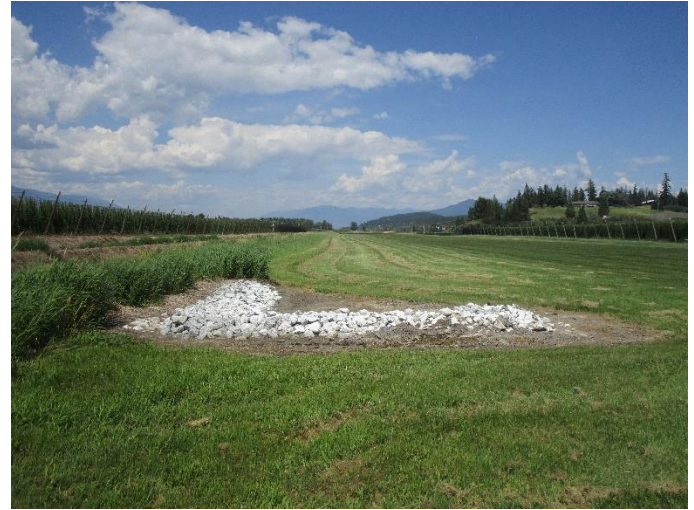
The painted rock boundary markers were in good physical condition. They were well put together and cared for. Overall, they had good vegetation control all around them. They had a good amount of paint coverage for the time being, however, I think that, in the next year or so, a new coat of white paint will do good and sharpen the visibility from the air.

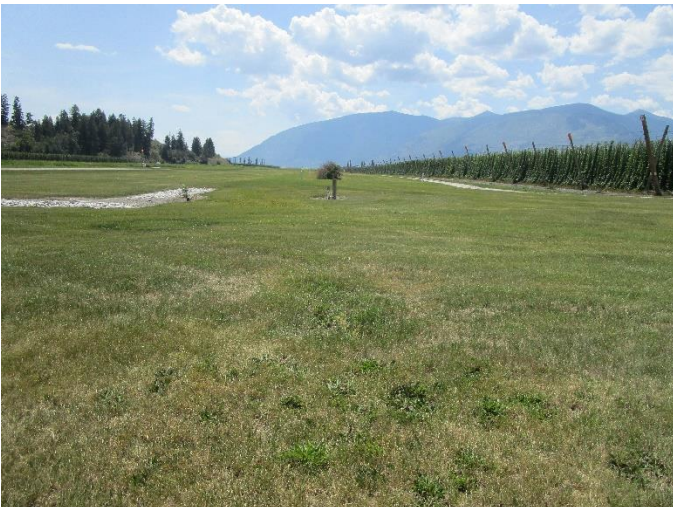
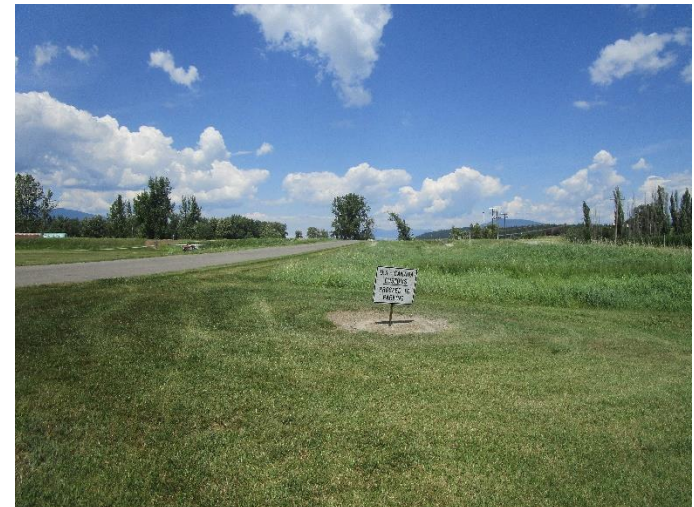
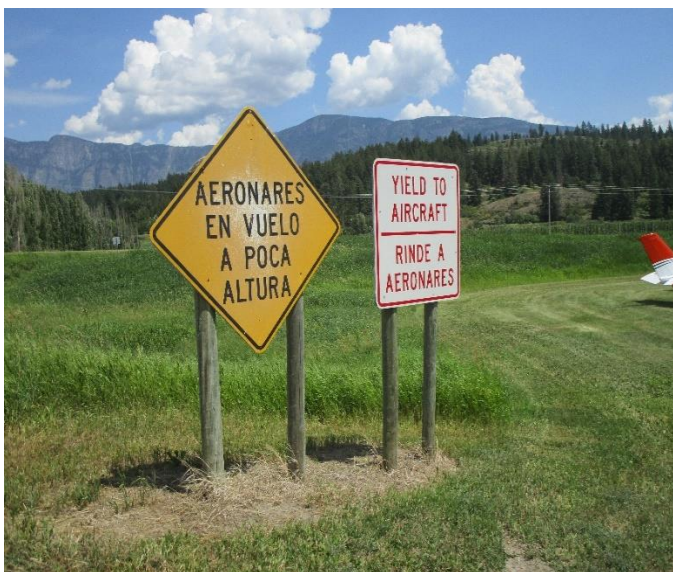
I am glad to see that the old sink hole that happened 3 yrs. ago, over by the lower tie-down parking area, has been taken care of. No other safety concerns or issues were observed at the time of the inspection.
