October 25, 2022

Subject: 2022 5010-1 Airport Inspection conducted August 15, 2022. (04326.\*A Sandpoint Sandpoint Airport)

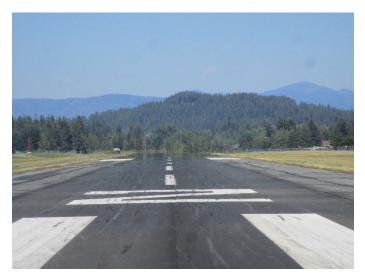
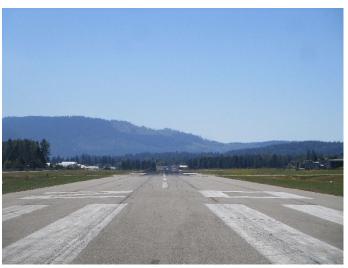
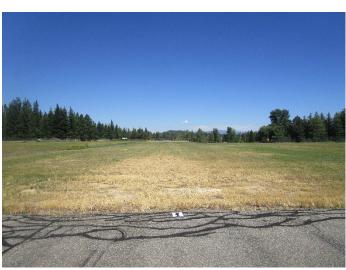
**Runway:** The runway surface continues to be in good condition overall. There are many visible cracks throughout the entire length of the runway, some that were treated already, and some new extensions of the existing ones. The center portion of the rwy pavement looks really good. The outside edges (approx.. 20') from each edge appears to be older asphalt and that is where most of the cracks are visible. The actual rwy edge lips were decent and I saw no crumbling of the edges. The markings on the runway are in good condition as well. The threshold lines, numbers, and centerline markings are good and visible from the air. Runway threshold and edge lights were all in good shape, none broken. Vegetation on the edges of the runway shoulders was good and well maintained. The approaches on both ends of the runway remain unchanged and you indicated you already knew and were working on the issues with the trees to the North of Rwy end 20.

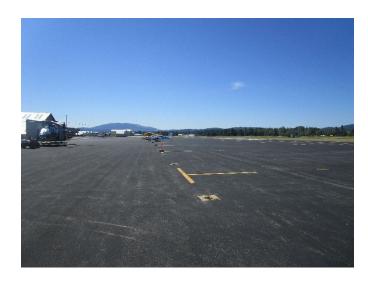
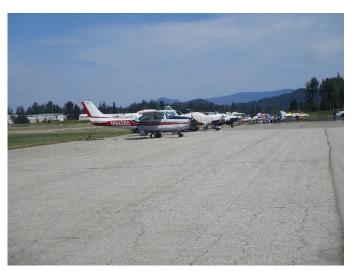
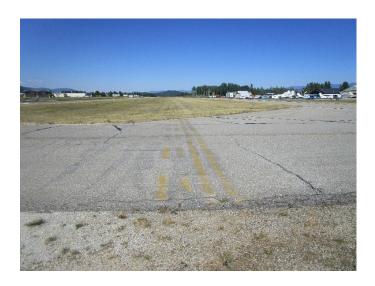
<u>Taxiway/Ramp/Tiedowns:</u> The surface of the ramp area appeared to be new and well marked. The surfaces between the hangars and the taxiway, which had both - newer and older asphalt, all seemed to be in good condition and with visible markings. I noticed some of the hold short markings at rwy end 2 and the taxiway centerlines were faded and could use some TLC. There was plenty of parking space on the ramp and all the aircraft parked there were secured with either chains or ropes.

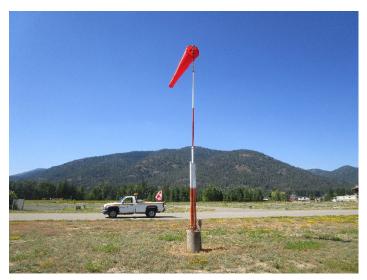
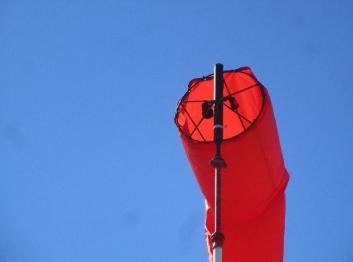
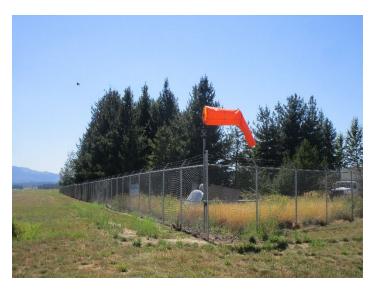
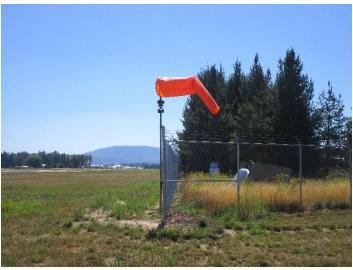
Windsocks/Standard/Segmented Circle: The existing 2 windsocks appeared to be new, in good condition, and working order. The only problem with the main windsock was, that it was installed wrong and the water drain hole was on top of the frame vs the bottom where it should be to allow for proper water drainage. If left unchanged, this will lessen the life of the sock, especially if you have lots of rainy weather in the fall and spring. The accumulation of water in the bottom portion of the sock will belly out like a fat guppy fish, and over time, it will stretch and rip sooner than otherwise. The non-standard segmented circle, that used to be there - made up of white, large cement blocks, was no longer present. The area was clean of vegetation, well maintained, and the cement blocks removed. The main windsock standard appears to be in good mechanical order and with good coat of white and orange paint. The other one close to rwy end 20, sitting on the corner of the chain link fence is good condition, but the metal standard was just a galvanized pipe with no paint.

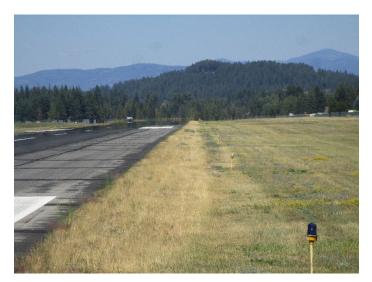
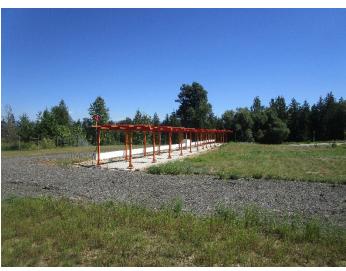
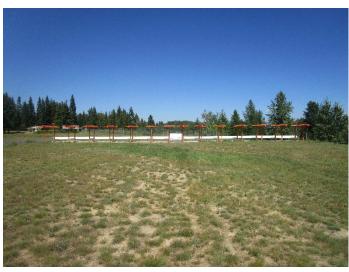
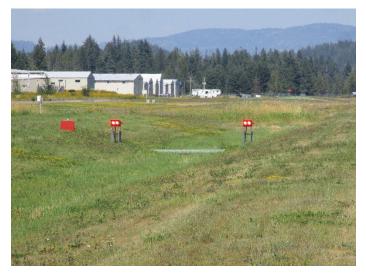
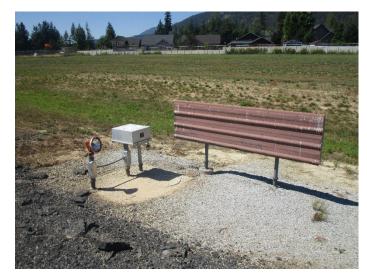
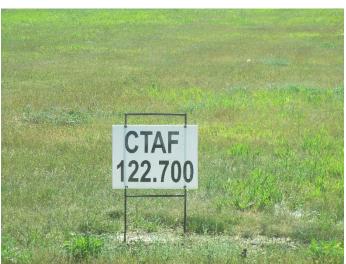
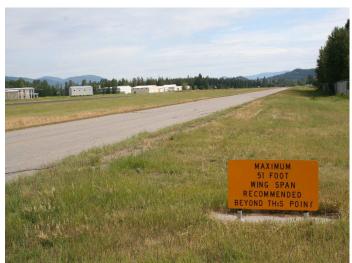
<u>Signs & Lighting:</u> All the lights and signs were in good working order and in the upright position at this airfield – runway threshold, runway edge, taxiways, REILs, and PAPI - all were in good condition. None of the structures were broken and had good vegetation control around all light fixtures and signs.

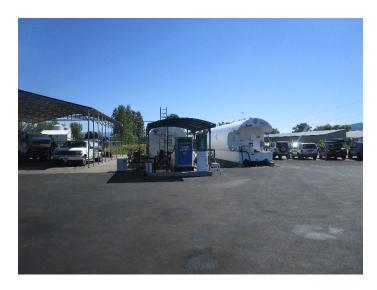
Your airport had good vegetation control overall. The fuel farm and the AWOS antenna and subsystems were all in good shape and the grounds well maintained. Please feel free to call me anytime should you have any questions or need any airport supplies. Thx and have a great day!
