## IDAHO TRANSPORTATION DEPARTMENT

SUBJECT: 2023 5010-1 Airport Inspections conducted August 15, 2023.  
(04329.\*A Shearer USFS Shearer, ID)

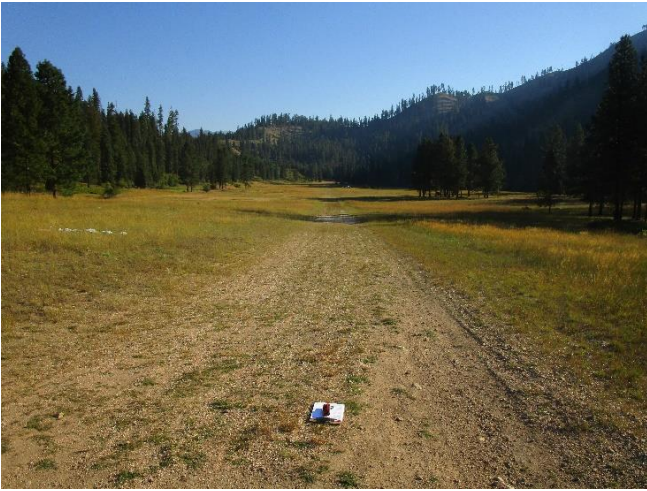
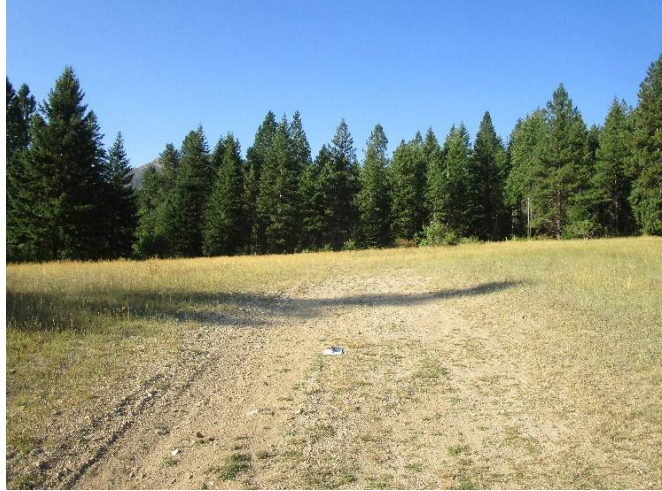
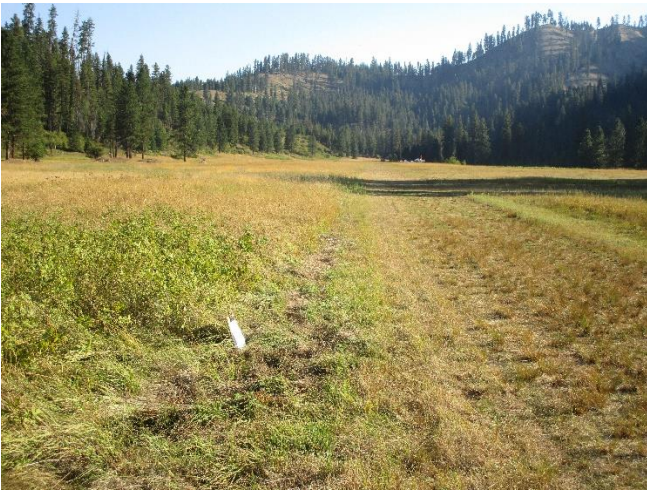
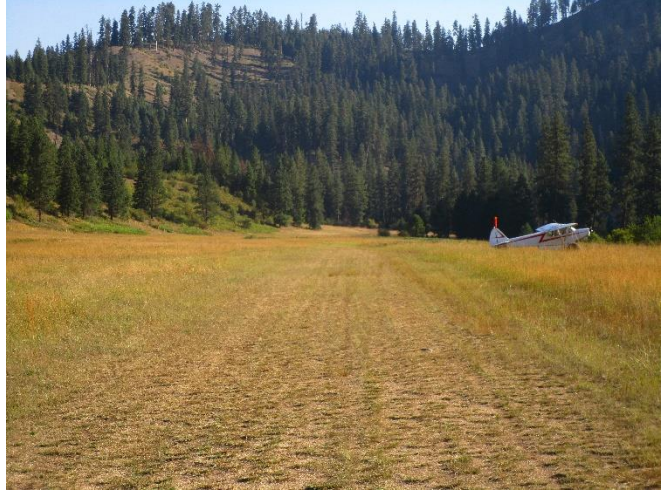
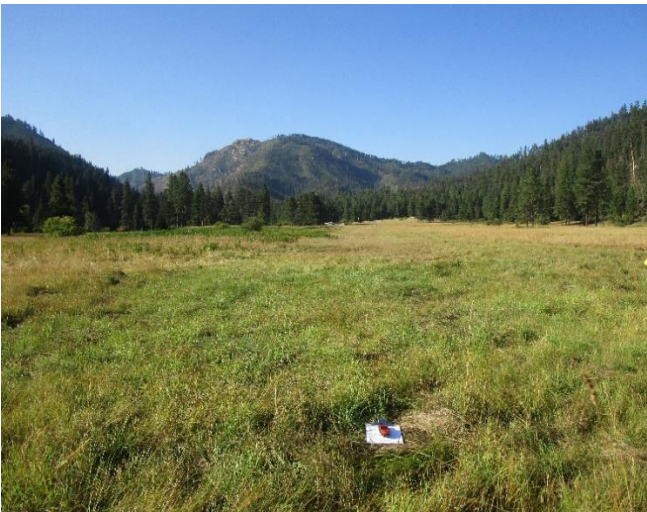
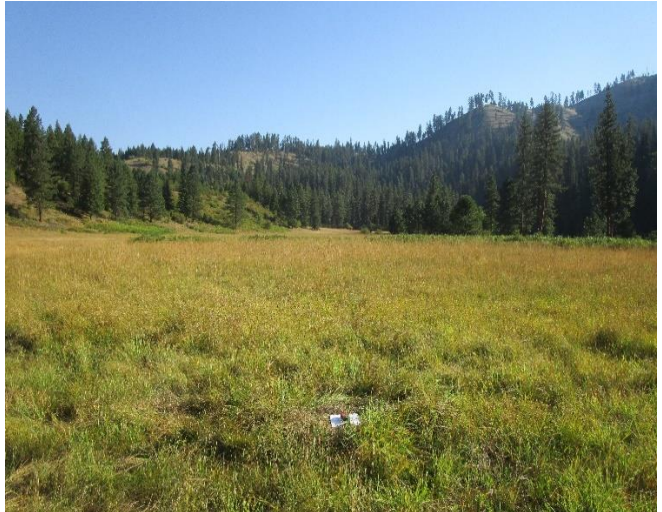
### **Runway 18-36:**

The turf runway surface continues to be in fair condition, displaying a thicker layer of grass in the first 300'+ of runway end 18. The rest of the runway had a mowed centerline of at least 15'-18' in width, with the upper end (rwy. end 36) showing a few loose rocks and a slight depression in the first 50-60'. There are a few undulations in the surface and lateral rodent activity near the midfield. There were no changes to the rwy. alignment or the approaches at this airport; both remain present with the same terrain topography/hazards from three years ago and remain relatively unchanged.

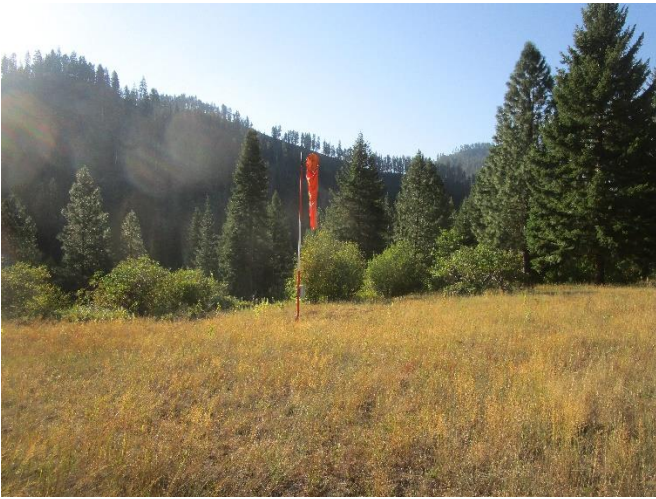
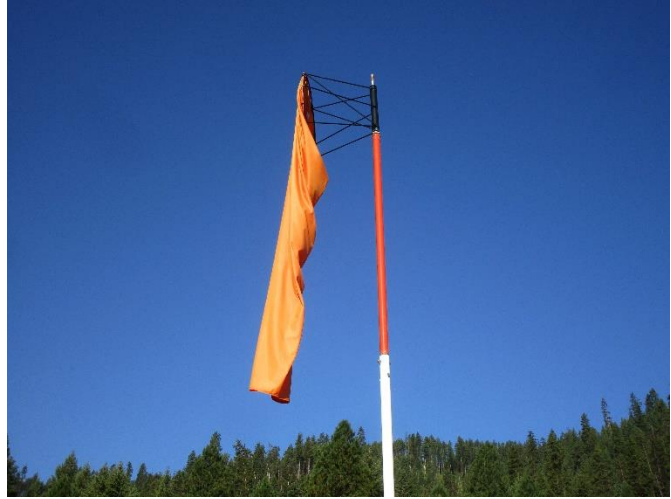
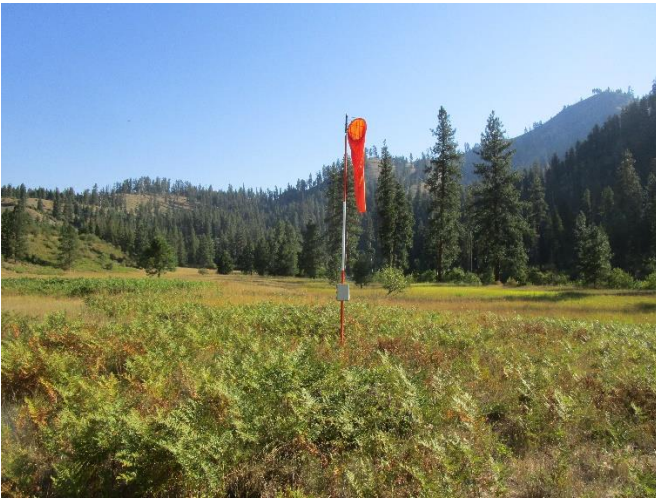
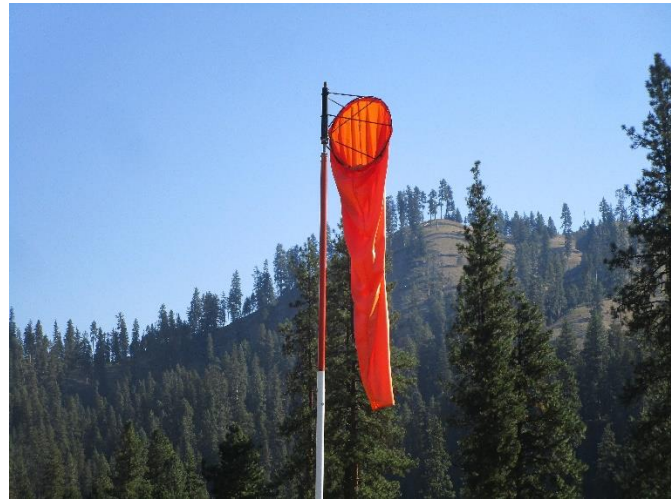
**Windsock/Segmented Circle:**

Both windsocks were in good condition and displayed no rips or tears. The metal standards looked brand new and were in good working order; they both had good white/orange paint coverage. Neither windsock had a segmented circle visible or present at this facility and there was a good amount of grass and fern type vegetation growing all around the metal standards.

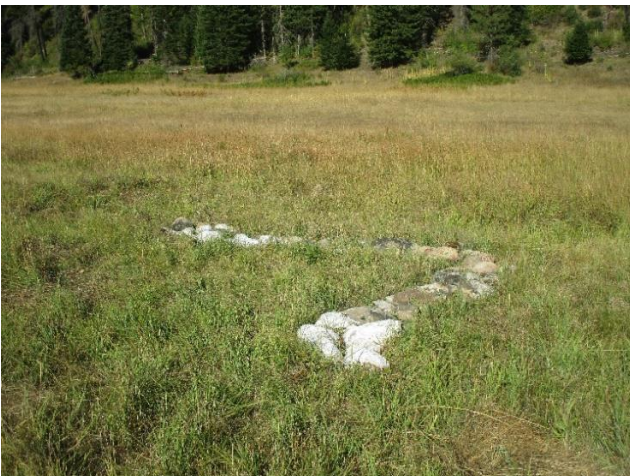
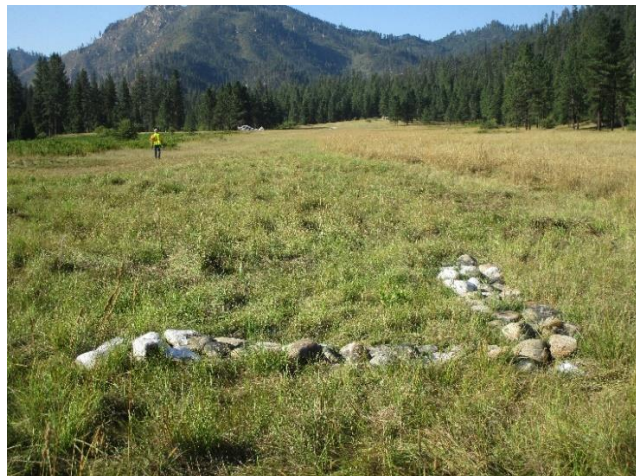
**Boundary Markers (BMs):** The non-standard and barely painted rock boundary markers are somewhat conspicuous from the air, however, a little more, white paint, would make them that much more visible. The culvert close to the end of rwy 36 is well marked and clear of the rwy.

1. Add more rocks to make the structure larger and paint the BMs at rwy end 18, white for better visibility.

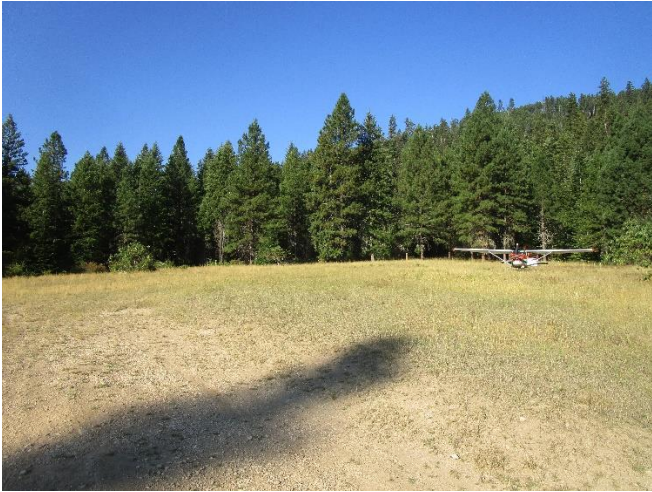
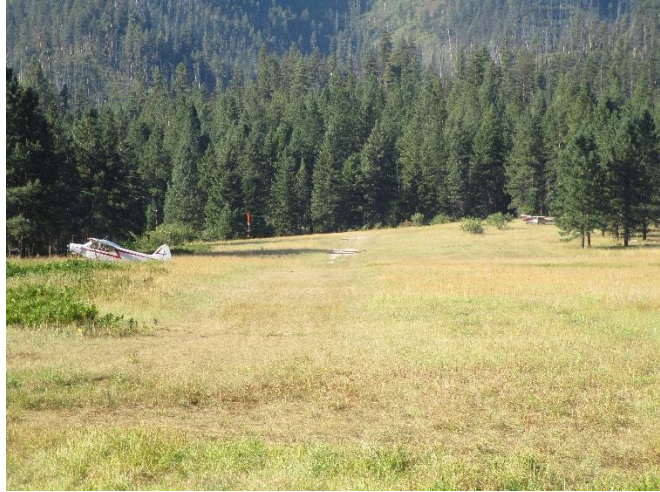
**Tiedowns:**

The tie down area located at the upper end of the airfield (rwy end 36) and to the right of the turnaround area, was not marked and had a rough surface due to uneven terrain and being covered in bunch grass. Several rocks that were present in the area were removed by hand and thrown to the side for better and safer access to parking. One other airplane was present on the airfield; the aircraft was parked in an unsafe fashion and made me think that maybe some signs to indicate where the parking area is might be helpful in the future.

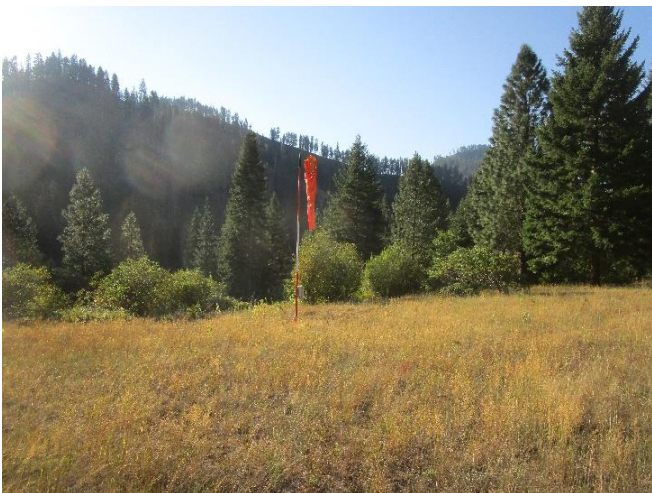
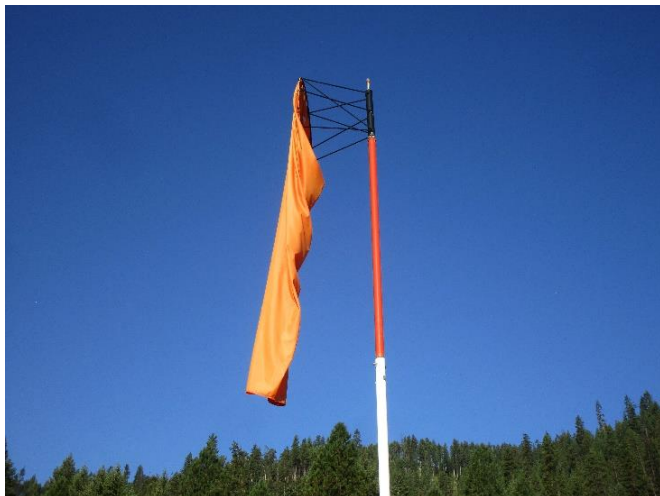
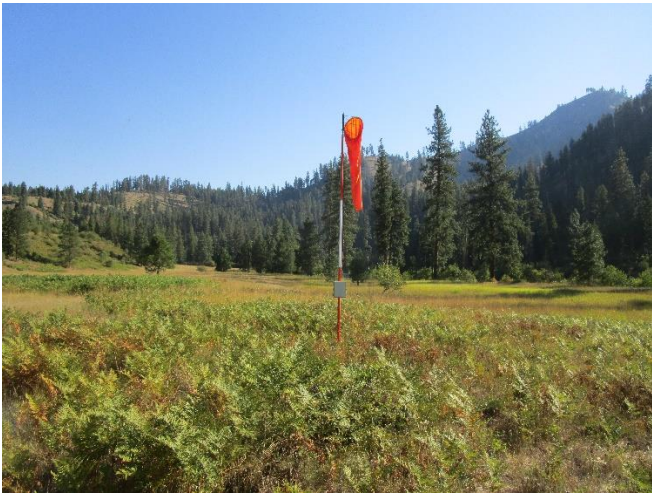
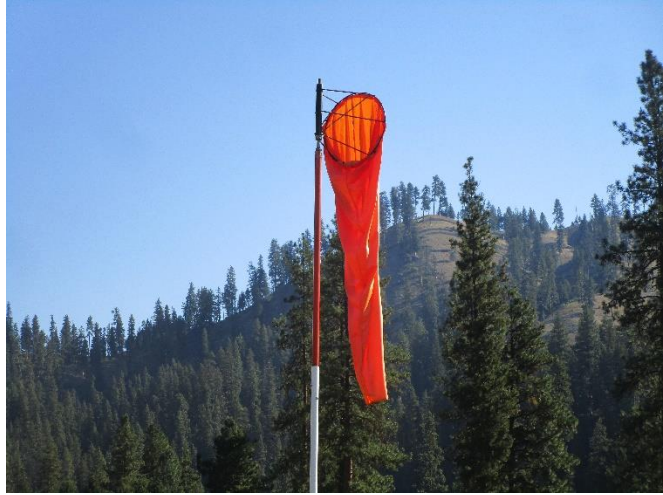
**Windsock/Standard/Segmented Circle:**

Both windsocks at this airfield were in good condition, had good color and displayed no rips or tears. The metal standards were in good mechanical order, looked brand new, appeared sturdy, and had excellent paint coverage. Neither windsock had a segmented circle present at this facility.

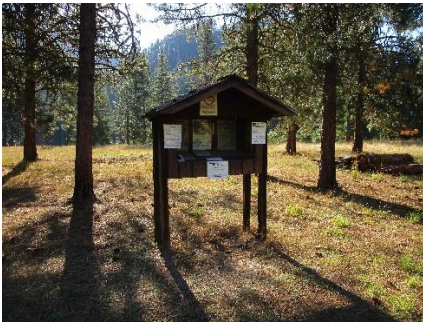
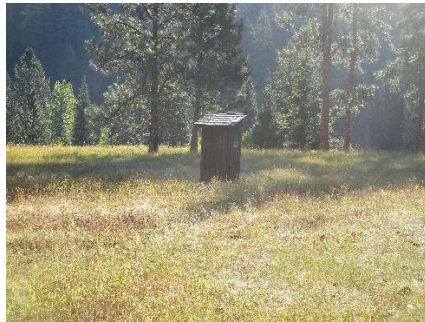
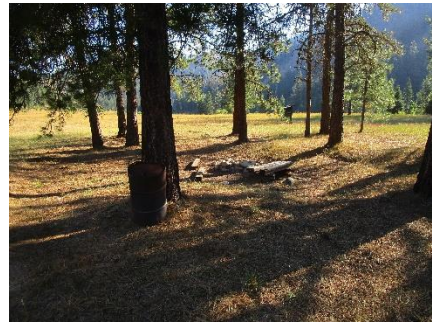
**Miscellaneous/Services:**

The info sign, outhouse, and the campground area at midfield were all in good order and available for use. I saw no other significant changes or safety concerns with this airfield. If you have any questions, please feel free to call anytime at 208-334-8895. Have a great day.
