Subject: 2023 5010-1 5010-1 Airport Inspection conducted July 6, 2023.  
(04295.A Smith Prairie Airport Prairie)

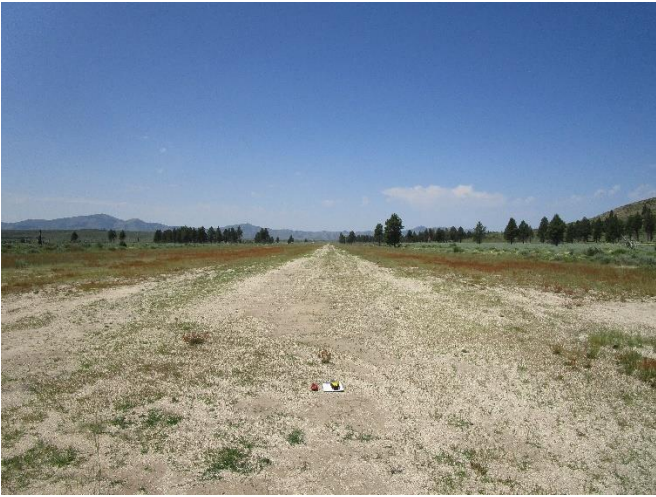
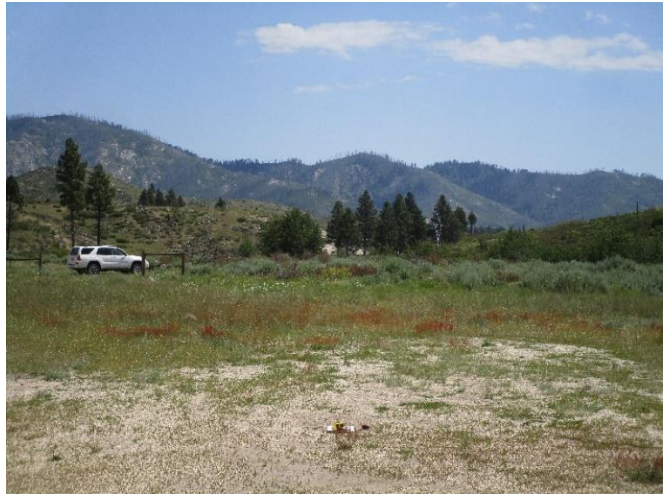
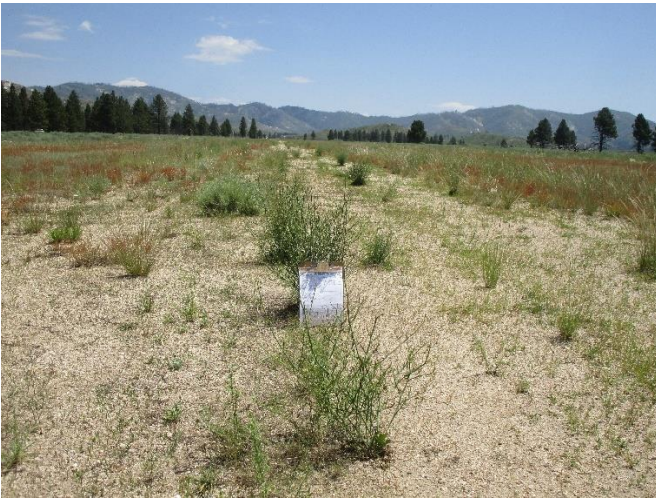
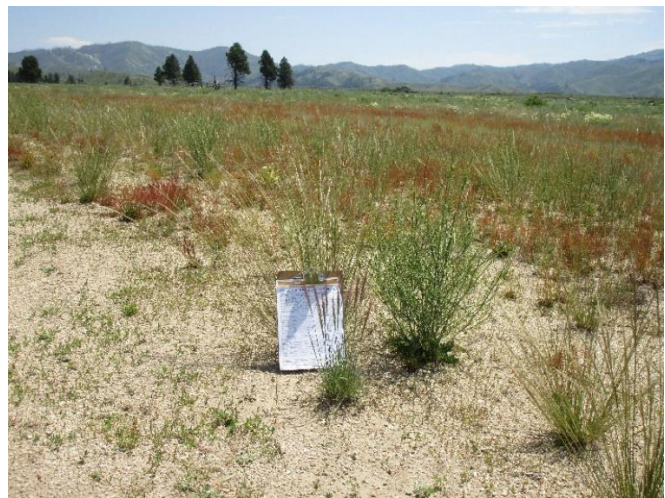
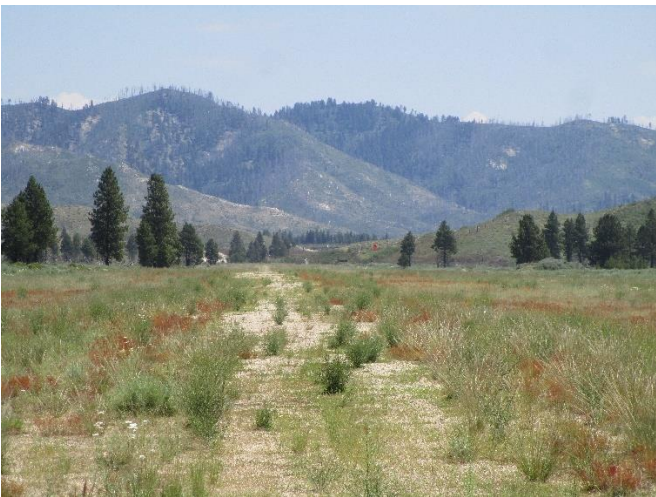
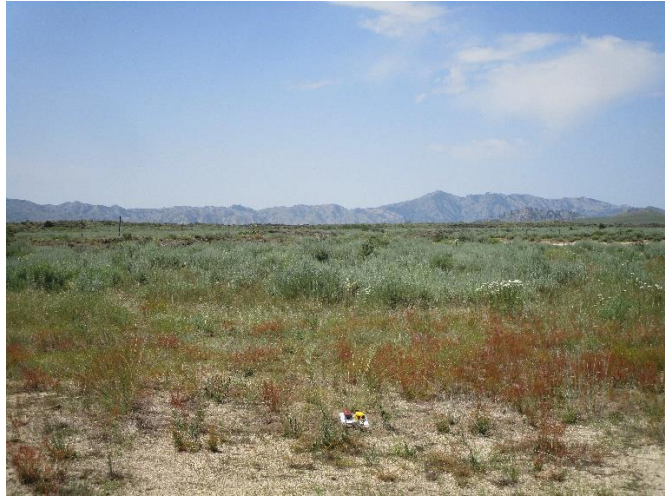
**Rwy 6-24:** At the time of the inspection the usable portion of the runway surface (center 25') was in good condition, meaning the surface was smooth and without any major undulations, but it did have some vegetation growth that was noticeable (vegetation growth was heavier towards the runway ends – see pics below). Outside that center 25 ft portion, the grass was pretty tall – up to 24" tall in places and needs to be mowed. Left undealt with, the vegetation/plants will mature, and the stock will develop into a hard structure that even if mowed, will leave the stocks behind that will contribute to a very rough rwy. surface. There were no changes to the approaches at this airport; both remain relatively clear and unchanged.

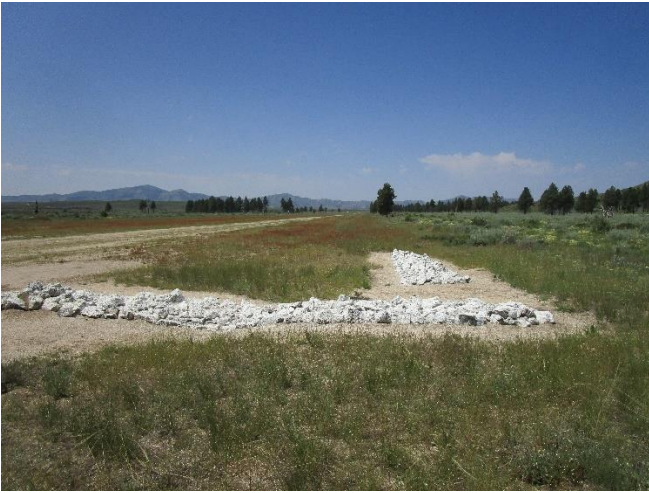
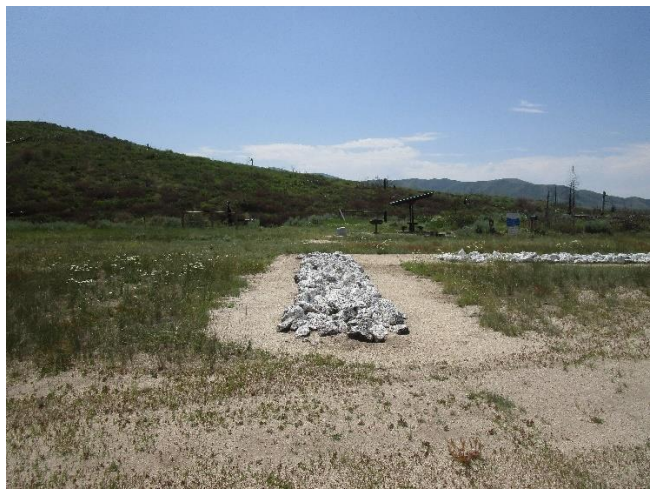
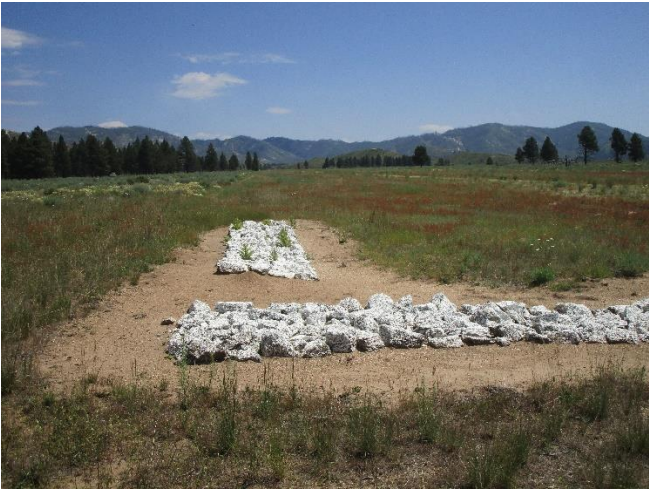
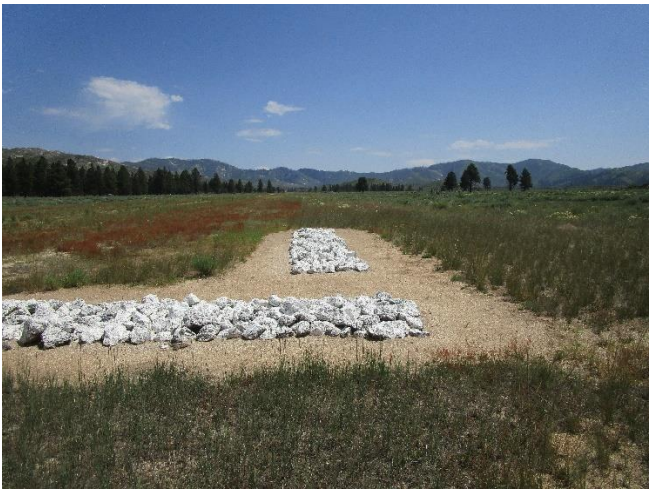
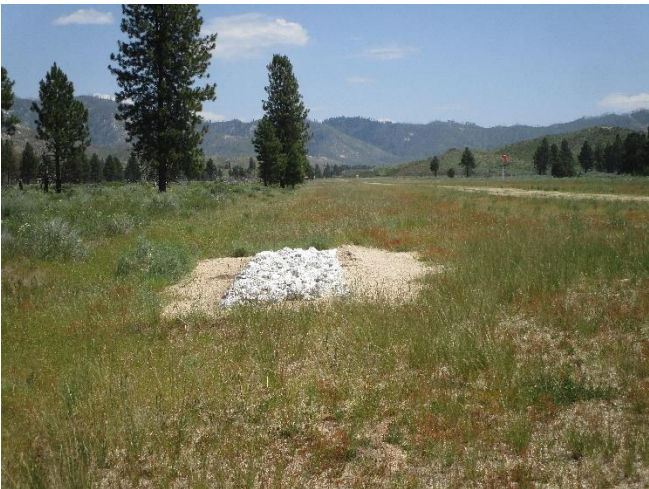
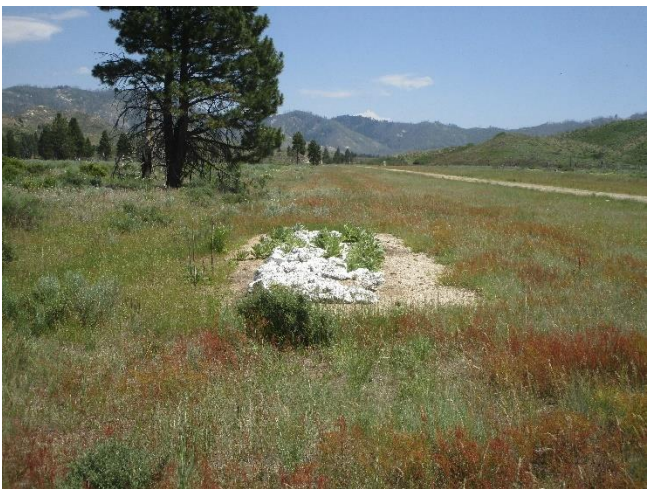
**Boundary Markers (BMs):**

All boundary markers were good and with plenty of white paint that made them visible from the air. Vegetation control was very good. There were a couple of exceptions where some minor grass/weeds growth was taking place on the side of some of the BMs. New paint may be needed in the next couple of years or so.

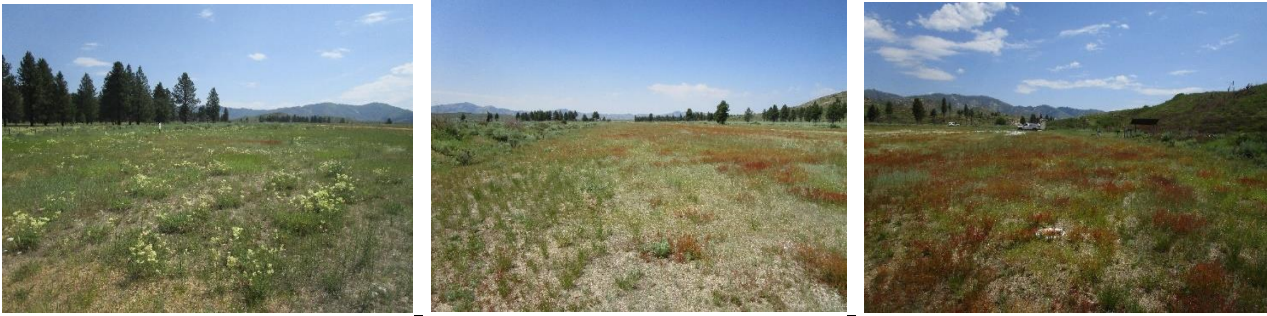
### **Tiedowns:**

The main tie-down area had ample space to park a dozen small airplanes, but I only saw 6 spots with tie down chains present. The other parking area on the west side of the facility, close to rwy. end 6, was much smaller – room for 2-3 airplanes and only 2 spots had chains present. Grass growth was pretty extensive with growth reaching up to 24" tall. Surface was rather rough due to the presence of lots of clump grass that most definitely contributes to making taxiing in the area a bit rough.

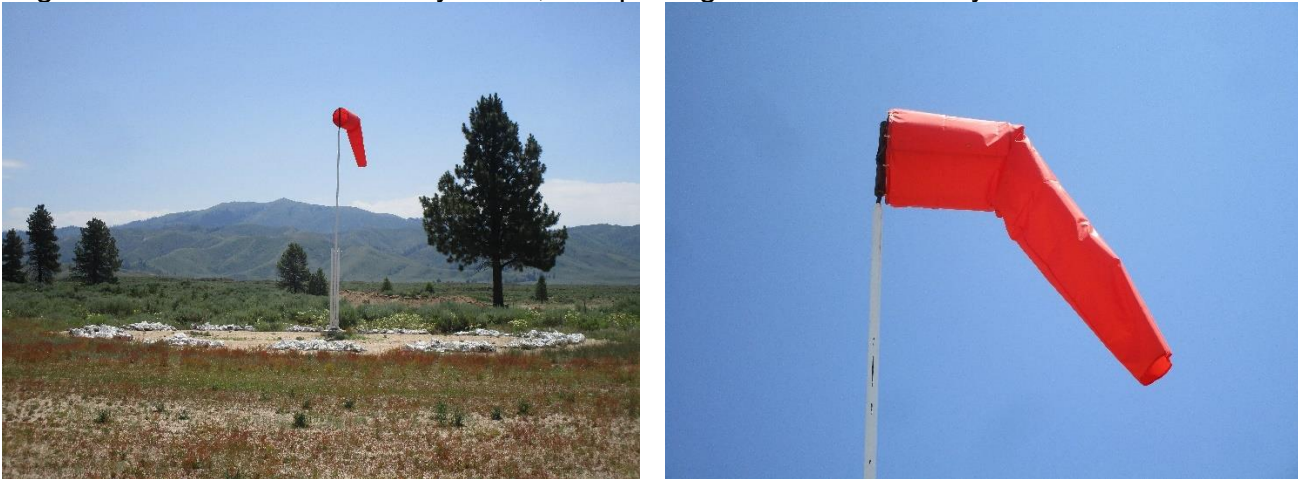
### **Windsock/Segmented Circle:**

The windsock was in very good shape and it looked almost brand new. The white metal standard was in good mechanical order and had plenty of white paint visible. The segmented circle had good vegetation control and was very clean, well put together and was very visible from the air.

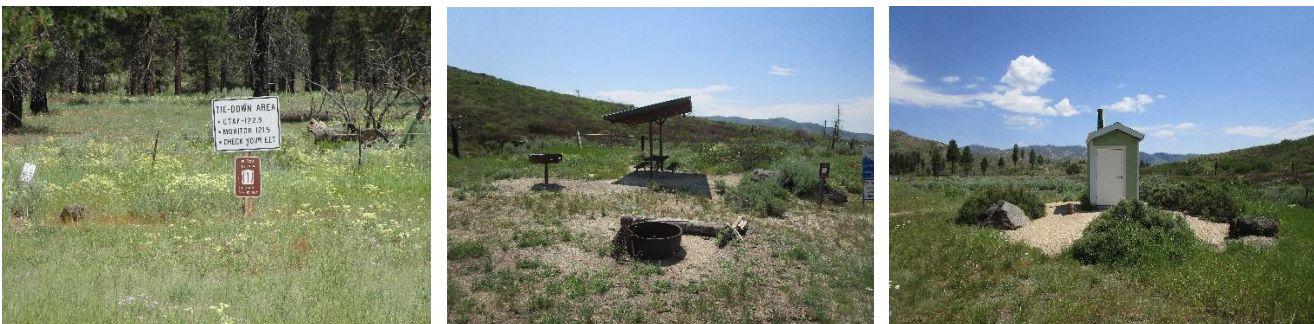
### **Misc/Services:**

All the signs were in the upright position, visible, and in good physical order. The picnic area was well maintained, and all the amenities were good and usable as one should expect. The outhouse was nice and clean and had toilet paper available. No other safety concerns or issues were observed at the time of the inspection. If you have any questions or concerns, please contact me at 208-334-8895.
