IDAHO TRANSPORTATION DEPARTMENT

SUBJECT: 2023 5010-1 Airport Inspection conducted June 13, 2023.
(04338. A Soldier Bar Soldier Bar USFS)

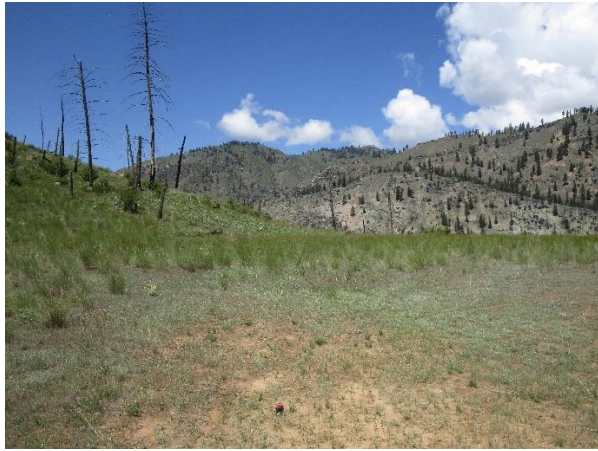
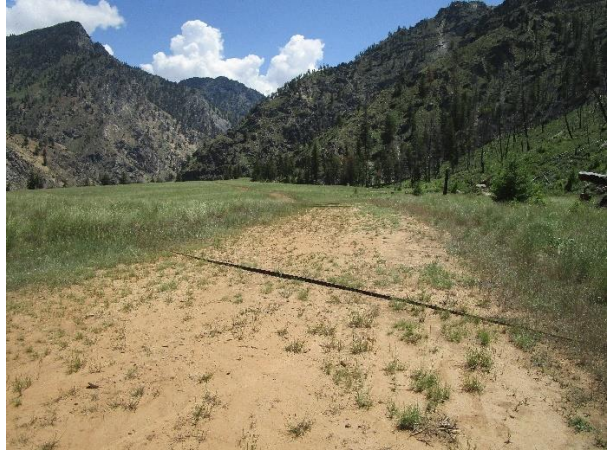
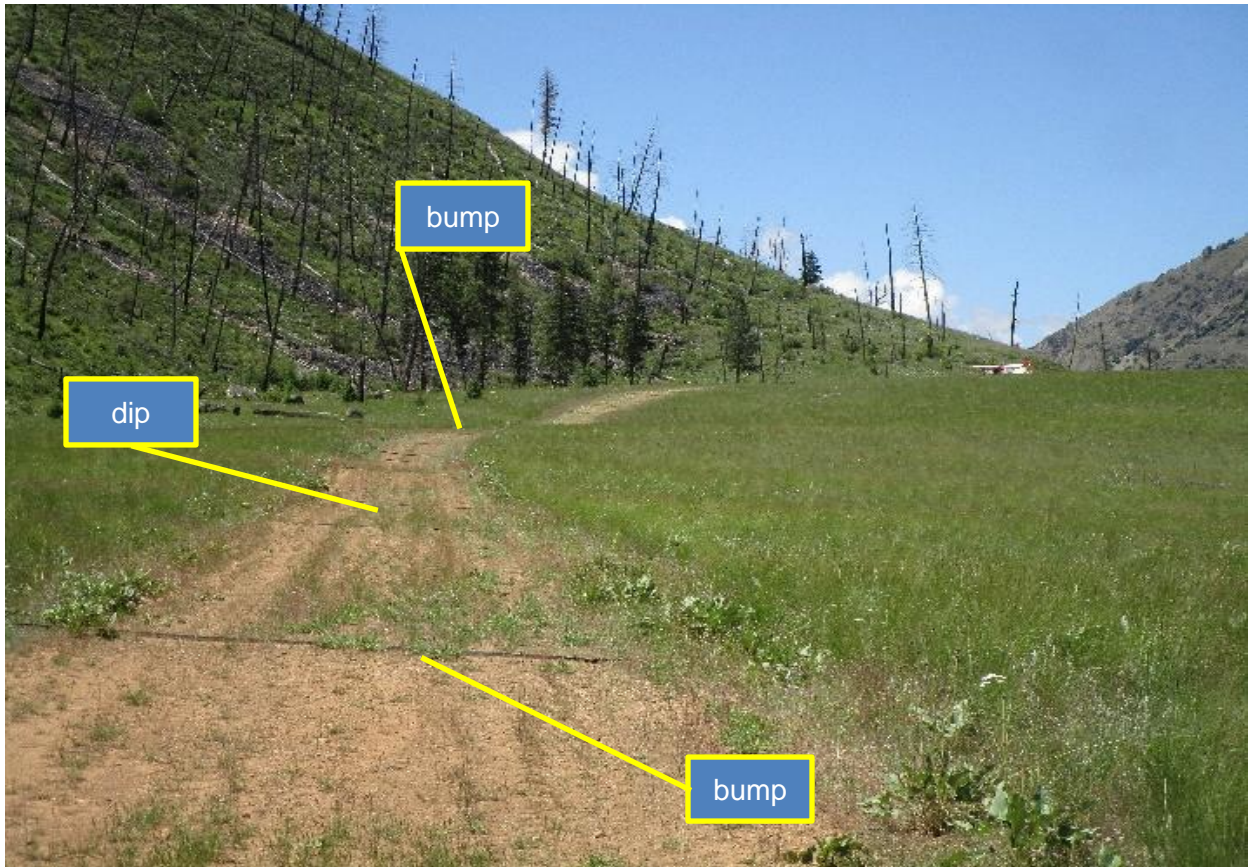
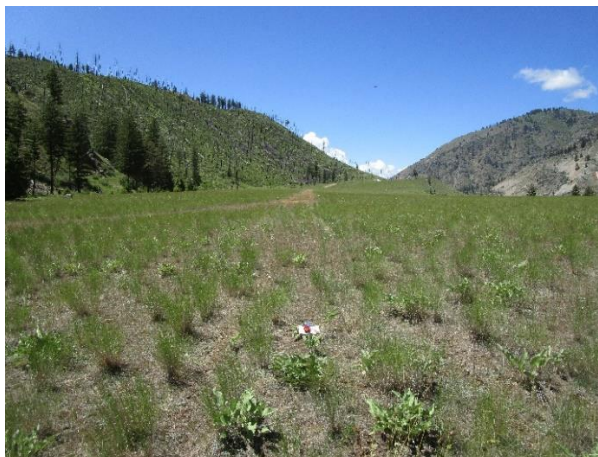
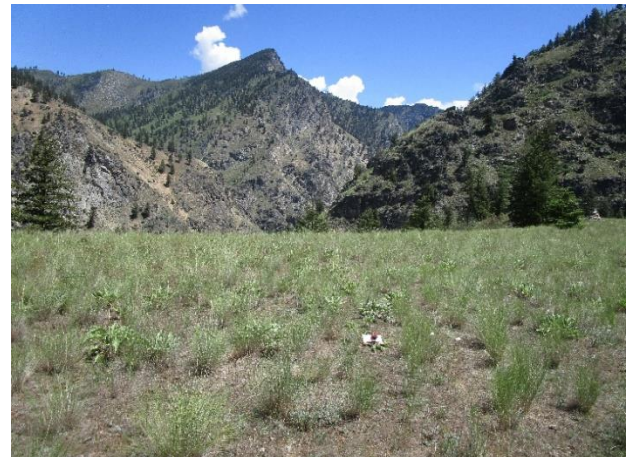
Runway 7-25: At the time of the inspection, the unmarked runway I found to be in fair condition, with the surface continuing to be rough, especially at the midfield area and toward the top on the west end. While very basic in nature, this runway is very challenging due to a variety of environmental factors – it has two major humps and each followed by dips that if you're coming in too fast, it will propel the aircraft back into airborne status if you are not careful....it is a scary feeling especially if you are not prepared for it. Lots of small loose rocks continue to work free from the surface on the west – due to prop wash on take-off. The water diversion rubber bars were all firmly anchored and appeared to be working as intended. No rodent activity was noted. Both approaches continue to remain unchanged and with the same controlling obstructions as indicated in the Airport Master Record – trees at rwy end 7 and a ridge/hill at rwy end 25.

1. If at all possible, smoothen out the rwy and get rid of the two bumps in the midfield; do your best to level that area of the rwy and make it as flat as possible.

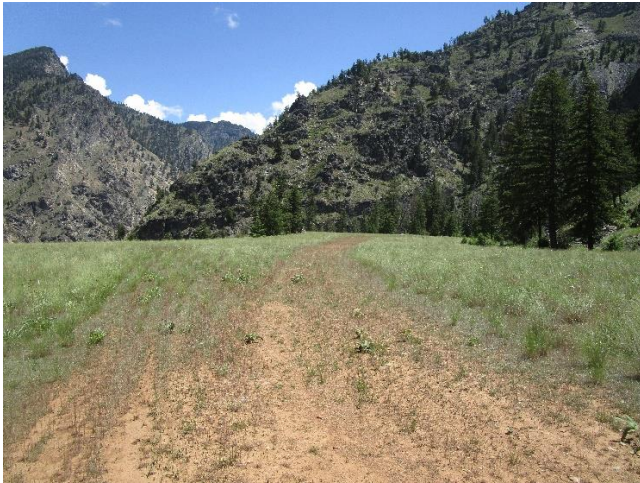
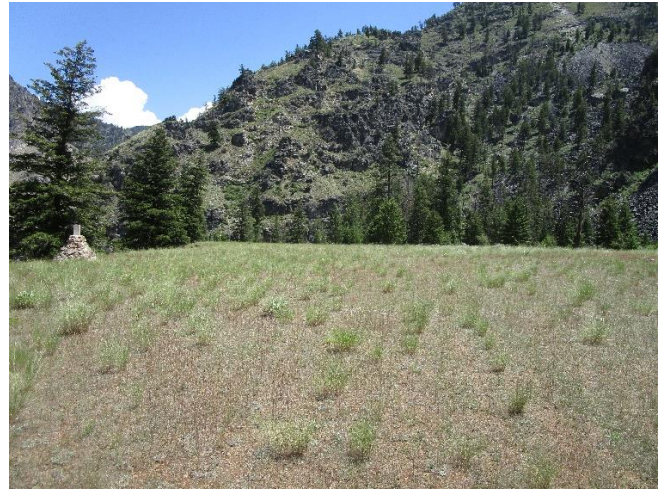
Tie downs: The tie down area close to rwy end 25 was in fair condition and had ample room to park several small airplanes. I saw no tie down chains present in the area. The dirt/grassy surface had some roughness to it due to the tall bunch grasses (10"-14" tall). I saw no signs to indicate the tie-down area.

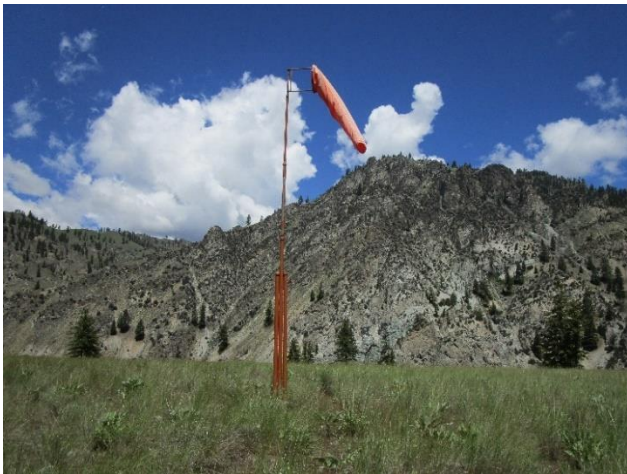
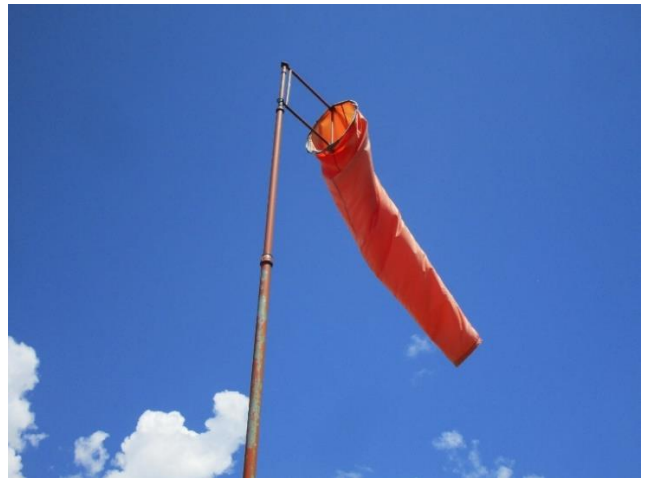
Windsock/Standard: The windsock was in good condition, had good color and it showed no rips or tears. The windsock on this airfield did not have a drain hole. The standard was in good working order and had good orange paint, even though I did notice some minor peeling. There was no segmented circle present at this facility.
