IDAHO TRANSPORTATION DEPARTMENT

Subject: 2023 5010-1 Airport Inspection conducted February 27, 2023.
(04353.*A Weiser Municipal Airport)

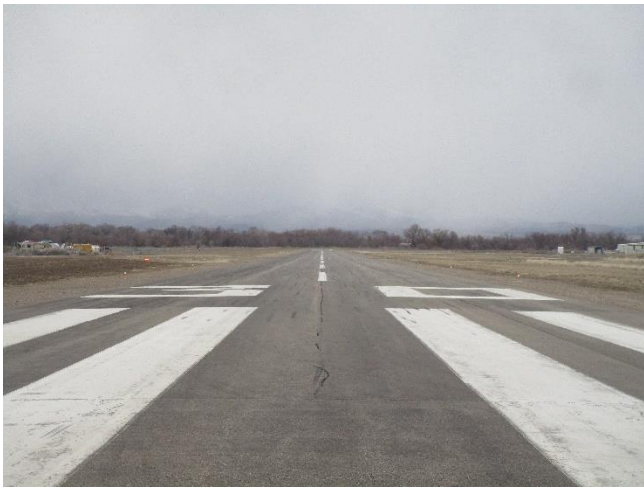
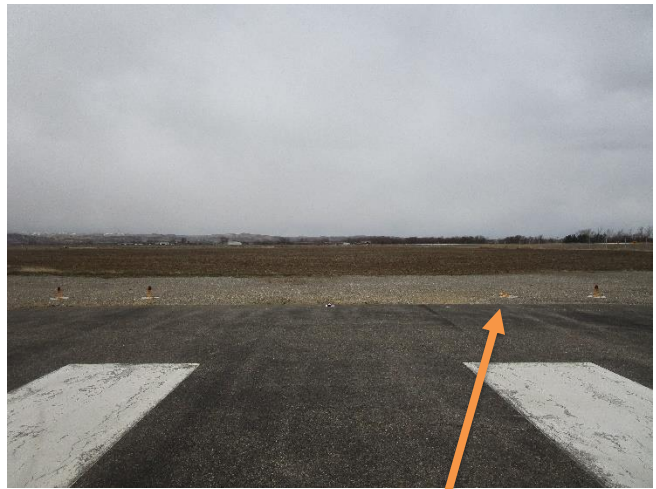
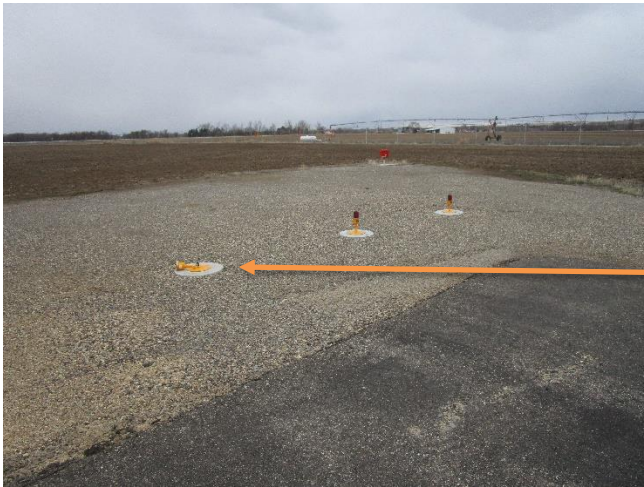
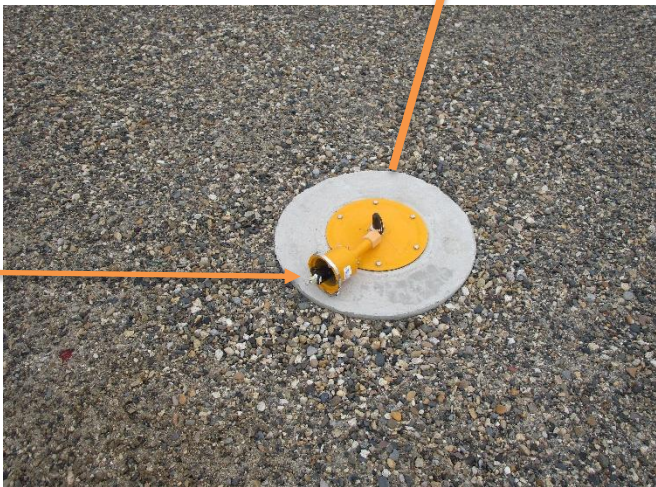
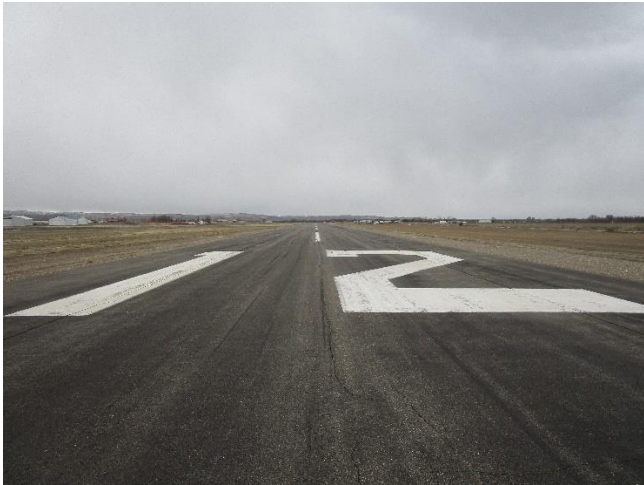
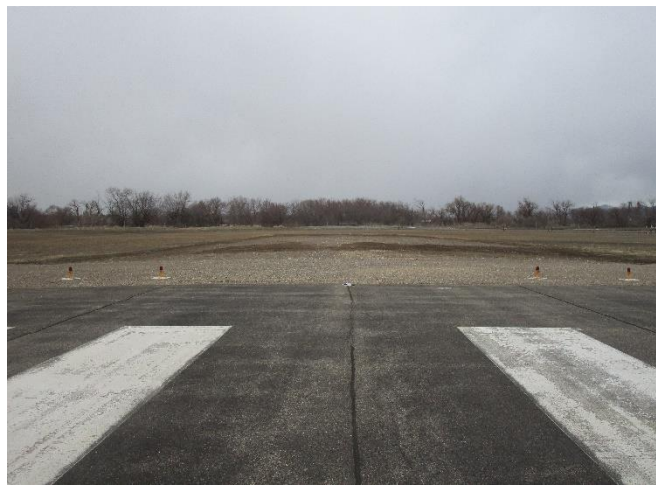
Runway 12-30: Overall, the runway surface is in great condition. Your pavement exhibits good integrity, color, and runway markings. The one, older longitudinal crack, that was treated previously and along the rwy. centerline is still there; the slurry seal is currently holding its fill well. The runway edges are solid, and I saw no crumbling anywhere. One of the threshold lights was broken at Rwy. end 30 and a PAPI bulb was out (see pics below).

Action items: Inspect and replace all broken lights and light bulbs associated with the runway.

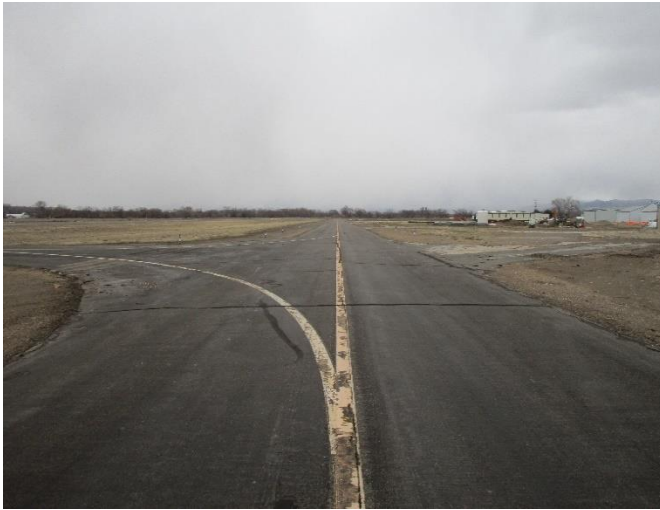
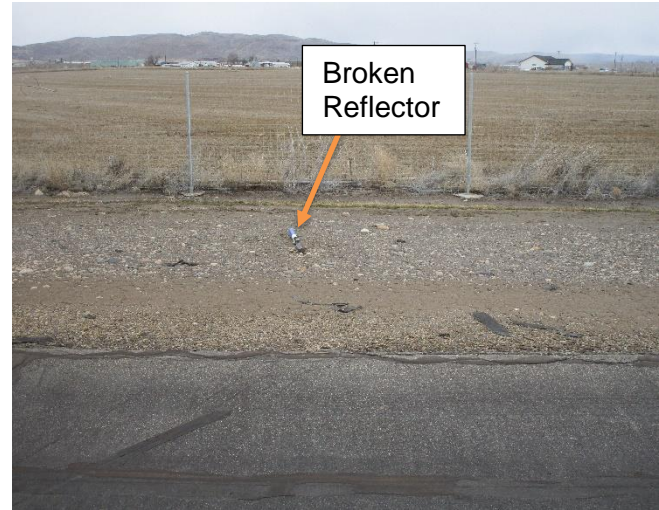
Taxiway/Ramp/Tiedowns: The ramp area is in good condition with the cracks tar-sealed and adequate tie downs; of the 14 parking spots, I counted 11 with chains or tie-downs present and available. The ramp also displayed great paint markings as well. The taxiway asphalt is in good condition on the parallel taxiway and it, too, displays excellent paint markings. Fine cracks are visible as they are starting to extend from previously sealed lateral cracks in several places but are still minor in nature and hardly worth mentioning.

Action items: Replace broken reflectors associated with the taxiway.

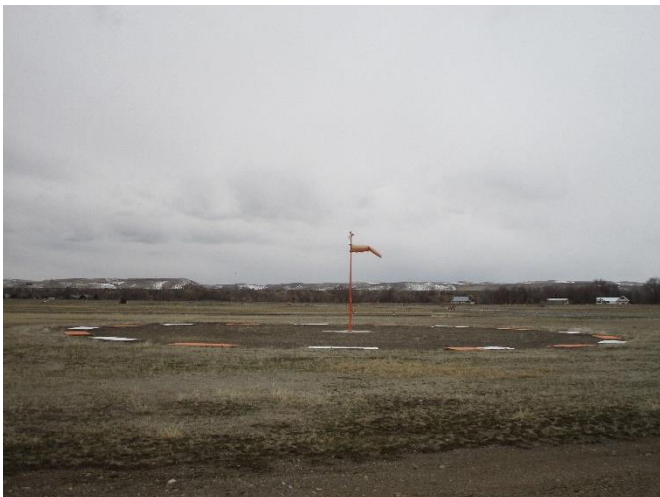
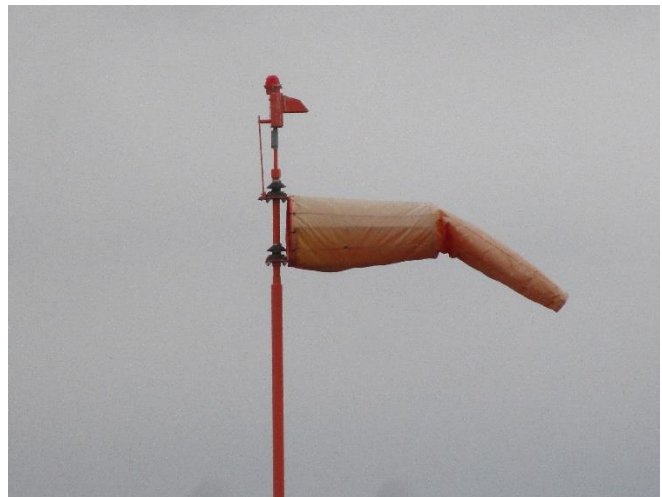
Windsock/Standard/Segmented Circle: The windsock near midfield was in good condition and saw no tears in it. The standard is in excellent shape and has excellent orange color. The cement panels are in great shape with excellent vegetation control and good white and orange paint; all were very visible from the air.

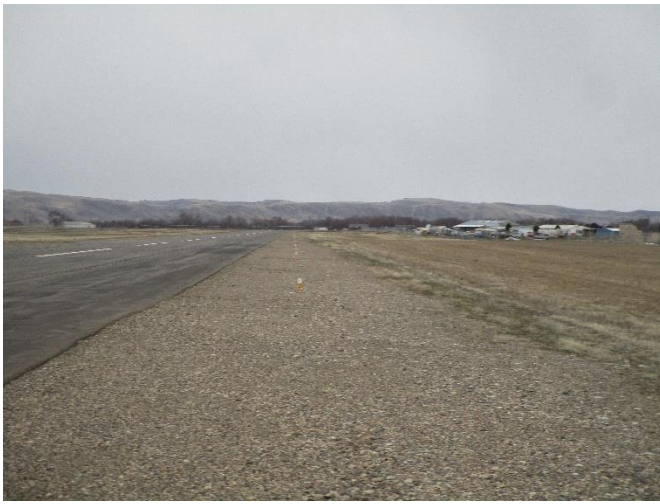
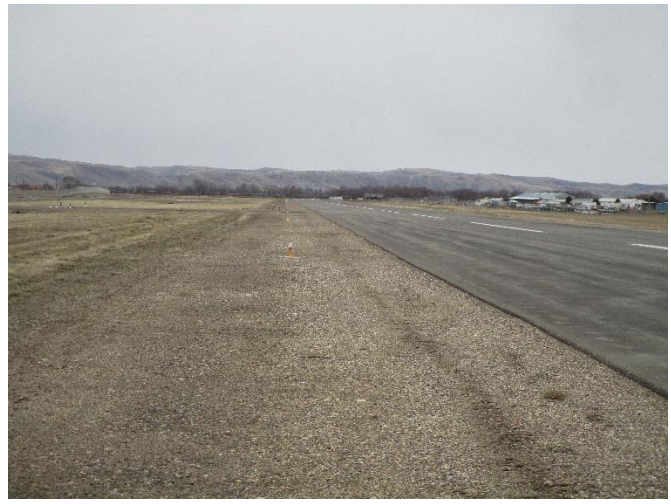
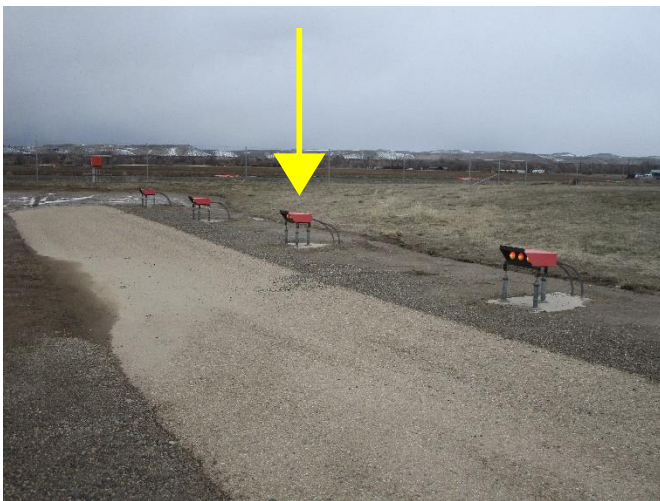
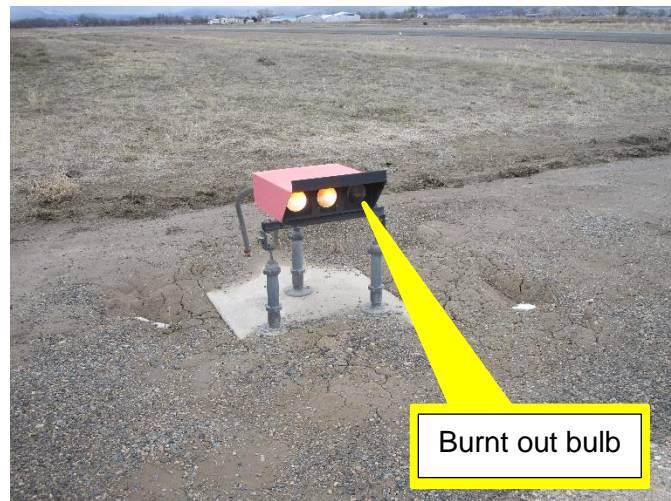
Lighting: All the MIRL lights were in good physical condition and in working order with the exception of the left threshold light closest to the centerline at rwy. end 30; the fixture was broken, and the lens was gone/missing. The PAPIs at rwy. 30 were working well and had great vegetation control around them. The second box closest to the runway had one of the bulbs burnt out (see pics below).

Burnt out bulb
