December 31, 2025  
Atlas File Number: IDBS251382

KEVIN SONICO  
IDAHO TRANSPORTATION DEPARTMENT  
5151 S. 5<sup>th</sup> Avenue  
Pocatello, Idaho 83201

**Project:** Pre-demolition Survey  
5565 Yellowstone Avenue  
Pocatello, Idaho 83202

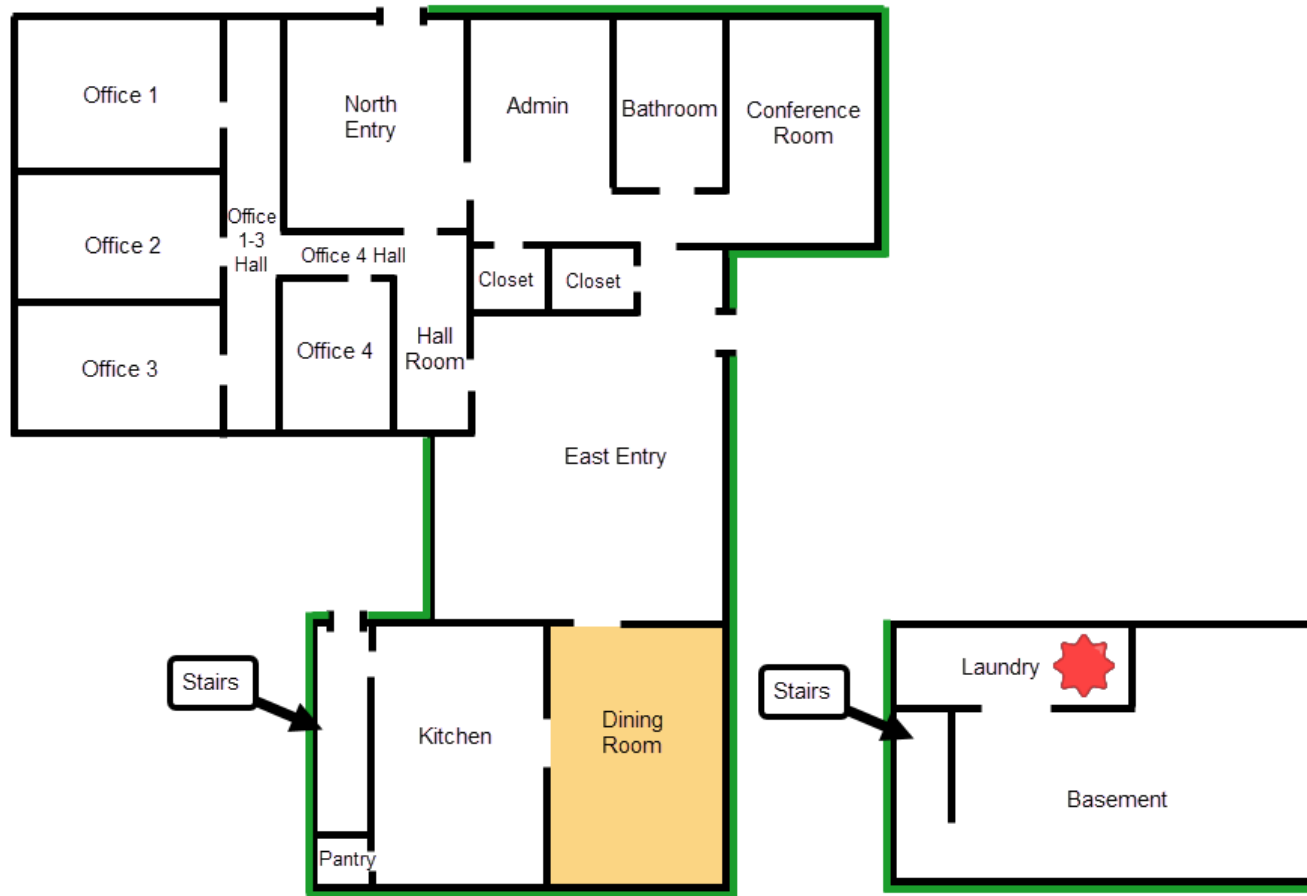
# Asbestos and Lead-Based Paint Locations

- Asbestos-containing putty/filler
-

- Asbestos-containing floor tile
-

- Lead-Based Paint

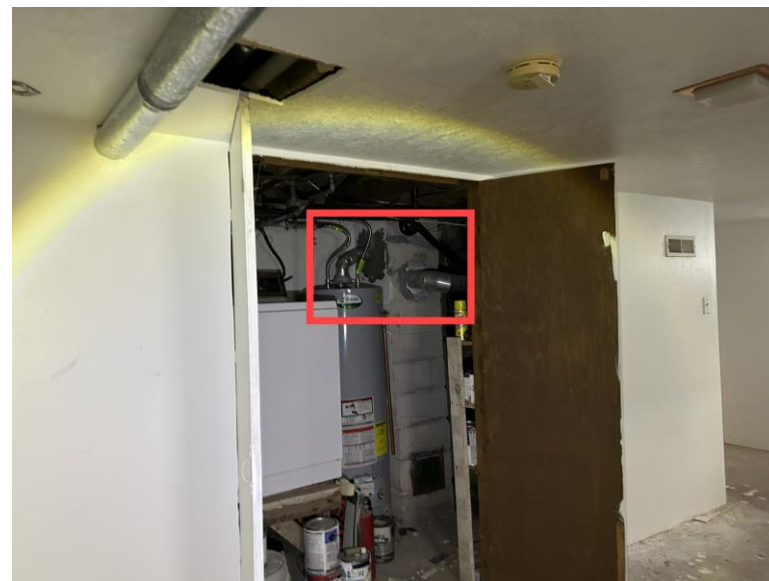
| Table 1: PLM Visual Estimation Results | | | | | | |
|---|---|---|---|---|---|---|
| 34-106,<br>34-107,<br>34-108 | Thermal putty/ filler | Laundry room (Basement) | 60% | RACM | No | ~2 SF |

View of the asbestos-containing putty/filler compounds in the basement

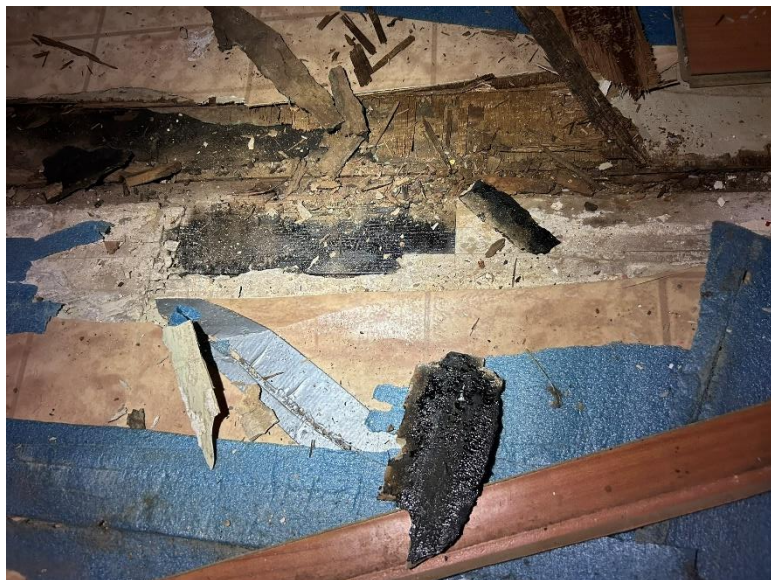
| Table 1: PLM Visual Estimation Results | | | | | | |
|---|---|---|---|---|---|---|
| 26-82,<br>26-83,<br>26-84 | Floor tile concealed under tan square sheet vinyl flooring | Dining Room | 6% | I | No | ~150 SF |

View of the asbestos-containing floor tile under the sheet flooring in the dining room

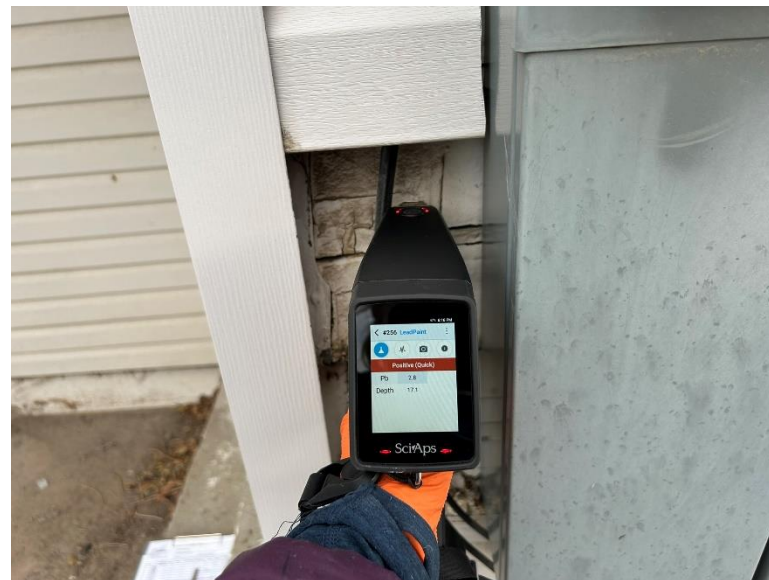
Photo of the lead-based paint silding under aluminum siding
