FROST HEAVES ON STATE HIGHWAY 15

RESEARCH PROJECT NO. 31

STATE OF IDAHO DEPARTMENT OF HIGHWAYS

A STUDY OF FROST HEAVES
ON
STATE HIGHWAY NO. 15

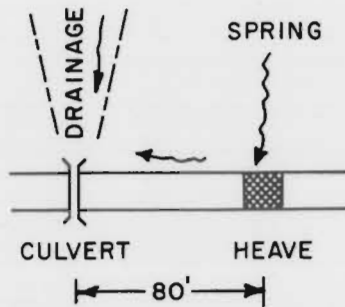
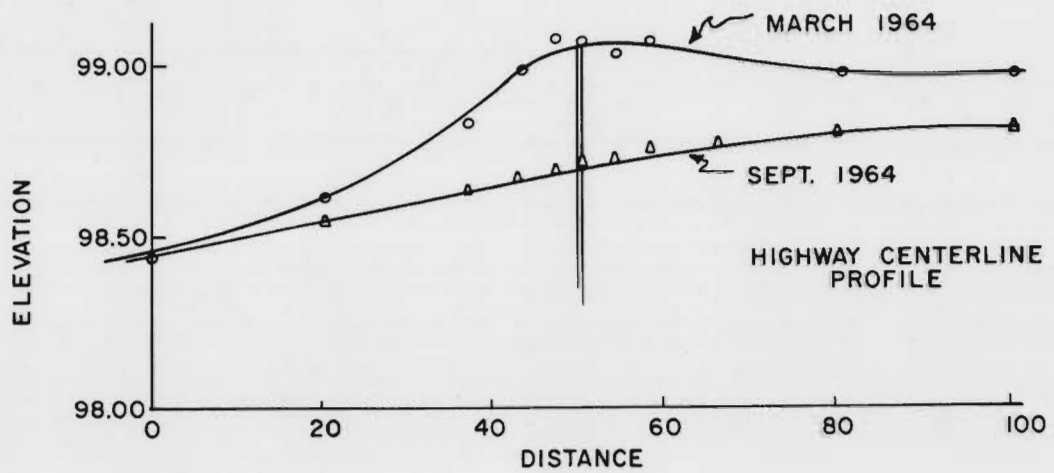
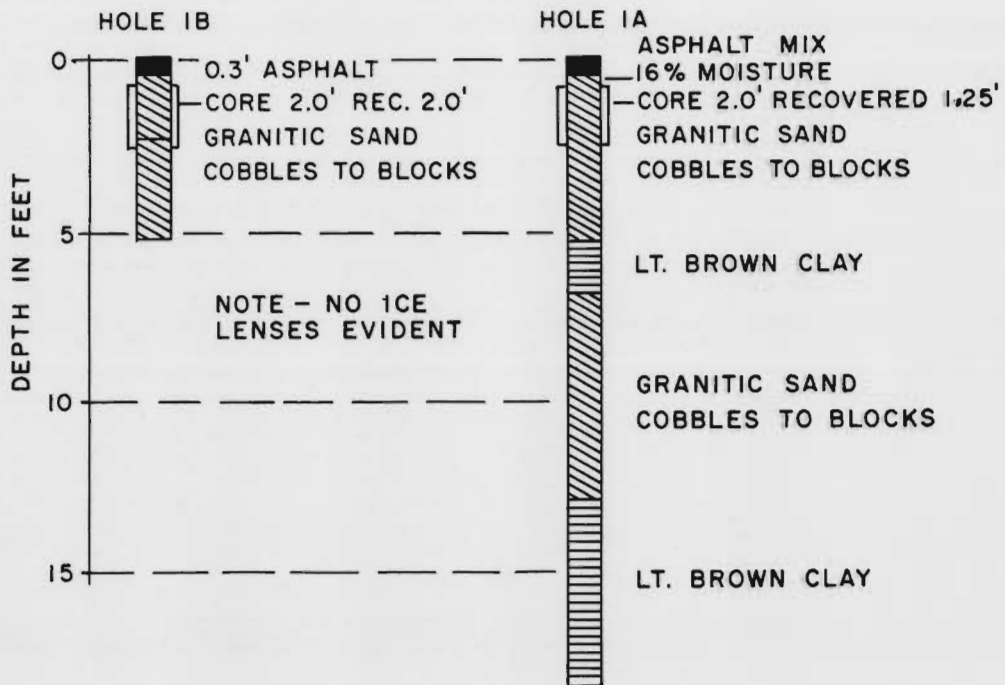
SITE NO 1 MILEPOST 44.7

Several heaves appear to be aggravated by adjacent drainages for which no culverts were provided, particularly sites 1 and 3. Since other areas show heaving even though culverts are present, we are led to the conclusion that providing a culvert does not necessarily solve the problem if drainage is other wise impaired.

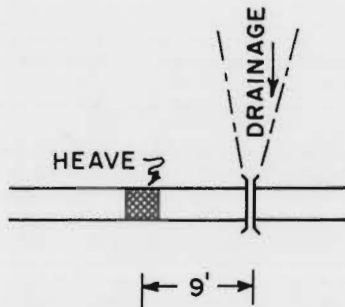
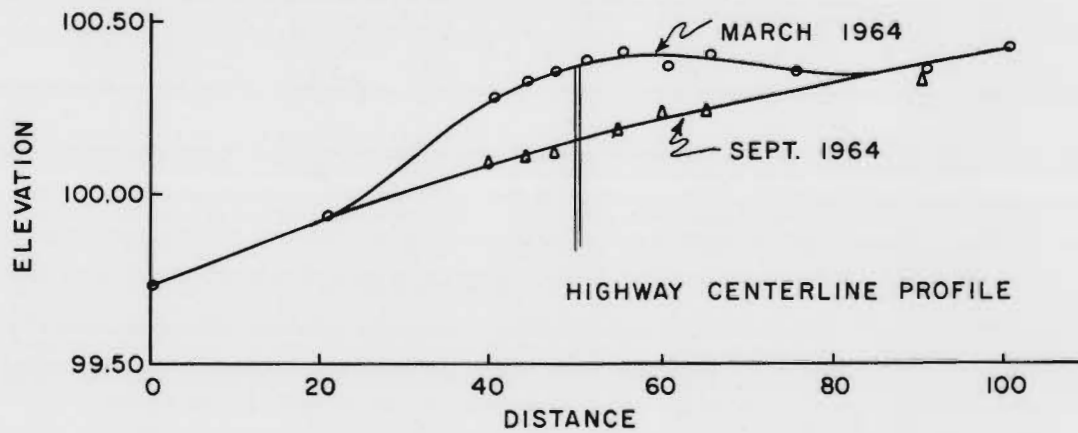
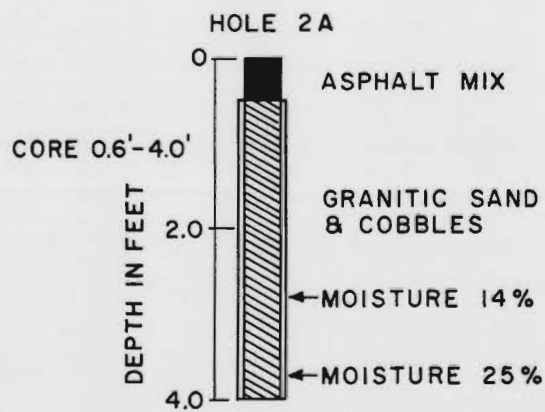
SITE NO 2
MILEPOST 53.5

NOTE - NO ICE LENSES EVIDENT

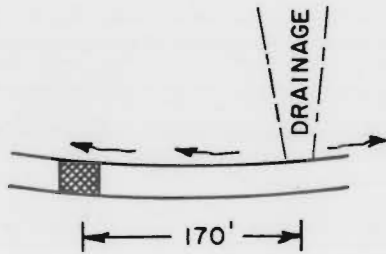
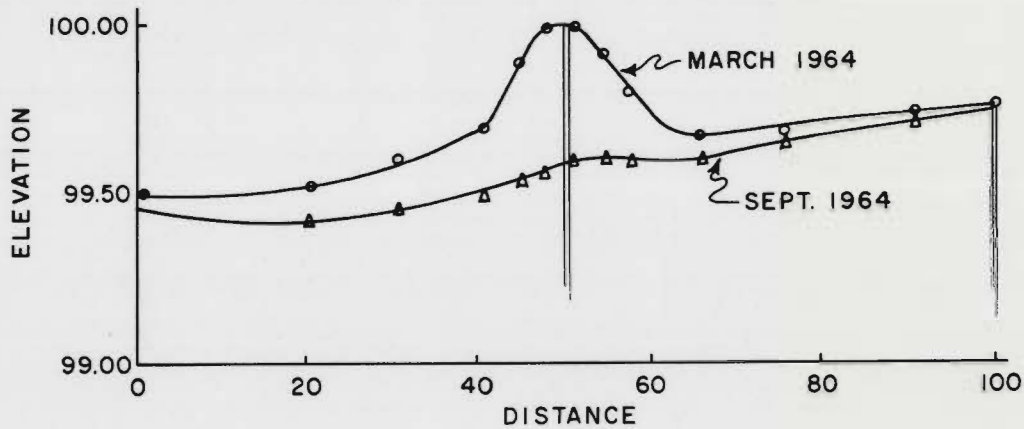
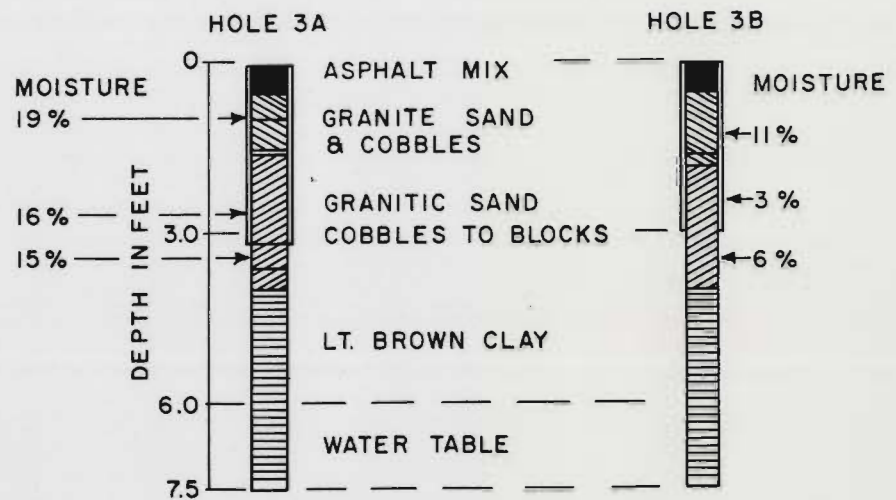
SITE NO 3 MILEPOST 54.7

ICE LENSES LOGGED AT 1.6', 3.3' HOLE 3A

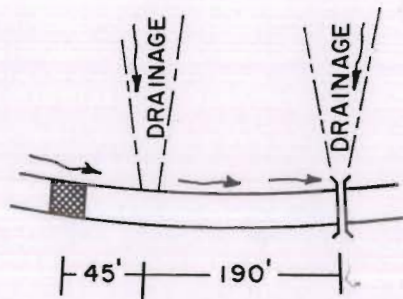
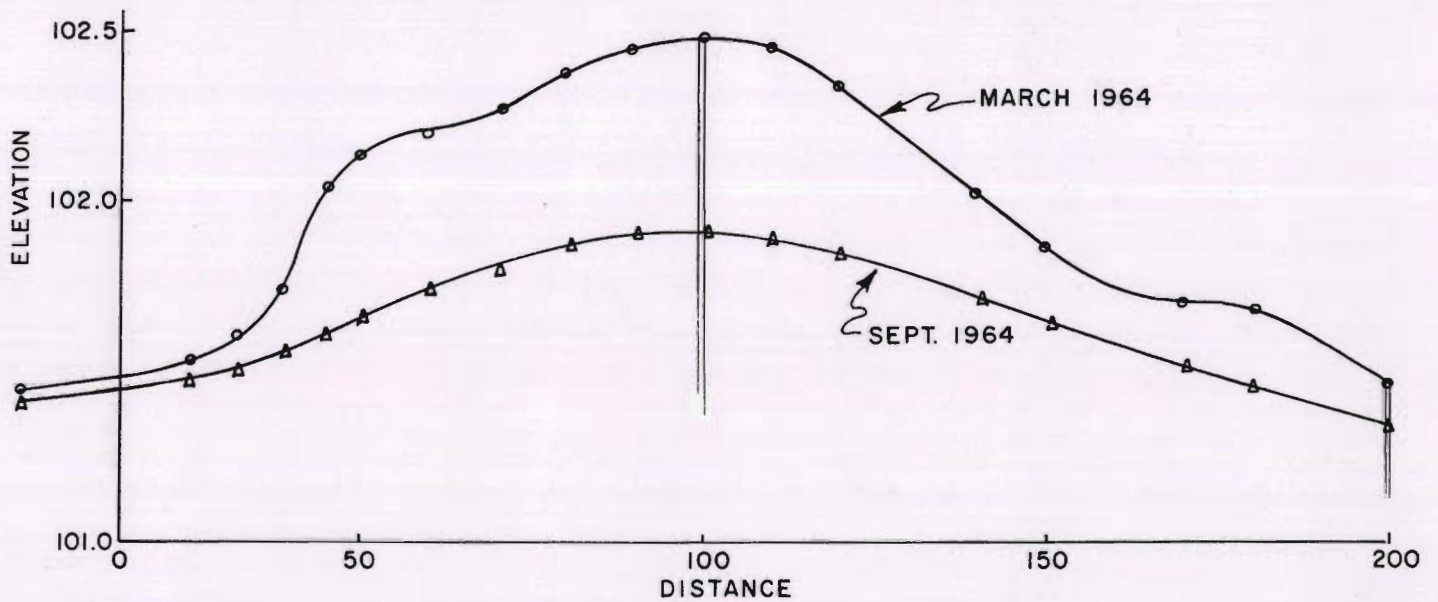
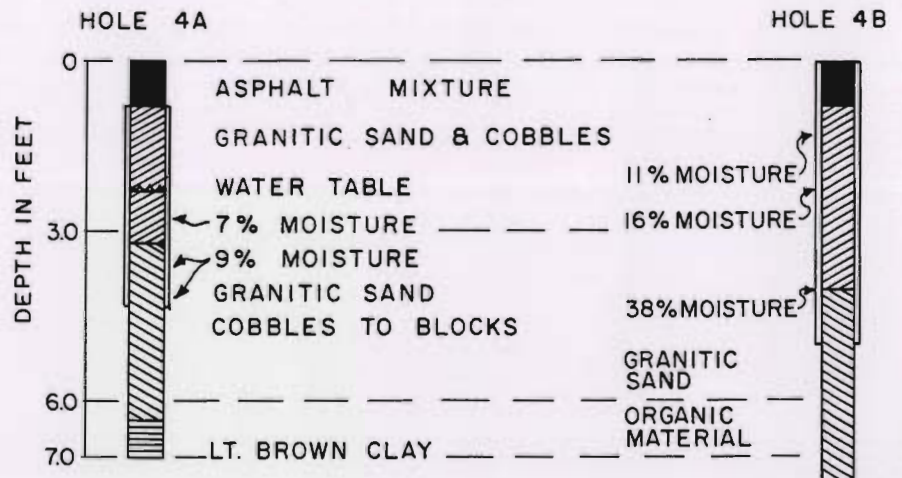
SITE NO 4
MILEPOST 56.7

NO ICE LENS NOTED

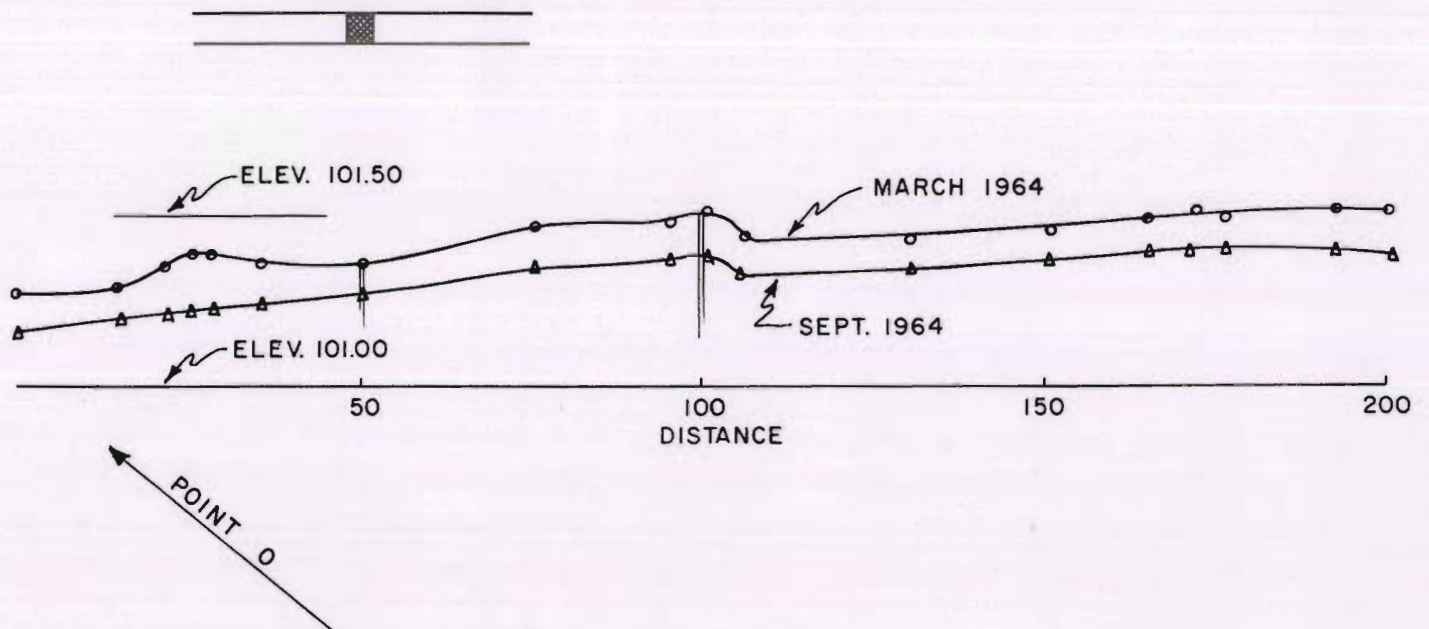
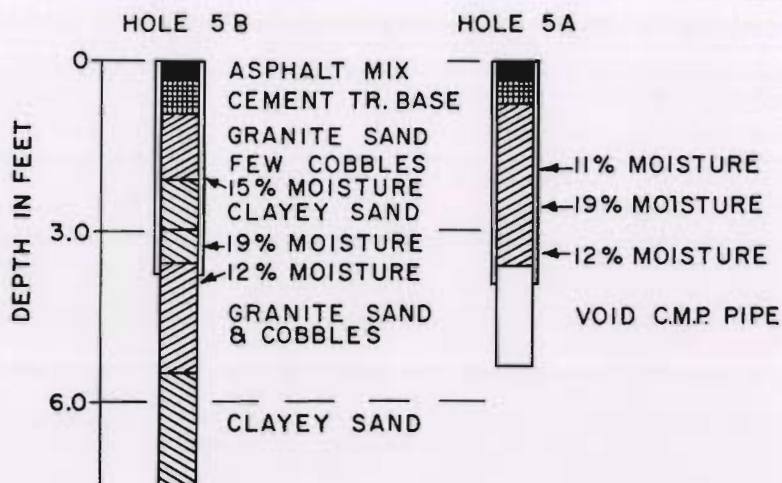
SITE NO 5 MILEPOST 58.1

Elevations taken during the March, 1964, investigation and again in September indicated that heaving exceeded 0.5 feet in several of the areas. These elevations also indicated a uniform heaving of the roadbed of from 0.15 - 0.30 feet for the distance over which levels were taken in Sites 5 and 9.

HEAVE AT CRACK

HOLE 5B ICE LENS AT 2.0, 2.9
HOLE 5A NO ICE LENS EVIDENT

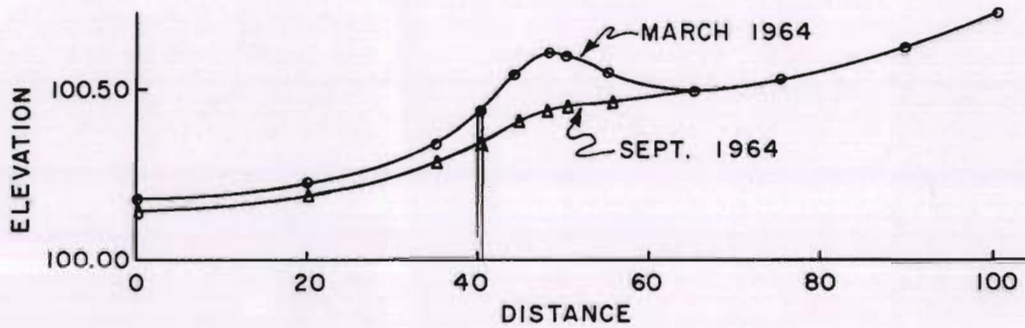
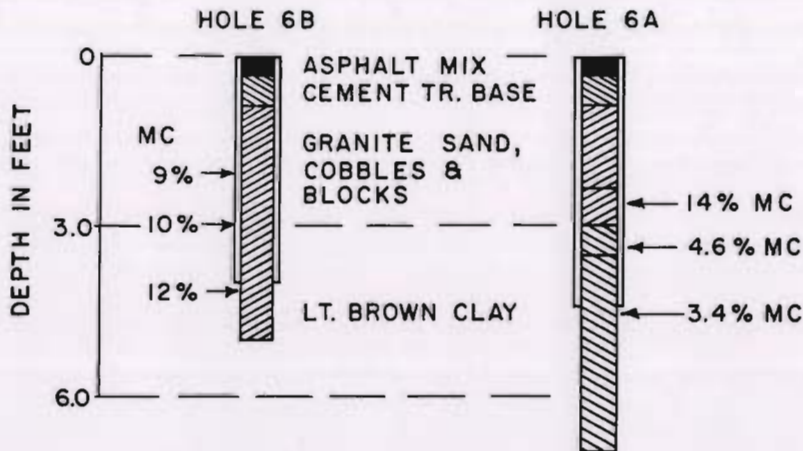
SITE NO 6
MILEPOST 59.8

Heaving occurs at the grade points at site 6 and 10 and in part of a cut at site 8. Drainage being blocked by snow contributes to these frost heaves.

HOLE 6A - ICE LENS AT 2.3, 3.1 AND 3.5
HOLE 6B - NO ICE LENS EVIDENT

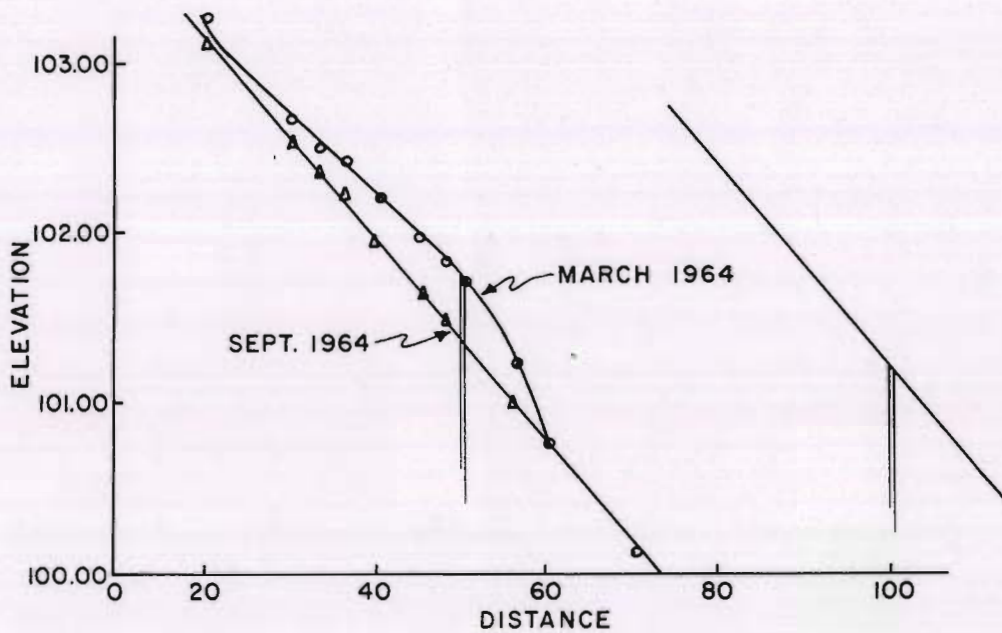
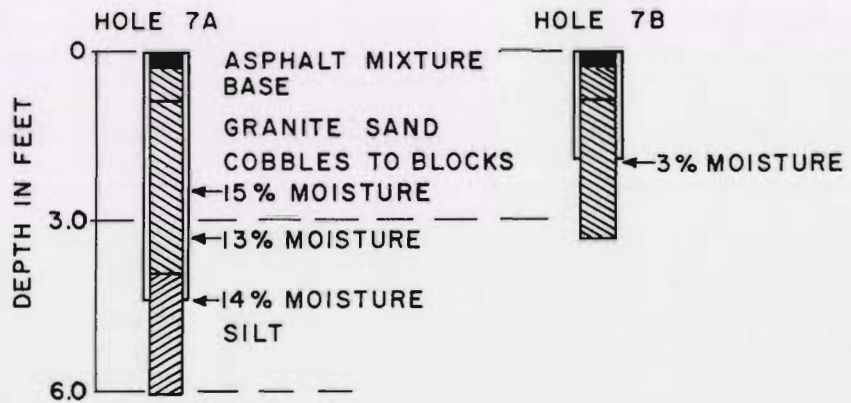
SITE NO 7
MILEPOST 76.4

HOLE 7A
1.4' - 4.4' = 2.65'
FROST TO 4.0'

HOLE 7B
MATERIAL NOT
FROZEN

NO ICE LENS
EVIDENT

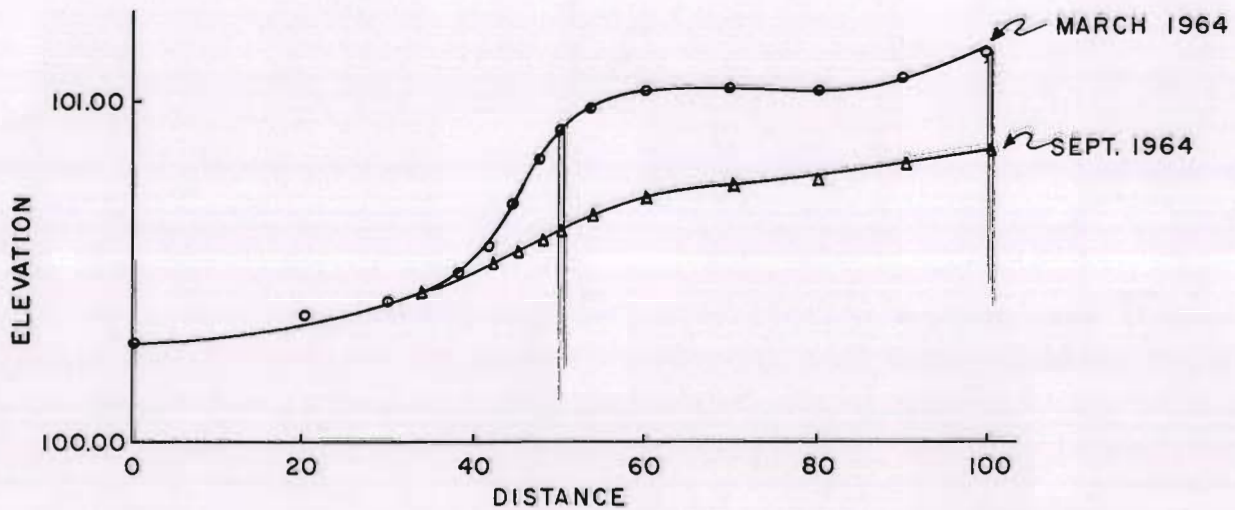
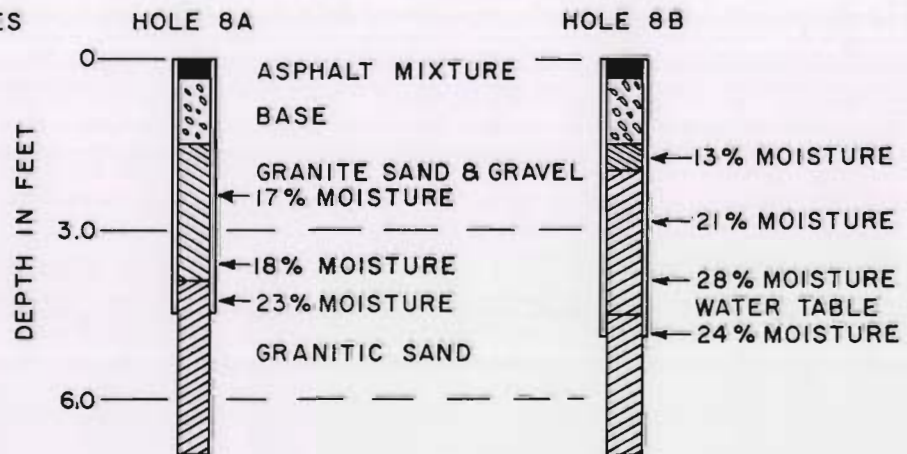
SITE NO 8

HOLE 8A - ICE LENS AT 1.8, 3.1, 3.4
HOLE 8B - NO ICE LENS EVIDENT

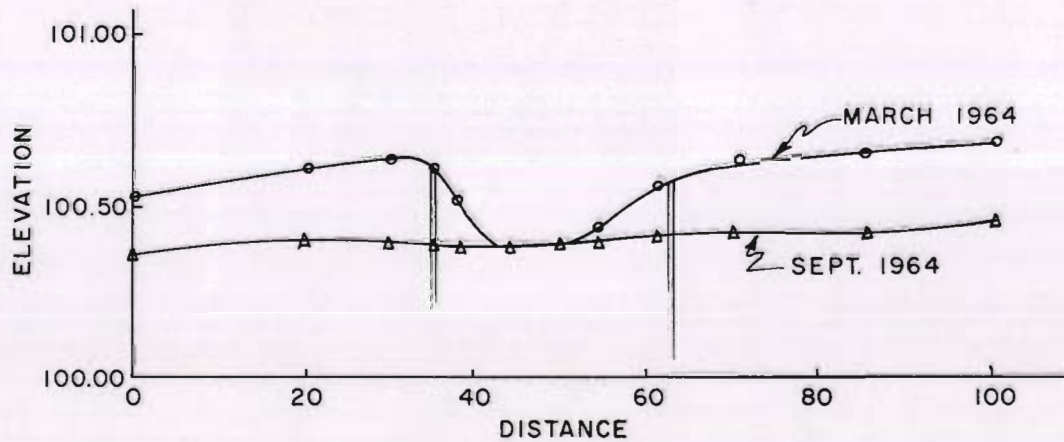
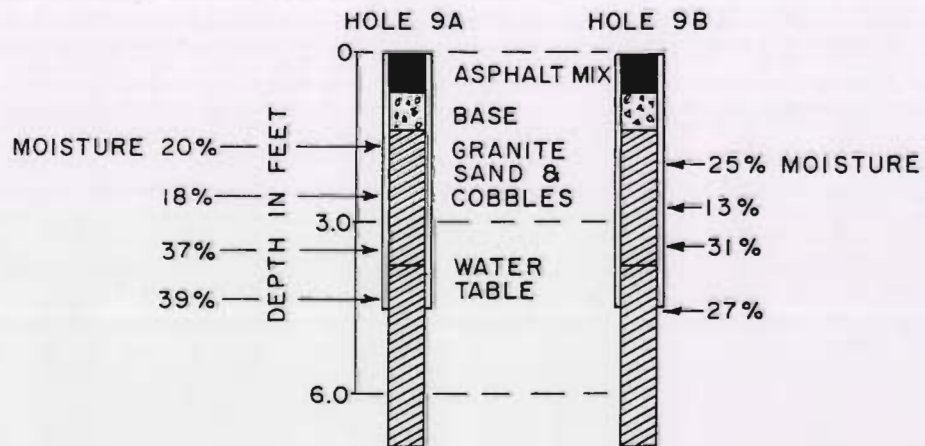
SITE NO 9
MILEPOST 87.5

HOLE 9A - ICE LENS AT 2.1, 3.3
HOLE 9B - ICE LENS AT 3.3

7. The frost heave on either side of the structure at site 9 can be minimized, insofar as abruptness is concerned, by placing a wedge of gravel tapering from nothing to about four feet in thickness at the abutment wall. This wedge should extend at least 25 to 50 feet back from the wall dependent on the severity of the heave.

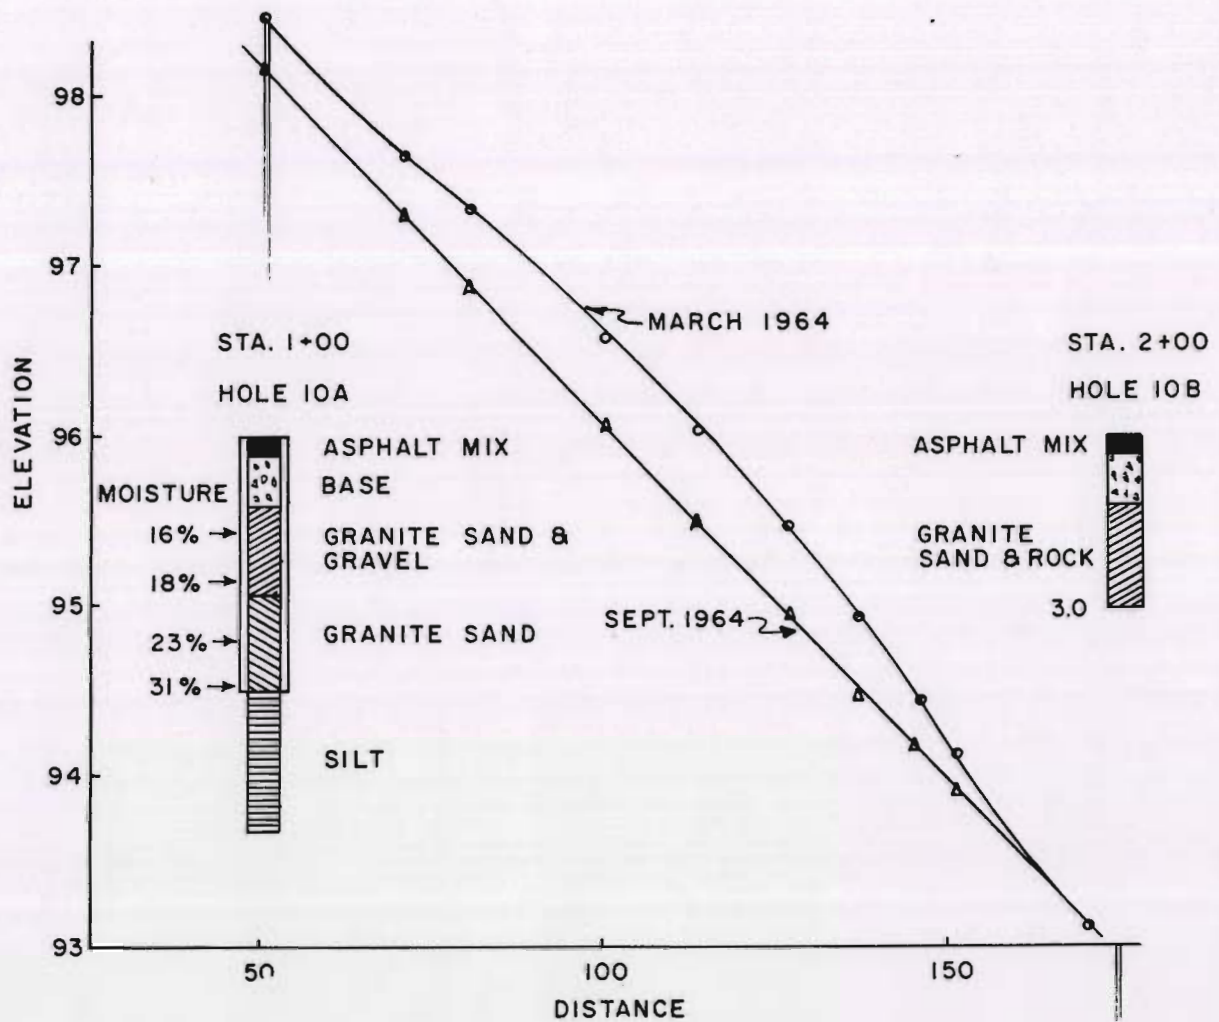
SITE NO 10

HOLE 10A - ICE LENS AT 3.3
HOLE 10B - NO CORES
