**SETTLEMENT STUDY CONDUCTED
ON 50-FOOT HIGH GRANULAR
APPROACH EMBANKMENT**

RESEARCH PROJECT NO. 52

STATE OF IDAHO DEPARTMENT OF HIGHWAYS

F-FG-3022(16)
East Connector to Boise

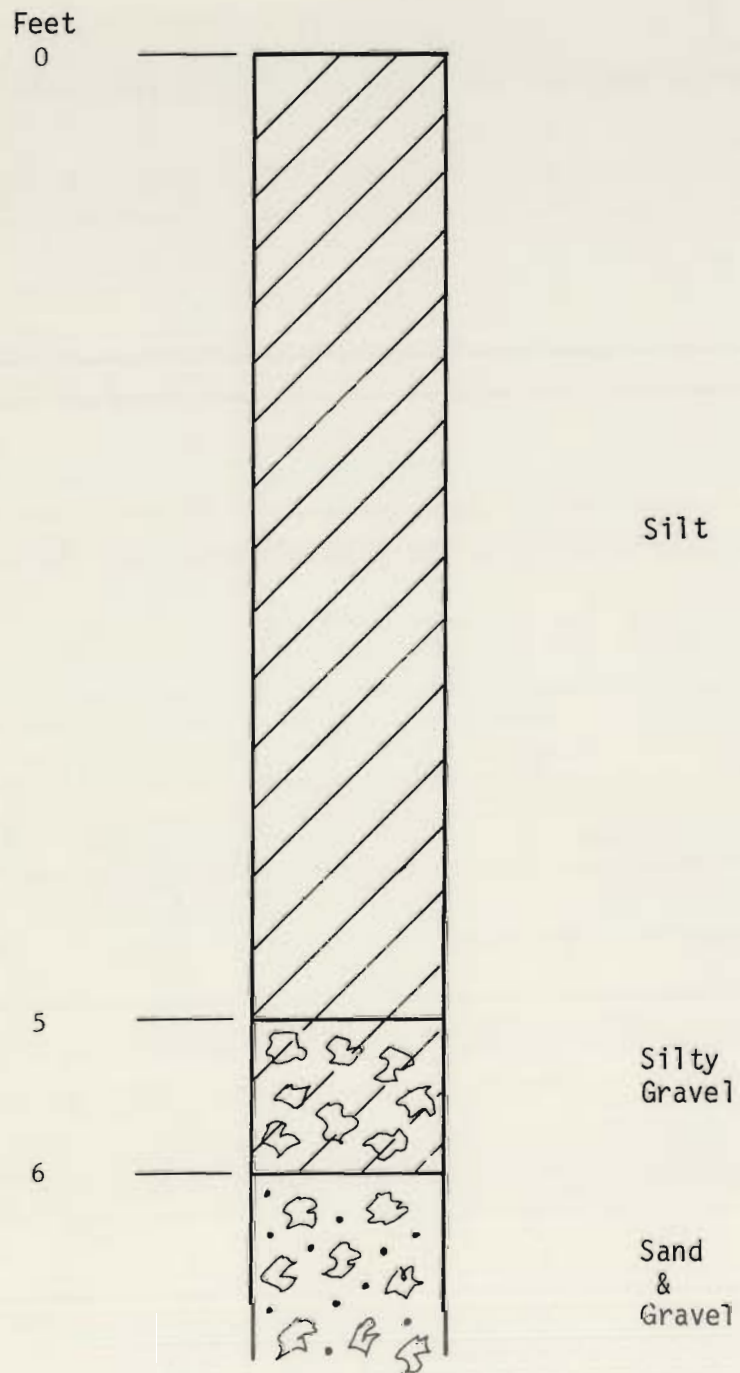
Figure 1 - Soil Profile at Sta. 25+00

The 50-foot high embankment was constructed on irrigated pasture land. Foundation materials at Station 25+00 are shown in Figure 1. They consist of approximately five feet of silt at dry densities ranging from 80 to 110 pcf and moisture contents of 10 to 15 percent. The angle of internal friction is 31-35 degrees. Compressions of about 1%/ksf at field moisture and 2%/ksf in saturated condition were found from laboratory compression tests. This indicates that with a load of 1.0 ksf, the silt layer would compress 1% if the foundation soils remain at present field moisture, or 2% if foundation soils should become saturated. The compression would be nearly proportional to the applied embankment load. The silt layer increased in thickness toward the structure and was about eight feet thick at Station 23+72.

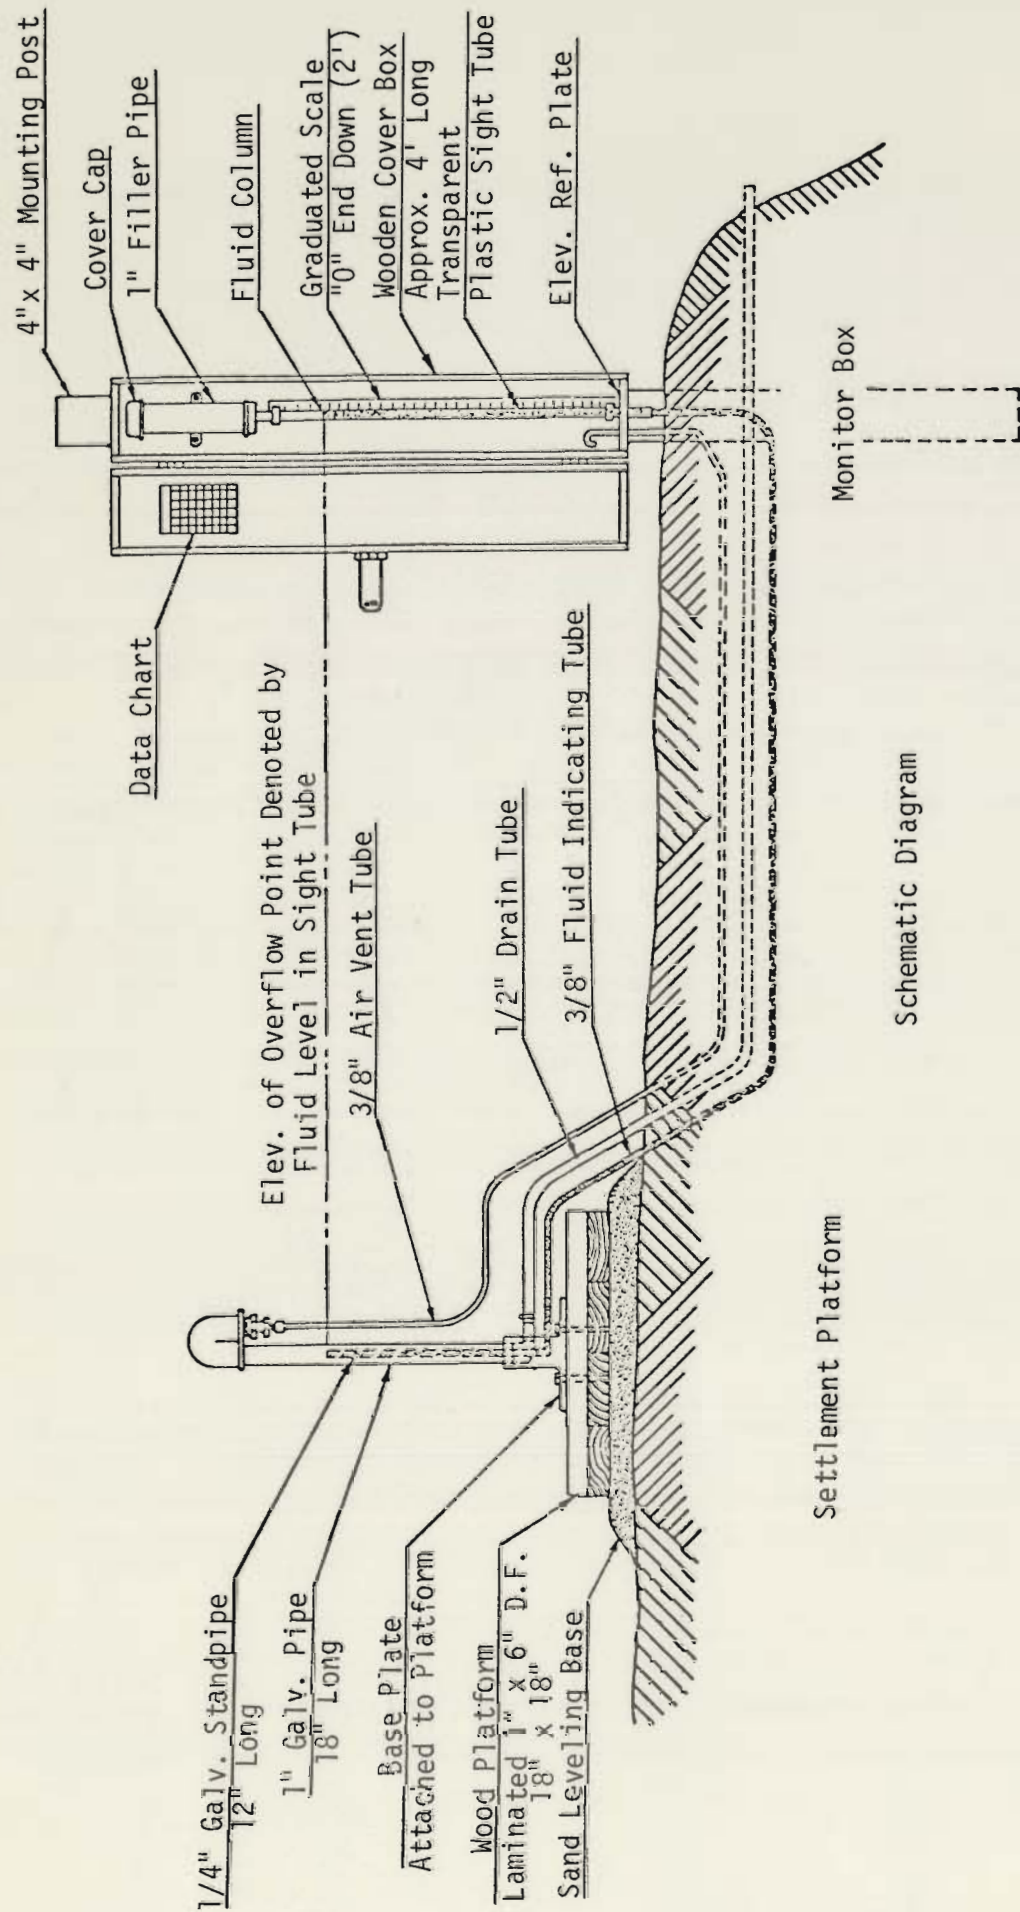
Figure 2 - Settlement Indicating Device - Sealed Fluid Level Type

Six settlement-indicating devices were constructed following the California design as shown in Figure 2. They were installed on centerline at the following locations:

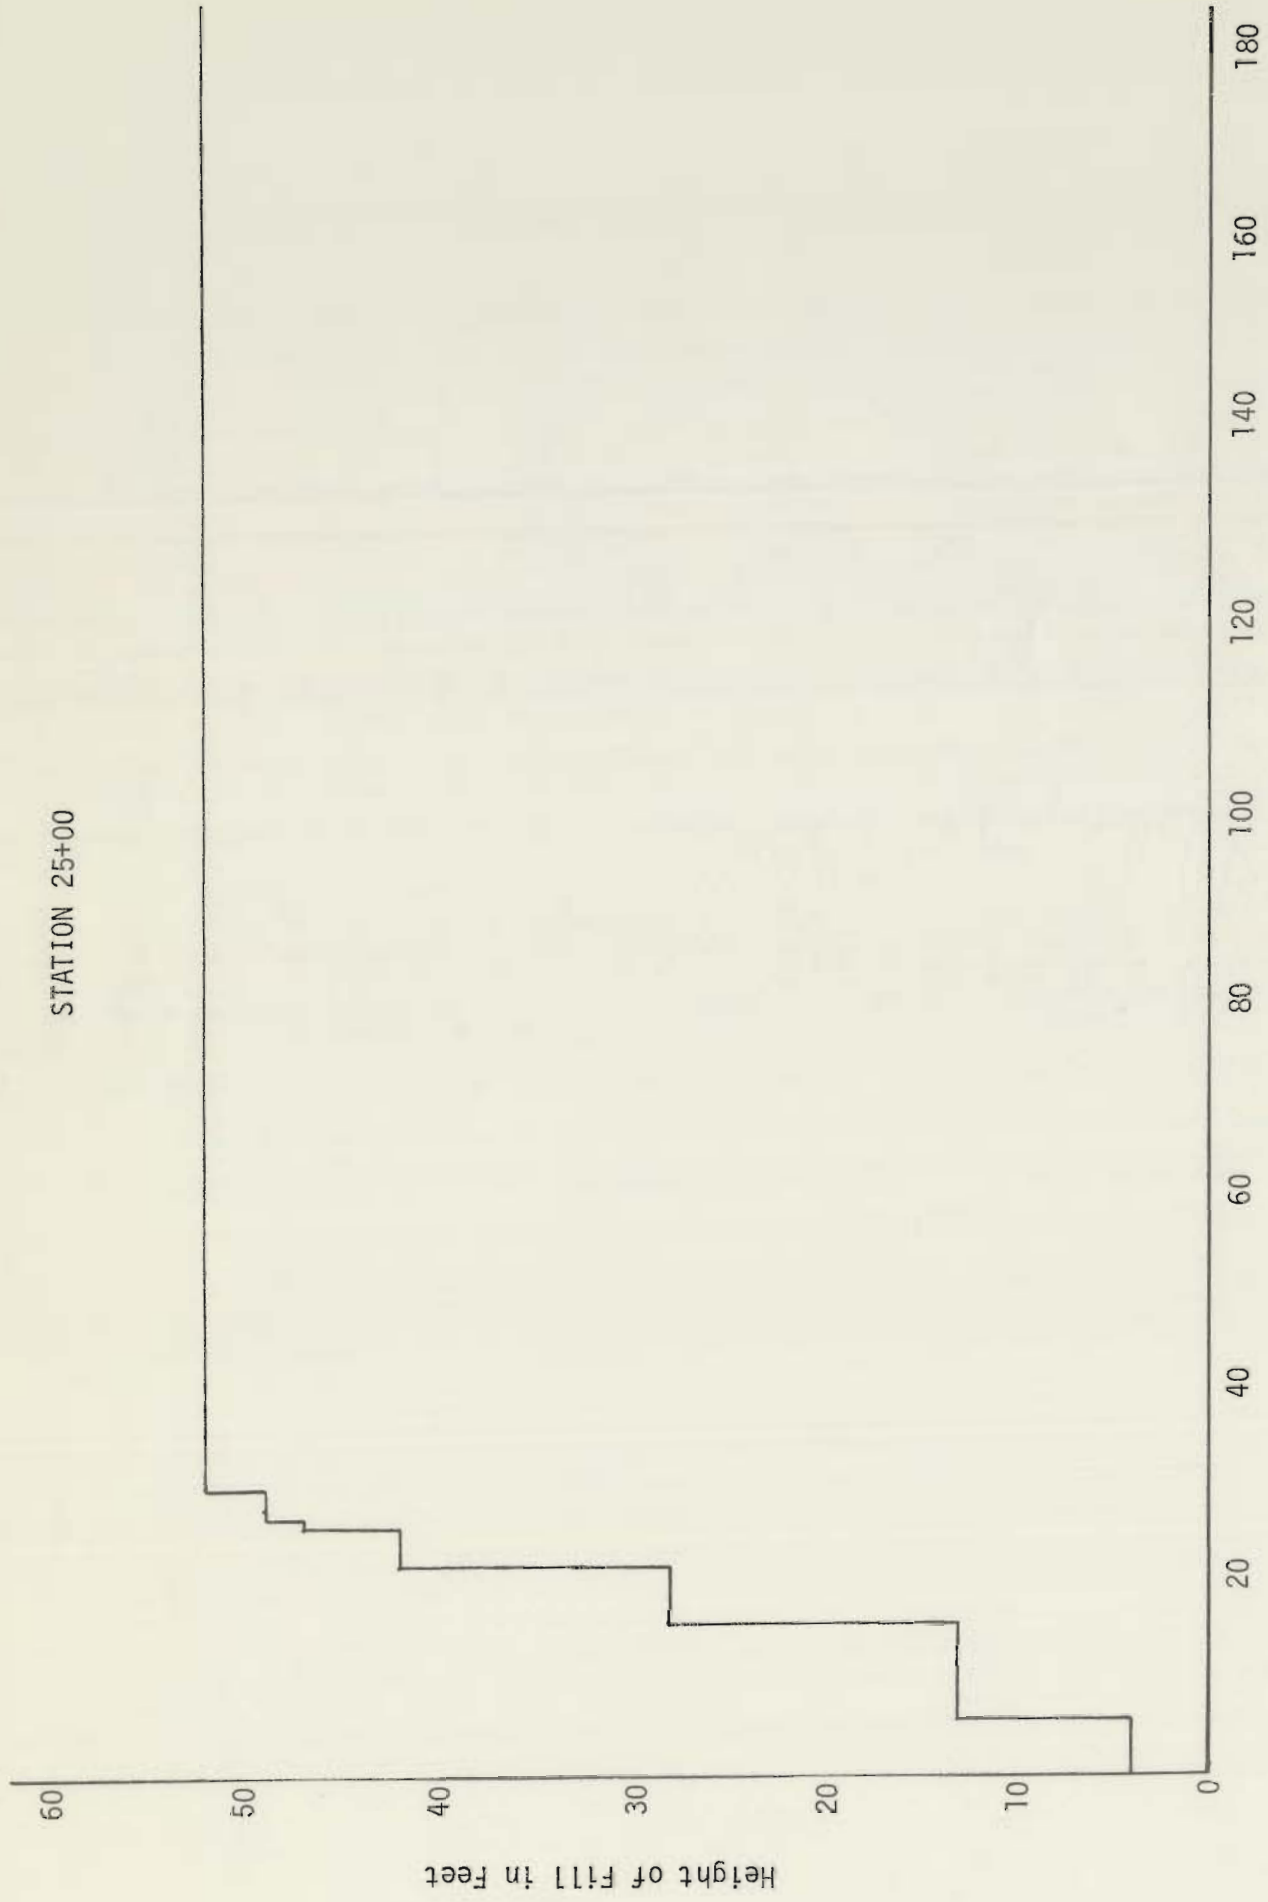
Figure 4 - Rate of Embankment Construction

The rate of building the embankment is shown in Figure 4.

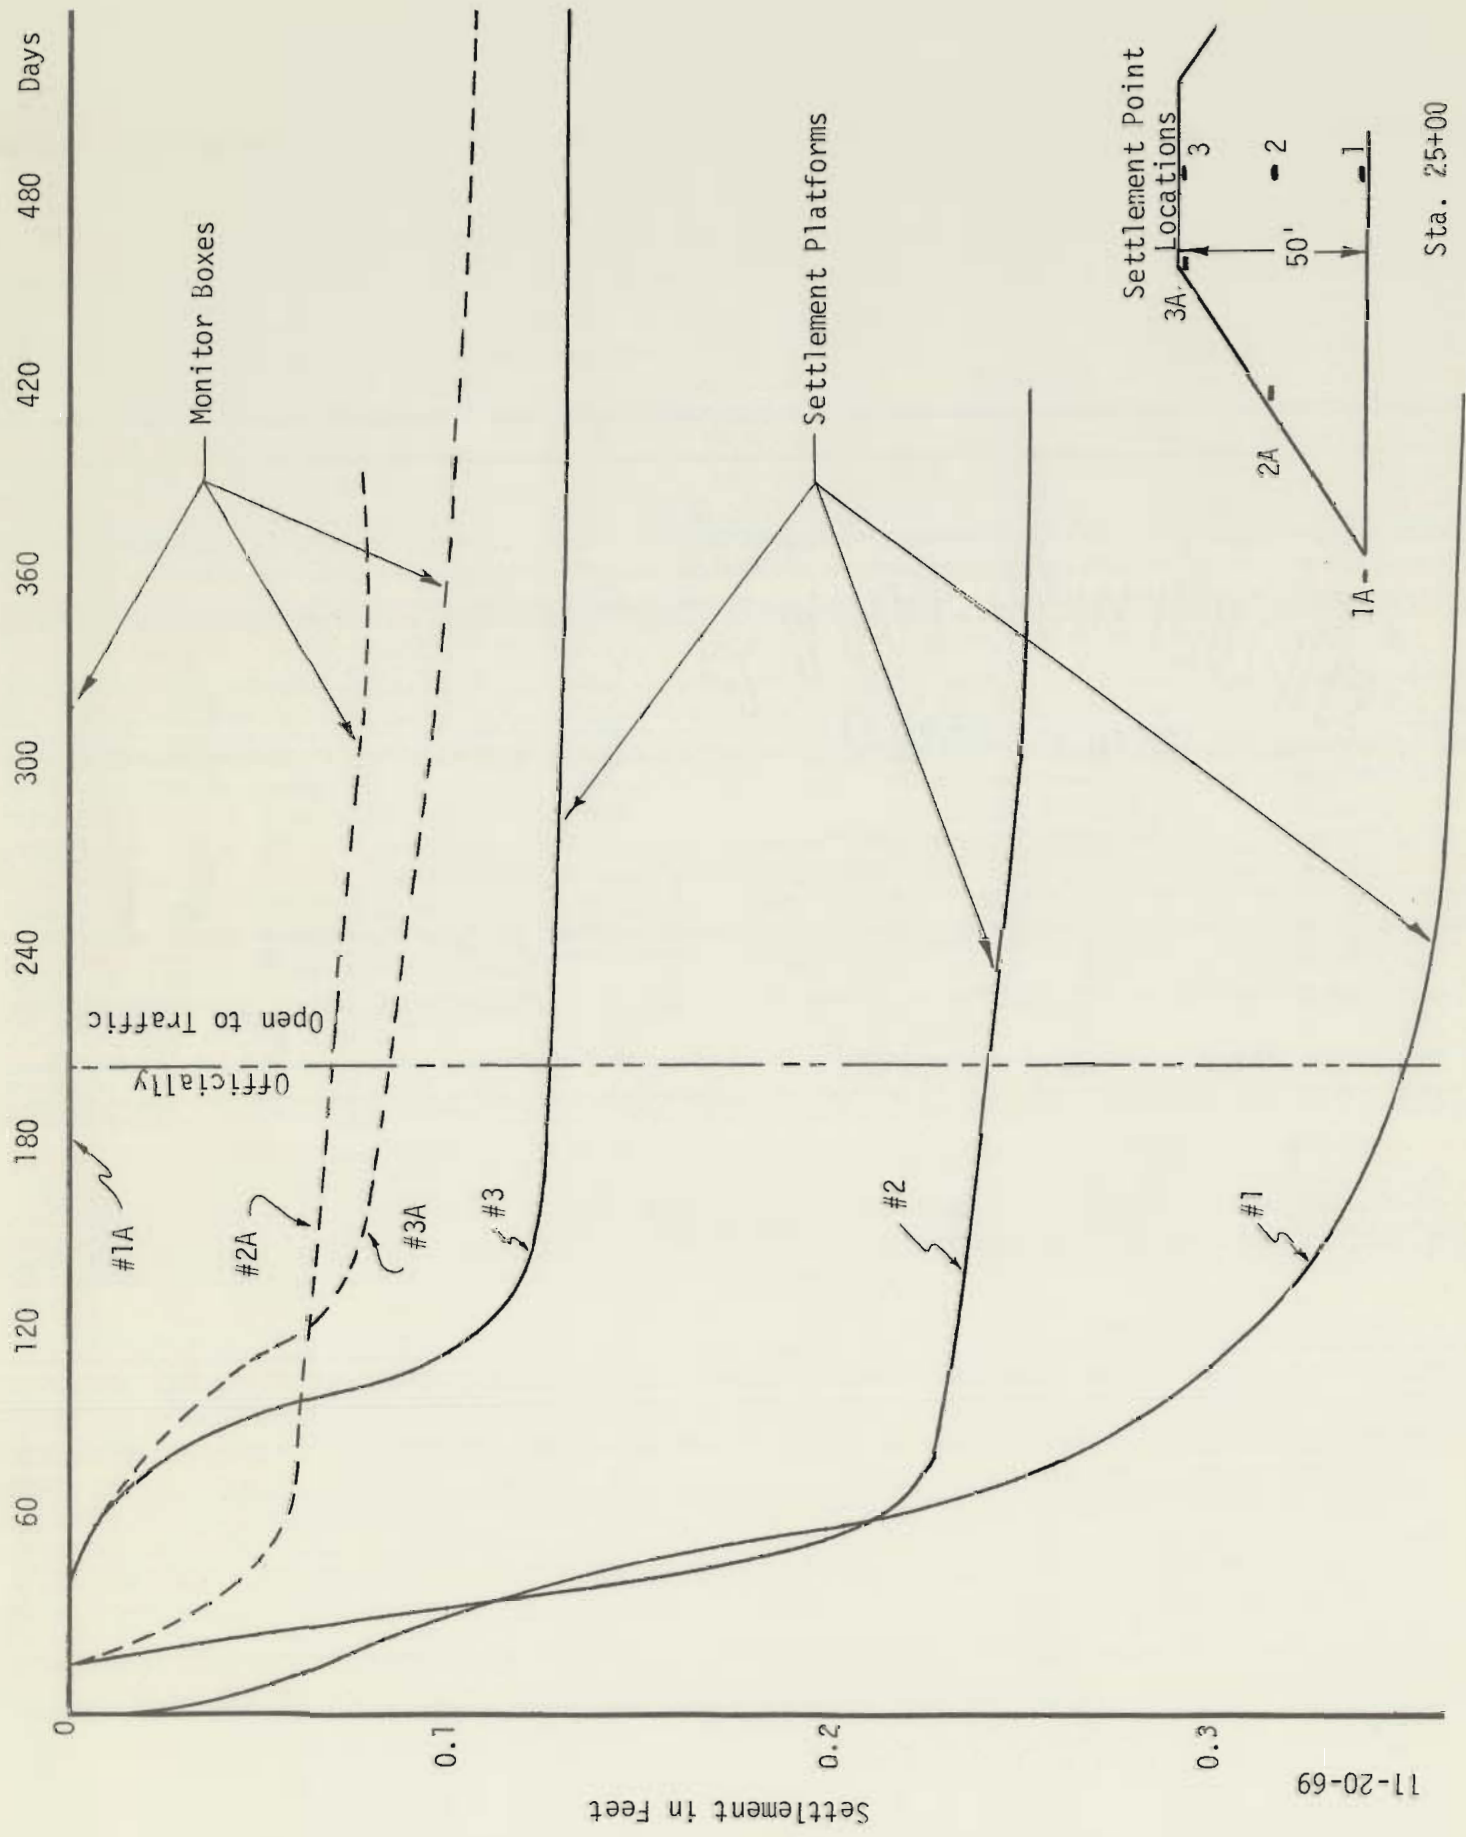
Figure 5 - Settlement Curves for Monitors at Sta. 25+00

Settlement of platforms 1, 2, and 3, and monitor boxes 1A, 2A, and 3A are shown in Figure 5. These curves are the average of scattered points from individual readings. Variation from reading to reading was experienced and is attributed primarily to temperature effects on the solution. No corrections were made to the readings to account for this.

Settlement monitor platform 1, placed at natural groundline on centerline indicates that about 0.35-feet downward movement has occurred. About 1/3 of this happened during embankment construction and 2/3's subsequent to completion of the embankment.

Settlement platform 2, located about 25 feet above natural ground, in the embankment recorded downward movement of 0.20-foot. Approximately 1/2 of this occurred during construction of the upper 25 feet of embankment. Settlement platform 3, near finished gradeline, recorded downward movement of about 0.10-foot.

The monitor boxes, placed in the embankment slope, show settlement at their locations. Number 2A and 3A show .07 and 0.10 feet of settlement, respectively, whereas 1A showed no movement.

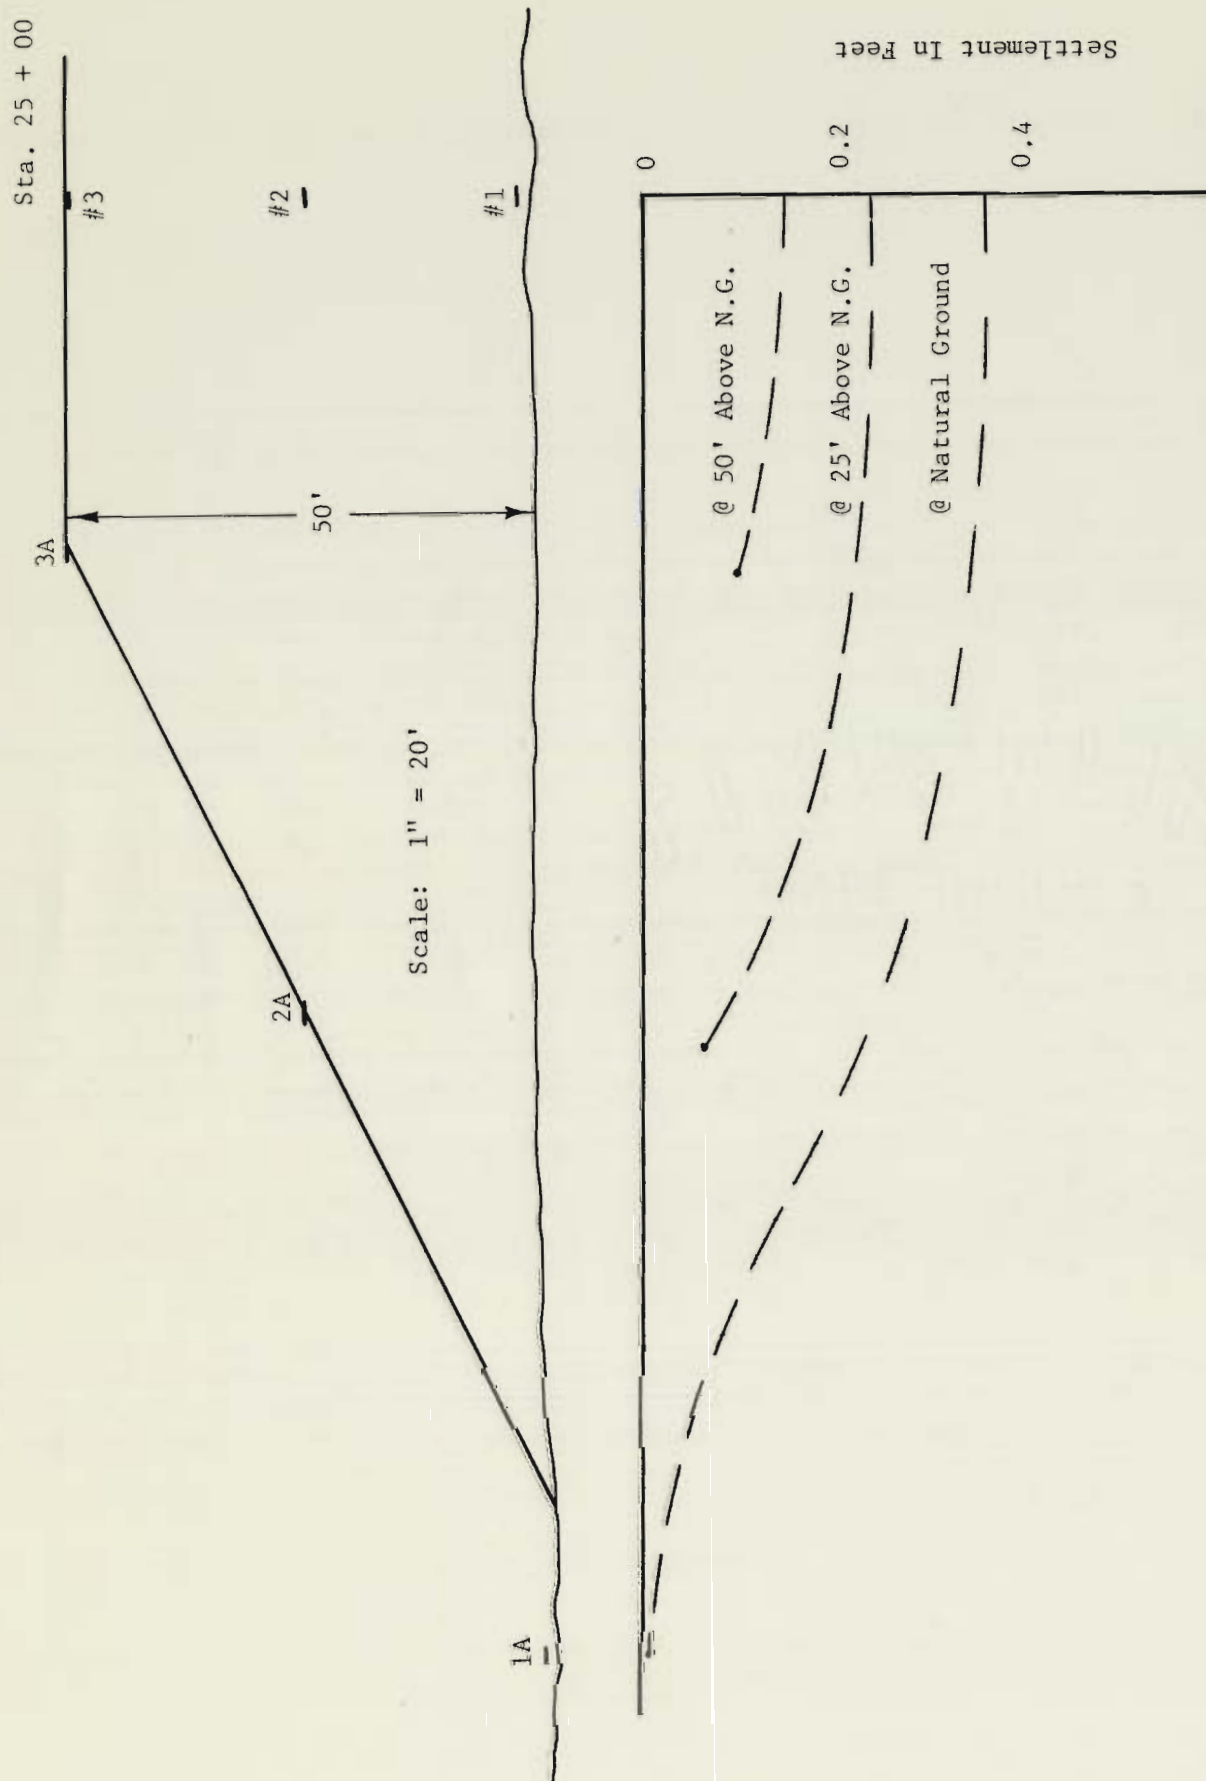
Figure 6 - Curves Showing Settlement of Monitor Units at Various Locations in Embankment X-Section

A plot of the amount of downward movement of each settlement platform and monitor box since installation is shown in Figure 6.

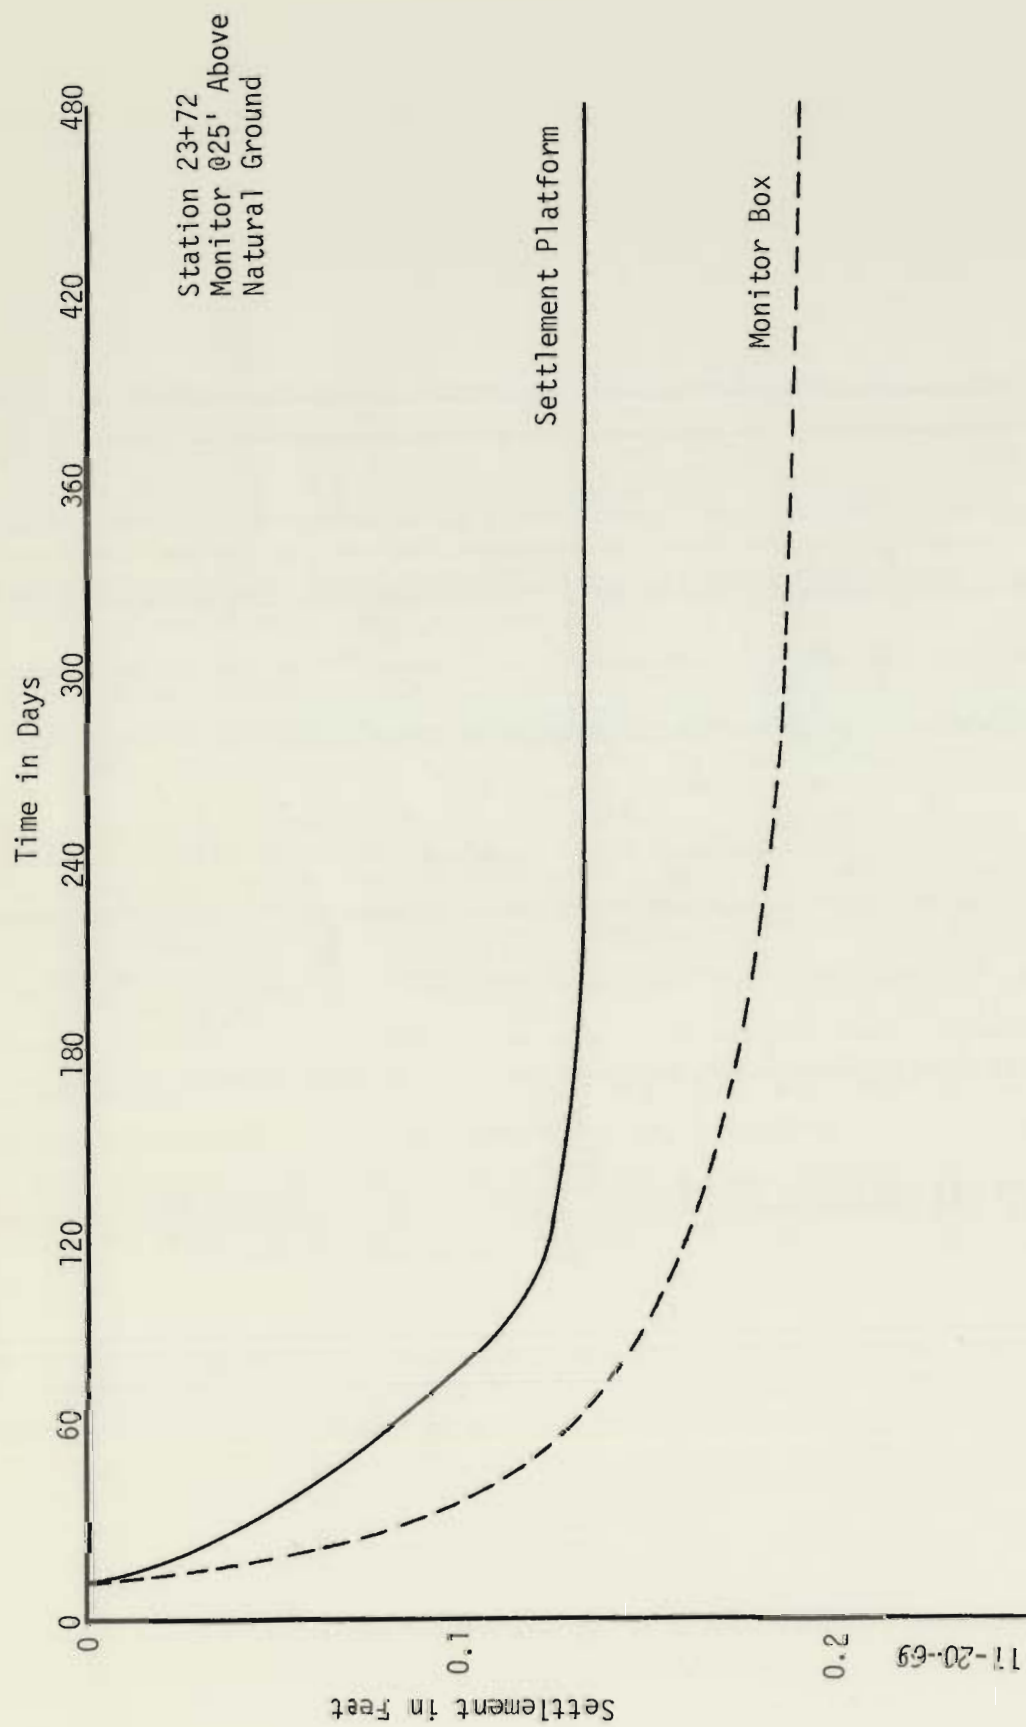
Figure 7 - Settlement Curves for Monitor @25' Above Natural Ground at Station 23+72

Settlement of monitors 1 and 3 is not included because of malfunction and late installation. Unit 2, as shown in Figure 7, had recorded downward movement of 0.11-foot at the settlement platform in the fill and 0.15-foot at the monitor box on the fill slope. This trend of greater settlement beneath the fill slope than beneath the embankment centerline, as shown in Figure 8, is opposite to the trend at Station 25+00. This was expected because the silt layer was subexcavated from beneath the centermost part of the embankment at the structure abutment location. Otherwise, approximately 0.5-foot of settlement could have been anticipated, resulting in considerable differential settlement between the approach, the abutment, and the other structure supports.
