ASPHALT PAVEMENT MIXTURE PERFORMANCE EVALUATION

ITD - RP070

JULY 1974

STATE OF IDAHO DEPARTMENT OF HIGHWAYS

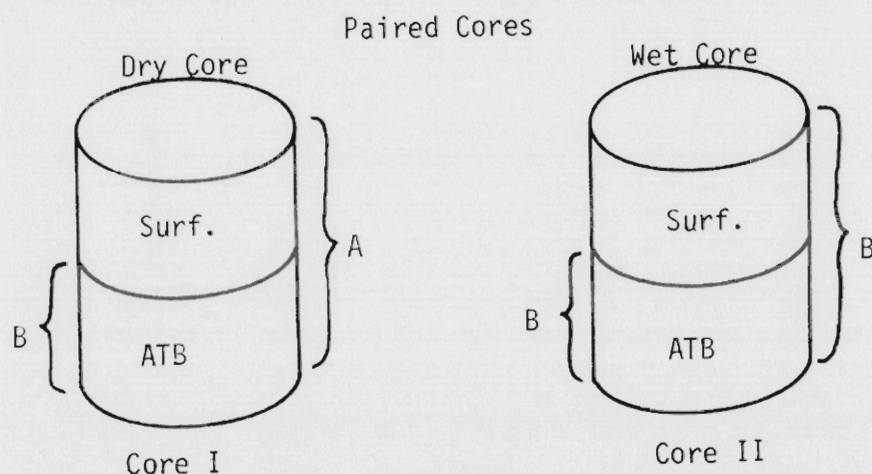
Figure 1 shows how the cores were numbered. At every milepost two cores were taken within a few feet longitudinally of each other, one received an "A" postscript (i.e. 601A) the other "B" (i.e. 601B). If the project had an asphalt treated base and was of sufficient depth for testing it was cut away and testing was conducted separately on the ATB portion of the core. To distinguish between ATB and surfacing for a given core a second postscript was assigned to the ATB portion of the core (i.e. 601AB for the ATB portion of core A, 601BB for the ATB portion of core B).

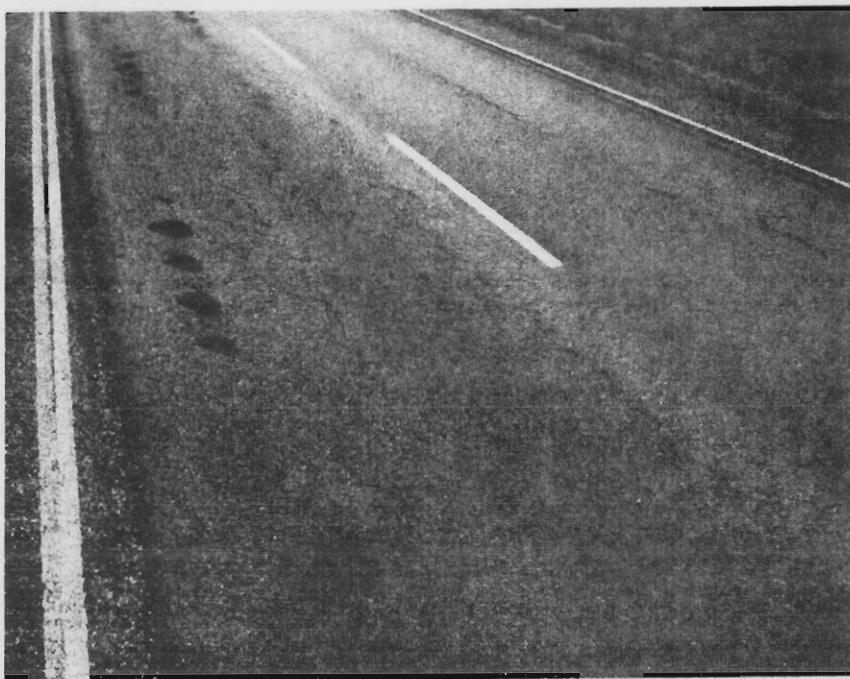
The section of Interstate from Igo Overhead to Rockland Jct. I.C. (American Falls Bypass) shows more distress in terms of pavement cracking than any of the other projects studied. Shown below is a picture which typifies the type and amount of cracking encountered along this section.

Cracking was most severe in the travel lane and portions of the mat were being displaced due to traffic action. Examination of test results (Tables I and II) show low average tensile strength for the Bypass Section. The tensile strength for Massacre Rocks Section are acceptable for the pavement age. Average air voids on both projects are within reasonable limits and the 4.6% air void average is quite acceptable for the American Falls Bypass Section.

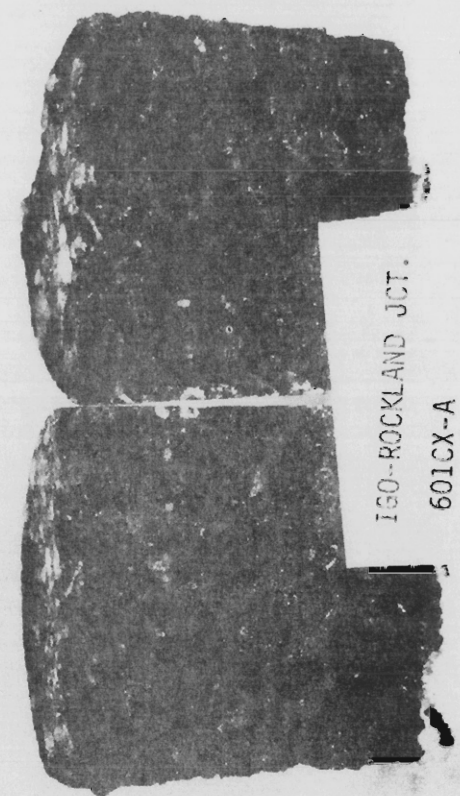
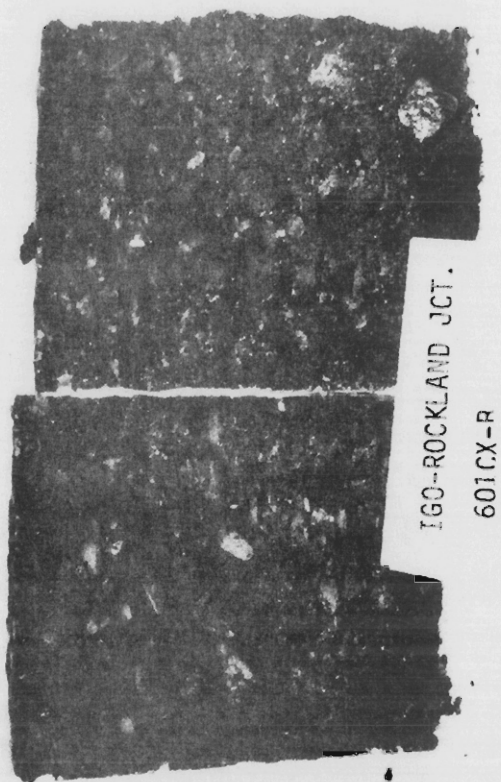
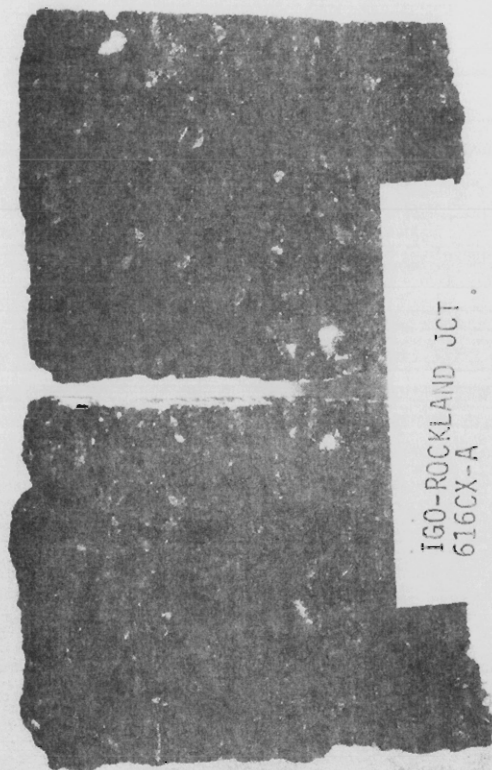
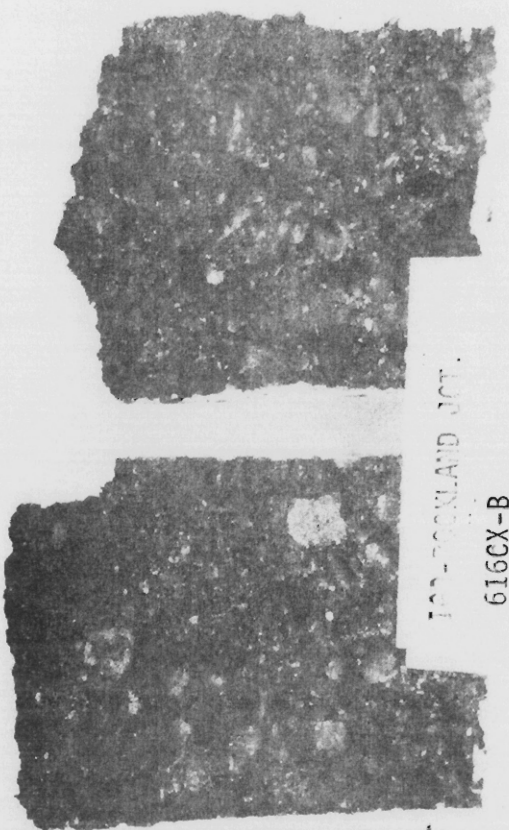
Figure 3 - Recovered cores from Igo-Rockland Section of Interstate.

Project data indicates that no anti-strip additives were used in the mix. It would appear based on project history, recovered cores, test data and field observation that the extensive cracking is directly related to severe stripping problems.

(1) Failure to apply anti-strip measures, i.e. rejection of the source or use of the same source with additives.

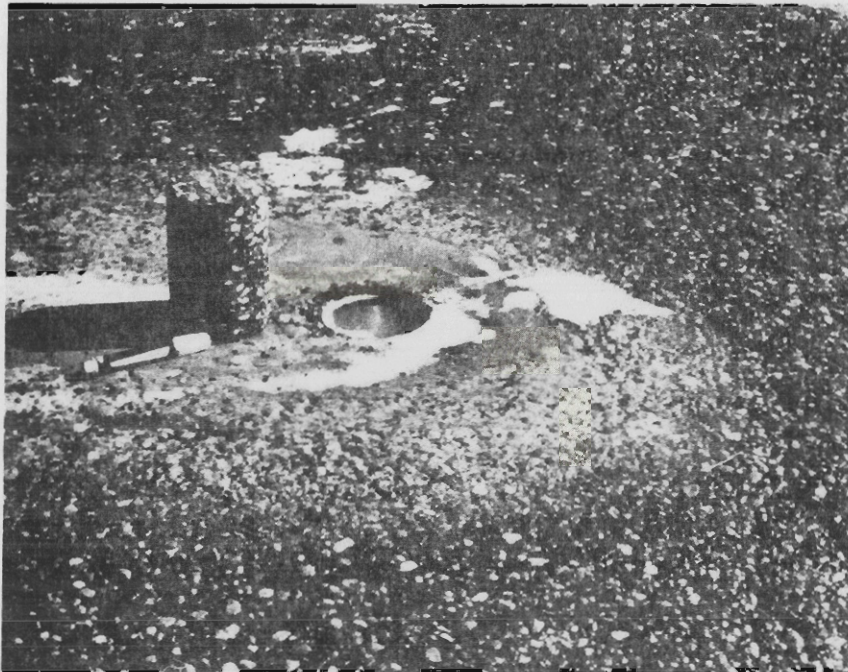
Figure 4 - American Falls Bypass

(2) Untreated base material was holding water and not allowing free migration downward. Figure 4 was taken some 10-15 minutes after the water was introduced into the core hole. Holding or ponding of water occurred at almost all drill holes where stripping was observed. There was not apparent drawdown even after one-half hour. The core hole depth was approximately 0.4' deep with the unprimed base exposed. Drainage should have occurred in the base but did not. It was evident that this base was not free draining as intended.

Several situations may be occurring independently or in combination. When certain soils or aggregates demonstrate low permeability they nearly always will have high capillarity. This might be possible, however, no testing was conducted on base material. Any water that can enter the pavements through cracks or surface imperfections will not be readily drawn away from the pavement-base interface, thus creating the environment for stripping activity at this interface. As stated earlier this stripping was progressively worse from top to bottom of each core observed. In summary, three distinct areas have contributed to rapid deterioration in this pavement.

(2) Poor permeability of the base material. The extensive cracking is merely symptomatic of loss of strength in pavement course due to progressive stripping.

5. Some aggregate bases appeared to trap water, thus promoting stripping. Gradation requirements for granular bases should be reviewed to assure ourselves that they will promote free migration of water. Macadam type bases could conceivably provide alternatives for impermeable granular bases.

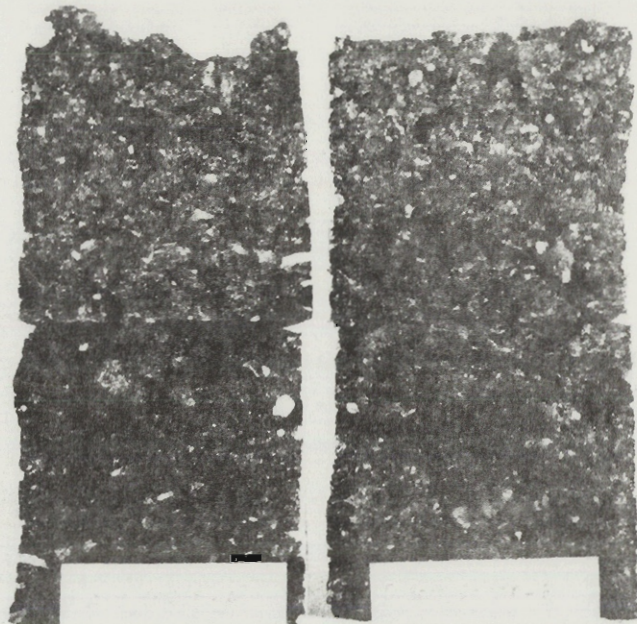
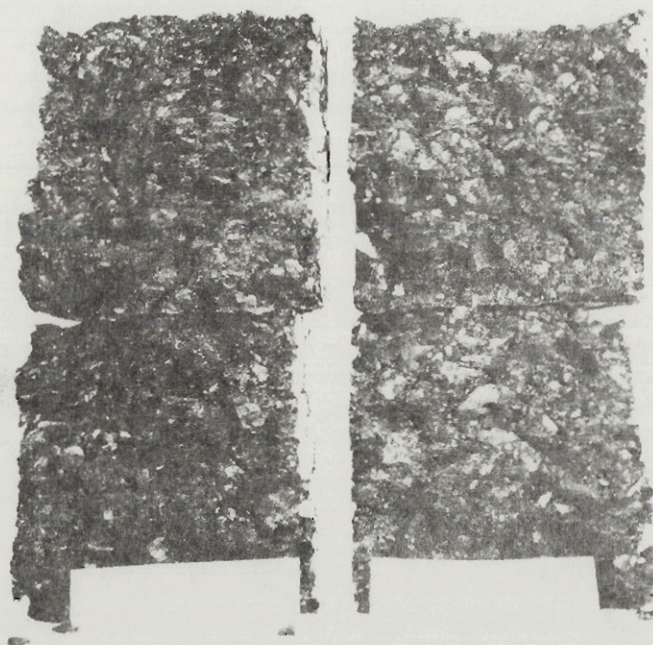
Figure 5 - Cores taken from Dubois Section of Interstate.

Although C1-40 and C1-56, based on aggregate source records, were not supposed to be stripping aggregates, stripping was quite evident on both projects. Figure 5 shows pictures of roadway cores taken from the Dubois project portraying some of the cores that were stripped.

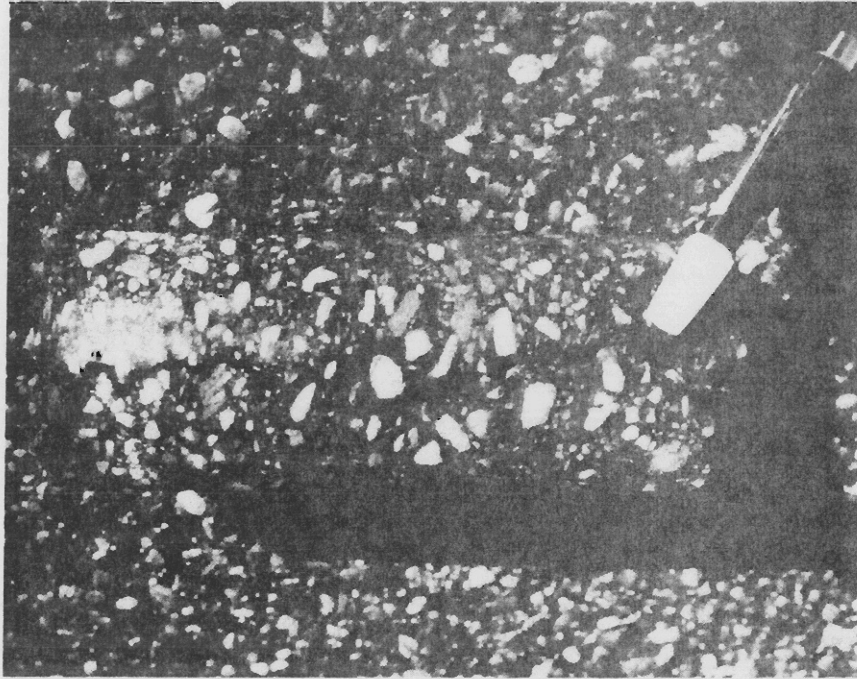
Figure 6 graphically portrays the problem encountered on both sections. Full width-full depth transverse cracks are occurring at 50'-150' intervals.

Core taken on transverse crack (cracked entire depth).

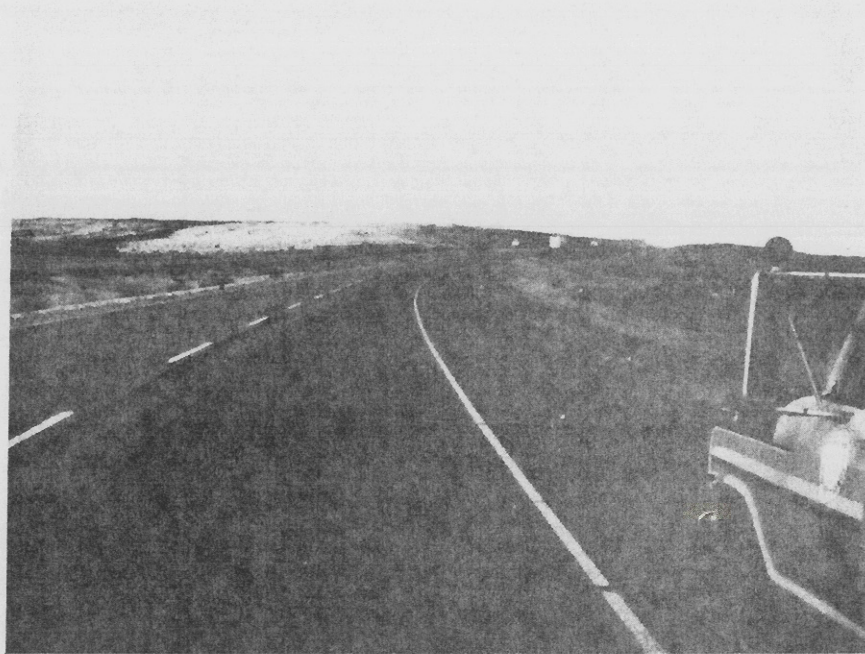
Full width transverse cracking occurring 50' to 150' intervals.

It is the author's opinion that the three conditions previously discussed, i.e. low viscosity, low penetration, and cold temperatures have been the primary cause of transverse cracking encountered in this area.

Two recommendations not related to stripping are suggested. It is recommended that all asphalt cements be selected with regard to environmental temperatures as outlined in the discussion. In no case should a brand or grade change be allowed without approval of the State Materials Engineer.

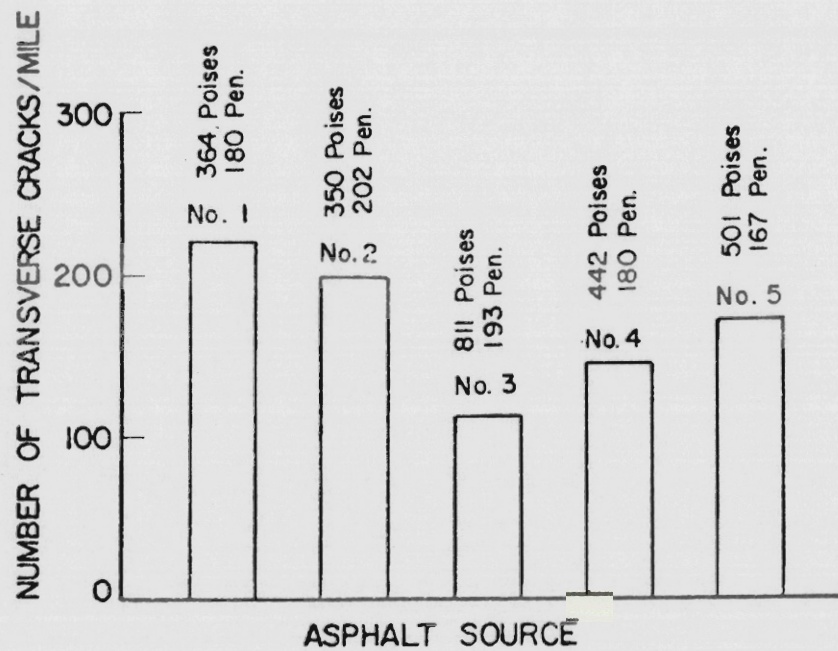
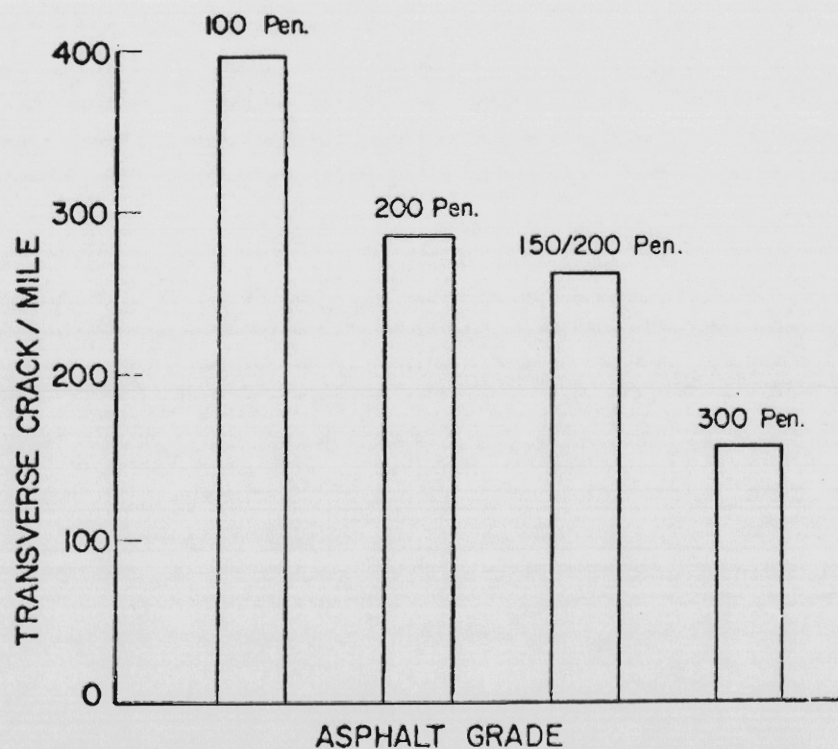
Figure 7 - "Low Temperature Pavement Cracking in Canada-The Problem and Its Treatment" by N. W. McLeod, et. al.

Note in the upper chart how the number of transverse cracks per mile decline with an increase in viscosity for a nearly constant pen grade asphalt. Referring to the other bar graph, as the pen increases the number of transverse cracks per mile decrease. The penetration and ductility numbers are original test values before mixing or laydown operations. Stated conversely a decrease in penetration number results in more transverse cracks and similarly a decrease in viscosity for a given penetration grade of asphalt also results in an increase in transverse cracking.

Figure 9 Summary of cracking versus asphalt source and asphalt grade from Saskatchewan experiment

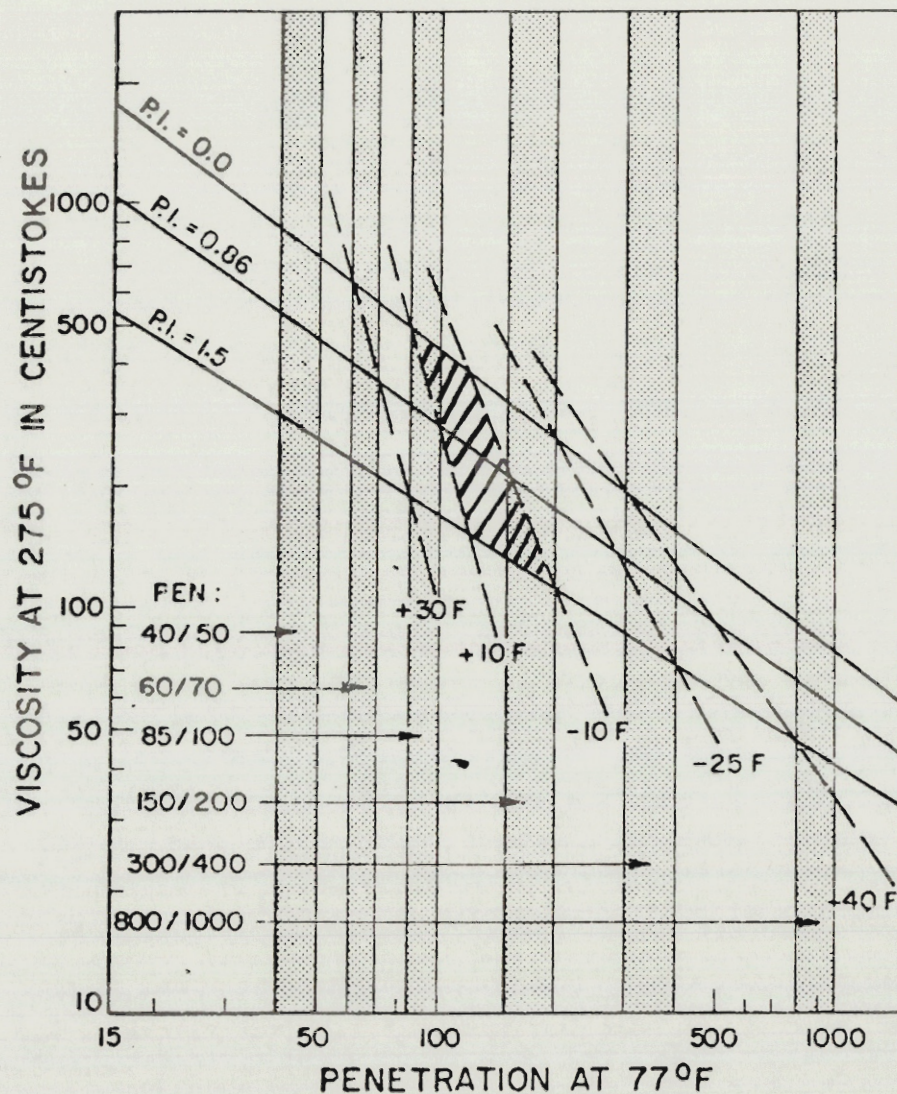
Figure 8 - "Low Temperature Pavement Cracking in Canada
The Problem and Its Treatment" by
N.W. McLeod, et.al.

Figure 15 Correlation between viscosity at 275°F and penetration at 77°F
