**RP 270**

# **Development of an Inventory and Inspection Database Framework for Asset Management of MSE Walls**

July 2019

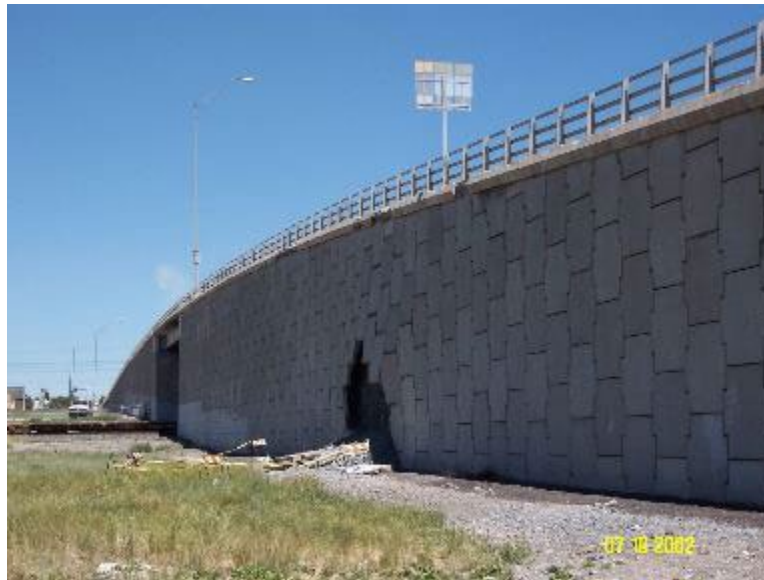
**Figure 2. MSE Wall Failure on SH-34, Soda Springs, ID, in July 2002 <sup>(3)</sup>**

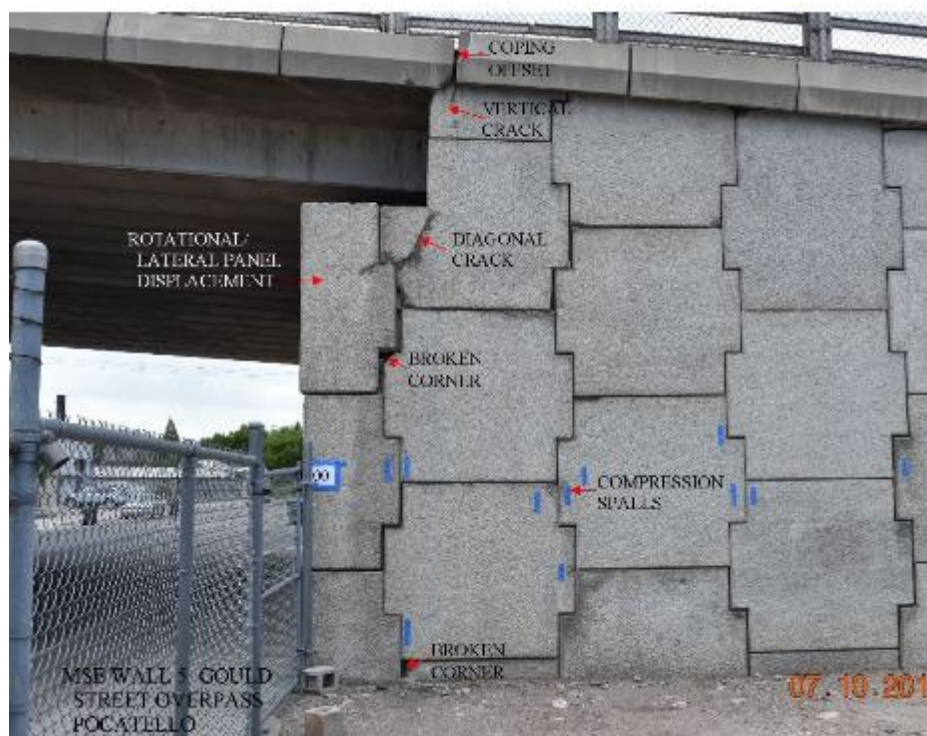
Gould Street/First Street Overpass: west bridge abutment; structural cracks and wall rotation/settlement

Figure 23. Severe Damage in MSE Wall 5 Beneath West Abutment of E. Gould Street Overpass

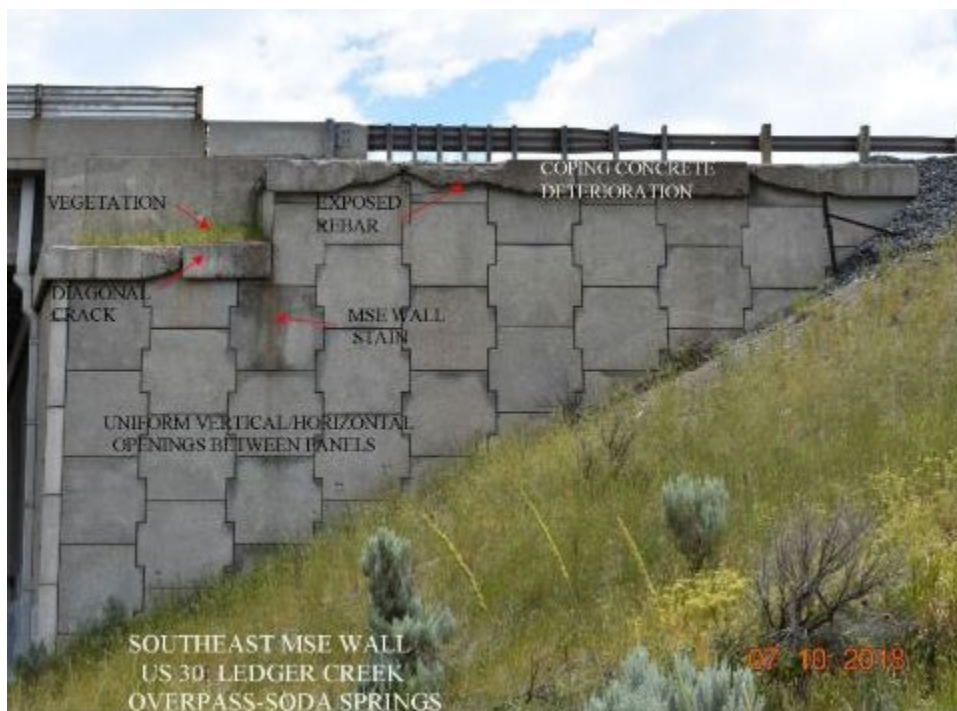
US-30 Ledger Creek Bridge: concrete coping deterioration

Figure 26. Severe Concrete Deterioration of MSE Wall Coping on Ledger Creek Bridge

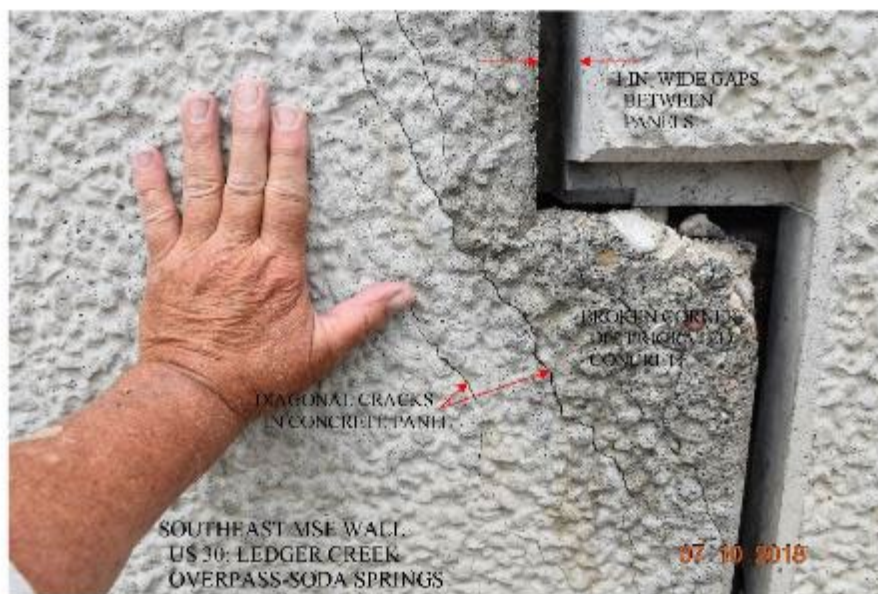
Figure 27. Concrete Deterioration and Diagonal Cracks in MSE Wall at Ledger Creek Bridge

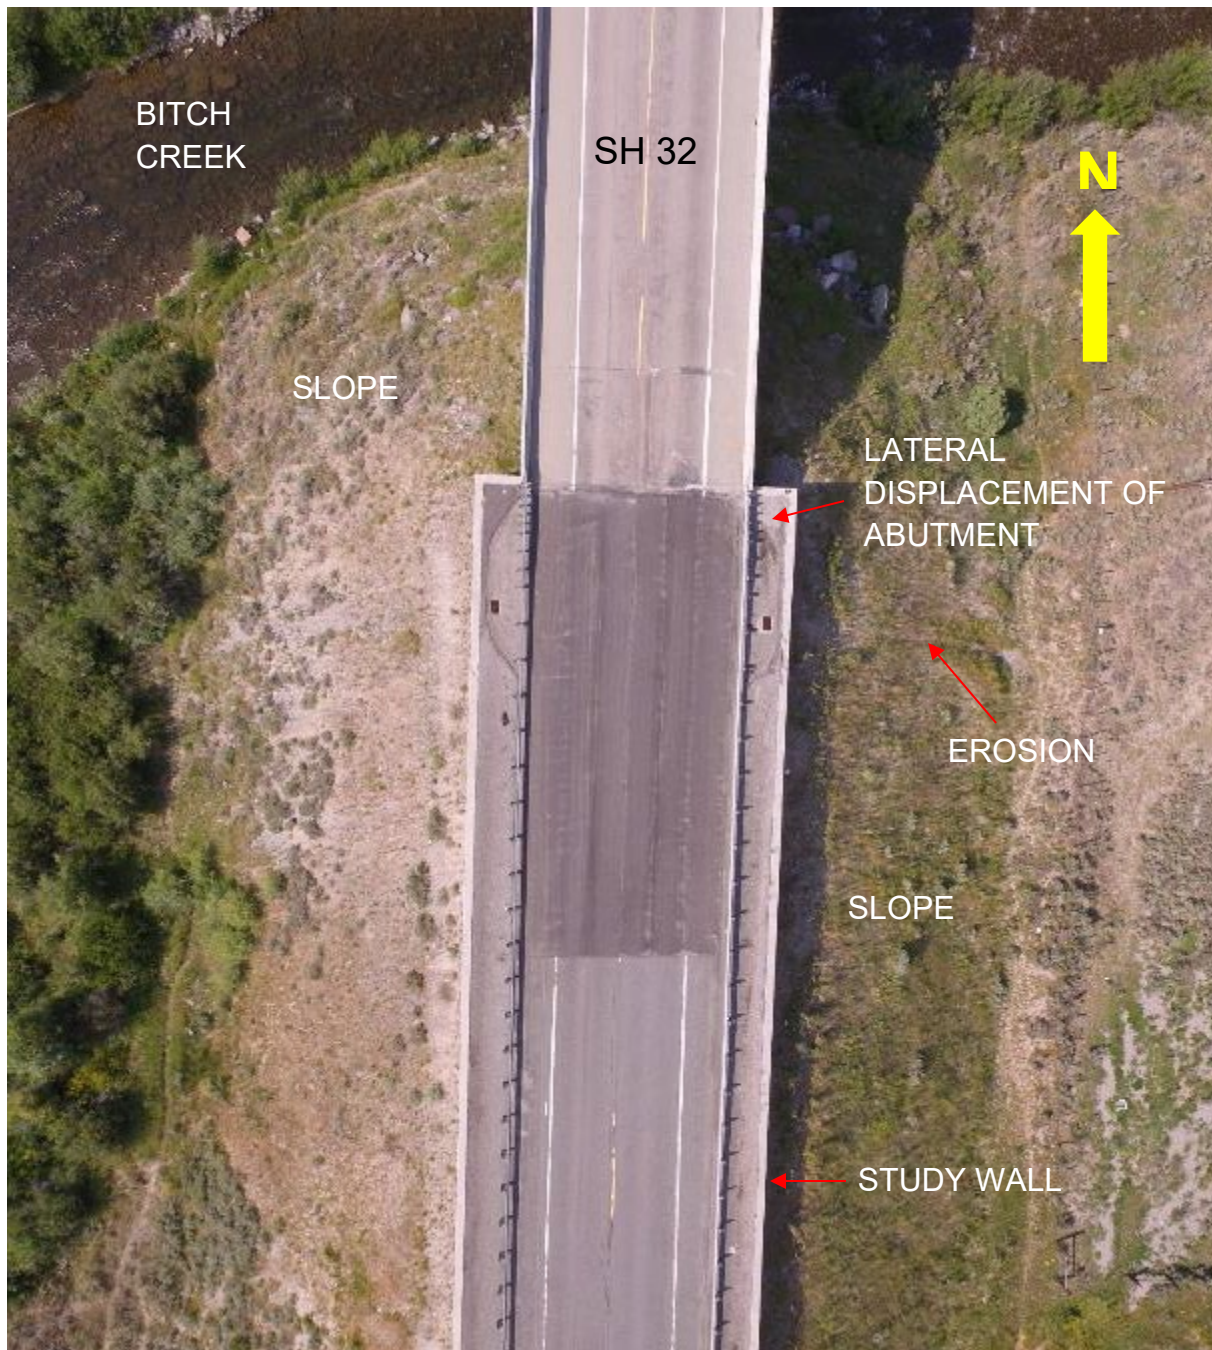
**Figure 32. sUAV Photo of Pavement Overlay in Area of MSE wall/Abutment Movement on Approach to Bitch Creek Bridge**

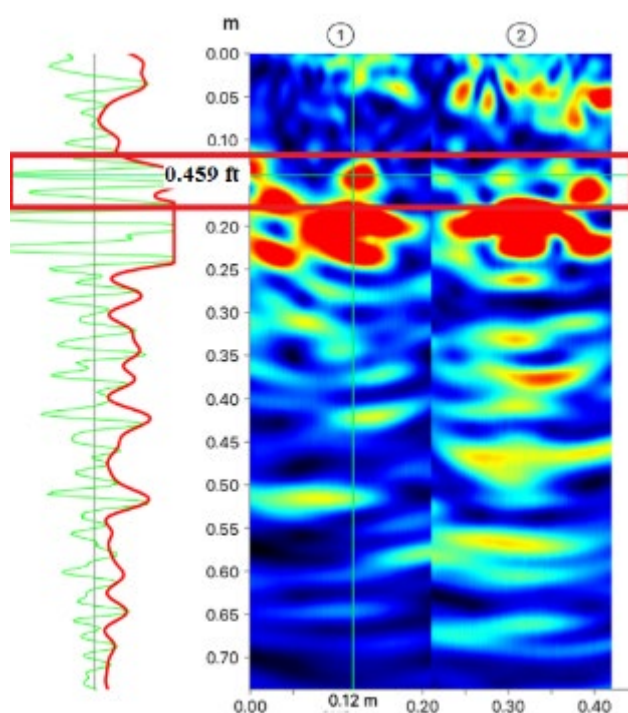
**Figure 47. A-scan (left) and B-scan (right) of potential delaminated area in Wall D3-3**

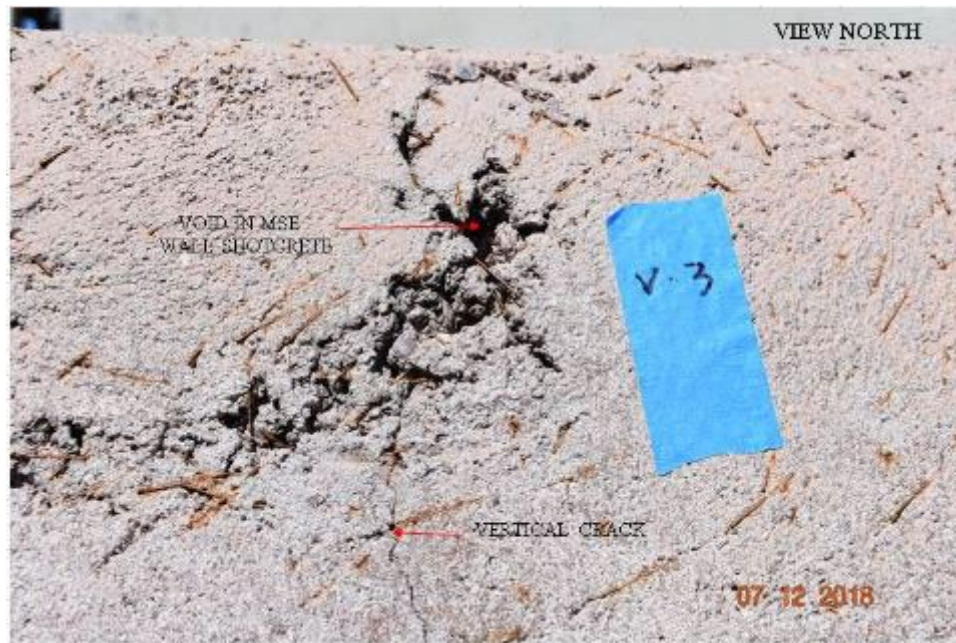
Figure 62. Void and Vert. Crack in MSE Wall Shotcrete, STA 1 + 92, Topaz Bridge

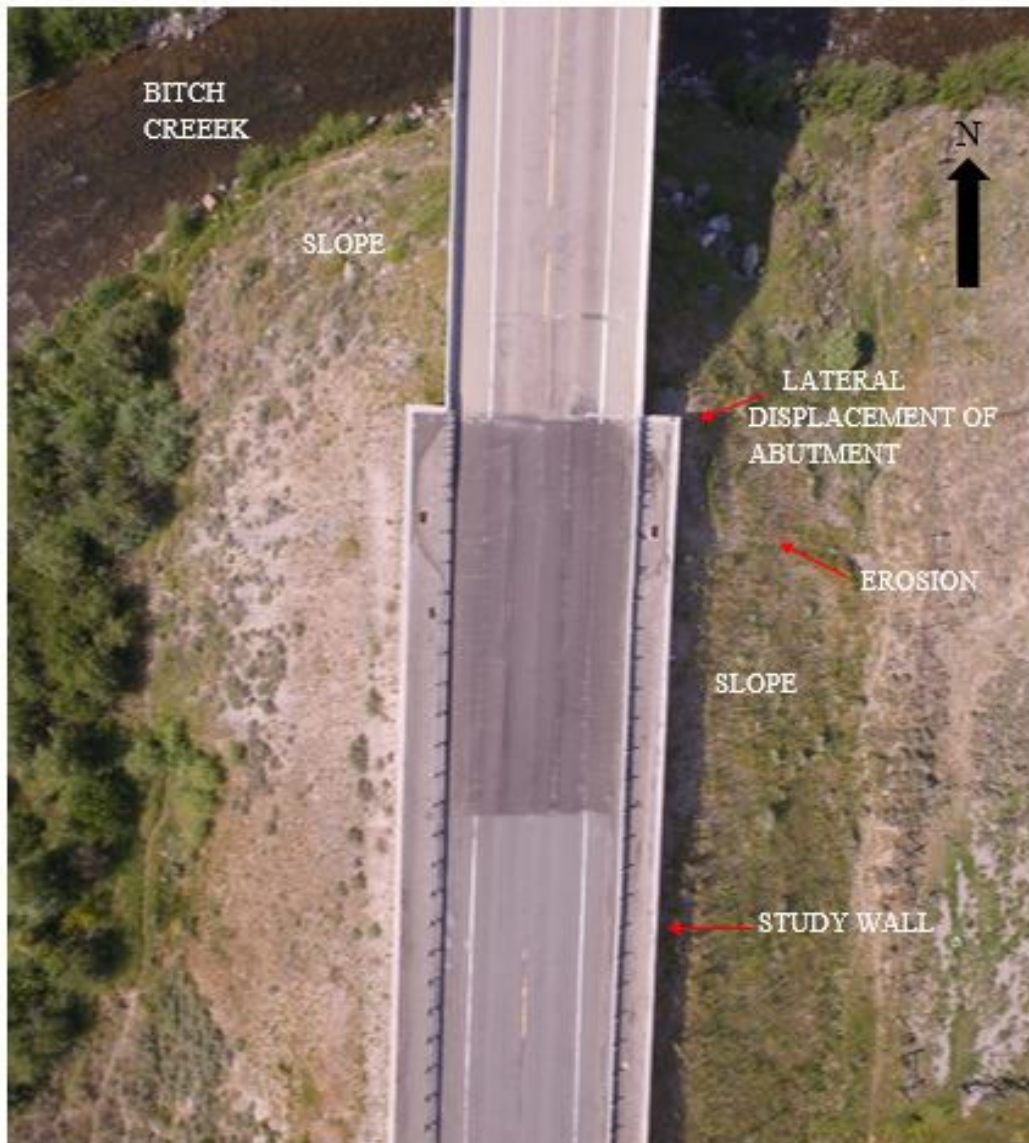
Figure 101. sUAV Photo of Pavement Overlay at South Abutment, Bitch Creek Bridge
