IDAHO TRANSPORTATION DEPARTMENT

Subject: 2020 5010-1 Airport Inspection conducted May 14, 2020.
(04141.311A Atlanta Atlanta Airport)

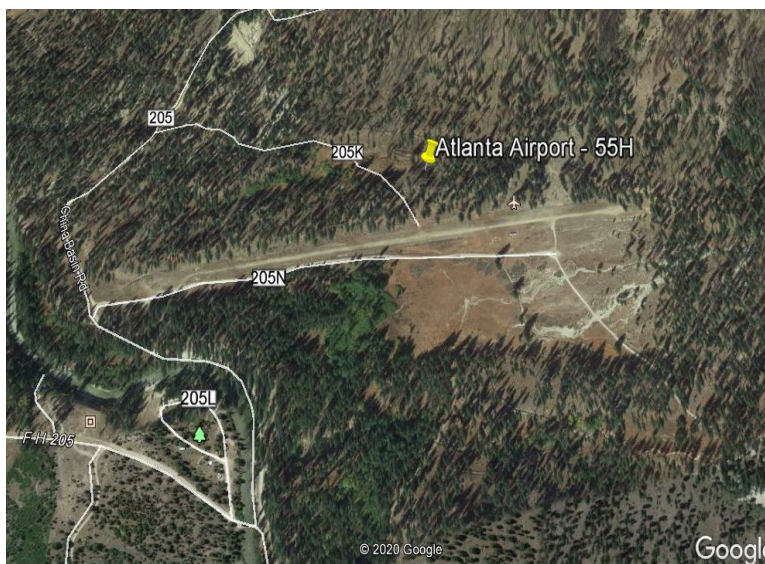
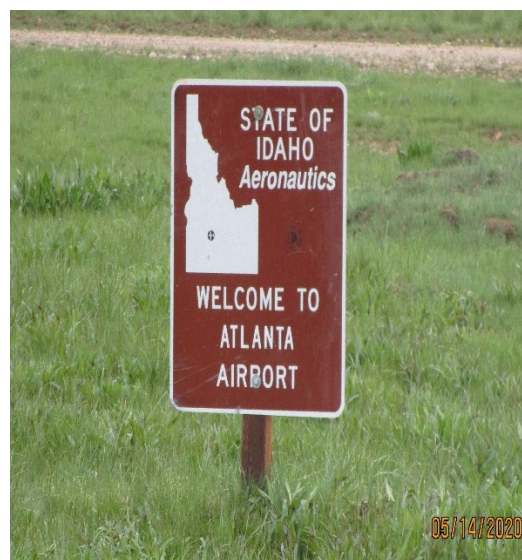
At the time of the inspection, the runway surface was in great condition and fairly smooth. The surface had no undulations, grooves or ruts, only some loose rocks, up to 3", were scattered down the bare centerline; I spent some time picking and throwing the worst of them to the side. Overall, the runway displayed good and well-maintained vegetation. The painted rock boundary markers were in great shape and had excellent paint coverage; there was very little vegetation growing through them.

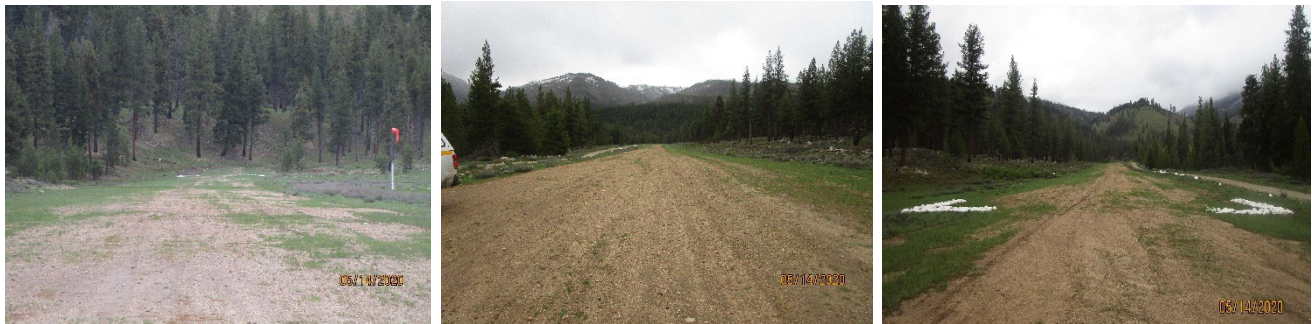
Tiedowns: There are two tie down spots, to the North of the windsock, and both had chains visible.

Windsock/Standard/Segmented Circle: I rated the windsock condition as good. The windsock standard was in excellent mechanical condition - solid, functional, and painted white. The non-standard segmented circle present was in good condition, had great paint coverage, and was very visible from the air. Some grasses were growing between the rocks and I don't believe that will be an issue in the immediate future, however, if time permits maybe a spraying- later, toward the end of the season would be beneficial.

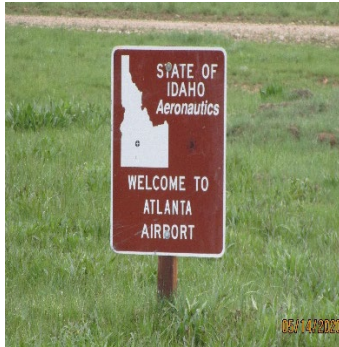
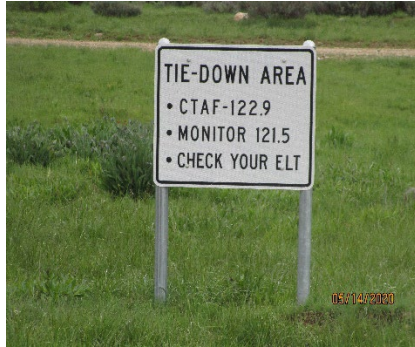
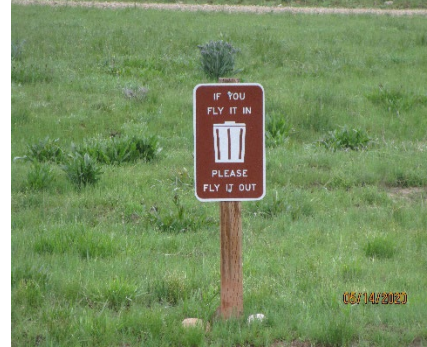
Miscellaneous/Services: All airport-related signs were upright, legible, and firmly mounted.
