IDAHO TRANSPORTATION DEPARTMENT

SUBJECT: 2023 5010-1 Airport Inspection conducted May 26, 2023.
(04142.A Bancroft Bancroft Municipal Airport)

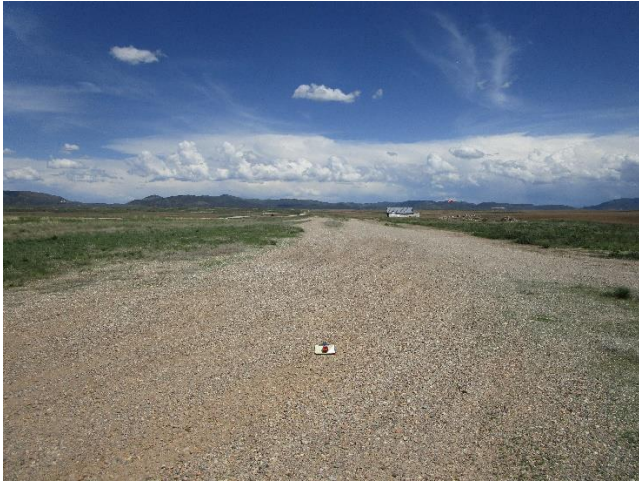
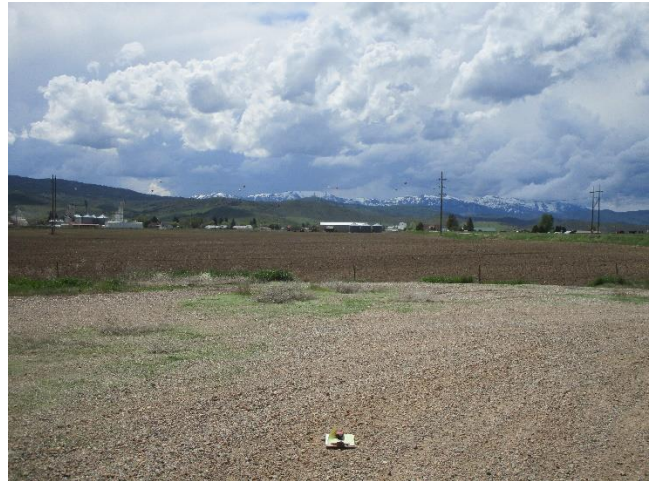
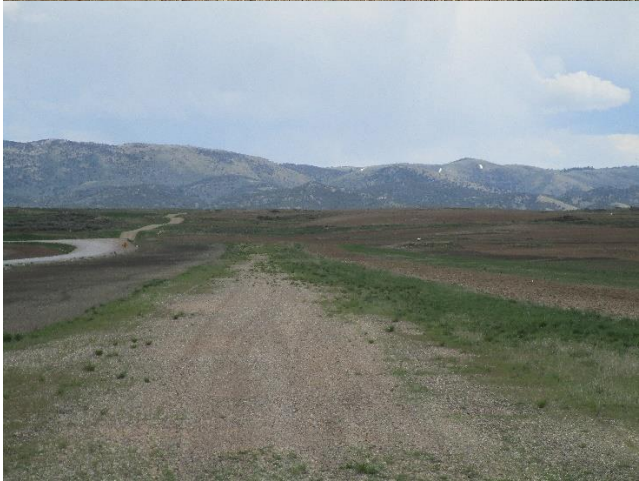
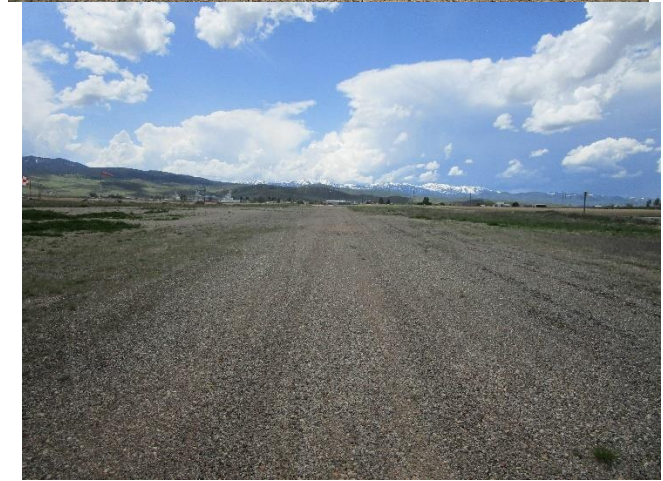
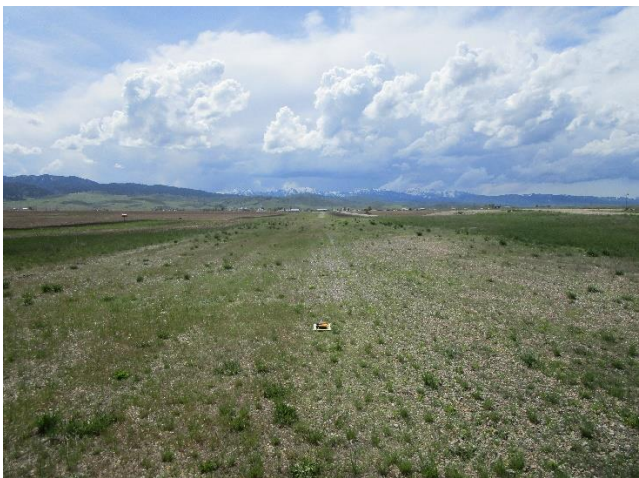
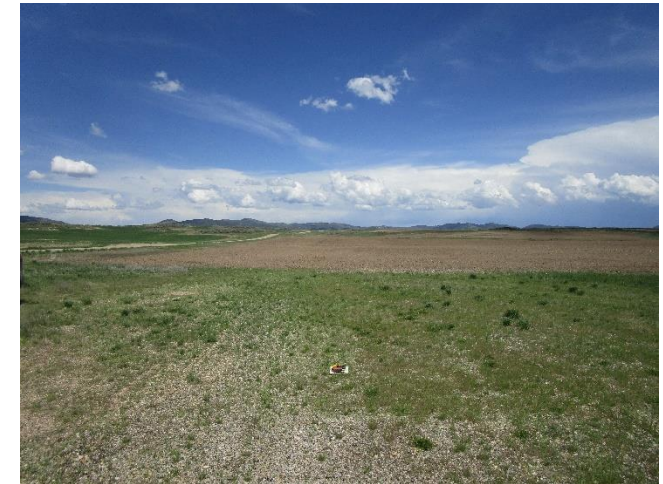
Runway 7-25: Wow George, the airport looks so much better and cleaner than it did 3 years ago when I first came and visited. The most noticeable is the pile of scrap metal and old appliances that used to sit East of the hangar...I am impressed; it is so much nicer with all that extra and unneeded stuff out of the picture. The runway surface condition continues to be fair, still; it is about the same as it was three years ago. Vegetation is mostly under control except for the eastern half of the runway that is still battling some 8 to 15" tall grasses. Both approaches remain unchanged and with the same controlling obstructions as before and as listed in the Airport Master Record.

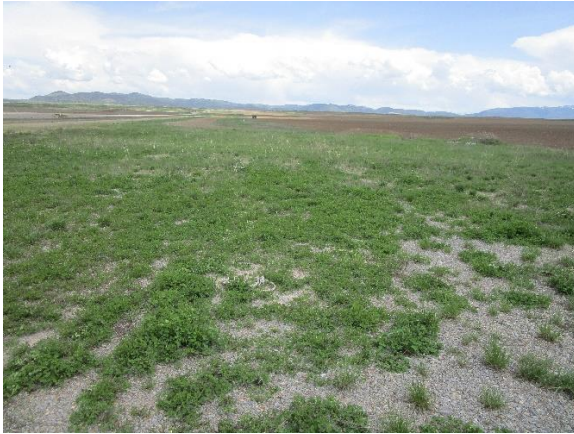
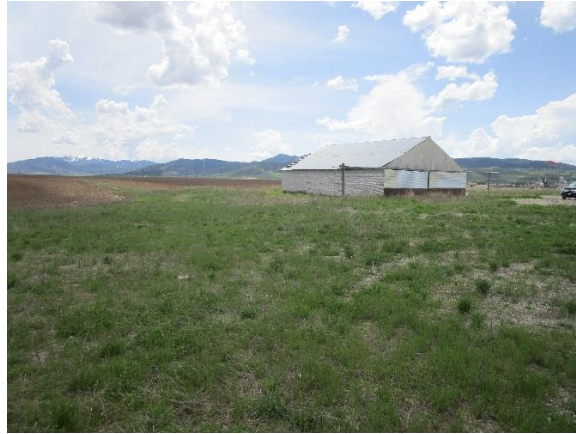
Tiedowns: The tie down area by the hangar used to have an older aircraft parked in it, but not anymore. The tie-down pad to the west of the hangar that was formerly occupied by the old fire truck and parts of the wrecked crop duster looked totally free of debris and it was nice and

clean. Of the possible 6-7 parking spots between the two parking areas, I saw only two sets of ropes present, one on each side of the hangar.

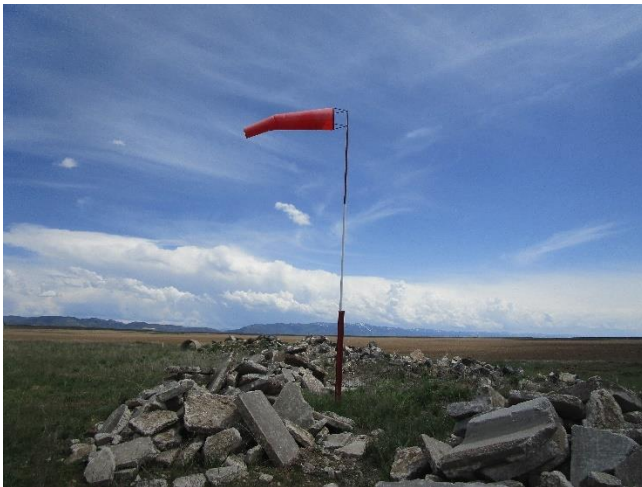
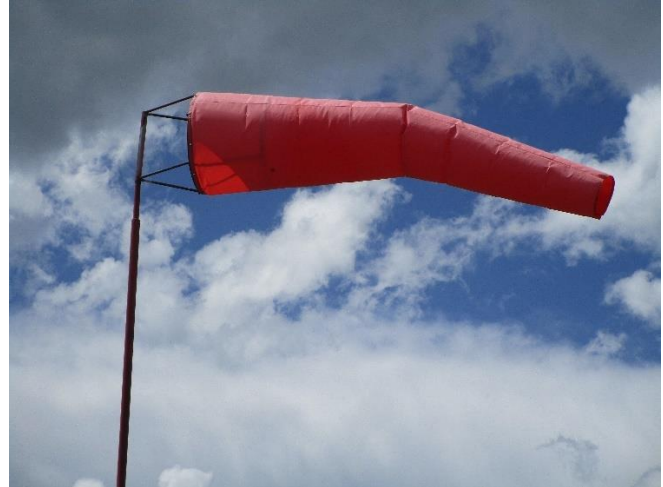
Windsock/Standard/Segmented Circle: The windsock was almost brand new and had been installed properly – with the drain hole at the bottom. The standard was solid, in great mechanical condition and with excellent red and white paint coverage. There was no segmented circle present around the windsock.

Action item:

1. My only suggestion here is to either slowly work on pushing back those big concrete chunks and push them toward the edge of the property line where the windsock standard is not surrounded by any of them. Or, use them to make a segmented circle out of them and paint them white for better windsock visibility (if you need any info on how to make the segmented circle, let me know and I will send you some helpful design info). However, you would still need to push the better majority of it to the side.
