IDAHO TRANSPORTATION DEPARTMENT

SUBJECT: 2020 - 5010-1 Airport Inspection conducted May 28, 2020.
(04163.4A Carey Carey Airport)

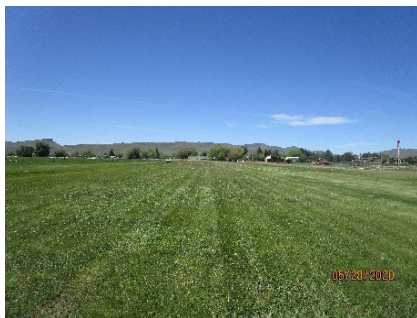
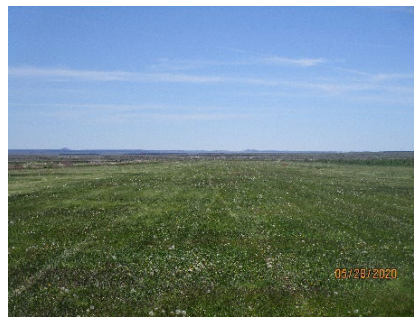
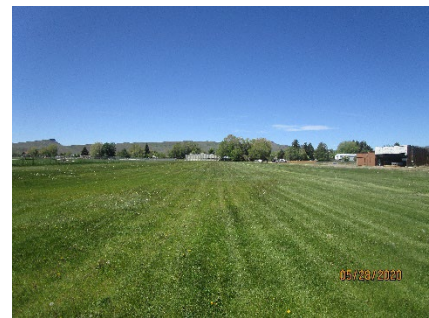
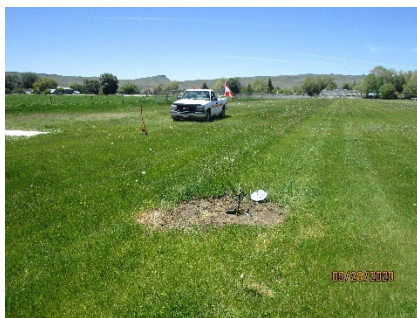
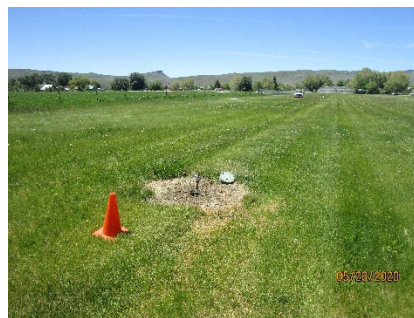
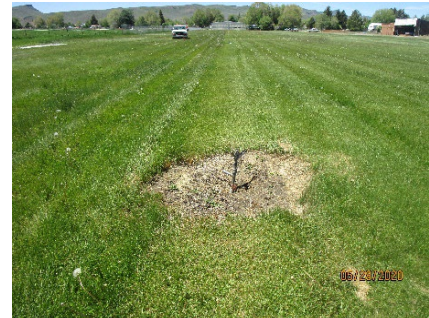
Runway 8-26 & Boundary Markers: At the time of the inspection, the turf runway surface appeared to be in good condition with a fairly thick and uniform 6-8" layer of grass, rich and decorated with dandy-lions. Overall, the surface was fairly smooth and level, and provided for a good take-off and landing roll. In terms of rodent activity, I did not see any dirt mounds or holes that were worth mentioning. I would continue to advertise the use of this airstrip "Normally land Rwy 26 and depart Rwy 8, if weather conditions permit" in an effort to minimize having to deal with the 30' hangar and 60' trees type obstructions located to the west of the airstrip. Even though you have a 750' displaced threshold, it would be wise and safer not having to deal with them on final approach. Another thing that I wanted to address was the sprinkler system access lids and the sunken-in area around each one of them, which are large enough and very noticeable. Again, my mentioning of it is only an observation and a mere suggestion to increase your safety of ground operations. A couple of things regarding those: one you could do nothing and continue operating as you have been, or, instead of using 2' tall orange cones to mark the sprinklers, you could paint each plastic lid with bright orange paint to make them more visible that way. With that said, you would still have to use cones to mark the sprinklers while in operation. The second thing I would consider would be to raise up each individual sprinkler and green canister to be level with the rest of the grass around them. By bringing in some fill dirt around each canister, and throw down some grass seed, in due time, this would eliminate the sunken-in area, which is pronounced and noticeable, especially if an aircraft rolled over them during landing. I am only suggesting this, as a way to enhance the safety for those using your airstrip, but ultimately, it is your airport and you guys have the final say on it. The boundary markers were in good condition, made out of solid cement panels, painted white, and are visible from the air.

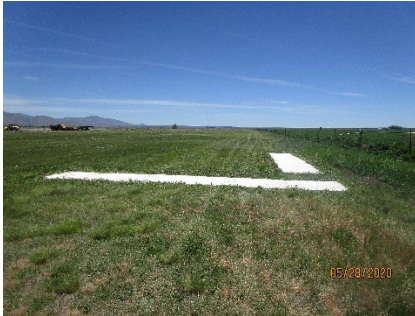
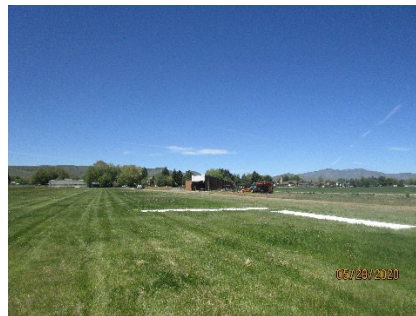
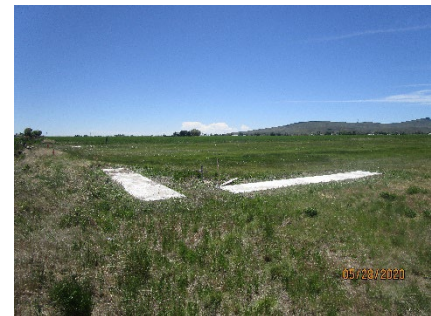
Parking Area/Tie-downs: The temporary parking/tie down area was in good condition with 5 available parking spots of which all had tie-down chains present. Good vegetation control around this area and the rest of the airstrip for that matter. I am sure the new tie-down location, along the fence on the south side of the airstrip, would be just as good.

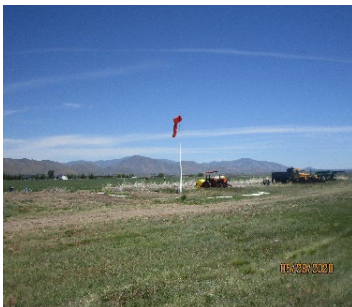
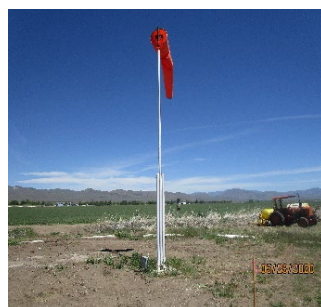
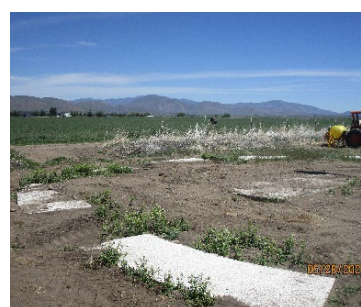
Runway 8 Windsock:

Windsocks/Standards/Segmented Circle: There are two windsocks at this airfield and both located on the north side of the airstrip – one closer to rwy end 8, which has lights, and the other right at the end of rwy 26. Each windsock was in good condition and had no apparent/visible tears. Both metal standards were mechanically sturdy, functional, and had good paint coverage. The cement panels of the segmented circle at rwy end 8, were adequately painted, but did have a bit of vegetation growing and encroaching on the panels. The segmented circle at rwy end 26 was in good condition and very visible from the air. A quick mow and a killer spray, at both windsocks, would take care of all those weeds in no time.
