IDAHO TRANSPORTATION DEPARTMENT

Division of Aeronautics
1390 W Gowen Road, Boise ID 83705

SUBJECT: 2023 - 5010-1 Airport Inspection conducted August 10, 2023.
(04163.4A Carey Carey Airport)

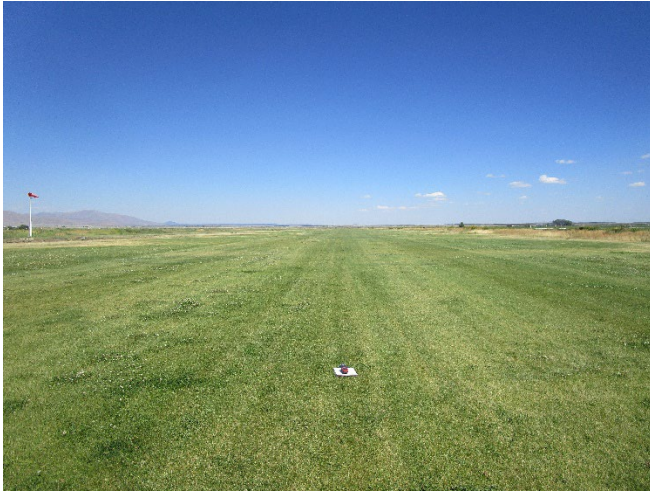
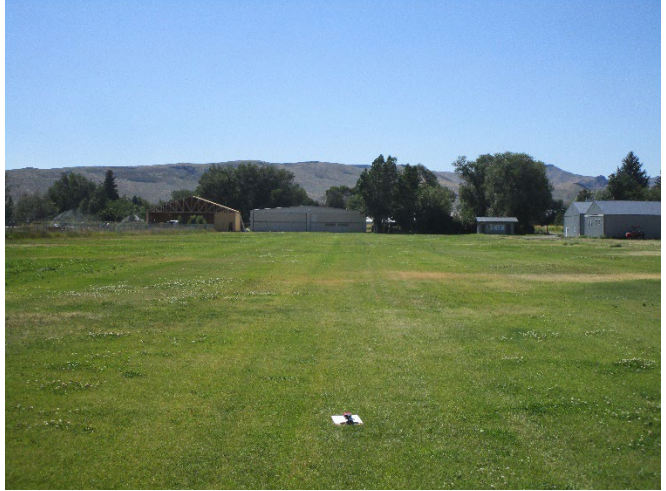
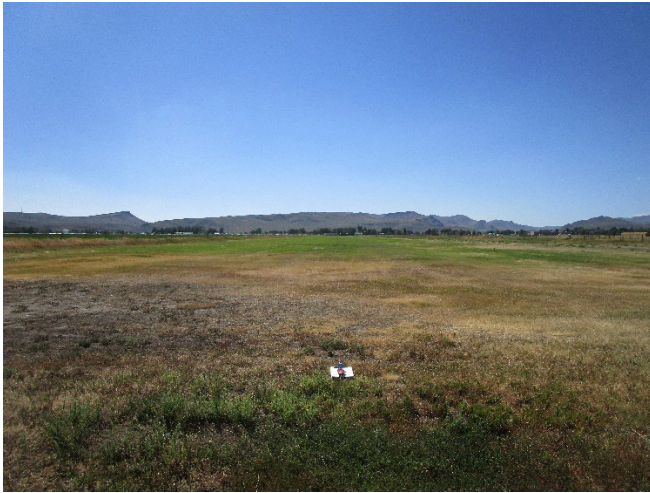
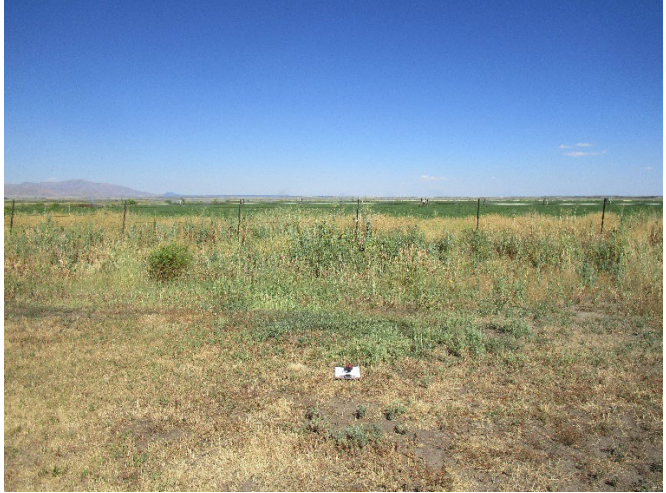
Runway 8-26: The surface continues to be in good condition, and during the ground roll test, surface was solid and covered with a healthy layer of grass 6-8" tall. The cement panel boundary markers were in good condition and displayed good white paint; they are visible from the air. The only other thing worth mentioning here is the sunken areas around each sprinkler can – sprinkler cans installed too low - that you and I had already discussed over the phone. Once you get those raised and dirt filled, your rwy would be almost perfect. There were no changes to the rwy alignment or the approaches at this airport; both remain relatively clear and unchanged.

1. Raise sprinkler cans and back fill the immediate surrounding area to the same level as the rwy surface.

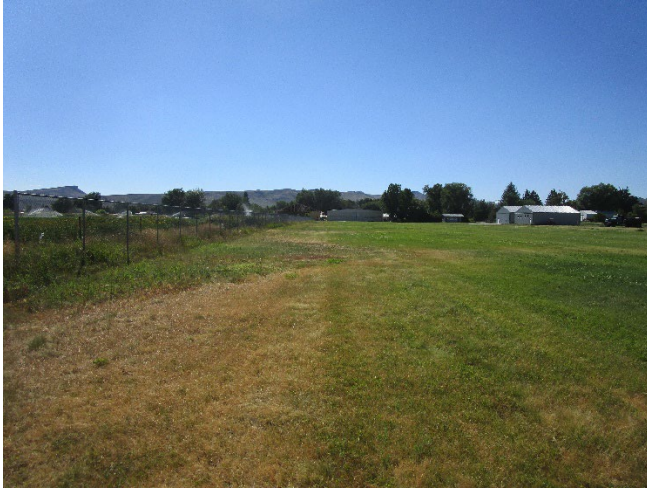
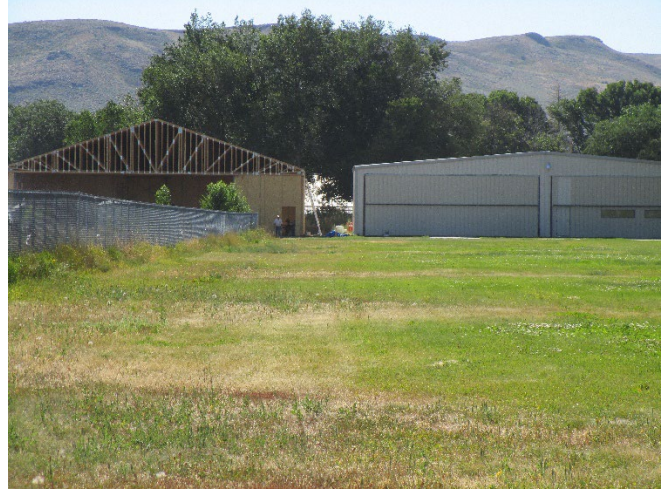
Parking Area/Tie-downs: The new parking/tie down area along the chain link fence was in good condition with 6 available parking spots of which all had tie-down chains present. Good vegetation control around this area and the rest of the airstrip for that matter.

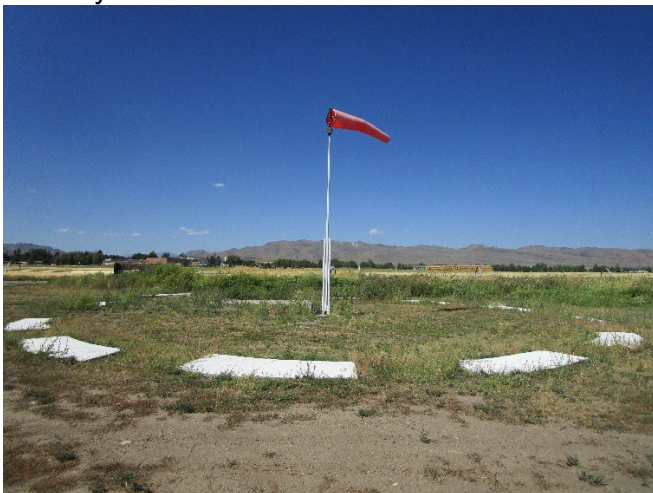
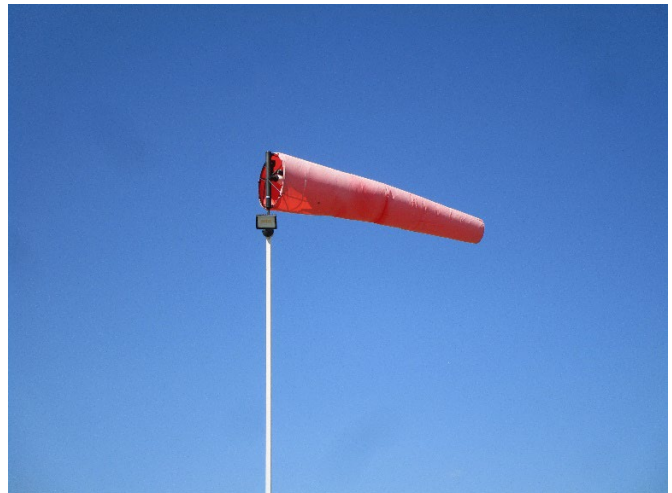
Runway 8 Windsock:

Windsocks/Standards/Segmented Circle: There are two windsocks on the airfield – one closer to rwy end 8, which is lit, and the other right at the end of rwy 26, unlit. Each windsock was in good condition and had no apparent/visible tears. Both metal standards were mechanically sturdy, functional, and had good paint coverage. The cement panels of the segmented circle at rwy end 8, were adequately painted, but did have some vegetation growing and encroaching on the panels. The segmented circle at rwy end 26 was in good condition and very visible from the air.

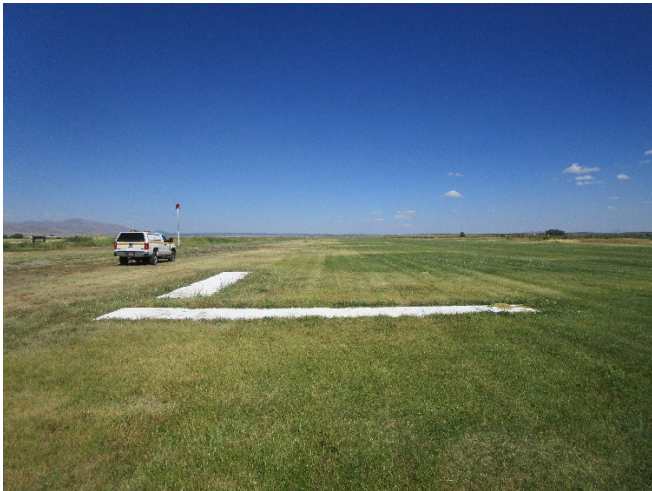
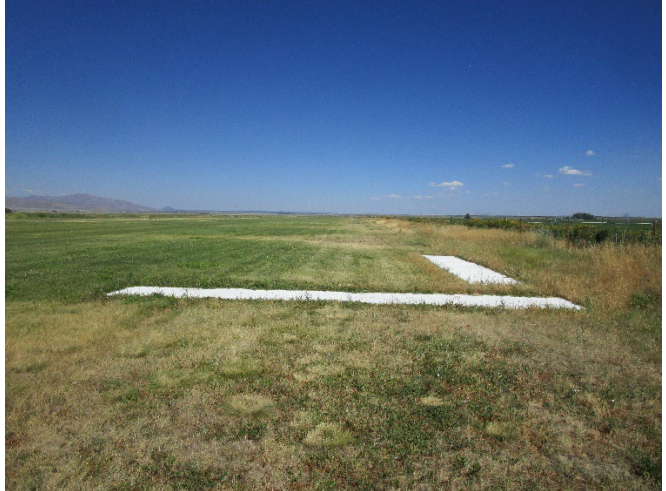
Boundary Markers (BMs): The painted cement panels boundary markers (BM) had good paint coverage and were in good condition. I saw very little grass growing around the edges, therefore, no issues with them. They were all visible from the air.
