IDAHO TRANSPORTATION DEPARTMENT

Subject: 2022 5010-1 Airport Inspection conducted July 6, 2022.
(04167.13*A Cougar Ranch Cougar Ranch Airstrip)

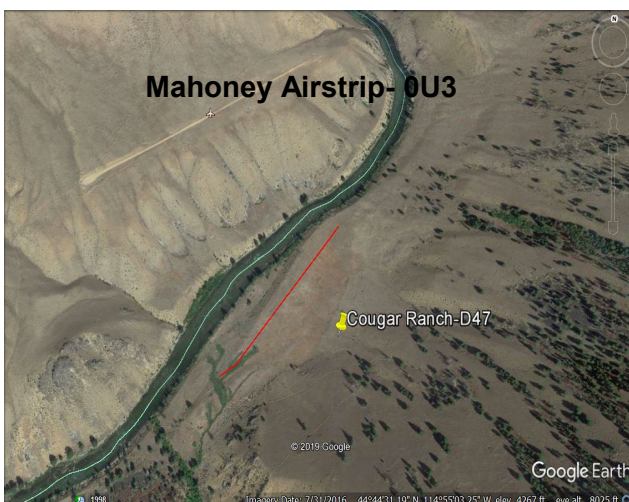
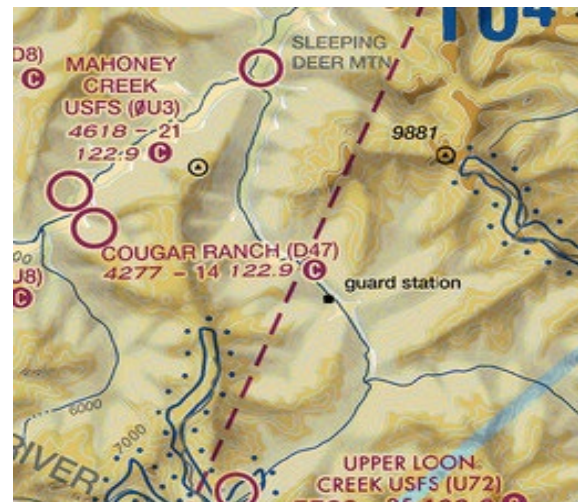
Runway (2-20): I rated the runway surface as fair and it continues to display roughness during both landing and takeoff. Three years ago the dirt runway was very conspicuous from the air and you could see the boundary markers and make out the landing area with ease. This time around the runway was less distinguishable from the air due the

grass growth that has covered most of the dirt rwy surface and the boundary markers. The things that were addressed three years ago, the white rocks on the lip of the canyon and the ditches located roughly at midpoint between the rwy and the river have not been mitigated or marked, and are still there (please reference the initial inspection report dated December 20, 2019). Approaches to the runway continue to be challenging due to high/steep terrain geography surrounding the airstrip.

Miscellaneous: For safety reasons, my suggestion continues to be: have those rocks on the lip of the canyon repainted in alternating white and red colors (3ft sections) just so they would not be confused with the boundary markers of the runway end 20. Also, the runway needs to be mowed, mark or fill up with dirt those two ditches at midfield (mentioned in 2019 letter) and clear the grass and spray white paint on the boundary markers to keep them visible.

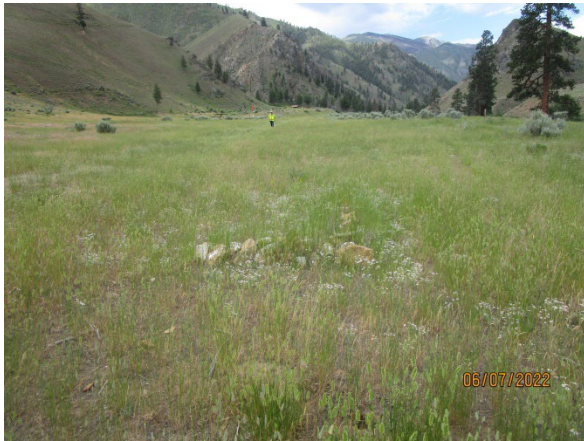
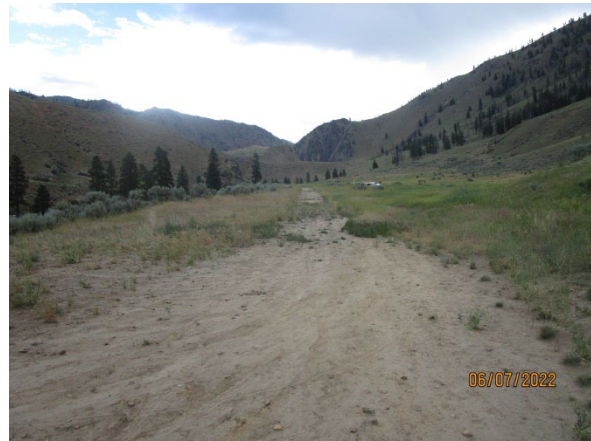
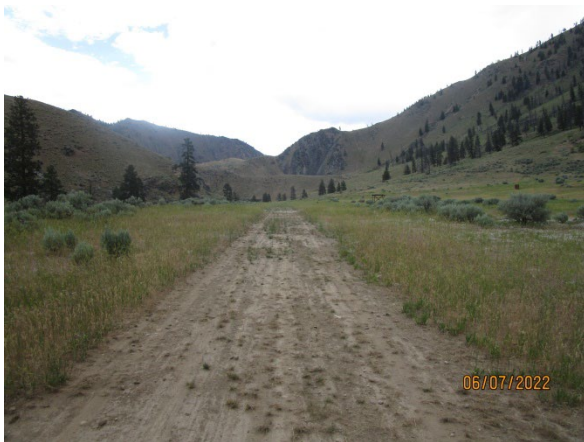
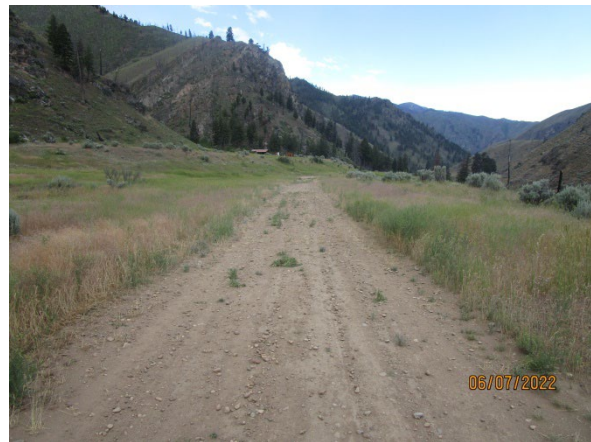
Tie-downs: There were two aircraft parking areas present on the airfield – somewhere around the midfield and on either side of the windsock. I did not see any aircraft securing devices (chains or ropes) present on the airfield. Area was overgrown by tall grasses and a bit rough to taxi through.

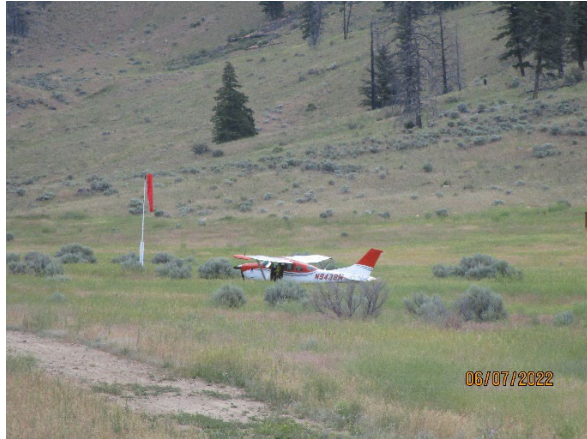
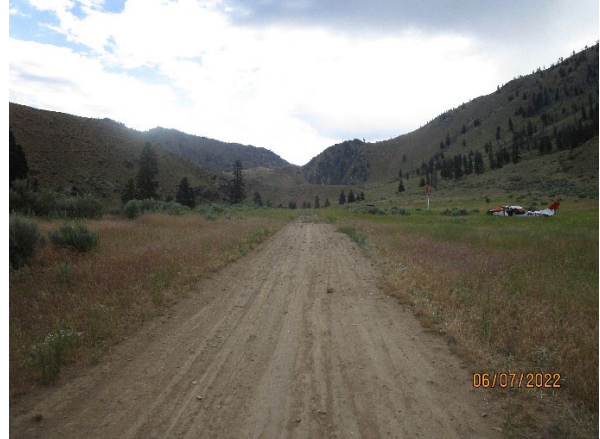
Boundary Markers (BMs): All non-standard (smaller) rock boundary markers were in place and covered by grass. They were not easily visible from the air. Need new white paint and spray/kill the grass in and around the BMs to enhance visibility.

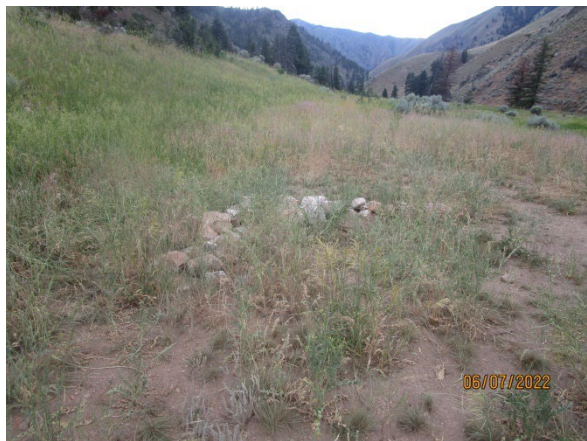
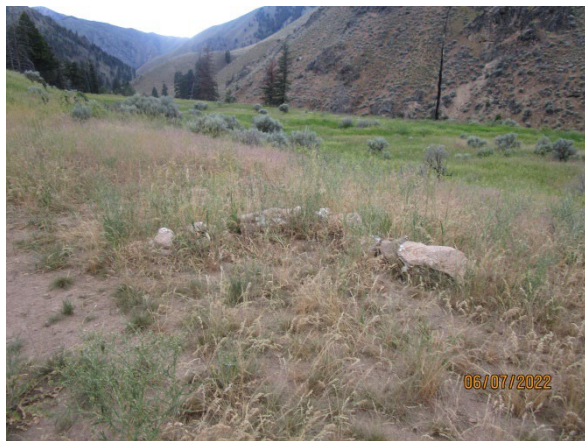
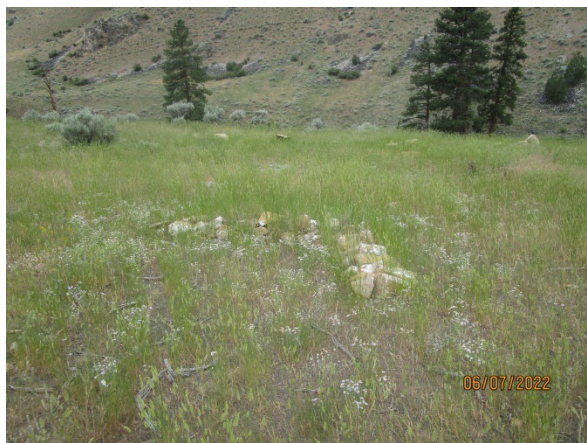
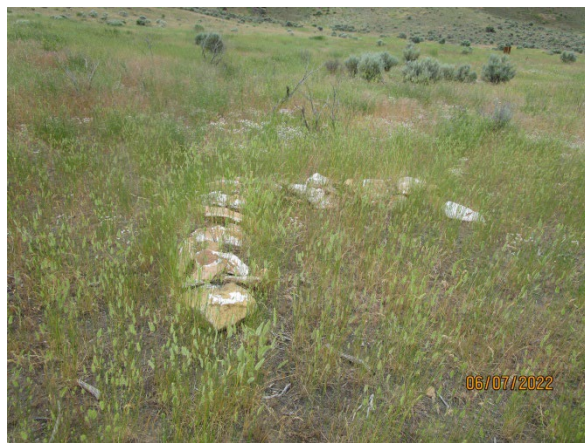
Windsock/Standard/Segmented Circle: The windsock was in poor condition, discolored and ripped. Because almost half of it was gone, I replaced it with a new windsock. The metal standard was in good condition and displayed good white paint. The non-standard segmented circle made of white painted rocks was obscured by tall grasses and sage brush.
