## IDAHO TRANSPORTATION DEPARTMENT

SUBJECT: 2023 5010-1 Airport Inspection conducted May 11, 2023  
(04182.A Donnelly Donald D. Coski Memorial Airport)

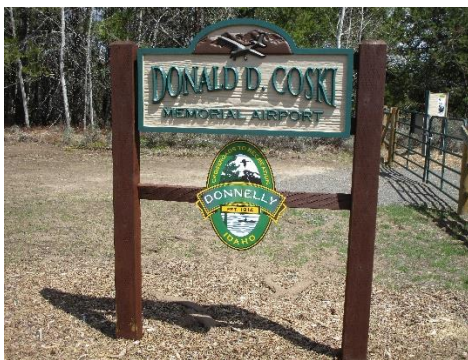
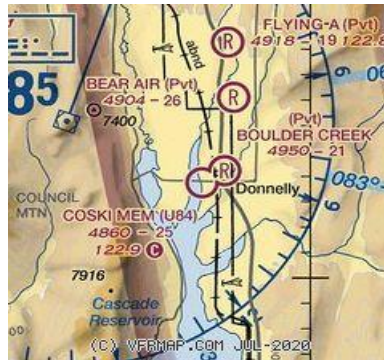
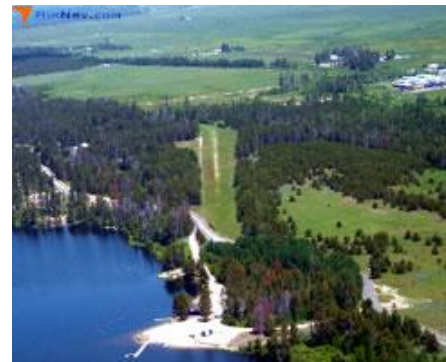
**Runway 18-36:** Approximately a week before the actual inspection, I was travelling through Donnelly and stopped by to see the airstrip and check out how much snow was still on the ground - there were still some small patches of snow mostly on the East side of the runway and in the shady areas. At that time, not only did I meet your friendly neighbor to the North of the airstrip (Josh Murray) and the local sheriff, but I noticed the runway surface was rather rough and needed leveling as you had lots of parallel grooves running almost the entire length and rodent activity on the runway. By May 11<sup>th</sup>, when I came back and did the inspection, I saw a lot of improvement that had taken place already. The runway surface was not perfect but had been graded a good deal and it was in a much better shape than the week before. As we discussed in your office, a little more levelling with some additional weight to your equipment might make sense in getting a better & smoother runway surface in the end. Vegetation was well under control and did not present an issue of concern. Both approaches remain unchanged and with the same obstructions listed in the Airport Master Record – trees at both ends.

1. When the time allows, it would be helpful for your maintenance folks to run a steel net/log/grader (similar to what they do to baseball fields), over the entire surface of the runway to smoothen out all the uneven imperfections/deformities caused by rodents and weather; have them use a log or railroad tie to weigh down the net for better results,
2. Re-establish the fence line based on the new property lines,
3. Establish Boundary Markers (BMs) to indicate the true dimensions of the runway and update the Airport Master Record (AMR) accordingly with new rwy. dimensions.

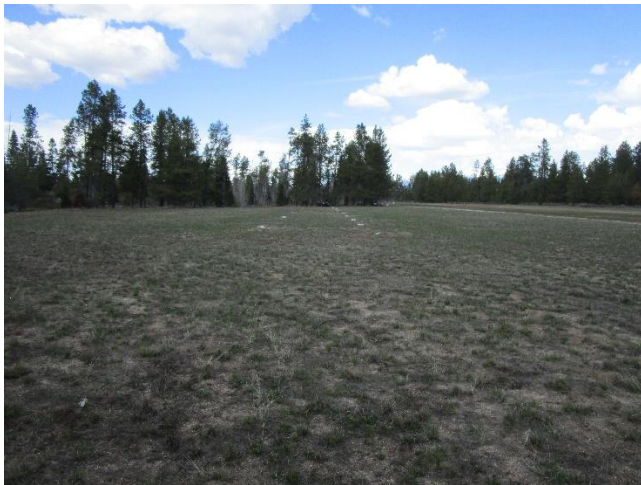
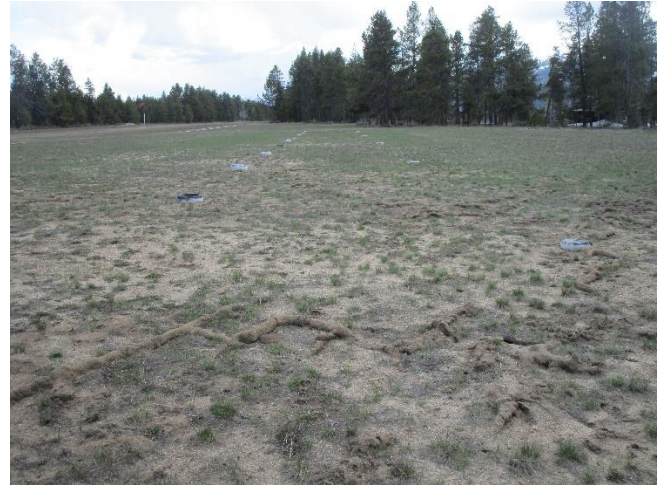
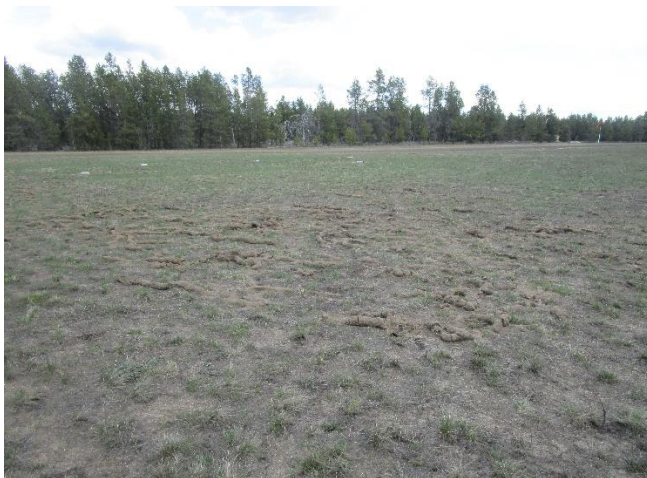
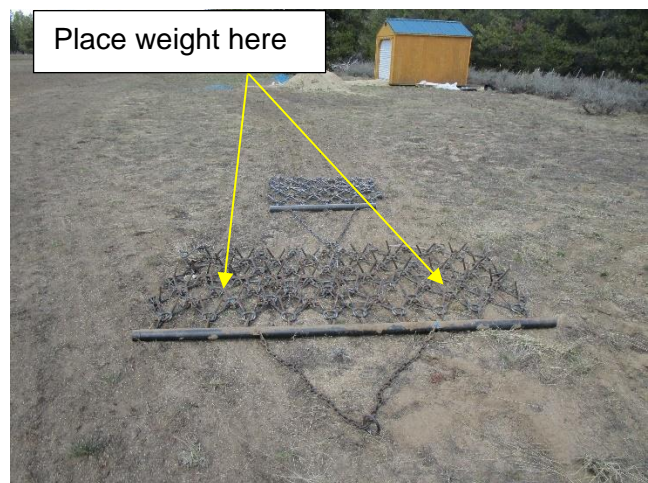
**Tiedowns:** The tie down area was in fair to rough condition with 5 spots available for aircraft parking. The surface was plagued by rodent activity and water run-off from the weather. Each spot was equipped with tie-down chains secured to concrete blocks inside small tires that were painted white. All five spots had tie-down chains present.

1. Place a log or railroad tie on top of the large steel net and run it (similar to what they do to baseball fields), over the entire surface of the tie-down area to smoothen out all the uneven imperfections/deformities caused by rodents and weather. Currently, it appears too rough to be parking airplanes in the area.

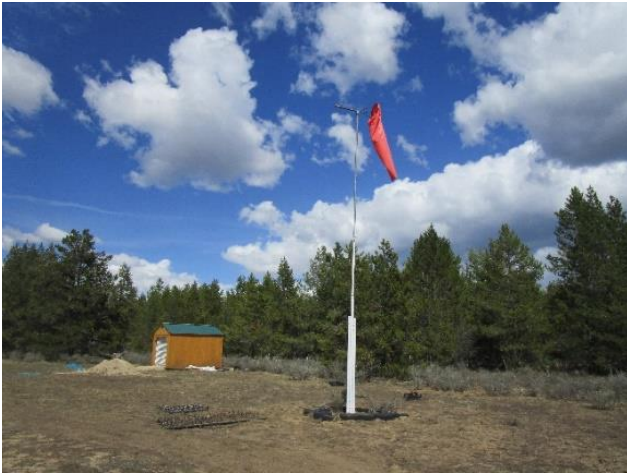
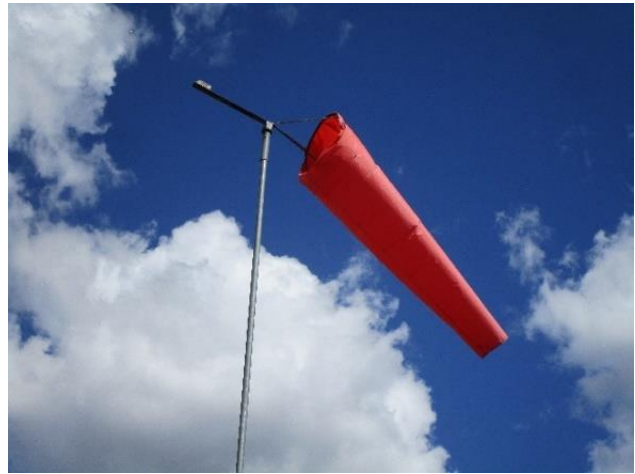
**Windsock/Standard/Segmented Circle:** The windsock at this airfield was in good condition & displayed no rips or tears; however, it was improperly installed with the drain hole on the side vs at the bottom. There was a non-standard segmented circle present made from black tires. The tires were not spread out around in a circular fashion as they should be and were more or less bunched up at the base of the metal standard. The metal standard was in good mechanical condition, but it does need some new white paint. Current paint is flaking and only the bottom half is painted; the upper half is not.

1. Re-design the segmented circle by bringing the tires out for a larger circle - 20' diameter,
2. Spread the tires in a circular fashion and paint them one white/one orange, or all white,
3. Keep the area of the segmented circle clean of vegetation for better visibility from the air,
4. Properly install the windsock with the drain hole at the bottom vs the side or the top.

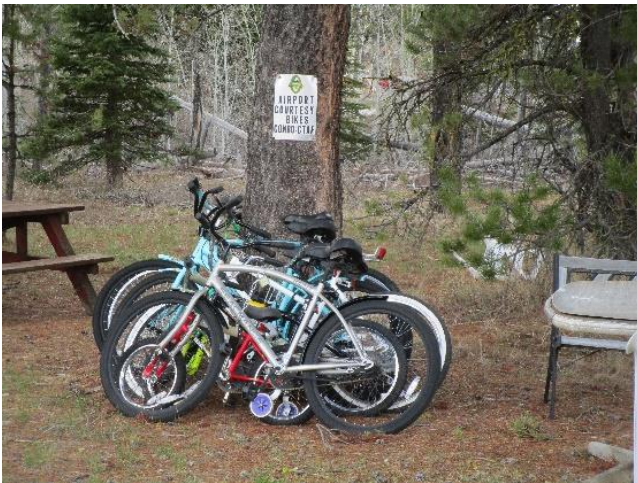
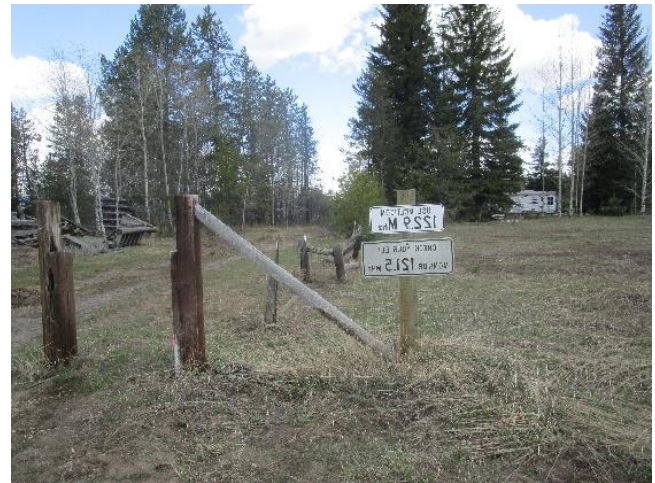
**Miscellaneous/Services:** All airport-related signs were upright, legible, and seemed to be in good working order. I saw no other significant changes or safety concerns with this airfield. If you have any questions or if I can be of any assistance to you, please reach out and call me at 208-334-8895. Have a great day.
