IDAHO TRANSPORTATION DEPARTMENT

SUBJECT: 2023 5010-1 Airport Inspection conducted August 21, 2023.
(04208.55A Howe Howe Airport)

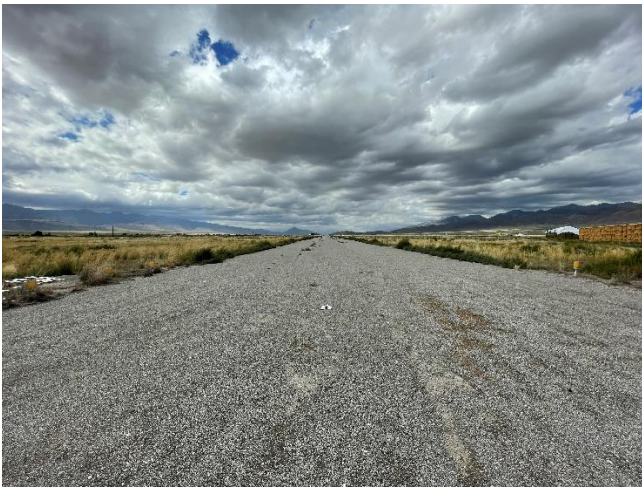
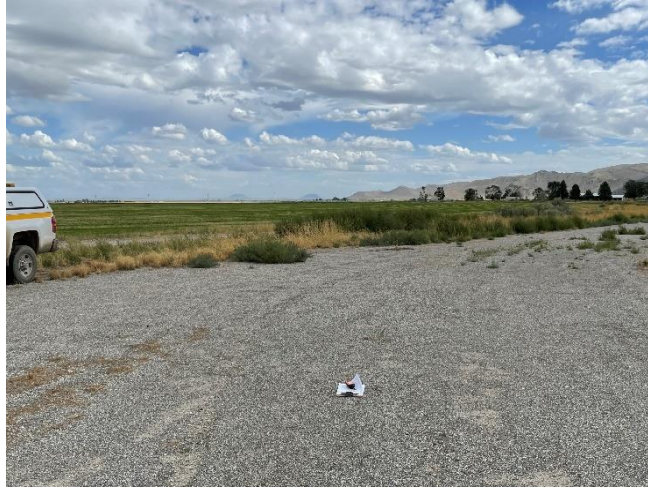
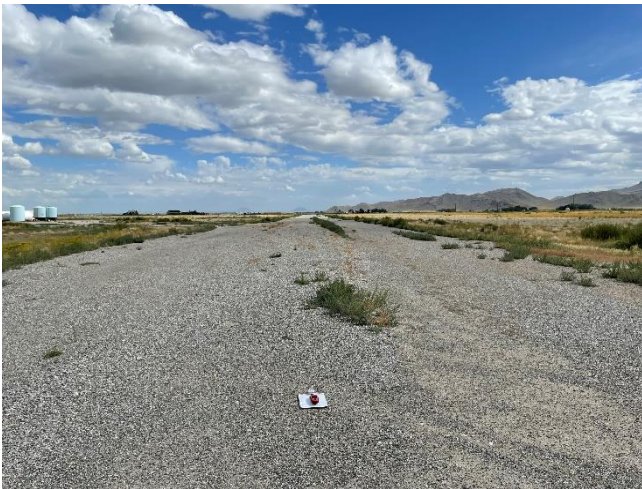
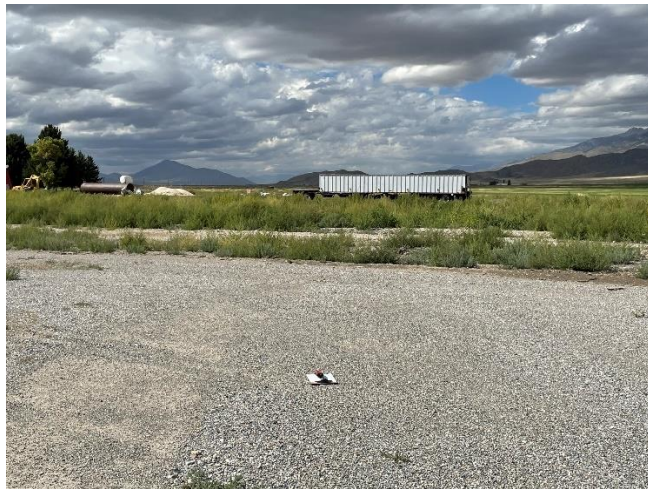
Runway (13-31): The gravel runway surface continues to remain in good condition. During my ground roll test, I noticed no deformities or undulations worth mentioning – the surface condition was good; the only thing I would like to address here is the few patches of grass growing sporadically, here and there, on the rwy. surface. All rwy. edge reflectors were upright and almost all of them were obscured by the encroaching vegetation growth. I did not see any gopher/rodent activity along the runway edges this time around. There were no changes to the approaches at this airport; both remain relatively the same and unchanged in the past three years.

Action items:

1. Clean/remove the gras that is growing on the rwy. surface and clean out the rwy. edges to make the reflectors visible again.

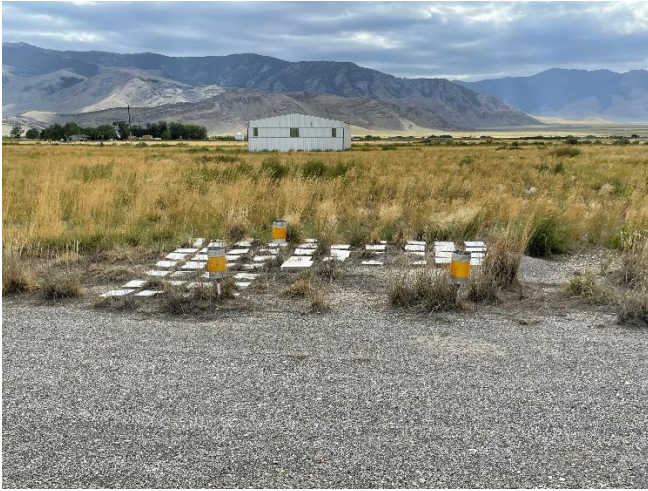
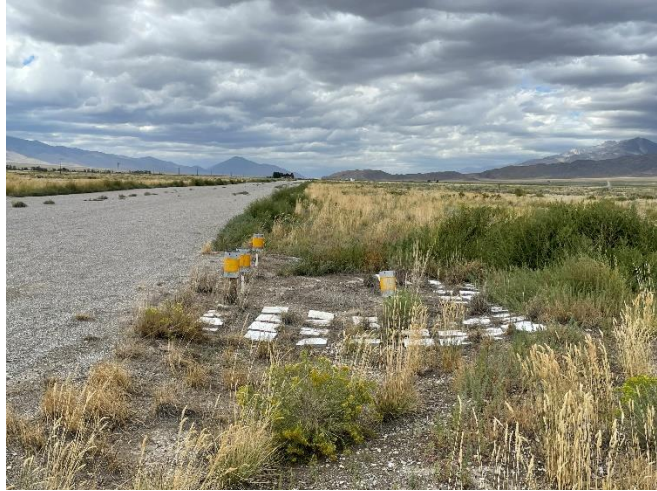
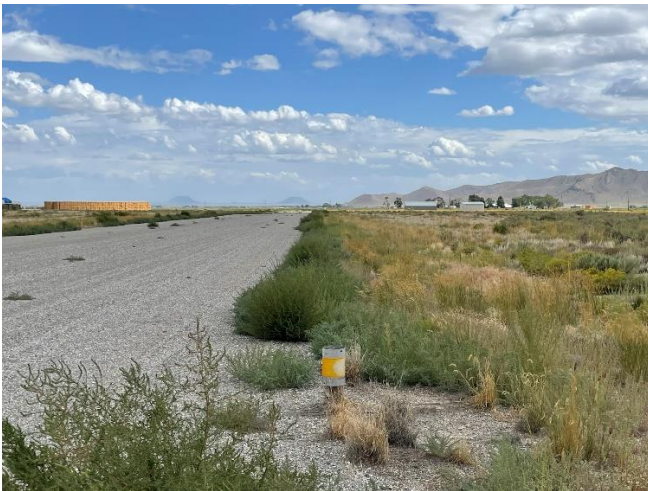
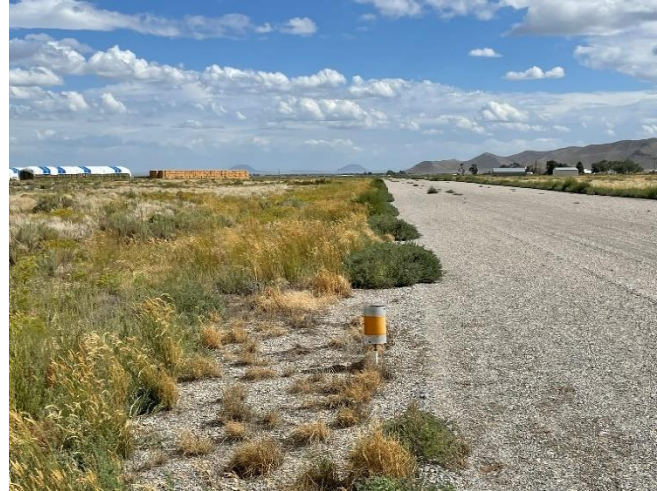
Boundary Markers (BMs): The non-standard BMs present at each runway end appear to be somewhat obscured by the 18-20" tall grass that is abundantly growing in between the white panels and reflectors. If the area where the white panels are located, is not sprayed/sterilized properly and regularly, those weeds will continue to be a nuisance and minimize the visibility of the BMs from the air. You should investigate that and have that area cleaned out and sprayed up good. During a recent conversation about weeds, I had with some county employees here in Treasure Valley, I learned that Krovar is good stuff when dealing with weeds long term, heave you heard of it? It is a very good ground sterilant and I was told that once applied, it will keep the weeds off - anywhere from 3 to 5 years; you should check into it.

Action items:

1. All boundary markers need some TLC and should all be cleaned of all the encroaching grass – both, rwy ends and rwy edge reflectors.
2. Reposition all the rwy end boundary marker reflectors to align and mirror the “L” shape of the boundary markers.

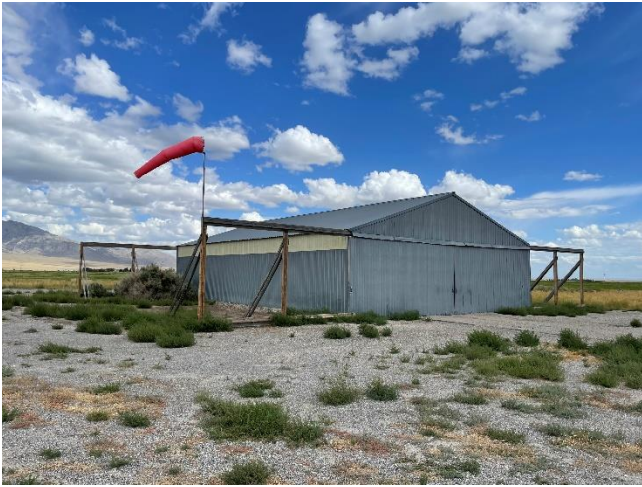
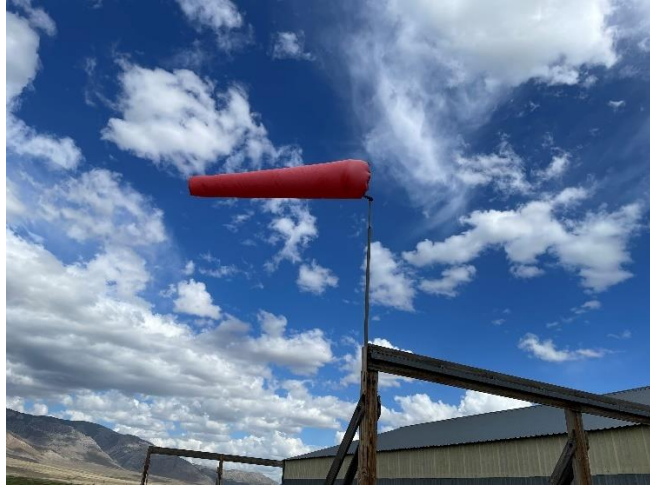
Windsocks/Standards: The only windsock present at this airport was functioning and in good condition – I saw no rips or tears. The galvanized, metal standard mounted on the frame of the hangar door (close to rwy. end 31) remains in good condition as well. There was no segmented circle at this facility.

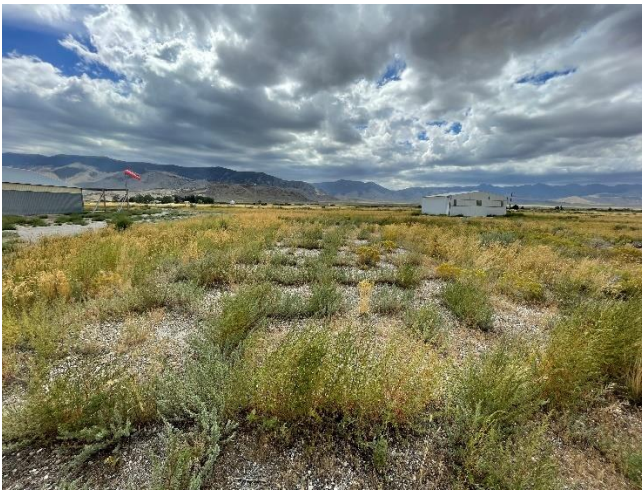
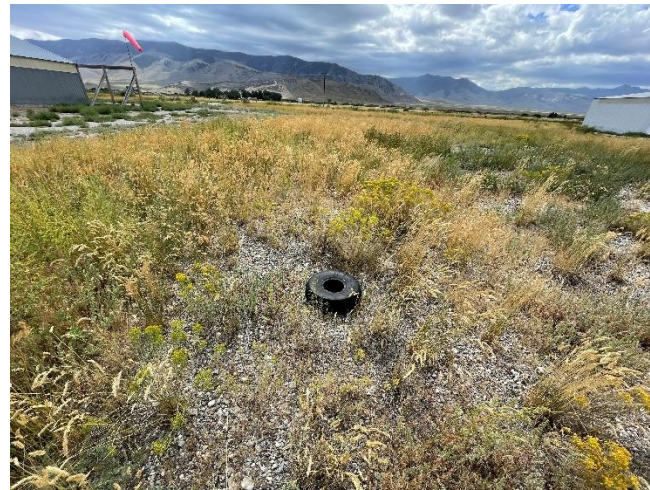
Miscellaneous/Services: Tie down area is in poor condition as it is overgrown by 24" + tall grass. There are no visible parking signs on the premises. With the obscuration of the tall grass and in the absence of signs, it would be difficult for any arriving pilot, that is not familiar with the airport, to locate the tie-down area in its current condition. During my inspection, I did locate two sets of tie-down chains that were marked by black tires hidden in the tall grass but were not easily visible. I saw no other new safety concerns or hazards that need to be addressed at this time. If you have any questions or concerns, please call me directly at your convenience: 208-334-8895. Have a great day.

Action items:

1. Mow the grass down and clean up the tie-down area to make those parking spots visible again,
2. Install a small sign to inform pilots and indicate where the tie-down area is.
