IDAHO TRANSPORTATION DEPARTMENT

SUBJECT: 2020 5010-1 Airport Inspection conducted June 2, 2020.
(04225.3A Twin Bridges Airport Ketchum)

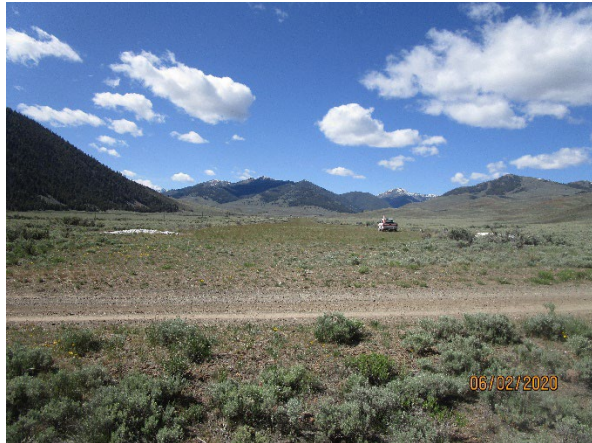
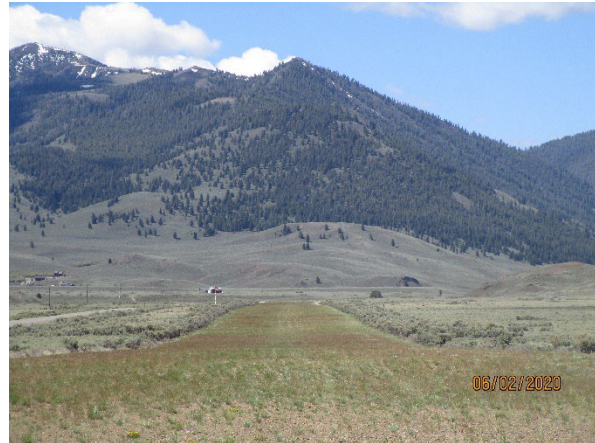
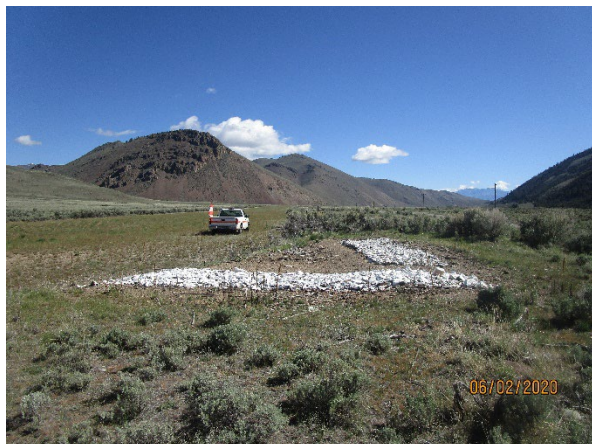
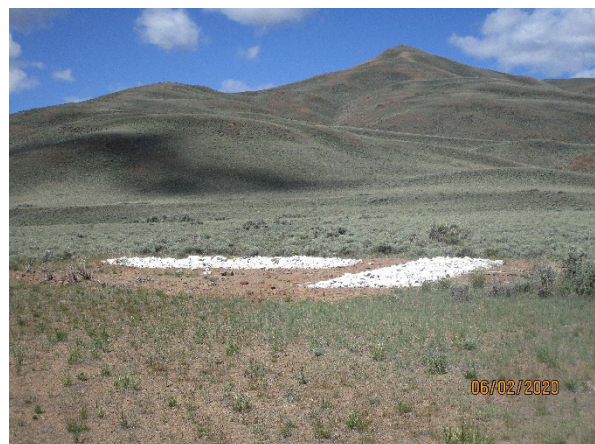
Runway: As always, I took two runs with my vehicle, up and down the runway to verify the surface condition and smoothness of the rwy. The runway surface remains in fair condition and continues to present itself as rough and bumpy due to the clump grass present. Did not notice too much varmint activity. All the holes/burrows visible are mostly present on the edges of the runway. All painted rock boundary markers had excellent paint coverage and no weed growth around the edges.

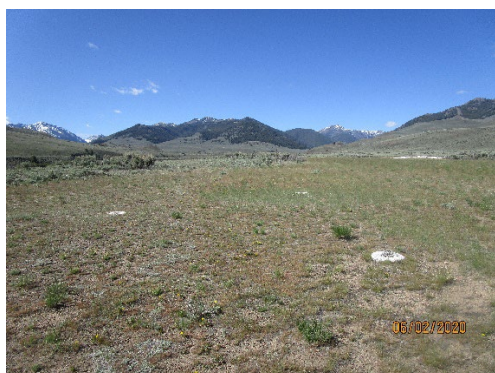
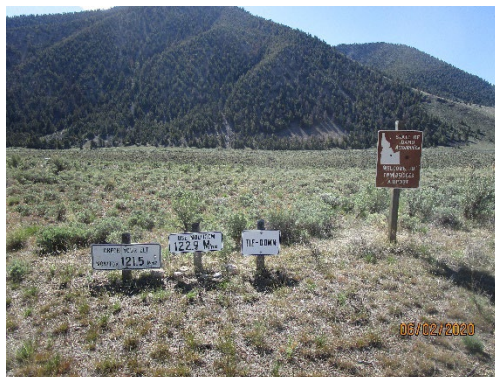
Taxiway/Ramp/Tiedowns: The tie-down area I found to be in fair condition overall with two serviceable parking spots; both had tie down chains present.

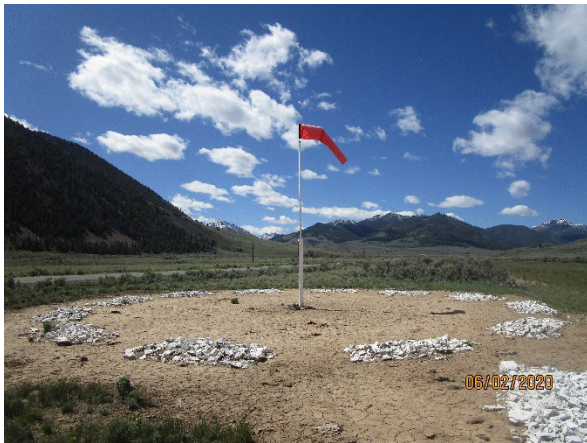
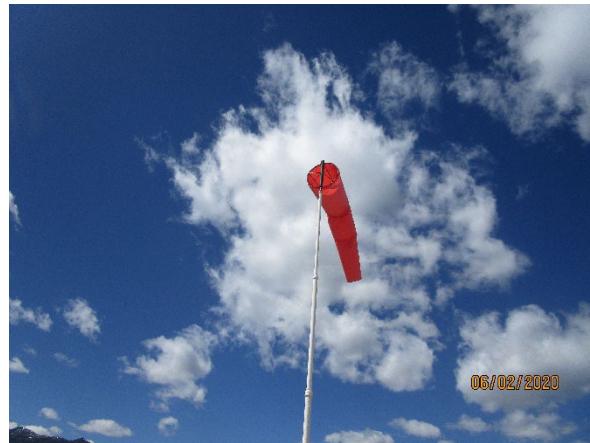
Windsock/Standard/Segmented Circle: I rated the windsock and standard in good condition with good and visible paint on the standard. The sock was good and it did not show any distress, rips or tears. The segmented circle I also rated as good with no vegetation encroaching on the rocks or around them. Both the segmented circle and the boundary markers had excellent paint coverage – they were very visible from the air.
