IDAHO TRANSPORTATION DEPARTMENT

SUBJECT: 2023 5010-1 Airport Inspection conducted July 27, 2023.
(04352.1A Warren Warren USFS Airport)

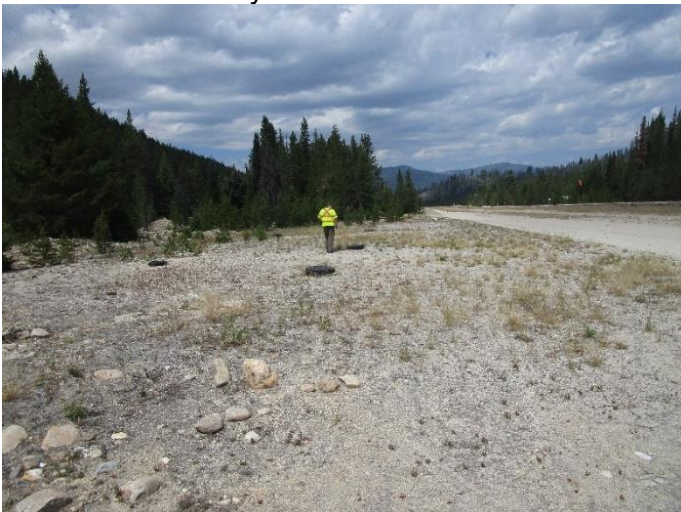
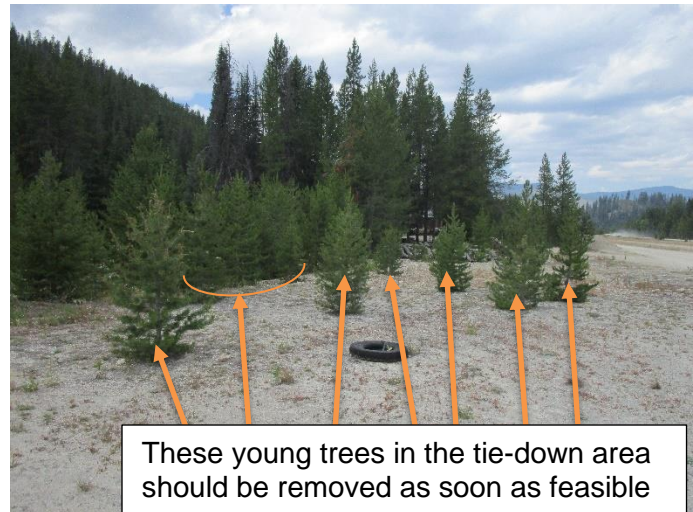
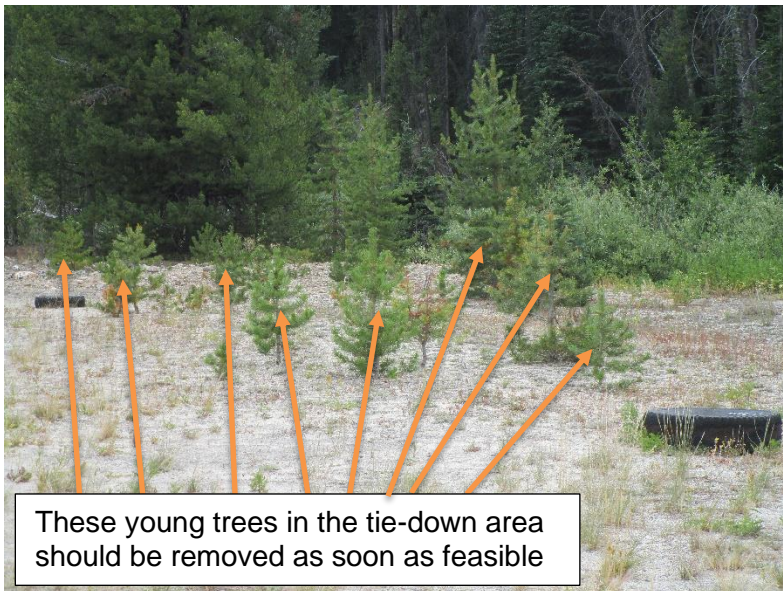
Ramp/Tie-Down Area: Tie down area was located on the south side of the rwy. and close to rwy. end 30. There I noted three parking spots available and all three had chains present and available for use. Most tie-down chains were housed and marked with black tires over inground metal boxes - all of them were rusty but secured to their base.

Action Items:

1. Remove all vegetation and young trees growing in the tie-down parking area, especially the west end.

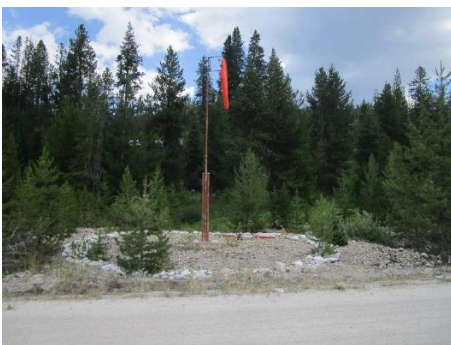
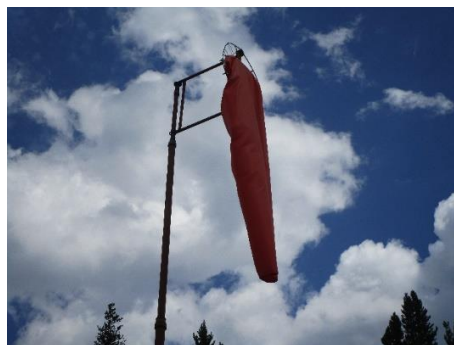
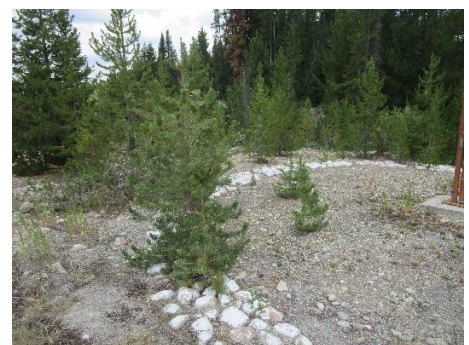
Windsocks/Standards: The only windsock at this airfield was located to the N of the airstrip and appeared to be brand new and in excellent condition. The orange painted metal standard I rated in fair condition as it needs new paint. The standard was mechanically sound and in good working order. I noticed that the same brand-new metal standard that was laying down 3 years ago and inside the segmented circle, it is still there and I presume it is intended to replace the old one soon. The segmented circle was not very segmented as the rocks formed one big continuous circle. My suggestion is that you figure out a way to conceal portions of the circle so instead of a continuous line you have segments of 4' lengths of the circle showing. Give the exposed rock segments a good coat of white paint and clear out all the vegetation that is encroaching in and through the rocks. By doing so you'll increase the visibility of the device and the overall safety factor, as this will make it easier for arriving aircraft/pilots to locate the windsock much quicker from the air.

Action items:

1. Re-design and build up the individual segments of the circle (4ft long with a 5-6ft gap between segments) vs one long continuous circle,
2. Clear all encroaching vegetation inside the rocks and around them,
3. Repaint the rock segments in white.

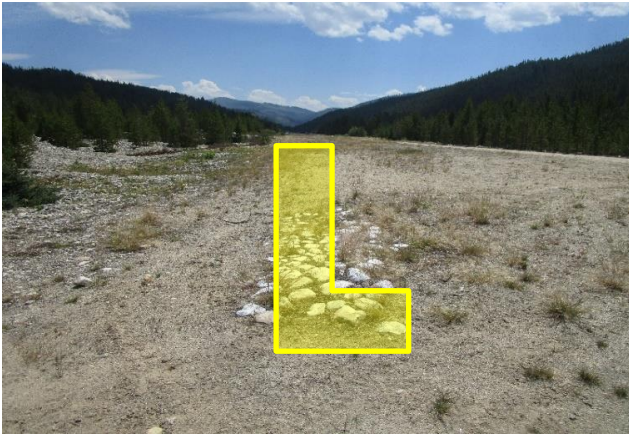
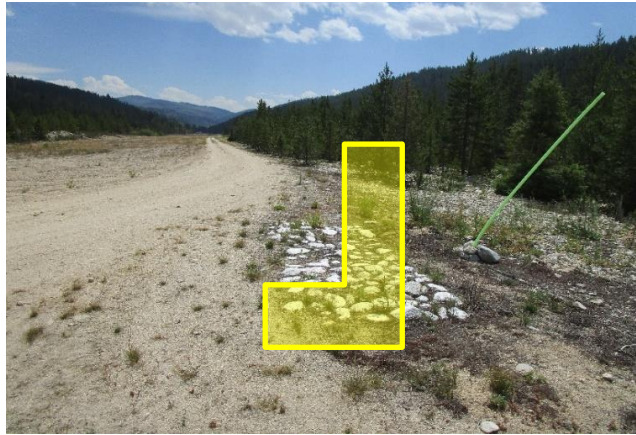
Boundary Markers: The condition of the available boundary markers at this airfield is poor. It was poor three years ago and it continues in that state today. They rocks need to be redone so they could resemble the “|_ _|” shape typically used to mark the usable runway surface, repaint with white color paint, and clear all vegetation around them as currently they are not very visible from the air and provide little or no useful guidance to a pilot (particularly at Runway 30 end).

Action items:

1. Re-design and add rocks to the boundary markers to resemble the two Ls that typically mark the end/beginning of a runway “|_ _|” (if you need any design info on the boundary markers, let me know and I can provide you some),
2. Clear all encroaching vegetation and repaint the rocks in white.

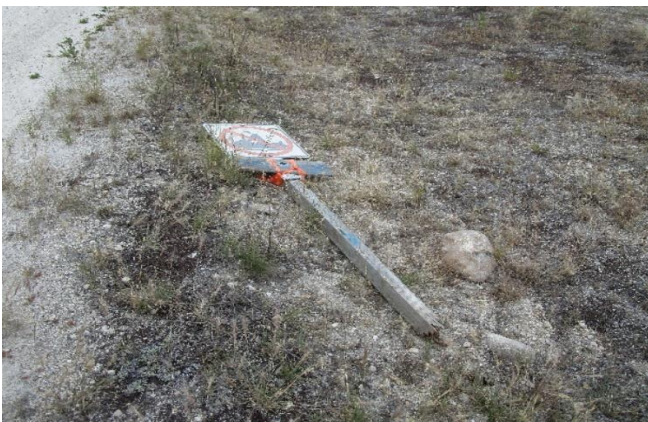
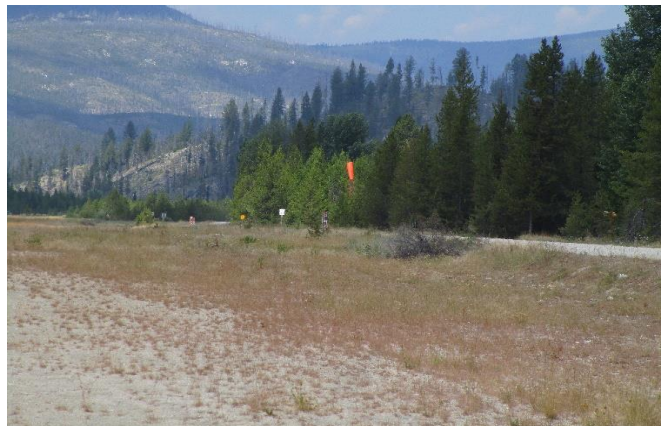
Miscellaneous/Services: A quick look around showed one of the “snowmobiles prohibited” signs present on the airstrip was broken and laying on the ground, therefore, in poor condition. That should be fixed, and all other signs posted on the airfield should be upright, legible and serving the purpose, they’re built for. I saw no other significant changes or safety concerns of note. If you have any questions, please feel free to call me directly at 208-334-8895.

Action items:

1. Repair all broken signs on the airfield.
