IDAHO TRANSPORTATION DEPARTMENT

Division of Aeronautics

Subject: 2023 5010-1 Airport Inspection conducted May 25, 2023.
(04269.*A Thatcher W.E. Ranch Airport)

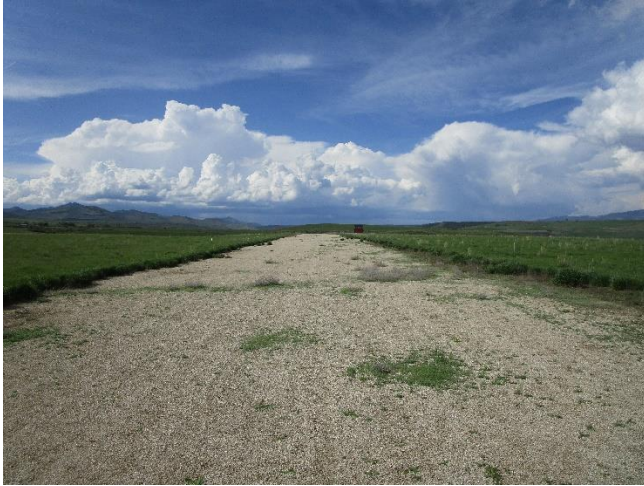
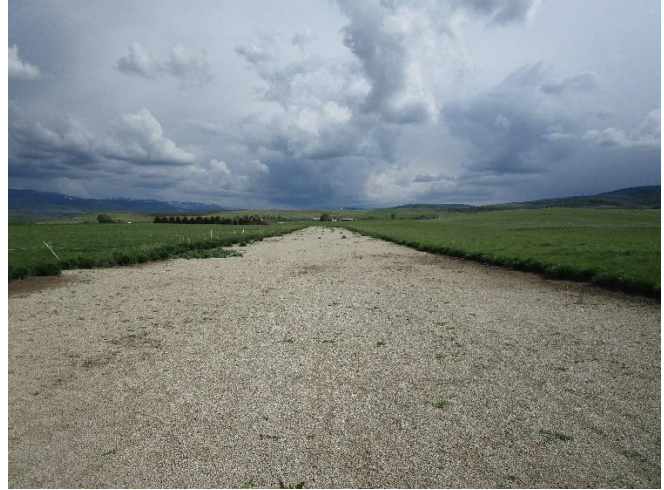
Runway (17-35):

Overall, the sandy/gravel runway surface was in good condition with just minor undulations present. Grass is starting to grow throughout the runway surface and noticed that the electric fence intended to keep livestock and other wildlife off the runway was broken & fallen down in many areas. Fixing that would ensure a higher degree of safety and separation between animals and the flying machine. Both approaches remain unchanged and clear of obstructions.

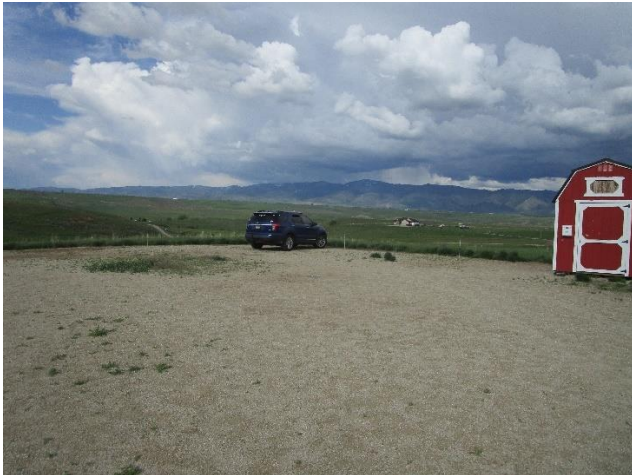
Ramp/Tie Downs:

The tie down area is at the North end of the airfield in the small turnaround area to the E of the runway and North of the shed – I saw one tie-down spot with chains available. Surface condition was good and with decent vegetation control.

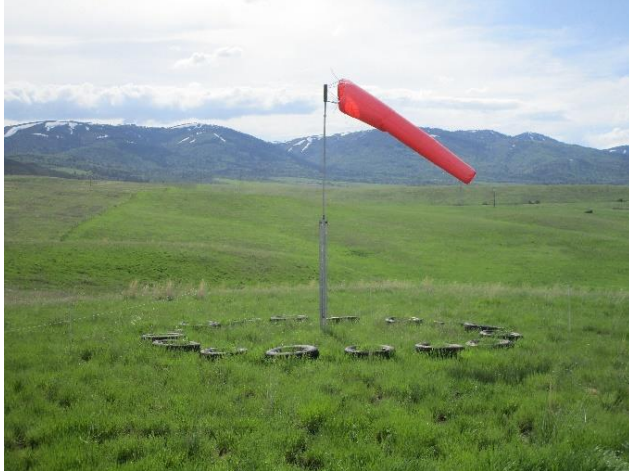
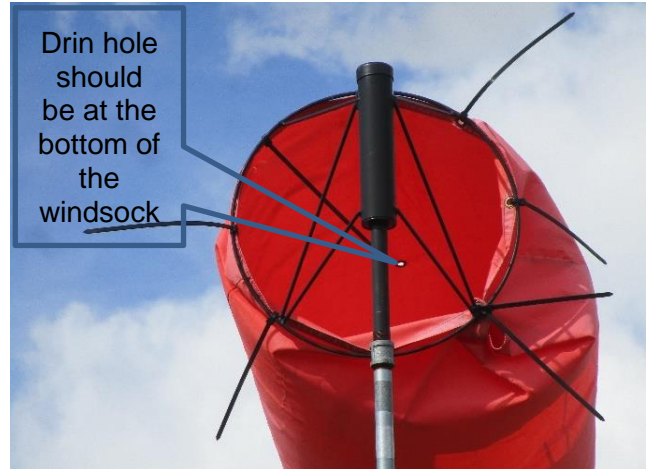
Windsock/Standard/Segmented Circle:

I saw that the windsock was relocated from behind the shed to the west side of Rwy End 17 and out in the open. The windsock was in good shape and so was the galvanized metal standard. The segmented circle made up of black auto tires needs some work:

1. Use the tires to make a better, 20-25' diameter circle around the metal standard - with tires evenly spaced in a circular fashion.
2. Paint the tires alternating white and orange or all white and keep the grass growth to a minimum inside and immediately around the segmented circle for increased visibility from the air.
3. Re-install the windsock so the drain hole is at the bottom vs on top (provides longevity).
