**PROGRAM ID, COUNTY, ETC.:**  
N 10<sup>th</sup> Avenue ITS & Overlay, Caldwell  
Canyon County

**RE:** Phase I(R) – Pavement Rehabilitation Report

**10th Avenue ITS and Overlay**

**Phase I(R) Pavement Rehabilitation Report**

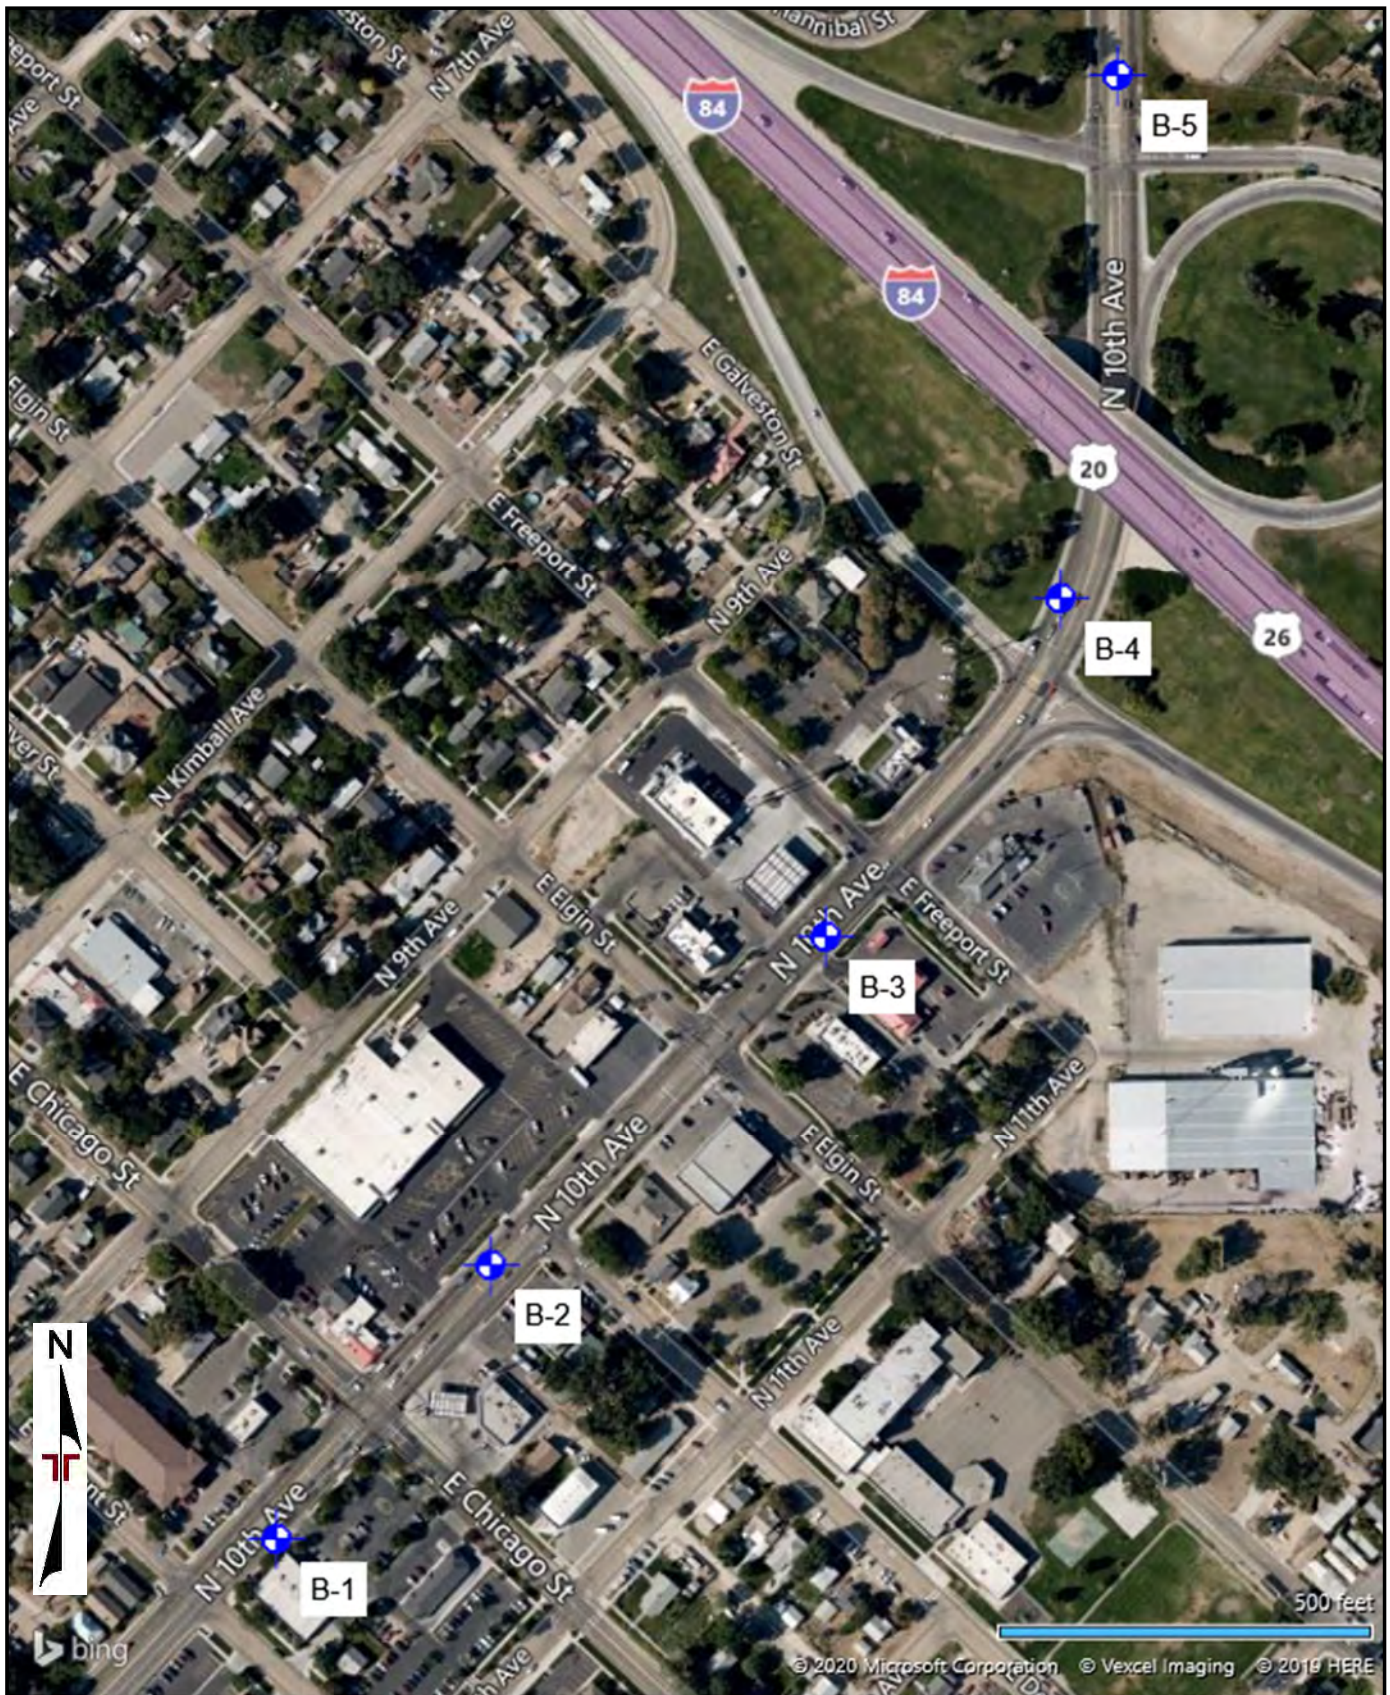
| Project Manager: GAB<br>Drawn by: AMS<br>Checked by: GAB<br>Approved by: KCH | | Project No. 62195037<br>Scale: AS SHOWN<br>File Name: Figures<br>Date: 1/8/2020 | | <b>Terracon</b><br>11849 W Executive Dr, Ste G<br>Boise, ID 83713-1944 | | <b>EXPLORATION PLAN</b><br><b>N 10TH AVENUE ITS &amp; OVERLAY</b><br>Albany Street to Kimball Avenue<br>Caldwell, ID | | Exhibit<br><b>A-2</b> |

Information regarding subsurface soil conditions was obtained from soil borings drilled within the roadway. The Exploration Plan, boring logs, and the Field Explorations Description are included in Appendix A. We conducted five borings for the roadway. Borings were drilled to a depth of about 6½ feet below ground surface. An asphalt core was obtained at each boring location. HMA core thickness was measured to the nearest ⅛ inch. Photographs of the cores are included in Appendix A.

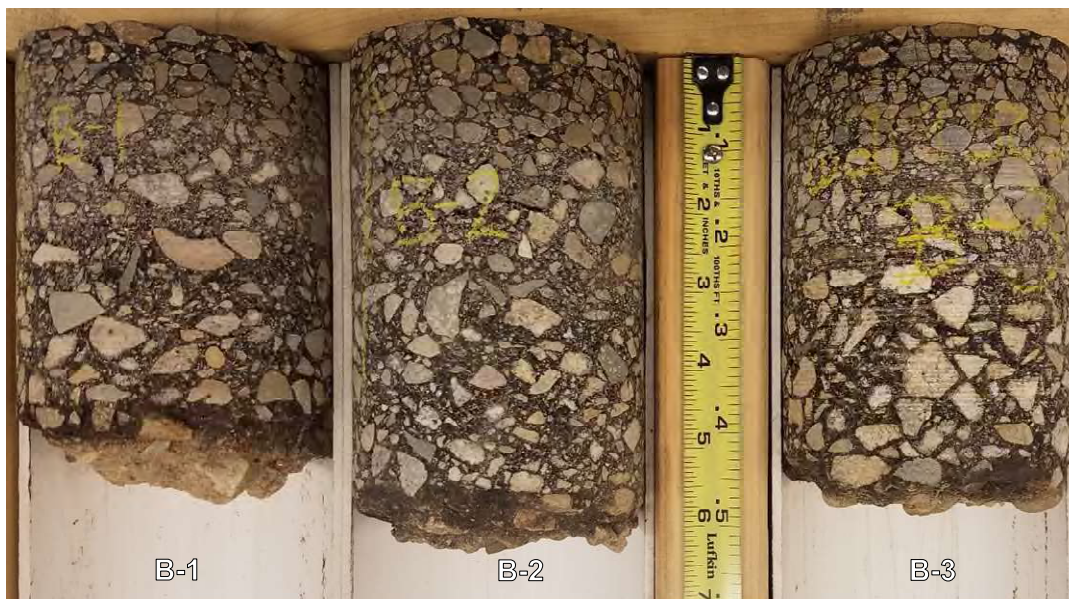
| Core ID: | B-1 | B-2 | B-3 |
| Approximate Location: | 8 ft W of curb in outside NB lane, 6 ft S of AutoZone Entrance | 19 ft. E of curb in inside SB lane, 33 ft S of BiMart sign | 22 ft. W of curb in inside NB Lane, 8 ft N of Fastrack Wash Exit |
| Total Thickness (inches) <sup>1</sup> : | 4 $\frac{7}{8}$ | 6 $\frac{1}{8}$ | 5 $\frac{1}{2}$ |

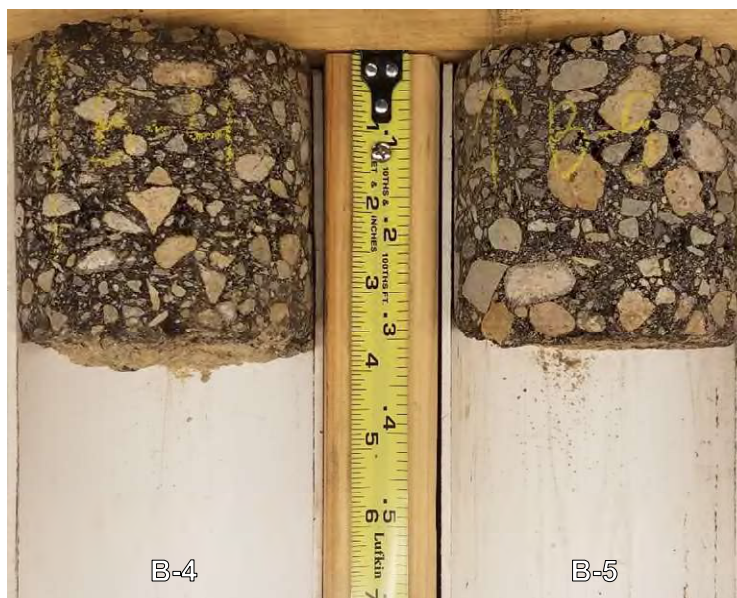
| Core ID: | B-4 | B-5 |
| Approximate Location: | 5 $\frac{1}{2}$ ft E of curb, in outside SB Lane, 60 feet north of stop line at I-84 EB ramps intersection | 33 ft. E of curb, in median, 62 $\frac{1}{2}$ ft north of stop line at I-84 WB ramps intersection |

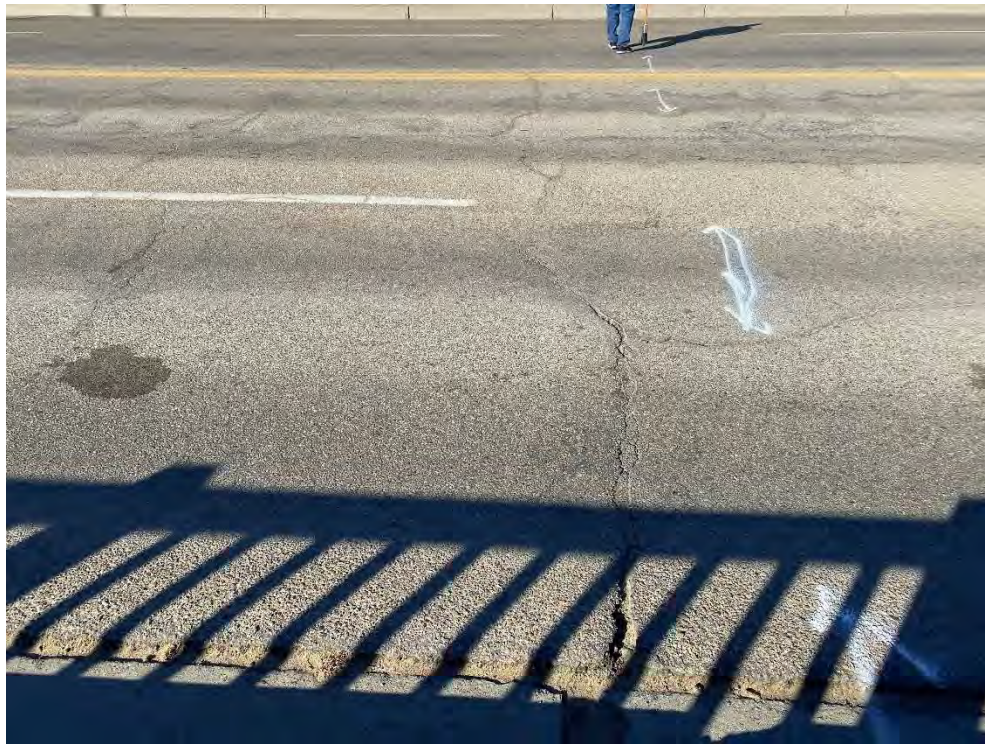
**N 10<sup>th</sup> Ave, north bound lanes from Main St to E Belmont St, transverse and longitudinal cracking**

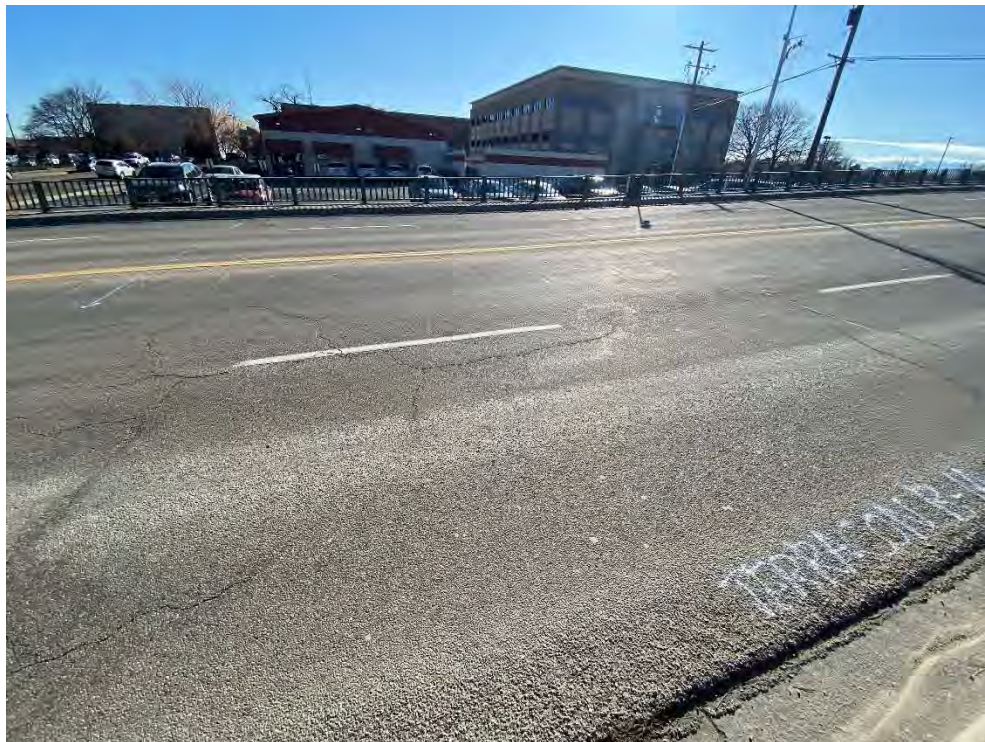
**N 10<sup>th</sup> Ave, north bound lanes from Main St to E Belmont St, transverse and longitudinal cracking**

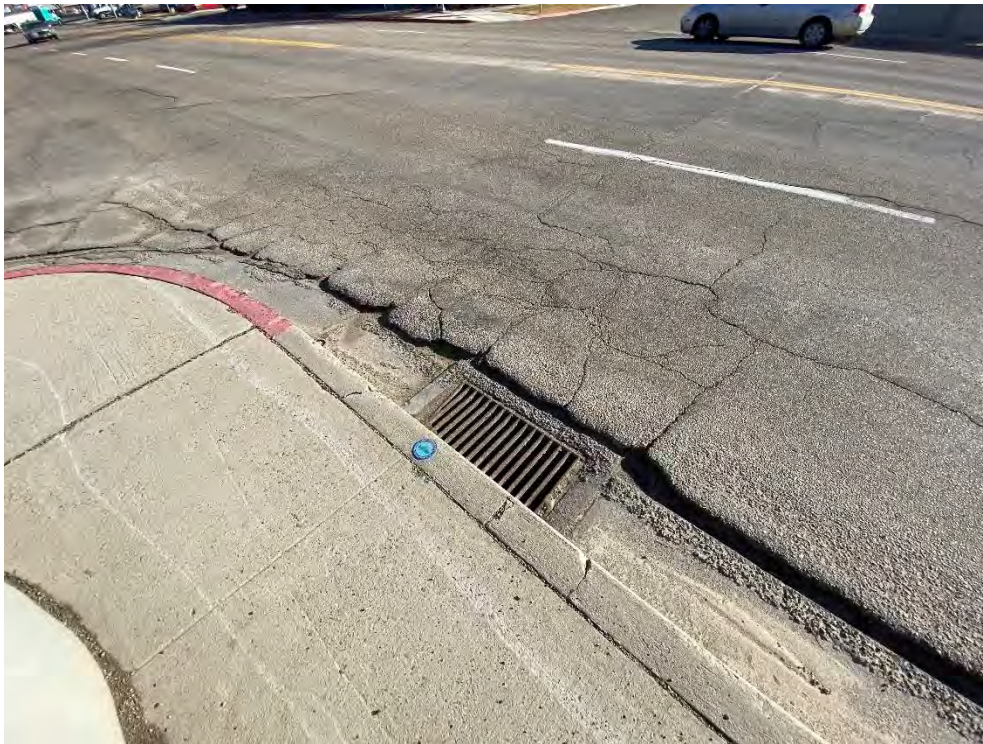
**N 10<sup>th</sup> Ave, SW corner of intersection with E Belmont St, transverse, longitudinal, and block cracking**

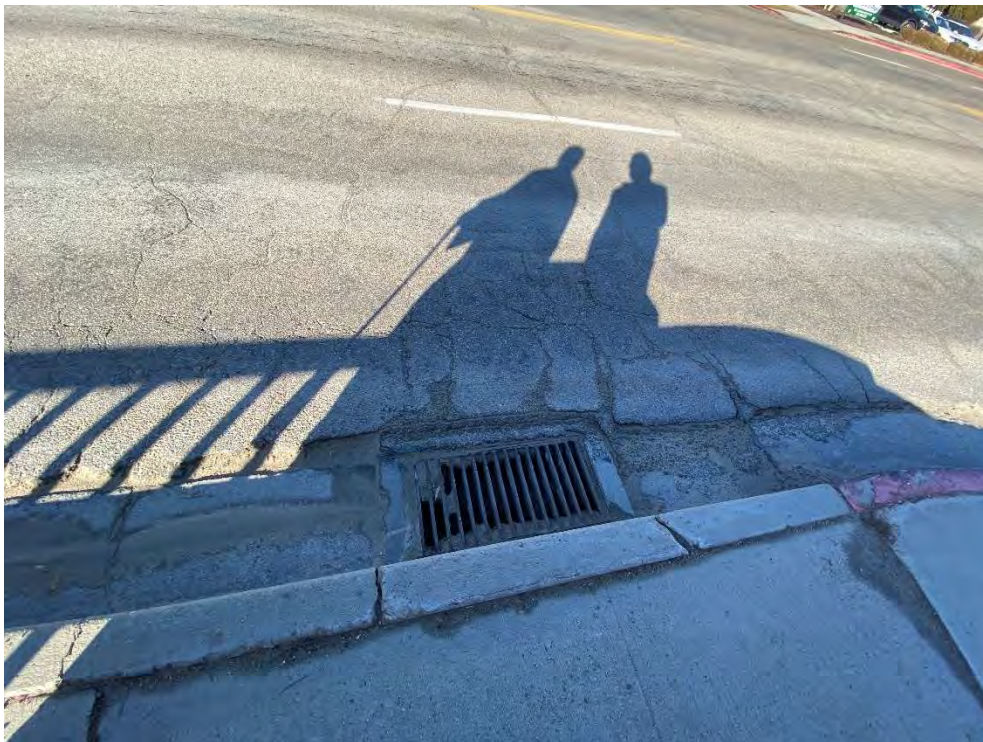
**N 10<sup>th</sup> Ave, SE corner of intersection with E Belmont St, transverse, block, and alligator cracking**

If the mill and inlay alternatives are ultimately selected for rehabilitation, areas of localized failure such as alligator cracking, closely spaced block cracking, fatigue failure in the wheel paths, and any potholes should be repaired prior to placement of the inlay. Repairs should consist of removal of the distressed pavement section (HMA, base, subbase) and underlying soils to the depth needed to accommodate the thicknesses of new Untreated Aggregate Base and HMA shown in the table below.

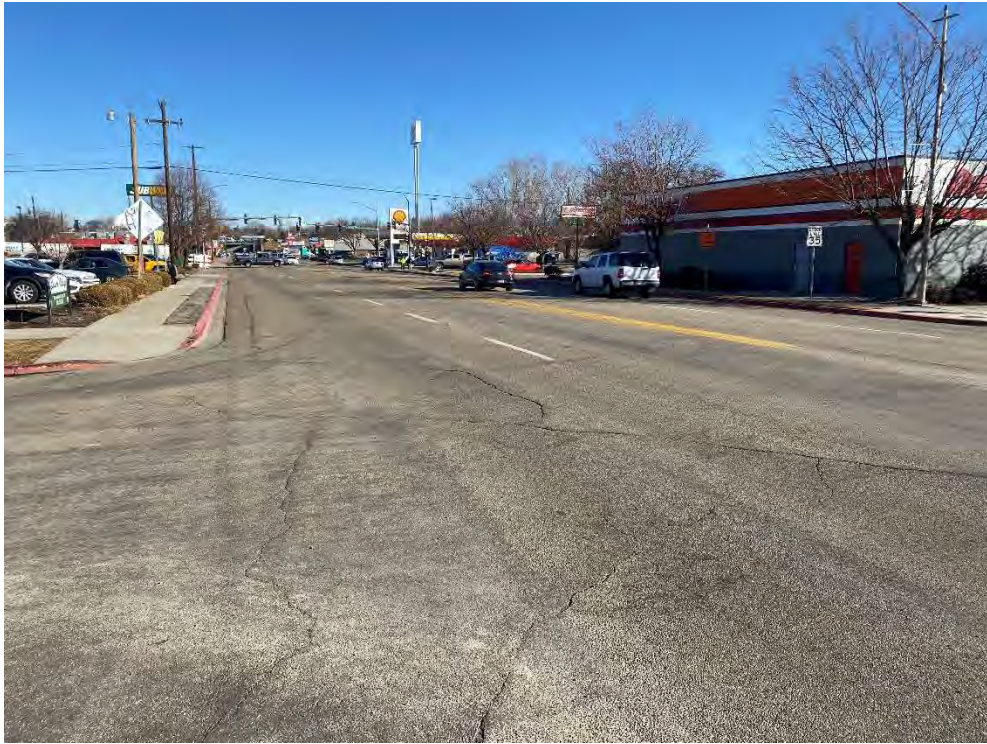
**N 10<sup>th</sup> Ave, south bound lanes in intersection with E Belmont St, longitudinal and transverse cracking**

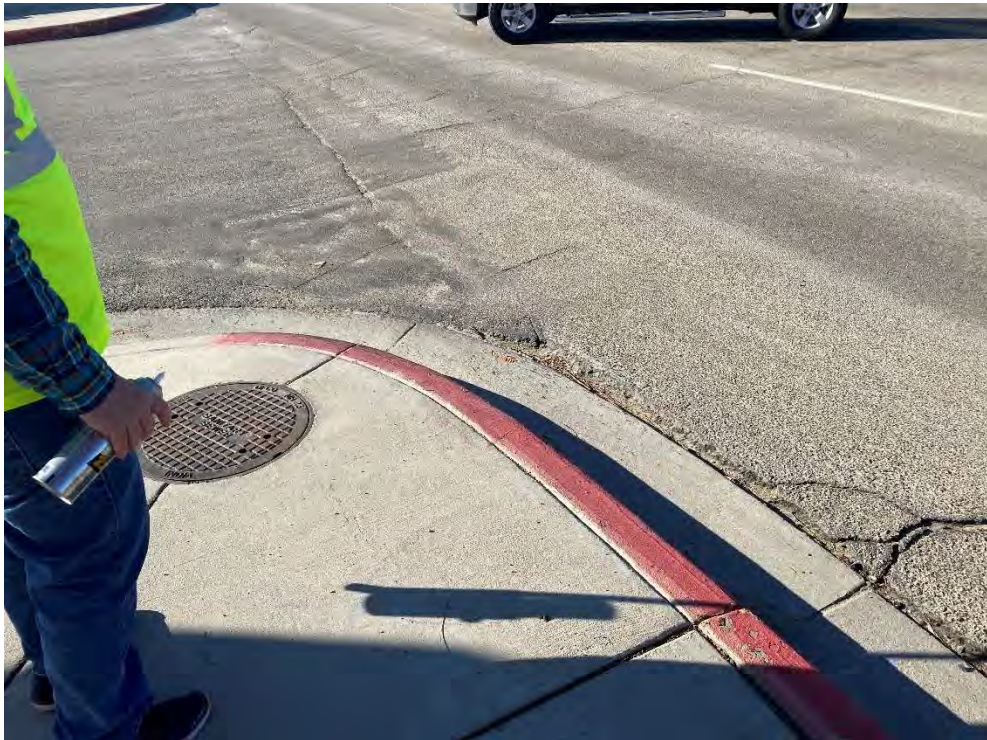
**N 10<sup>th</sup> Ave, NE corner of intersection with E Belmont St, transverse and alligator cracking**

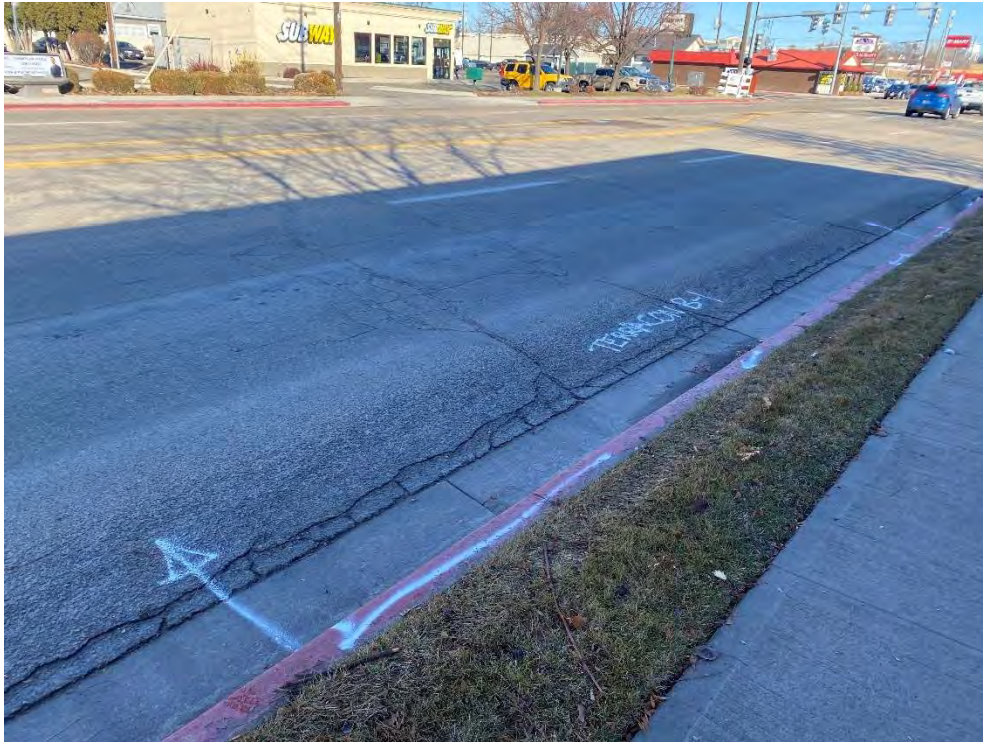
**N 10<sup>th</sup> Ave, north bound lanes from E Belmont St to E Chicago St, transverse, longitudinal, and alligator cracking, with edge failure**

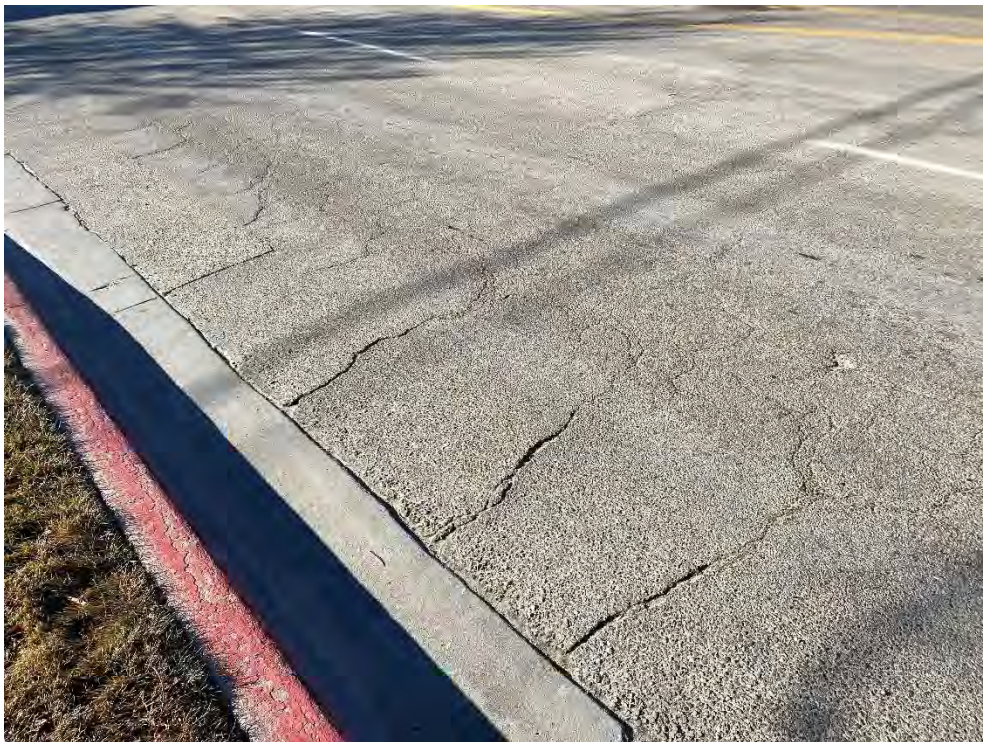
**N 10<sup>th</sup> Ave, northbound lanes from E Belmont St to E Chicago St, transverse and alligator cracking**

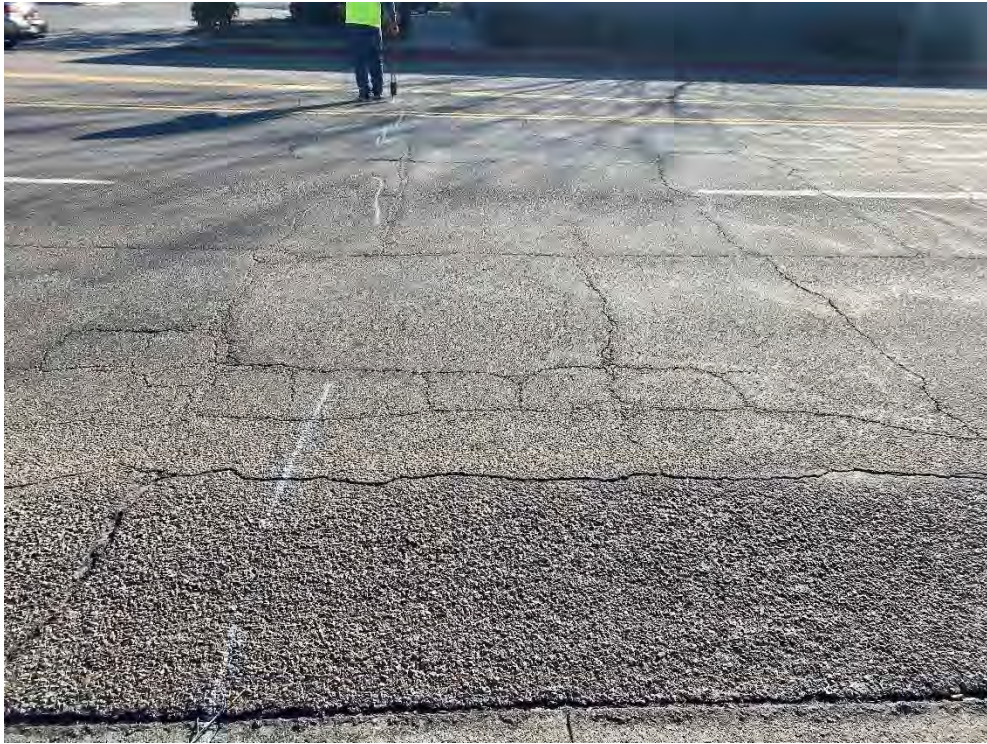
**N 10<sup>th</sup> Ave, southbound lanes from E Belmont St to E Chicago St, transverse, longitudinal, and block cracking**

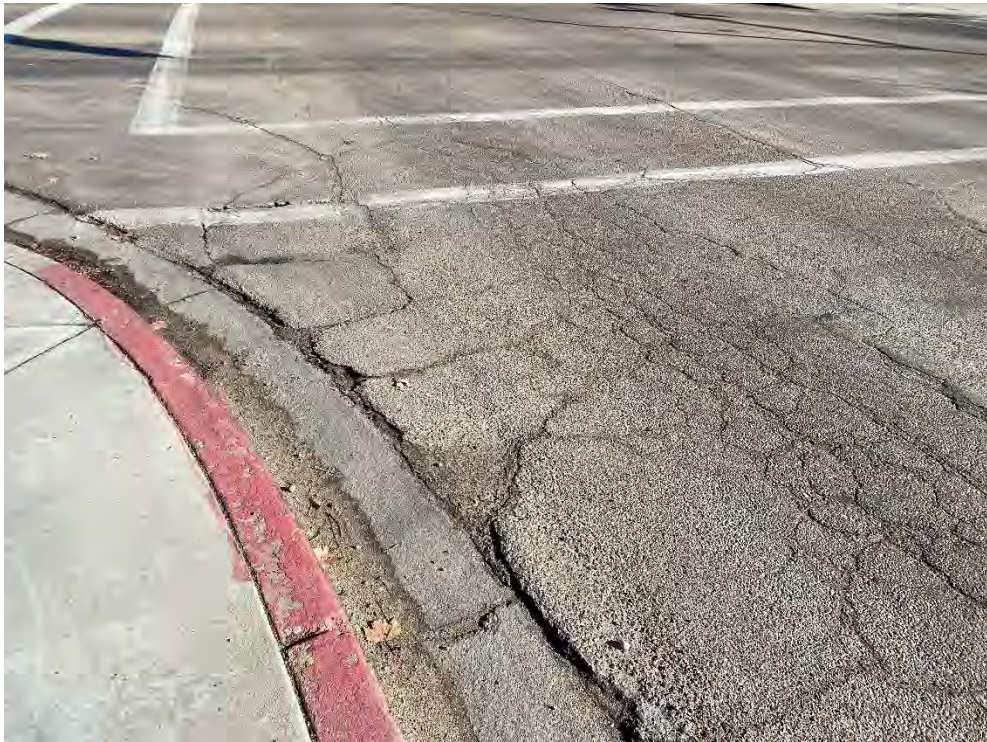
**N 10<sup>th</sup> Ave, SW corner of intersection with E Chicago St, longitudinal, block, and alligator cracking**

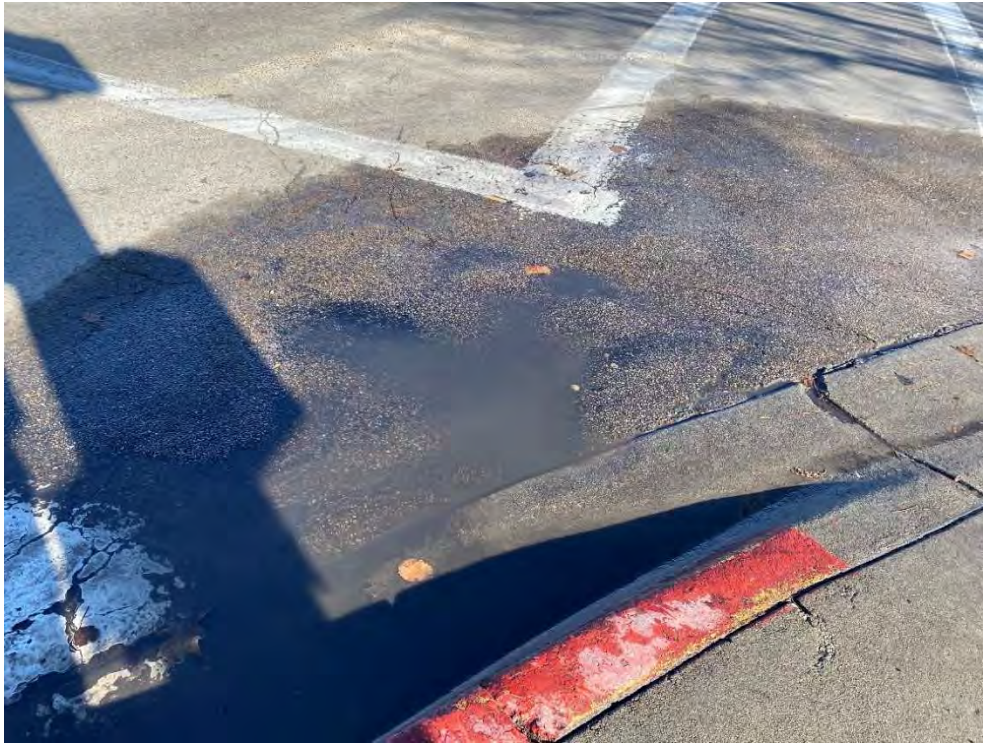
Paved areas should be sloped to provide rapid drainage of surface water away from the pavement surface and edges. Where water is allowed to pond on the pavement, subgrade soils can become saturated and soften, and subsequently accelerate pavement deterioration.

**N 10<sup>th</sup> Ave, SE corner of intersection with E Chicago St, ponding on surface**

Drainage improvements may be included as part of this project. These improvements will be identified by others. Surface runoff should be channeled to existing storm drainage features or collected and diverted to reduce the potential of subgrade saturation. It should be noted that pavement distress was noted near existing drainage features (storm inlets). Project plans should include mitigating poor drainage areas and performing repair of distressed pavement in these areas.

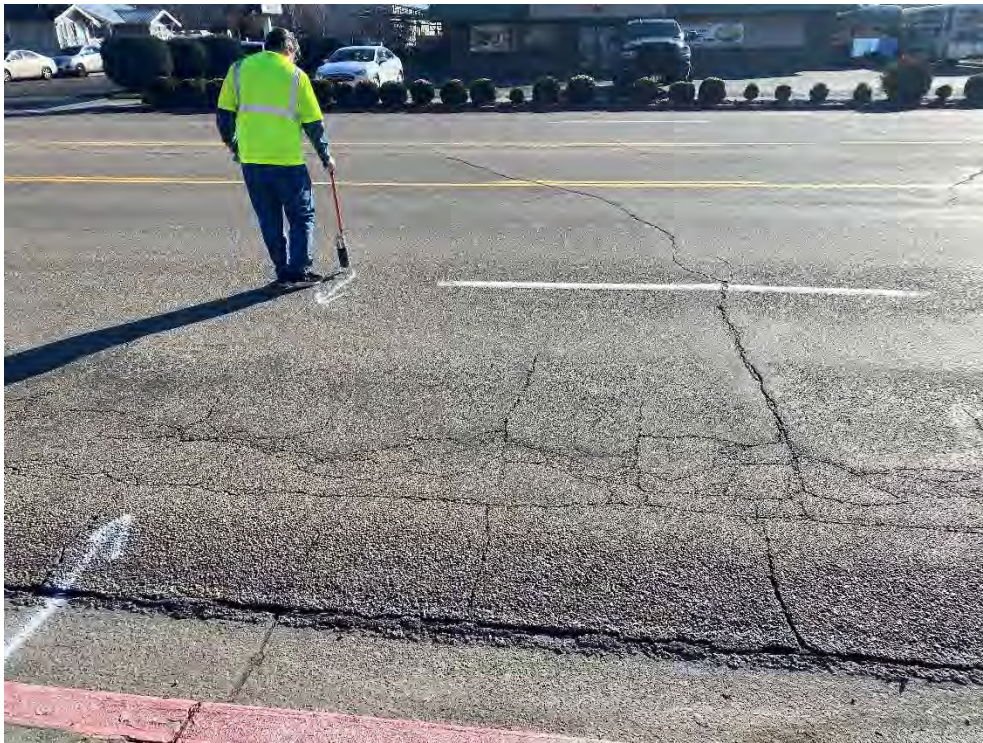
**N 10<sup>th</sup> Ave, from E Chicago St to E Denver St, transverse, longitudinal, block, and alligator cracking**

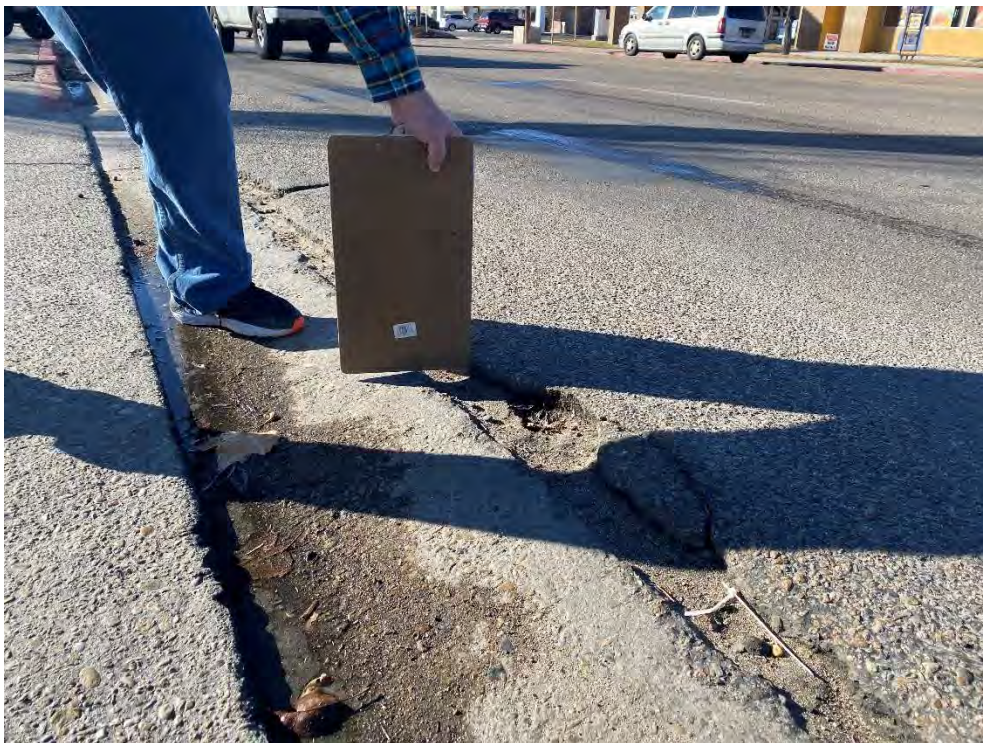
**N 10<sup>th</sup> Ave, from E Denver St to E Elgin St, extensive edge failure**

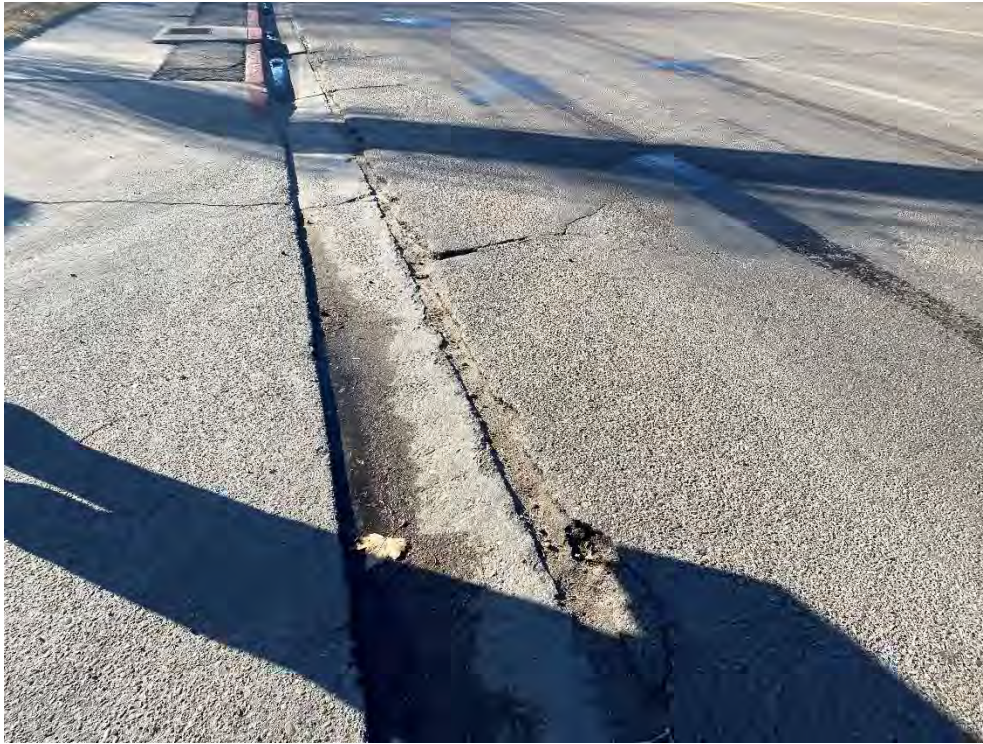
**N 10<sup>th</sup> Ave, from E Denver St to E Elgin St, extensive edge failure**

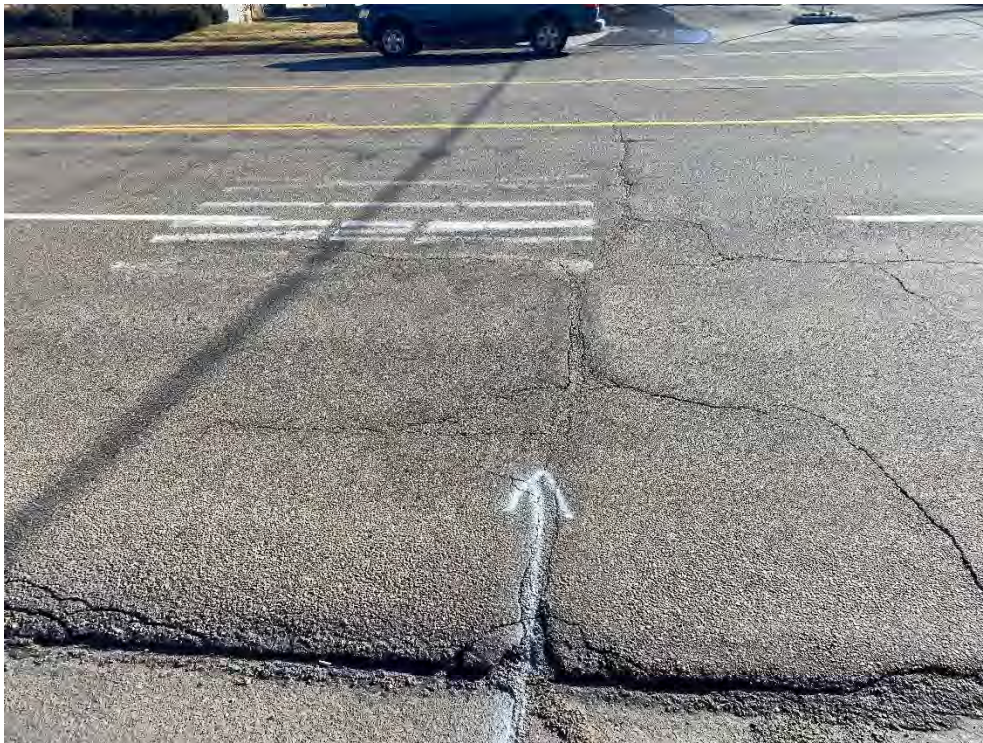
**N 10<sup>th</sup> Ave, south bound lanes from E Denver St to E Elgin St, transverse and longitudinal cracking**

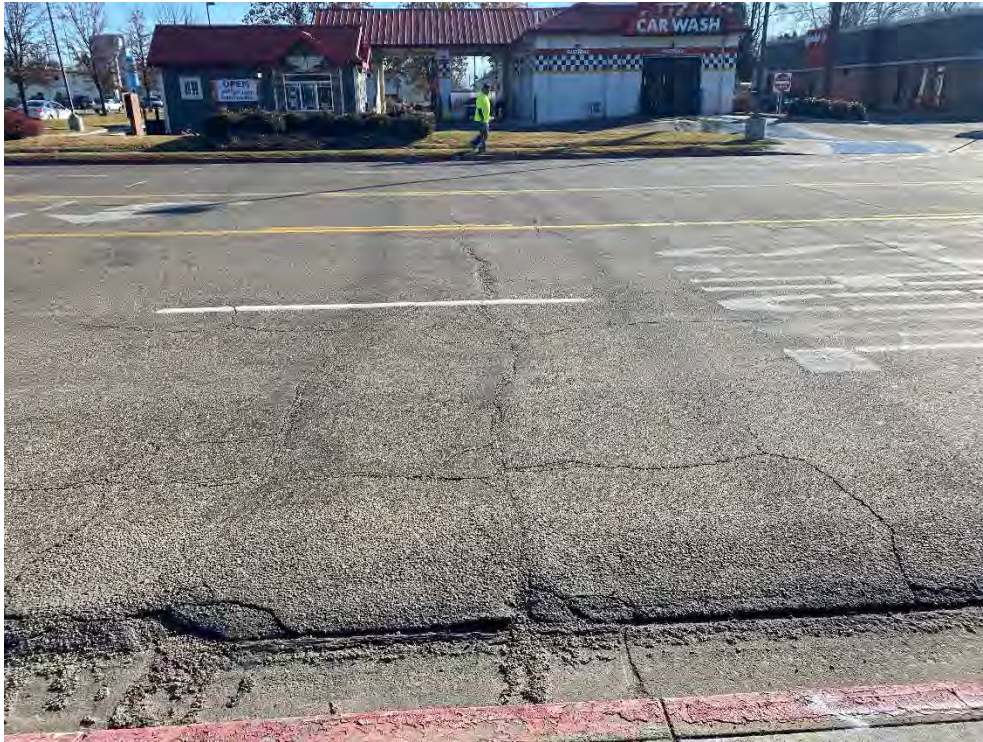
**N 10<sup>th</sup> Ave, south bound lanes from E Denver St to E Elgin St, transverse and longitudinal cracking**

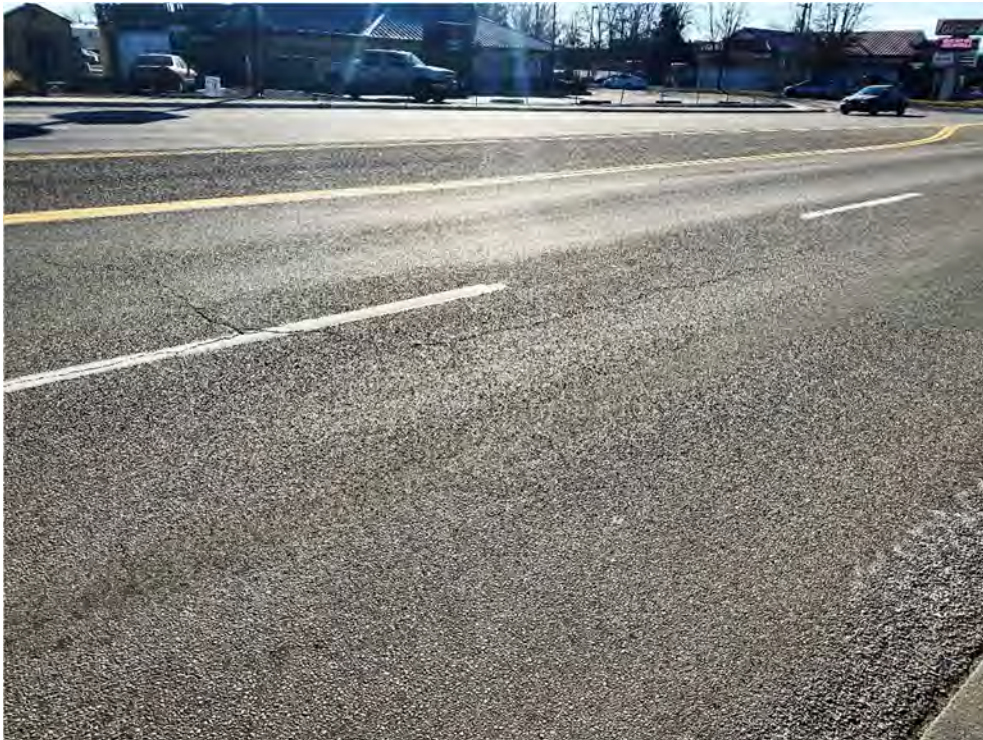
**N 10<sup>th</sup> Ave, south bound lanes from Freeport to east bound I-84 exit ramp, transverse and longitudinal cracking**

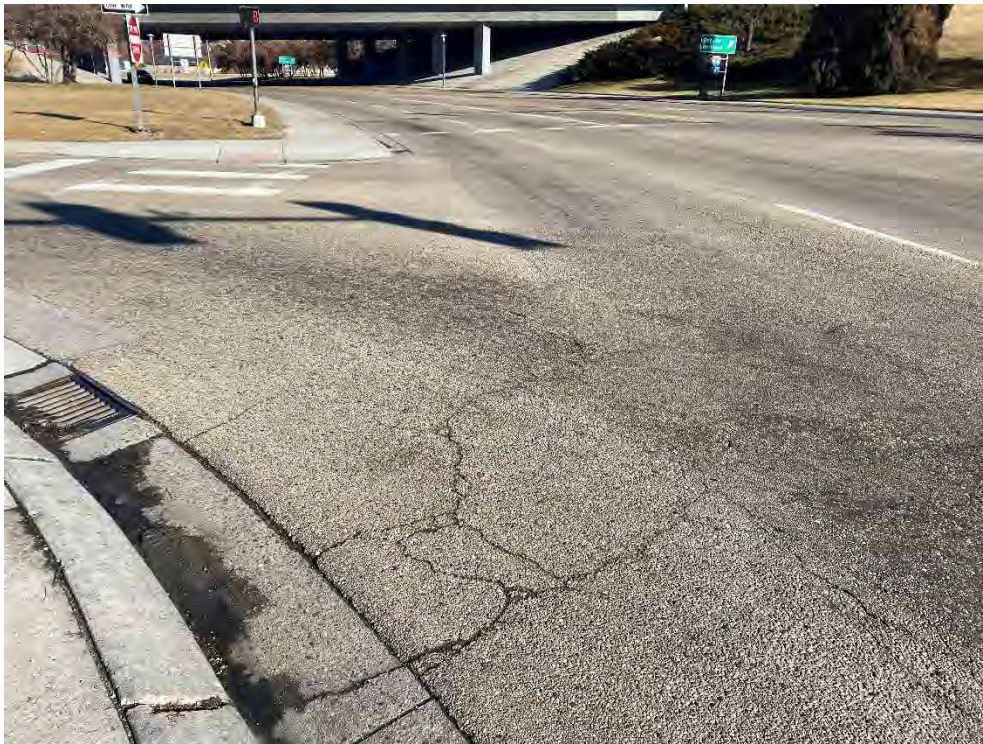
**N 10<sup>th</sup> Ave, SW corner of intersection with east bound I-84 exit ramp, transverse and longitudinal cracking**

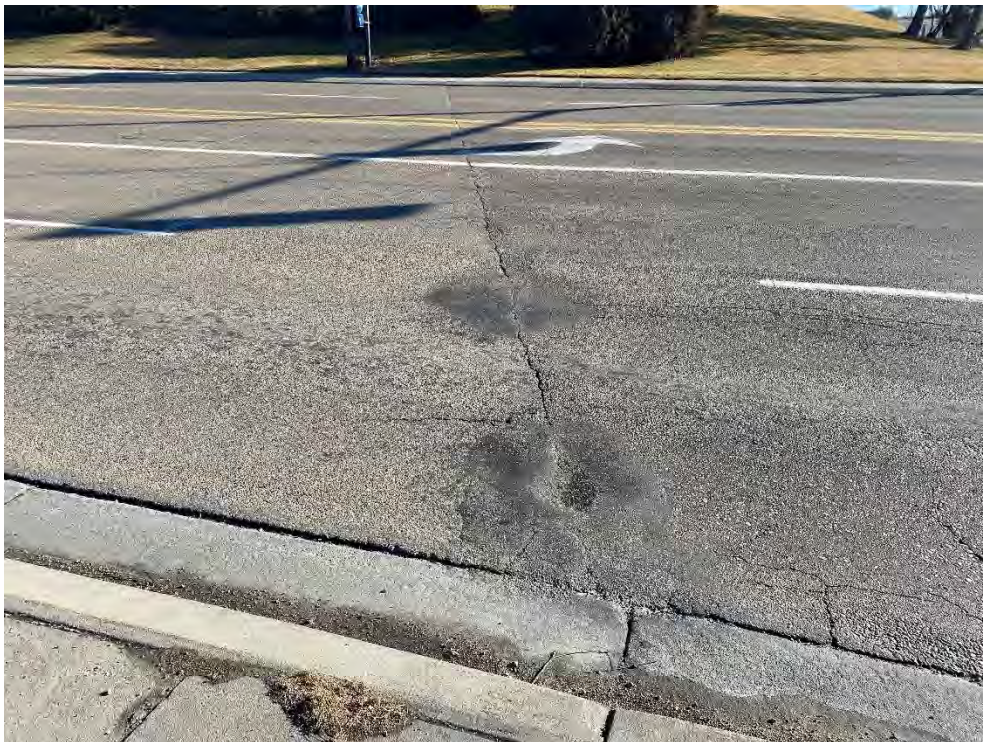
**N 10<sup>th</sup> Ave, from east bound I-84 entrance/exit ramps to I-84 overpass, transverse crack extending across all 5 lanes**

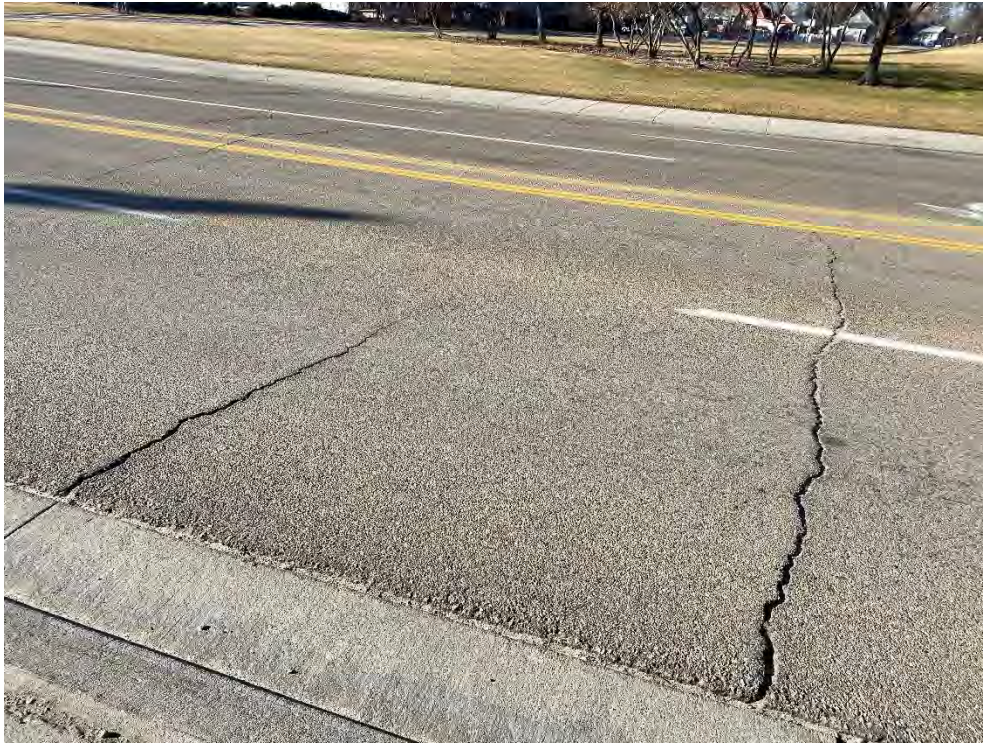
**N 10<sup>th</sup> Ave, north bound lanes from east bound I-84 entrance/exit ramps to I-84 overpass, transverse cracking**

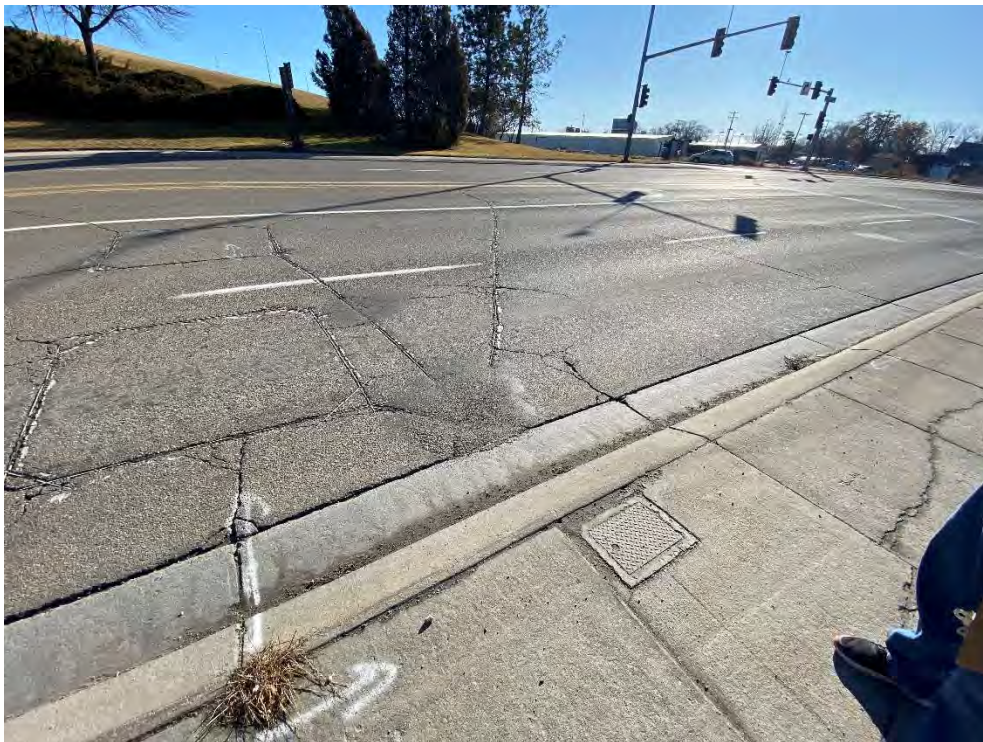
**N 10<sup>th</sup> Ave, south bound lanes from east bound I-84 entrance/exit ramps to I-84 overpass, transverse and longitudinal cracking with utility patches**

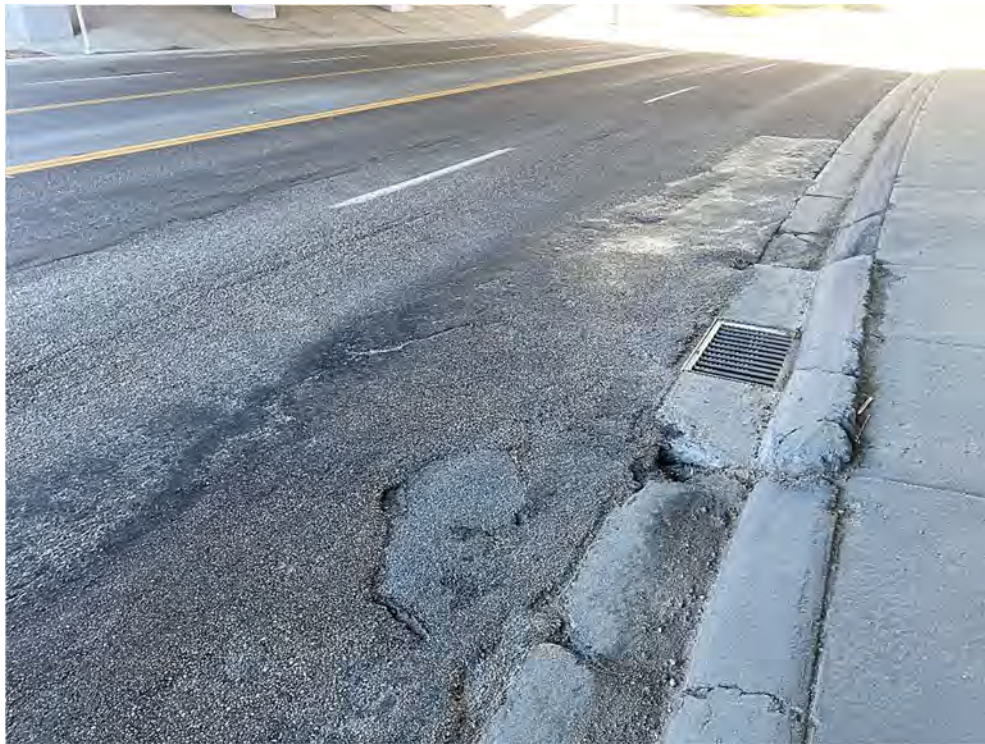
**N 10<sup>th</sup> Ave, south bound lanes from I-84 overpass to west bound I-84 entrance/exit ramps, longitudinal cracking and soft spots surrounding storm drain**

Soils that rut, pump, or are otherwise disturbed are not suitable for support of pavements. If unstable soils are encountered, the contractor should remove a minimum of 18 inches of existing material and replace them with compacted  $\frac{3}{4}$ -inch crushed aggregate base. The actual depth of over-excavation should be determined by the contractor based on the specific depth of unstable soils.

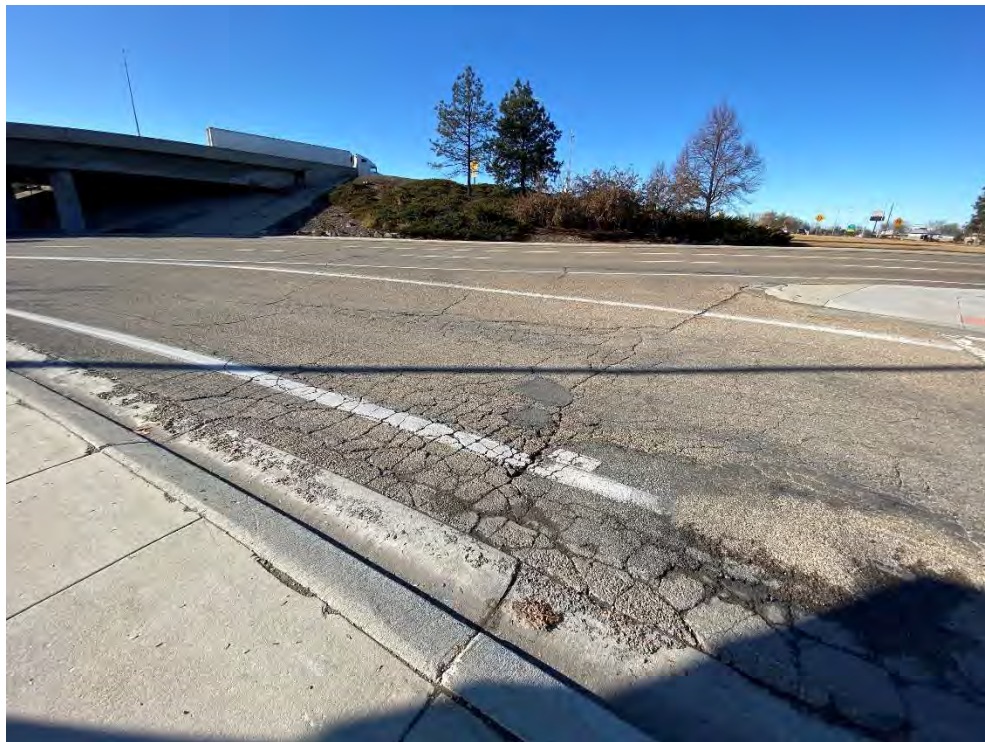
**N 10<sup>th</sup> Ave, north bound lane from I-84 overpass to west bound I-84 entrance ramp, transverse, longitudinal, and alligator cracking**

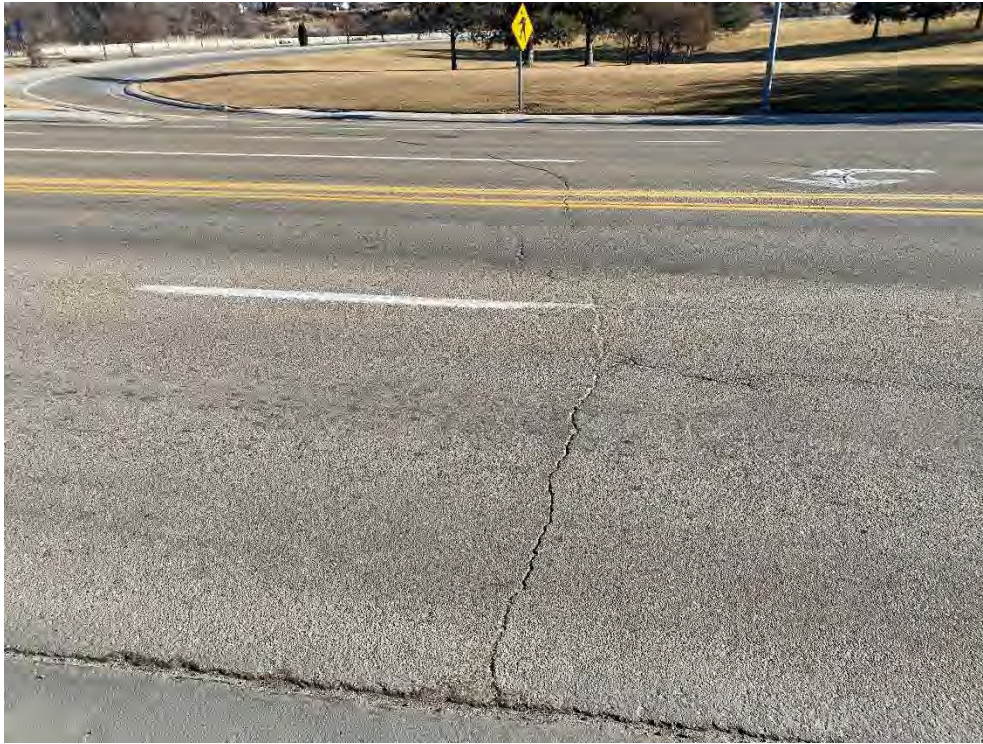
**N 10<sup>th</sup> Ave, south bound lanes from I-84 overpass to west bound I-84 entrance ramp,  
transverse and longitudinal cracking**
