**PROGRAM ID, COUNTY, ETC.:**  
N 10<sup>th</sup> Avenue ITS & Overlay, Caldwell  
Canyon County

**RE:** Phase I(R) – Pavement Rehabilitation Report

**10th Avenue ITS and Overlay**

**Phase I(R) Pavement Rehabilitation Report**

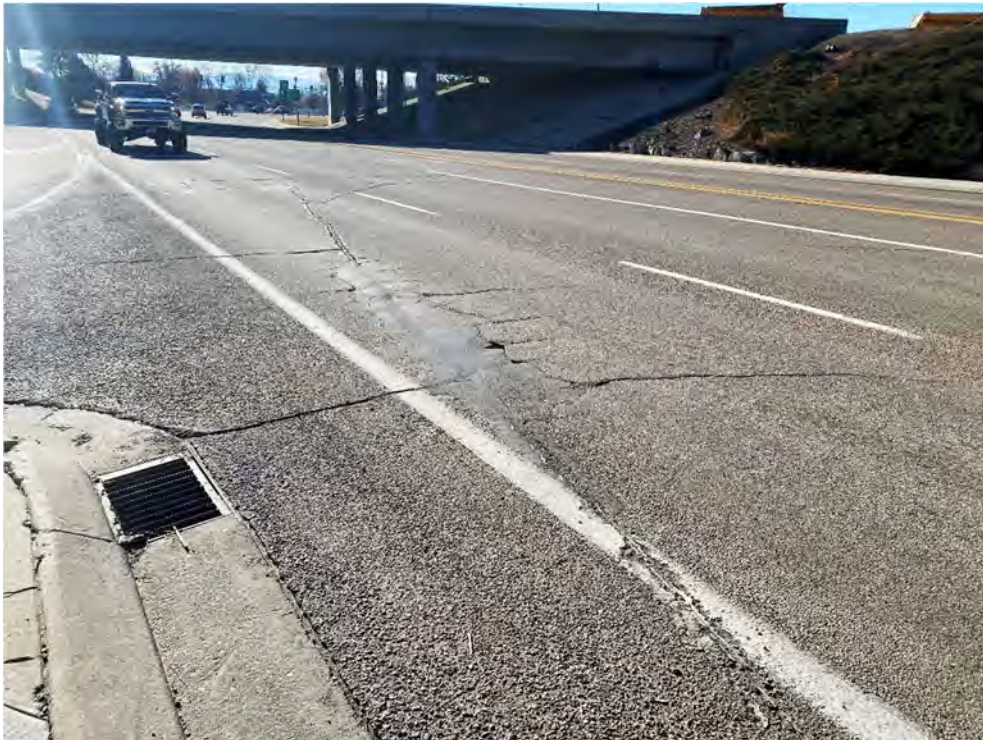
**N 10<sup>th</sup> Ave, north bound lanes from I-84 overpass to west bound I-84 entrance/exit ramps,  
transverse and longitudinal cracking**

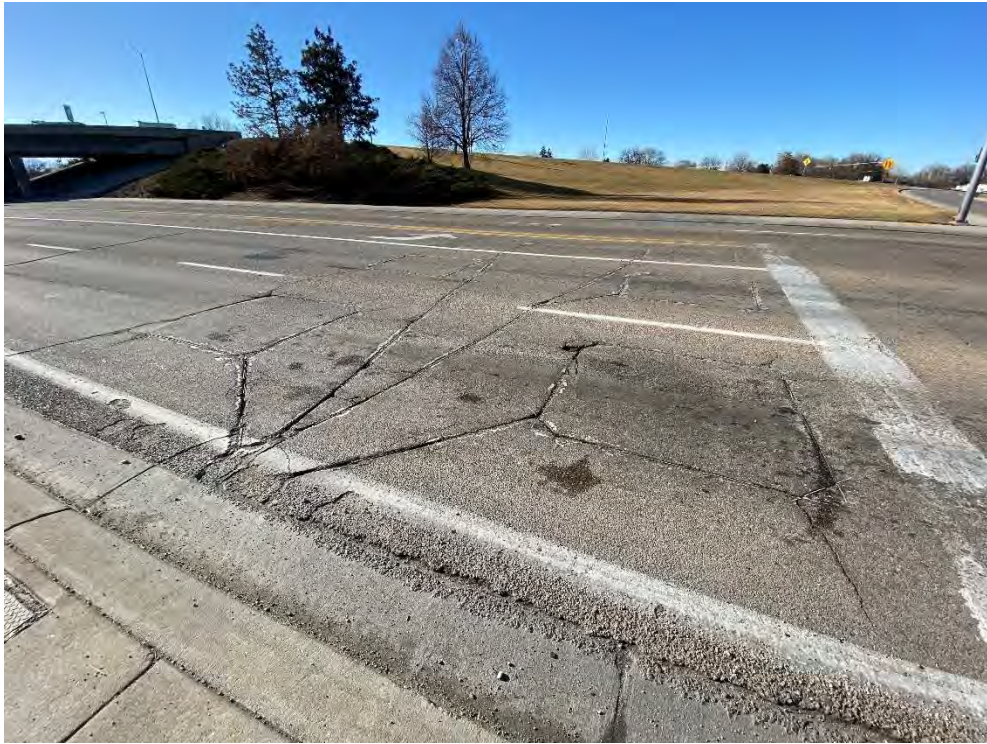
**N 10<sup>th</sup> Ave, north bound lanes from I-84 overpass to west bound I-84 entrance/exit ramps, transverse and longitudinal cracking with utility patching**

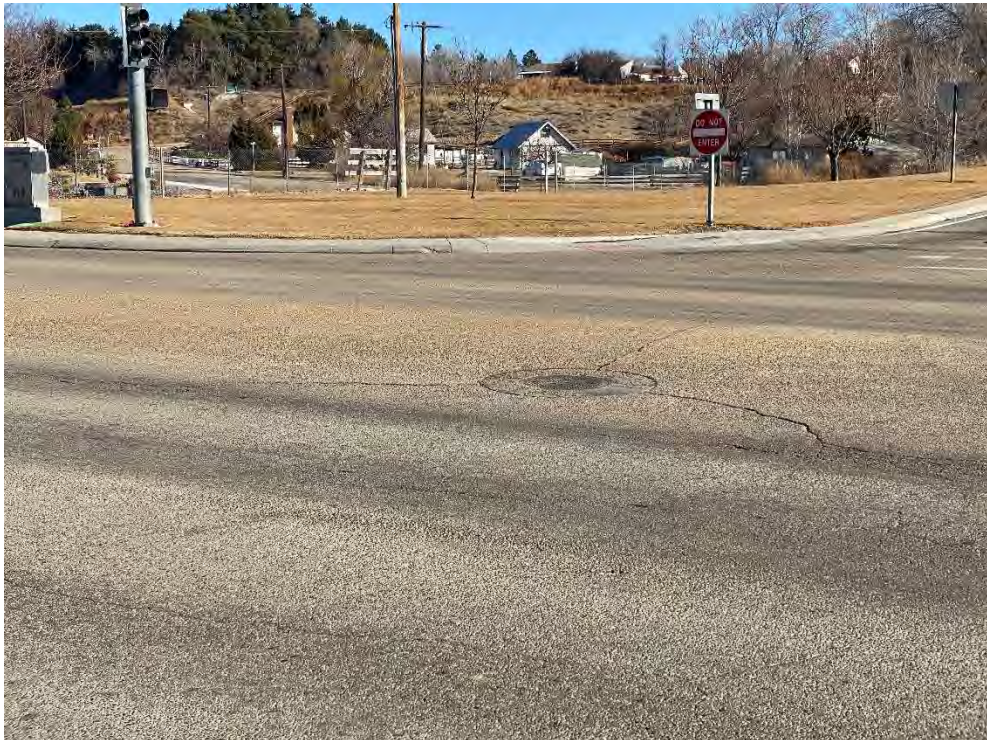
**N 10<sup>th</sup> Ave, intersection with west bound I-84 entrance/exit ramps, transverse and longitudinal cracking from utility**

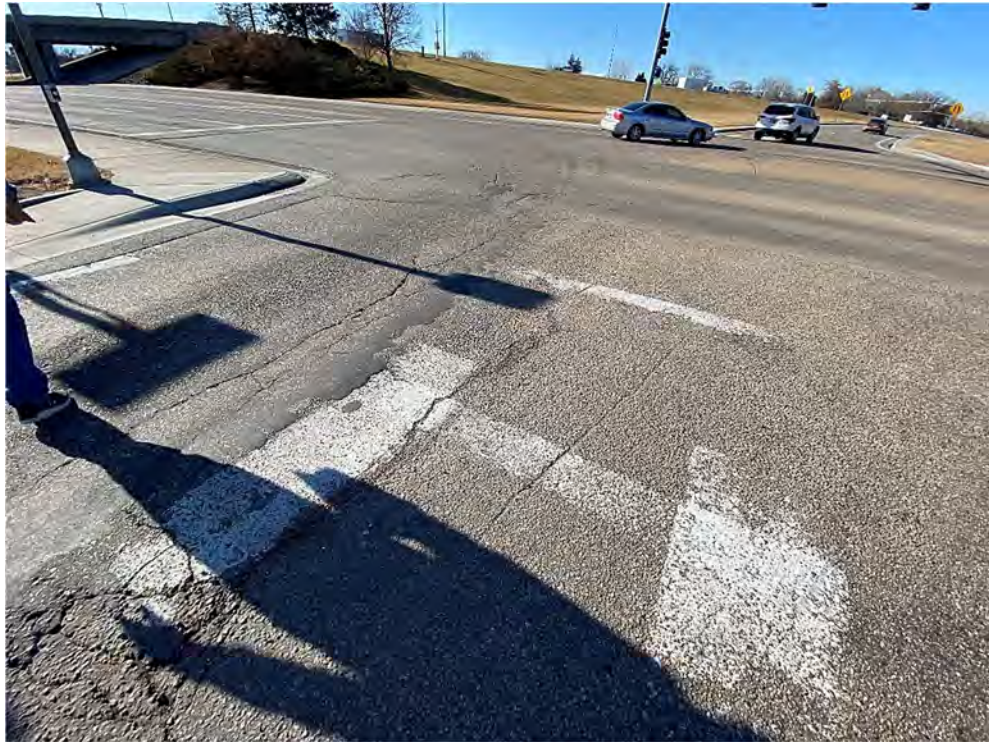
**N 10<sup>th</sup> Ave (N Illinois Ave), SE corner/crosswalk of intersection with west bound I-84 exit ramp, longitudinal, transverse, and alligator cracking**

If the mill and inlay alternatives are ultimately selected for rehabilitation, areas of localized failure such as alligator cracking, closely spaced block cracking, fatigue failure in the wheel paths, and any potholes should be repaired prior to placement of the inlay. Repairs should consist of removal of the distressed pavement section (HMA, base, subbase) and underlying soils to the depth needed to accommodate the thicknesses of new Untreated Aggregate Base and HMA shown in the table below.

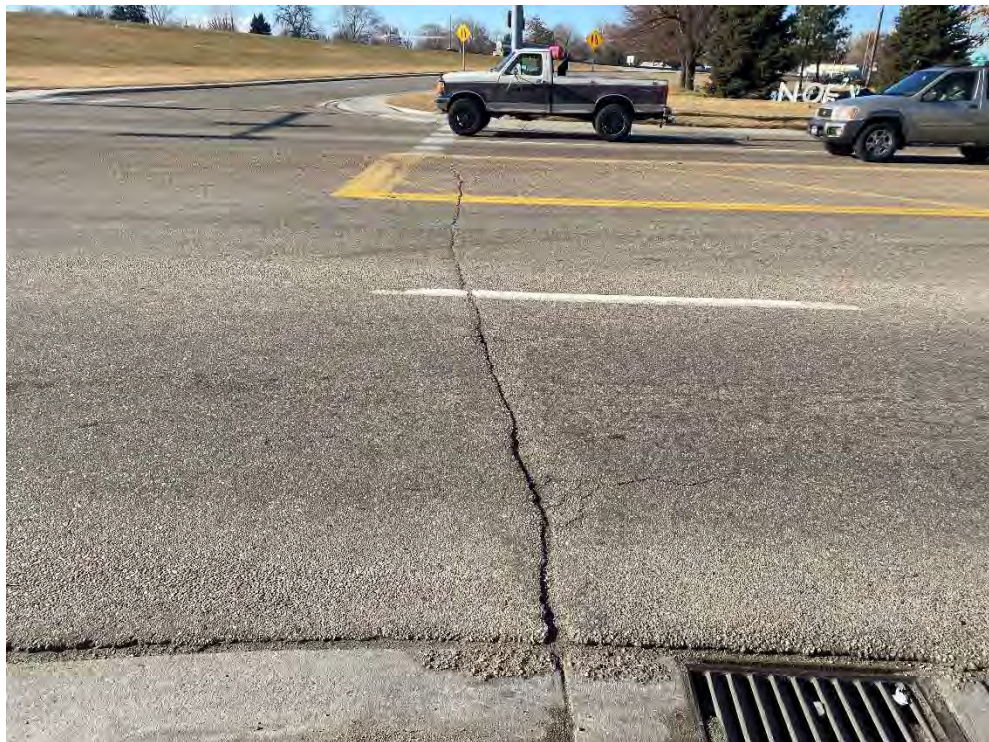
**N 10<sup>th</sup> Ave (N Illinois Ave), NE corner of intersection with west bound I-84 entrance/exit ramps, transverse and longitudinal cracking**

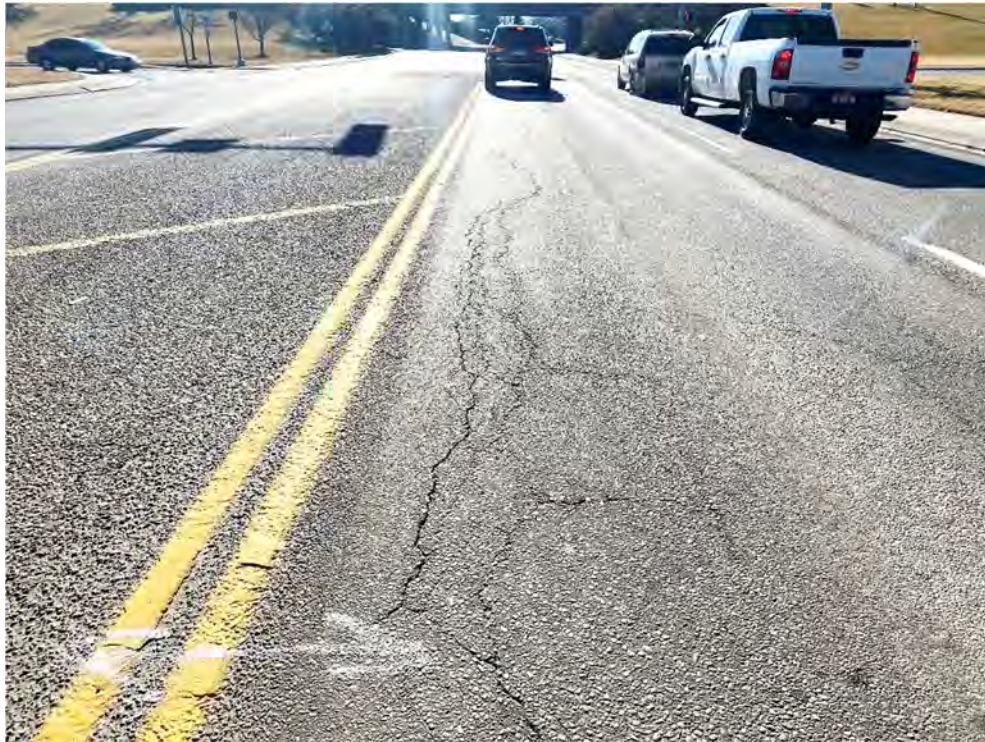
**N 10<sup>th</sup> Ave (N Illinois Ave), south bound lanes from west bound I-84 entrance/exit ramps to W Kimball Ave, longitudinal and transverse cracking**

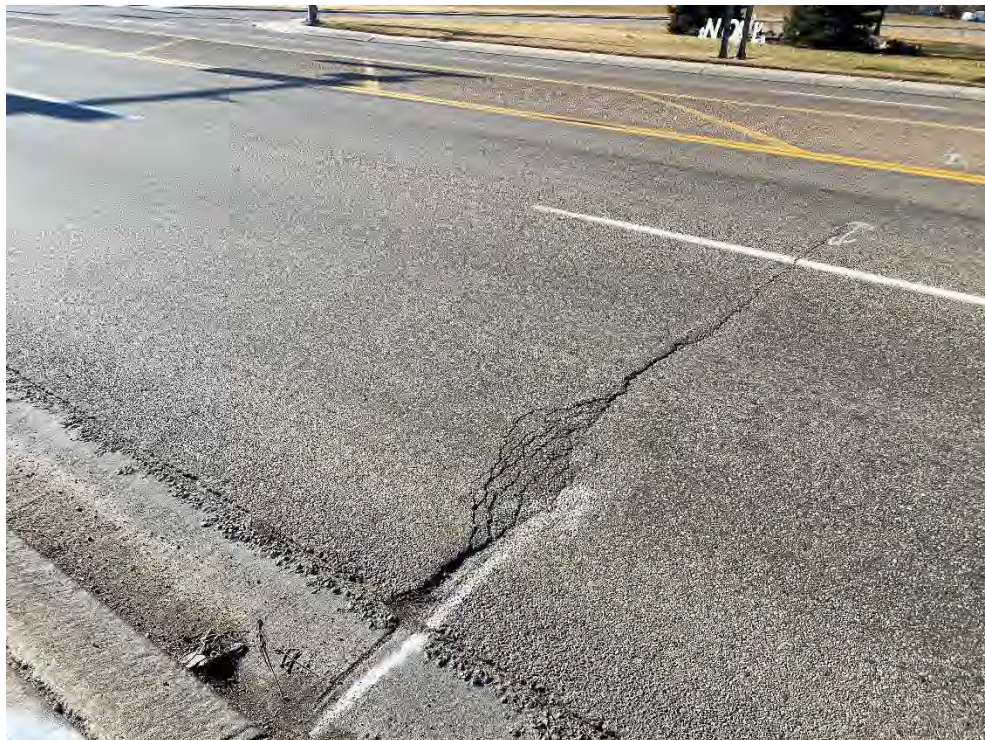
**N 10<sup>th</sup> Ave (N Illinois Ave), north bound lanes from west bound I-84 entrance/exit ramps to W Kimball Ave, transverse and alligator cracking**
