RP 262

Concrete Performance in Aggressive Salt and Deicing Environments

RESEARCH REPORT

IDAHO TRANSPORTATION DEPARTMENT

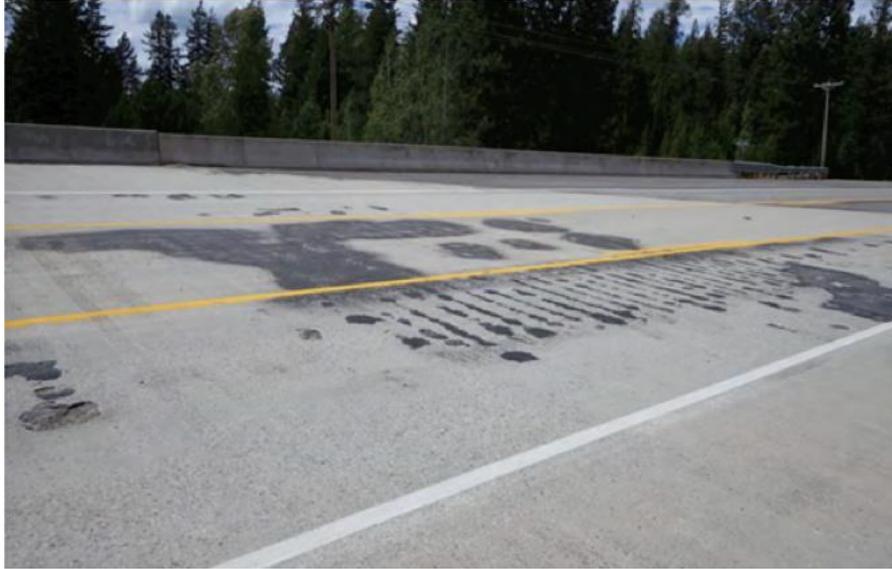
Figure 3. Large Area of Concrete Spalls with Rebar Exposed and Delamination at Midspan of the Deck

The research team has received reports of tests conducted by American Engineering Testing (AET) Inc. on hardened concrete core samples obtained from Centerline Tall Rail and Westbound Standard Rail precast concrete barriers on I-90. These barriers were cast between June 2014 and June 2015 which showed varying degrees of surface scaling and mortar flaking after winter season. The observed distress on the barriers was due to exposure of concrete to saturation and cyclic freezing and thawing, salt ingress from the snow events and spray of passing vehicles. The study concluded that the entrained air percentages in the samples were very low and did not follow the standard percentages for concrete under severe exposure. In addition, the penetration of deicers coupled with the coverage of barriers by snow, snow slushing, and the accompanied freeze and thaw cycles led to the distress observed. Figure 3 shows one of the bridge decks in District 1 experienced spalling and deterioration, while Figure 4 shows a significant spalling in a bridge rail located in the same district.

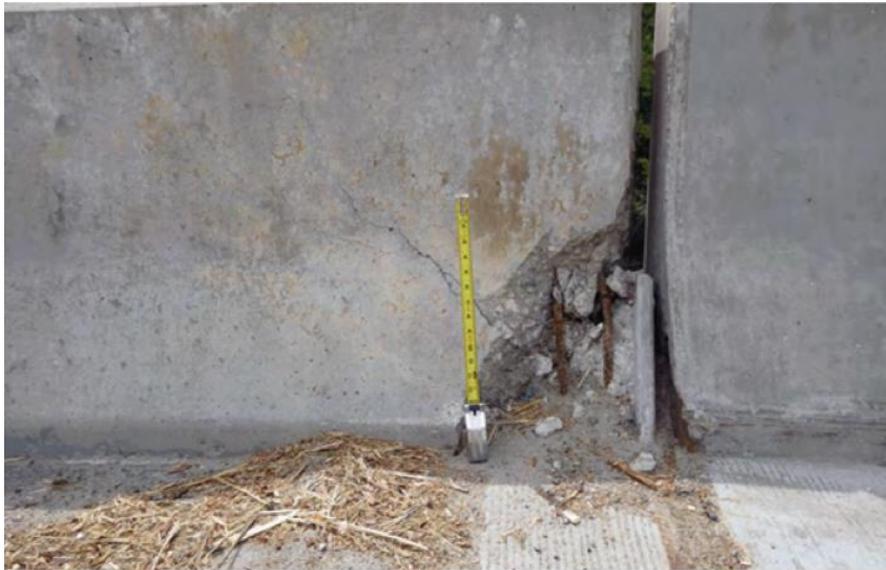
Figure 4. Concrete Spalling in a Concrete Rail (District 1)

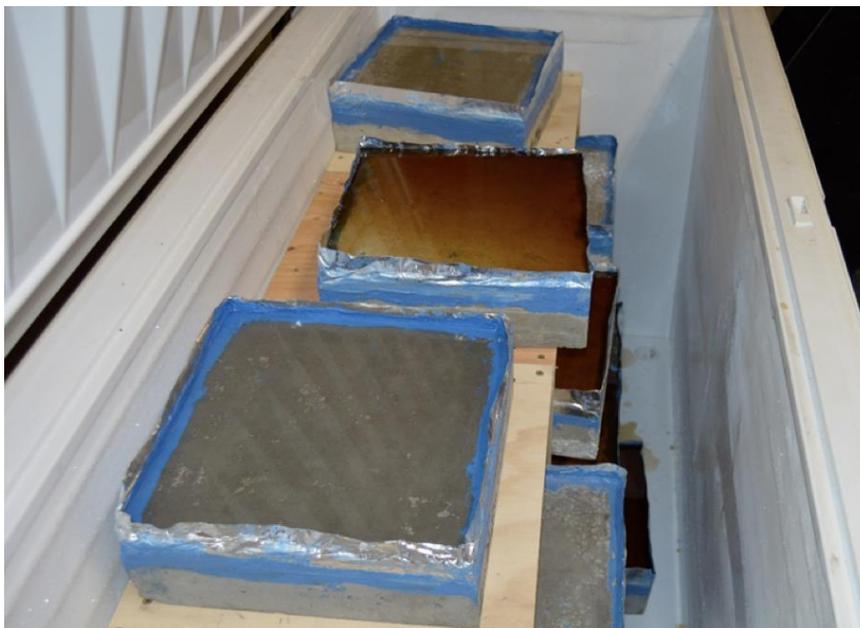
Figure 8. Slabs Exposed to Freezing Environment During Deicing Scaling Test

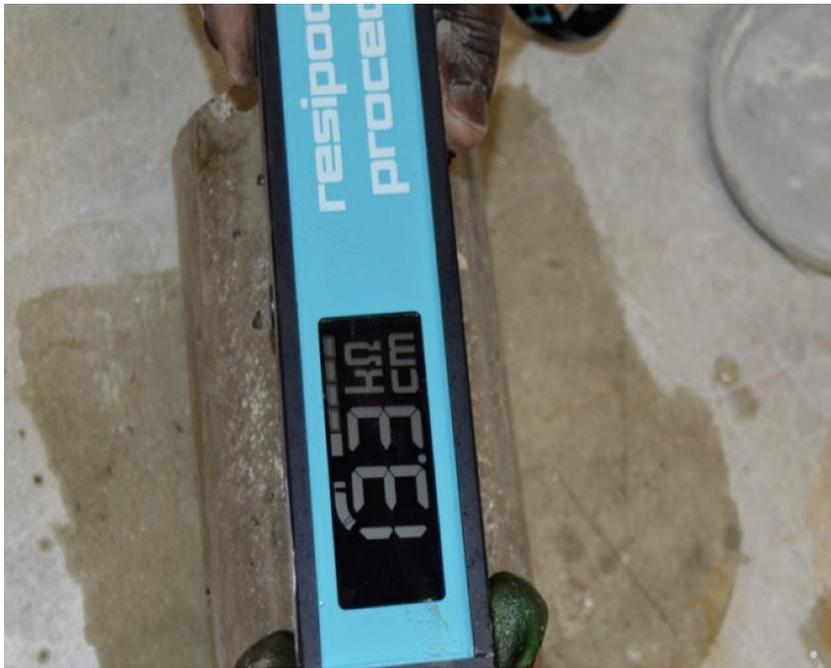
Figure 9. Surface Resistivity Testing

Concrete surface resistivity is a non-destructive test conducted on cylindrical specimens according to the procedure outlined in AASHTO T358 “Standard Method of Test for Surface Resistivity Indication of Concrete’s Ability to Resist Chloride Ion Penetration”. In this project, the test was performed on 4-inch diameter cylindrical specimens using Proceq resistivity meter. The surface resistivity was conducted on 3 specimens per mix per district. Each specimen was marked at four quadrants representing 0, 90, 180

and 270 degrees, and two readings per quadrant were taken in the order of the marked angles to ensure consistency and no significant differences between the operator or the equipment. The surface resistivity measures the degree to which the concrete sample resists the flow of an electrical current. While the solid material in concrete has a relatively high resistivity, the pores are usually partially or fully saturated with a concentrated alkaline solution that has a relatively low resistivity. Thus, the flow of electrical current through the pore solution, gives an indirect measure of the quality of the microstructure of the concrete. The specimens were tested using the Wenner four-electrode test, which consists of four equally spaced, co-linear electrodes placed in contact with a concrete cylinder specimen. The testing procedure involves passing alternating current to the outermost electrodes and measuring the voltage between the middle two electrodes to calculate its resistance. The specimen resistivity was then calculated using the resistance, length between the electrodes, dimensions of the cylinder specimen and necessary correction factor. The surface resistivity meter is shown in Figure 9.

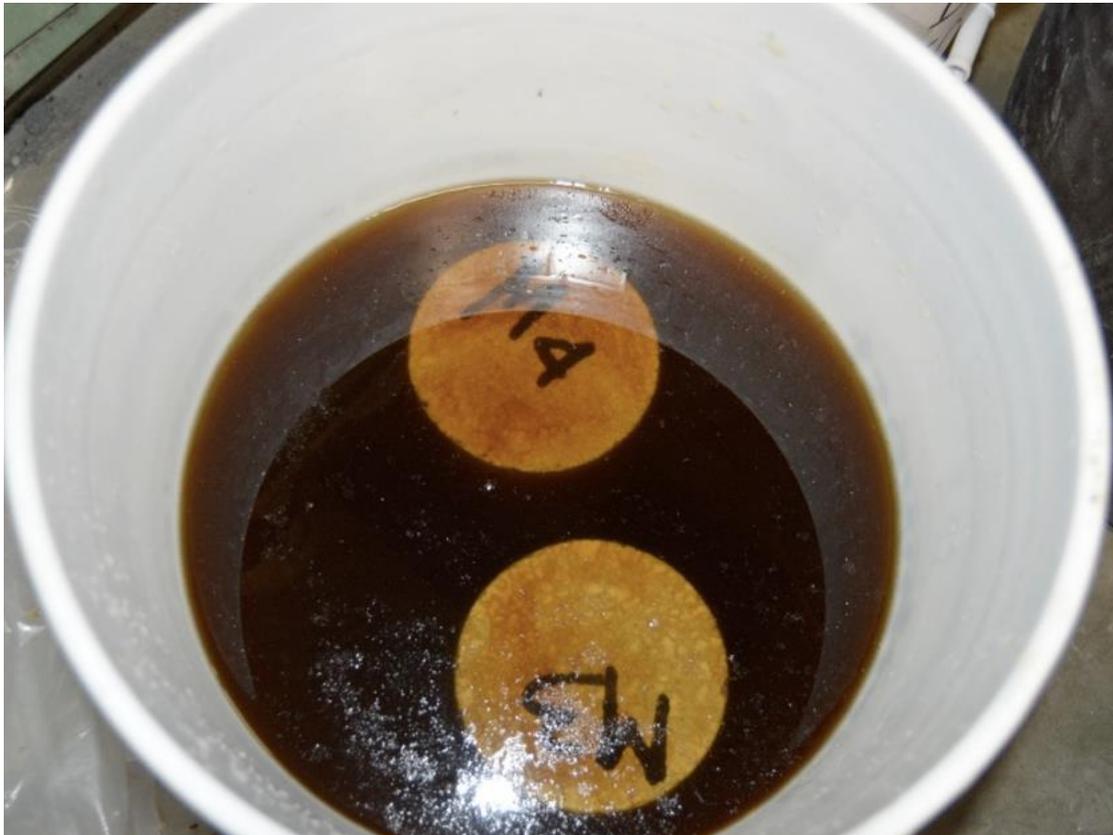
Figure 10. Concrete Specimens under Continuous Soaking

This test aims to study the deterioration of concrete microstructure after 90 days of continuous submerging in deicing chemical solutions. The cylindrical specimens were soaked (Figure 10) in salt solutions obtained from Districts 1, 2, 3, 5, and 6. The cylinders were 455 days (1 year and 3 months) age before soaking because they were from RP 253 project. After 90 days, the specimens were tested under uniaxial compression to investigate the loss in strength (ASTM C39). Two reference cylinder specimens were moist cured in the humidity chamber for 90 days and tested under uniaxial compression on the same day of testing the soaked specimens.

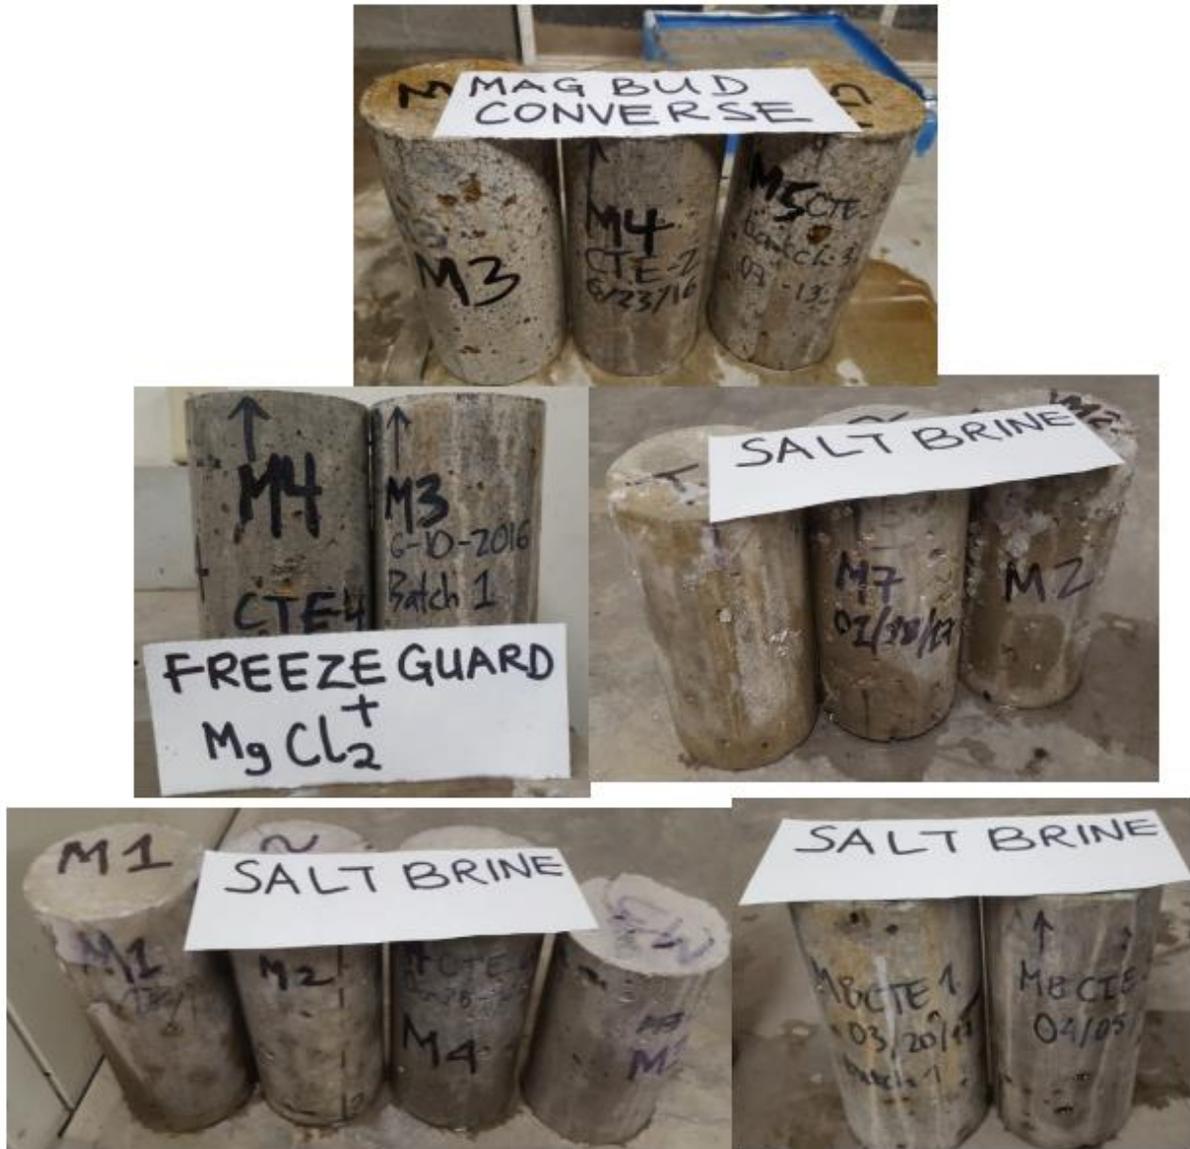
Figure 12. Concrete Specimens after 90 Days Continuous Soaking in Deicing Salt

As previously described, all the specimens were soaked continuously for 90-days in deicing chemicals at a temperature of 5°C (41°F) to promote the formation of Oxychloride compounds. As shown in Figure 12, the specimens soaked in mag-bud converse, and freeze guard plus magnesium chloride (M3, M4, and M5) displayed heavy deterioration of ASR with concrete spalling and severe cracks extended to the whole surface of the specimens with major signs of spalling, while those soaked in salt brine had mild to moderate deterioration except M2 where it showed major concrete spalling. The ASR cracked pattern observed on the concrete cylinders can be confirmed by petrographic analysis, which forms part of the suggested tests to be conducted in the future.

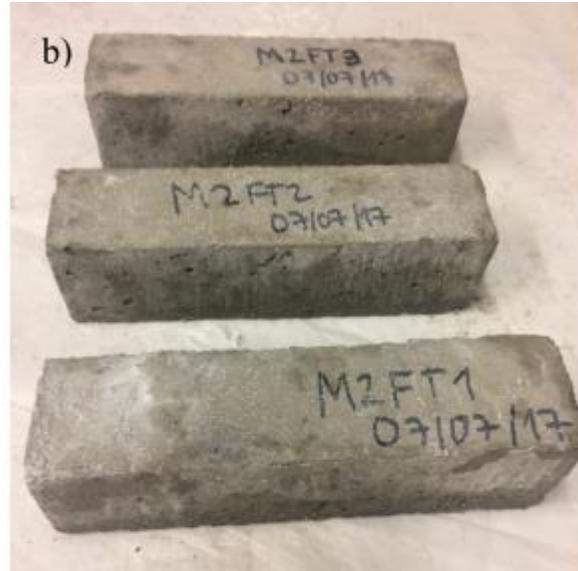
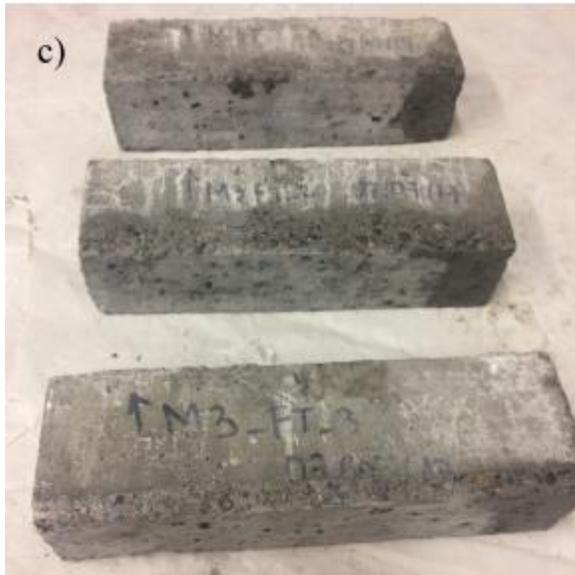
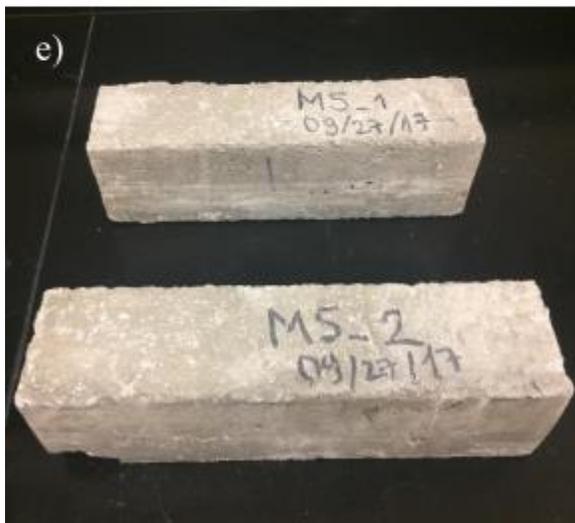
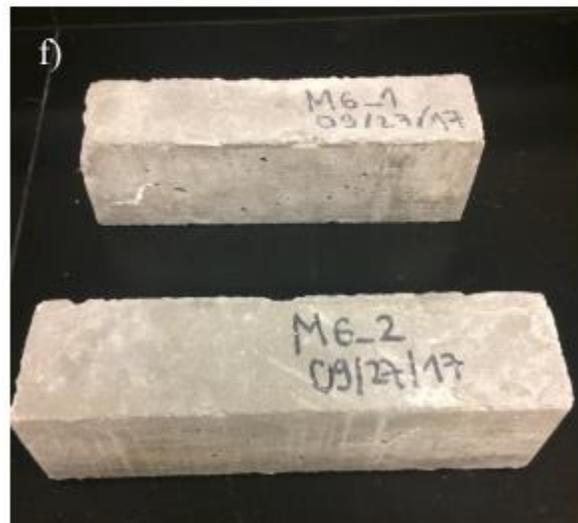
Figure 15. 300 F-T Cycles Results: a) M1, b) M2, c) M3, d) M4, e) M5, f) M6, g) M7, h) M8

Excluding mixtures M3 and M4 [see Figure 15 (c) and (d)], Figure 15 shows that the tested specimens after the entire F-T test exhibited some calcium leaching on the surface due to the prolonged contact with the water, minor damage on the surface, and overall good structural integrity, consistent with a satisfactory F-T performance elaborated above.

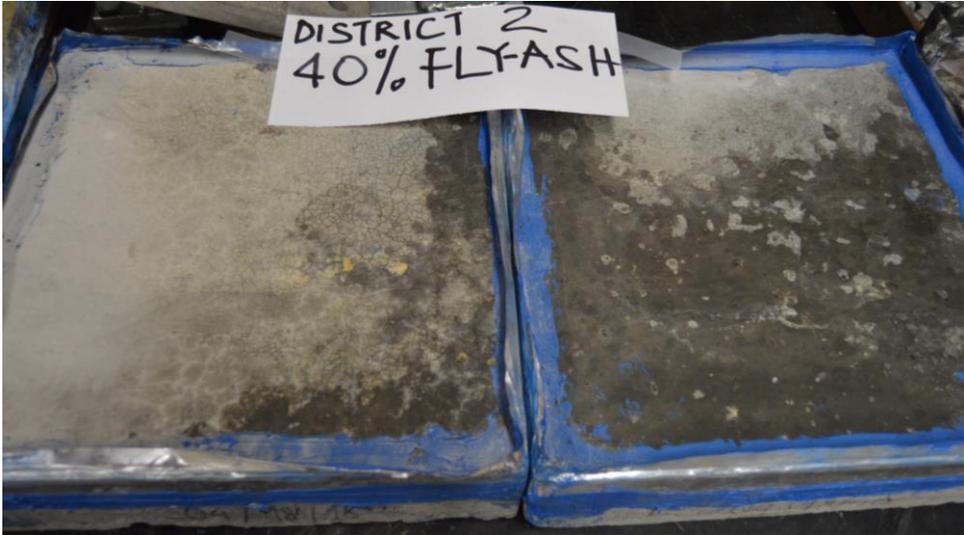
Figure 23. Specimens Tested for Deicing Scaling (District 2)

District 1 and 6. Severe scaling (visual rating of 5) was observed as shown in Figure 21 and 22. A 35-40 percent cement replacement with fly ash was reported to reduce Calcium-Oxychloride (CAOXY) formation which resulted in no scaling⁽⁵⁰⁾ (Suraneni, et al. 2016). However, other authors⁽⁵¹⁻⁵⁴⁾ reported that increasing fly ash content in concrete with water-to-cementitious ratio above 0.4 will increase scaling damage in concrete. on the contrary, very slight scaling was observed in the specimens with 40 percent fly ash for district 2 as shown in Figure 23, while the ternary mixture showed no scaling (Figure 24).

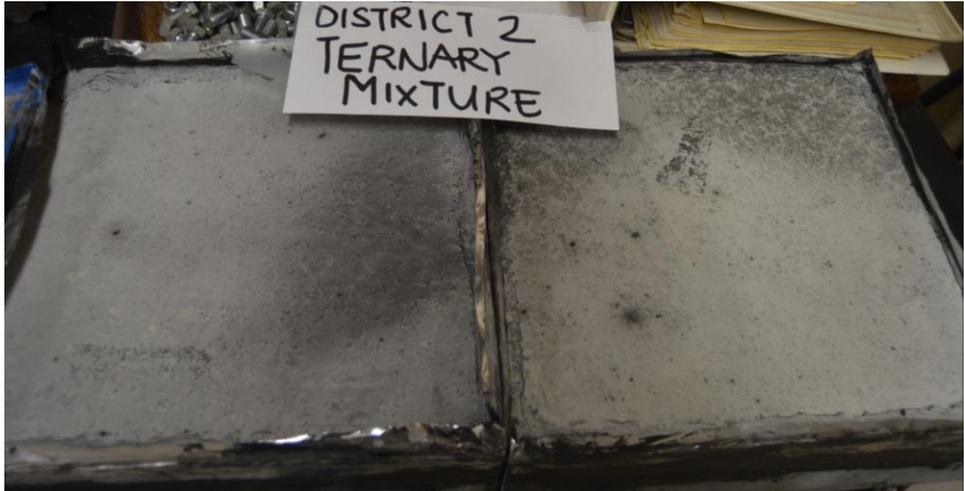
Figure 24. Specimens Tested for Deicing Scaling (District 2)

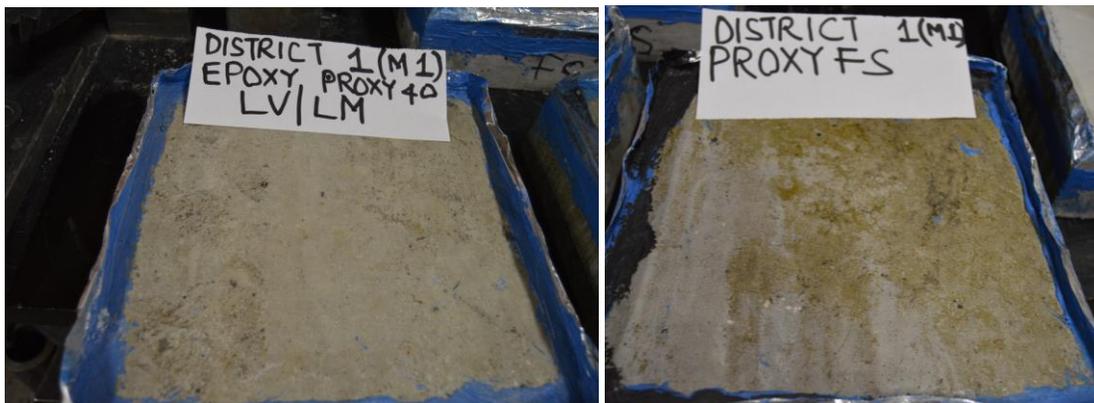
Figure 26. Epoxy coated Specimens Tested for Deicing Scaling (District 1)

The original structural mixtures specimens when coated with epoxy sealers showed no scaling as shown in Figures 25 and 26 and summarized in Table 12. Therefore, it is important to state that bridges and concrete pavement made with current ITD concrete mixtures can be protected from deicing scaling by applying epoxy sealers, if the cost is economical.
